Inspection Photos

API: 05-071-09613

Operator: Evergreen NATURAL RESOURCES

Inspection Date: 5/22/2019

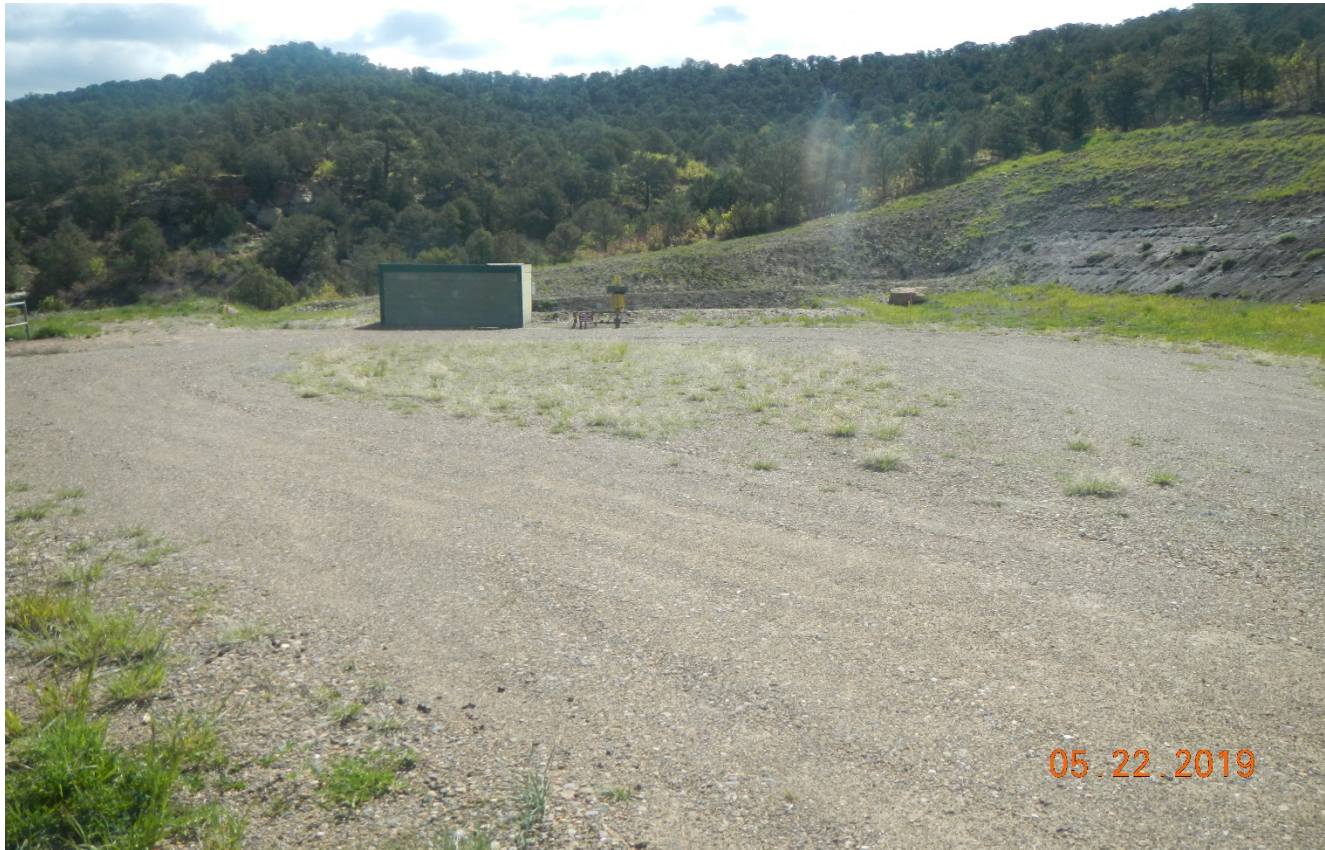
Photo 1. Facing east toward the location.

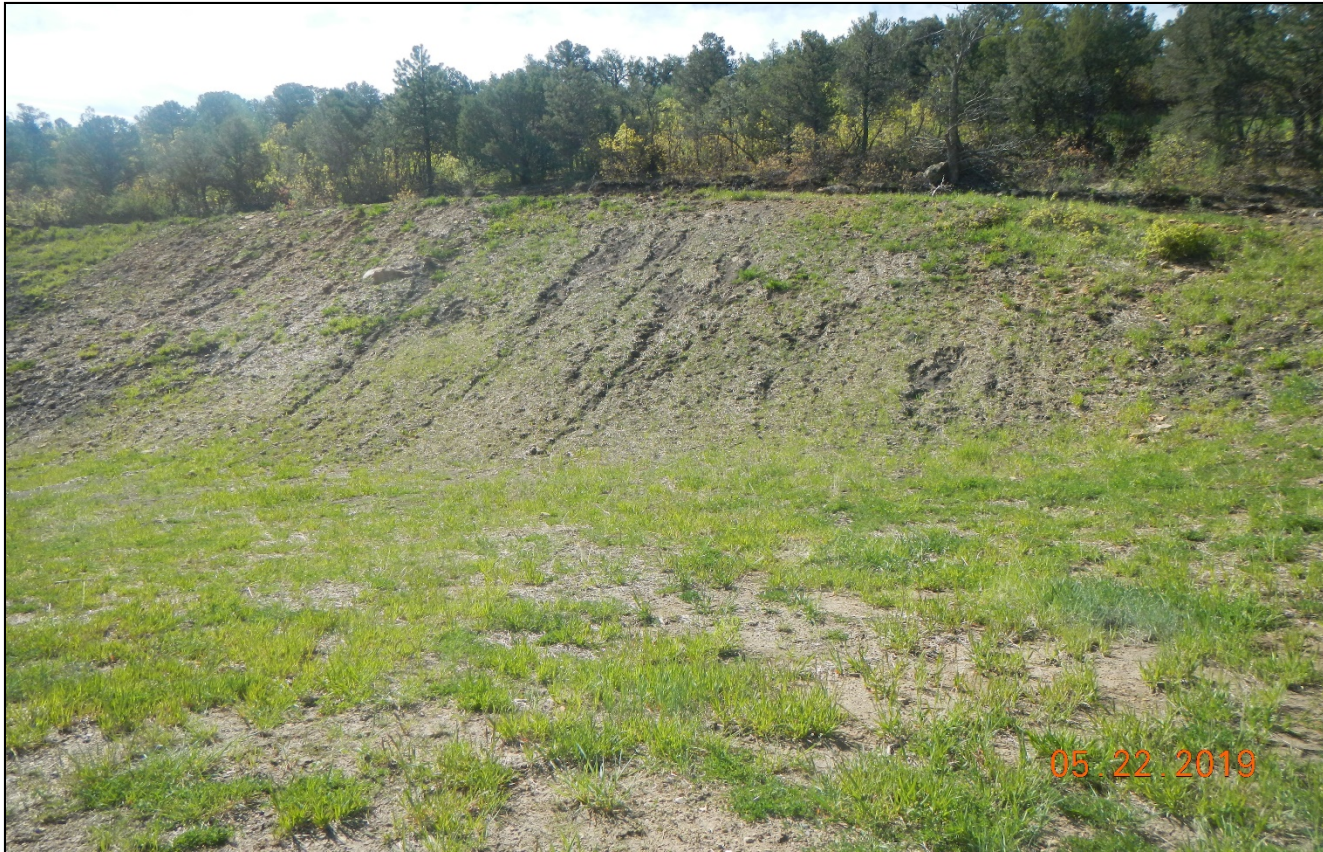
Photo 2. Facing toward the cut slope which appears to have recently been seeded and mulched. There is some rilling occurring,

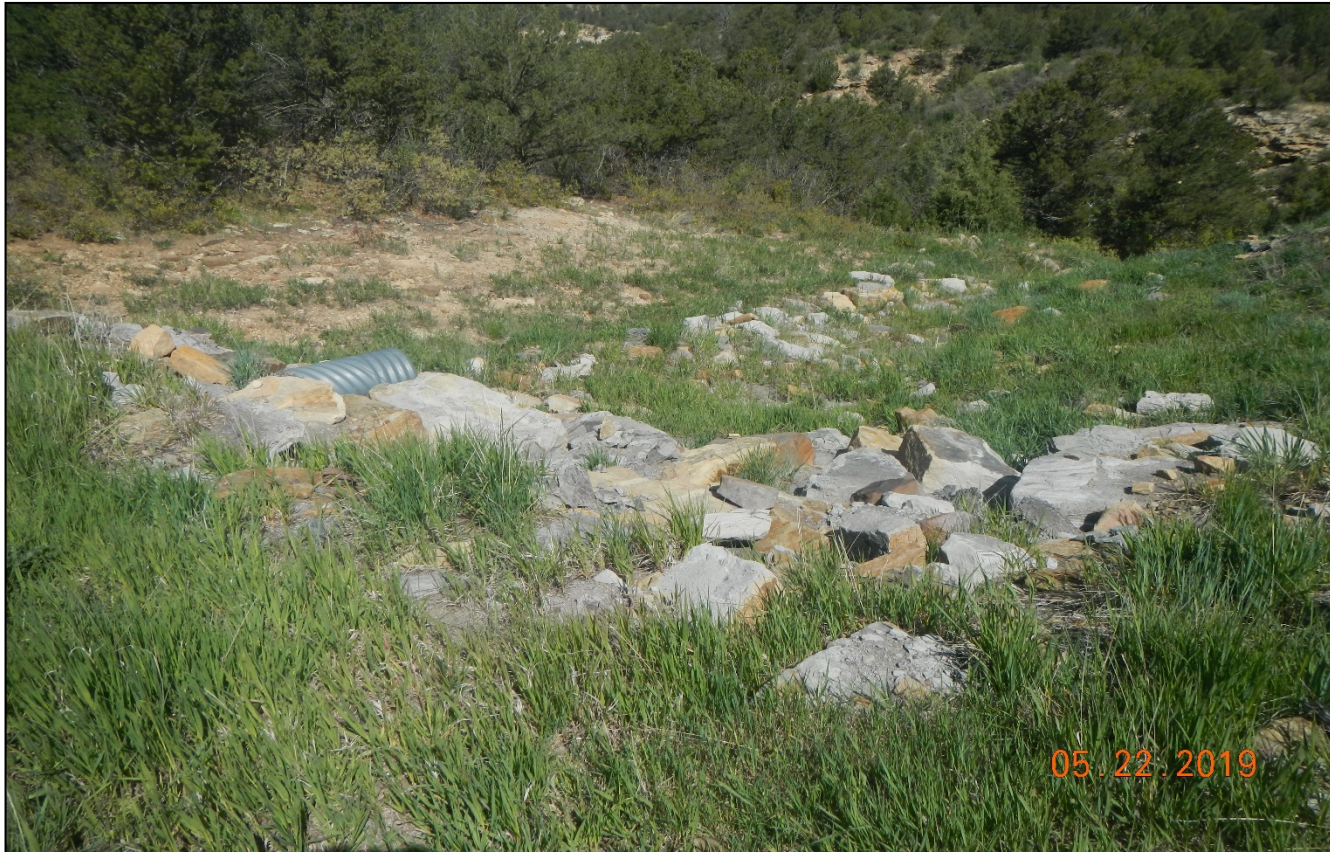
Photo 3. Outlet protection is installed at the culvert.

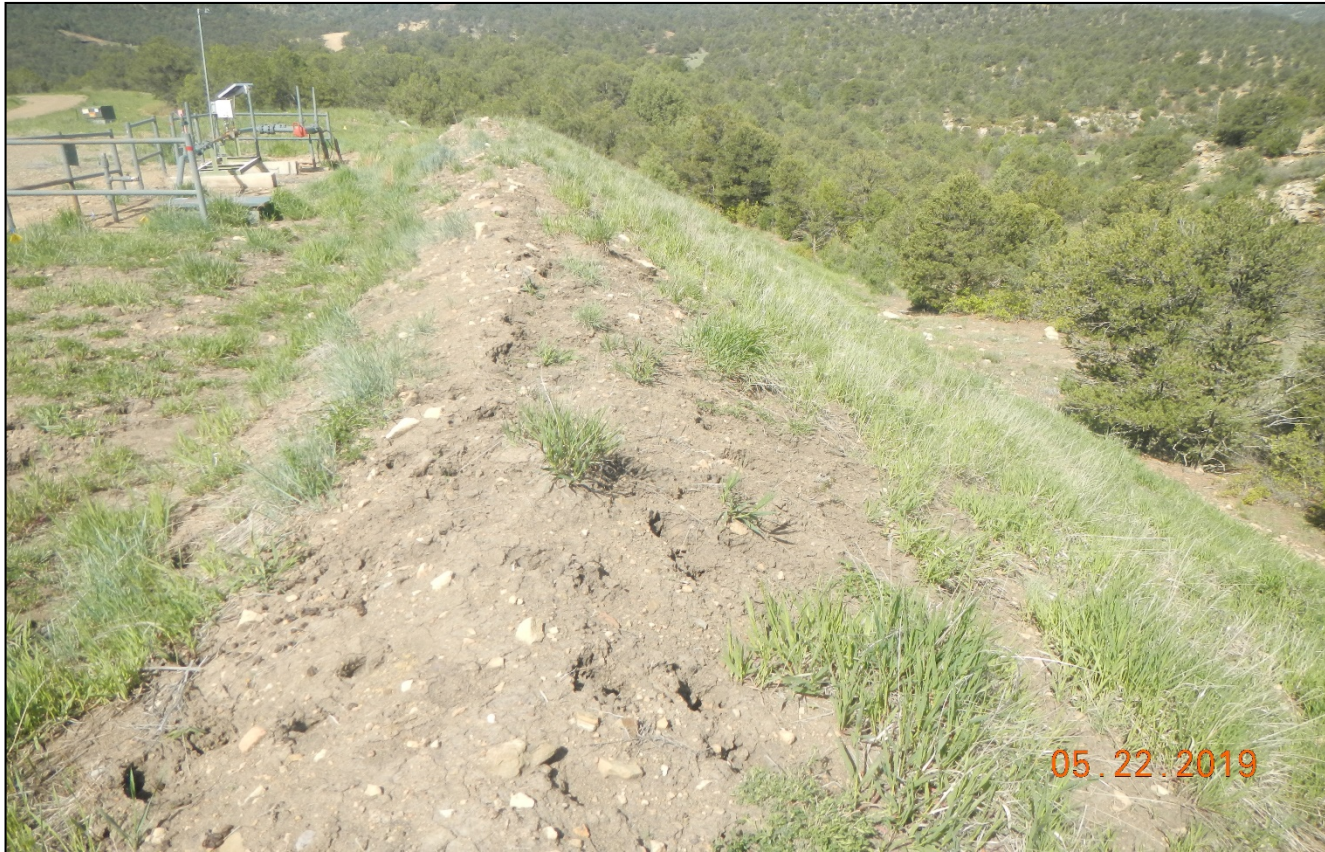
Photo 4. There is vegetation establishment along the fill slope.

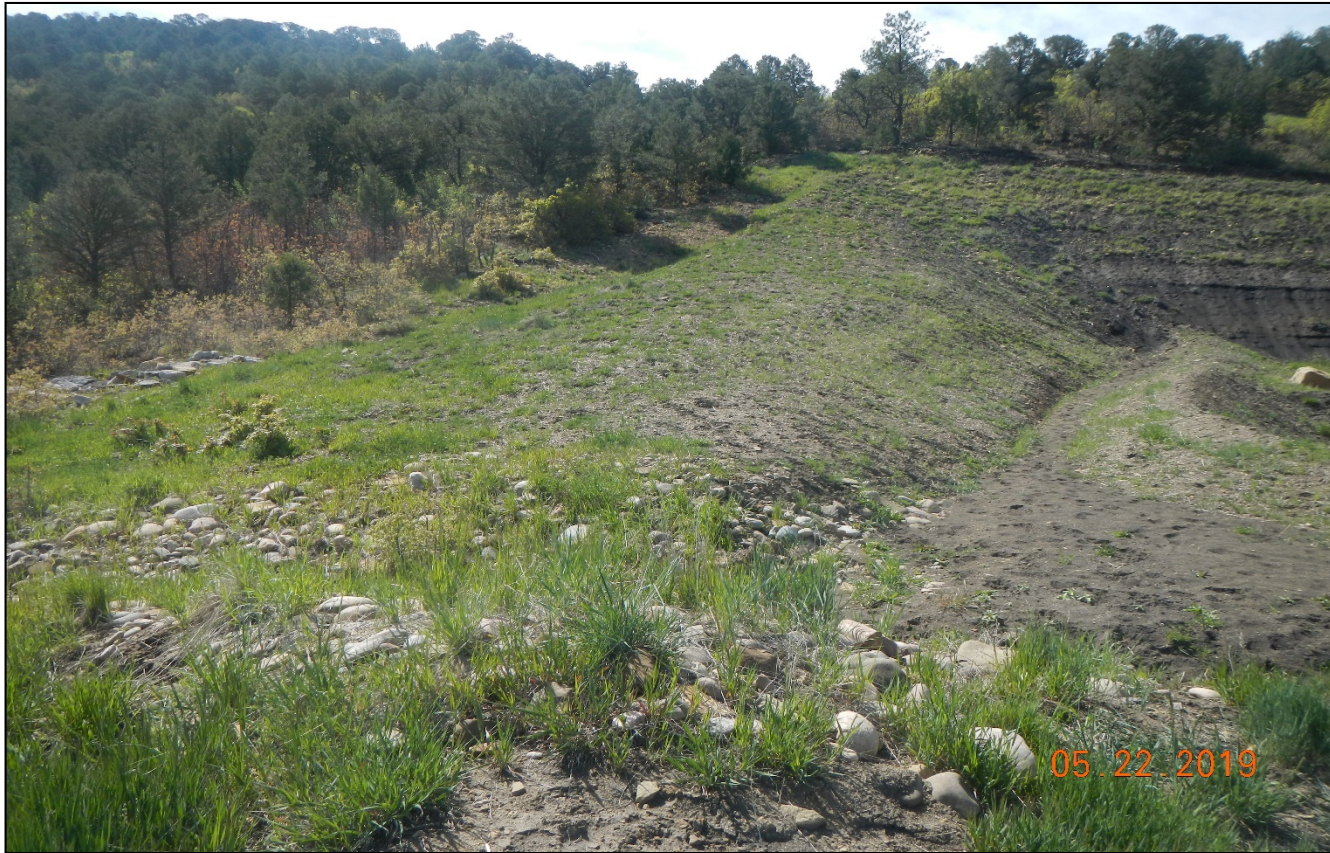
Photo 5. There is vegetation establishment along the cut slope.

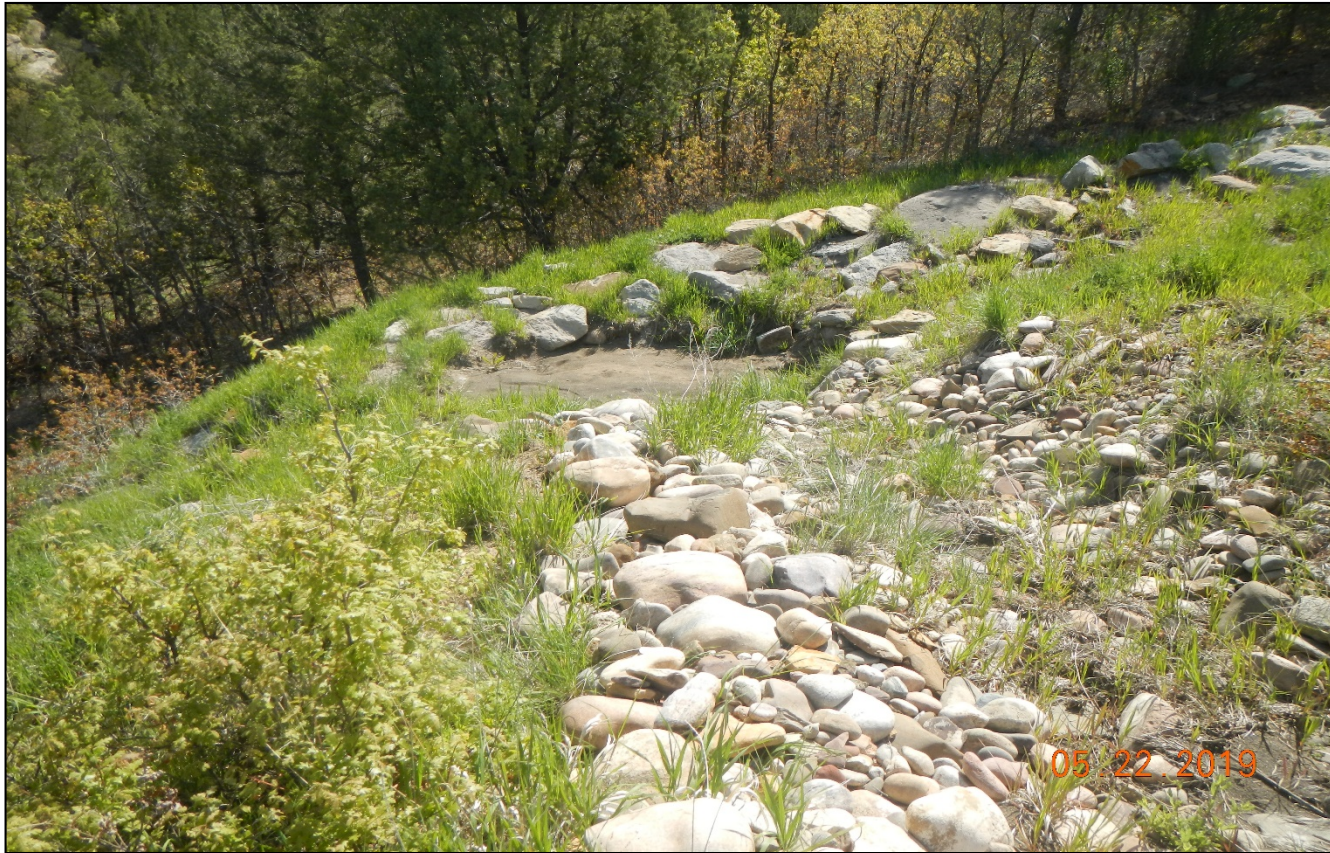
Photo 6. The sediment trap at the east side of the location needs to be cleaned out.
