Inspection Photos

API: 05-071-06636

Operator: Evergreen NATURAL RESOURCES

Inspection Date: 5/22/2019

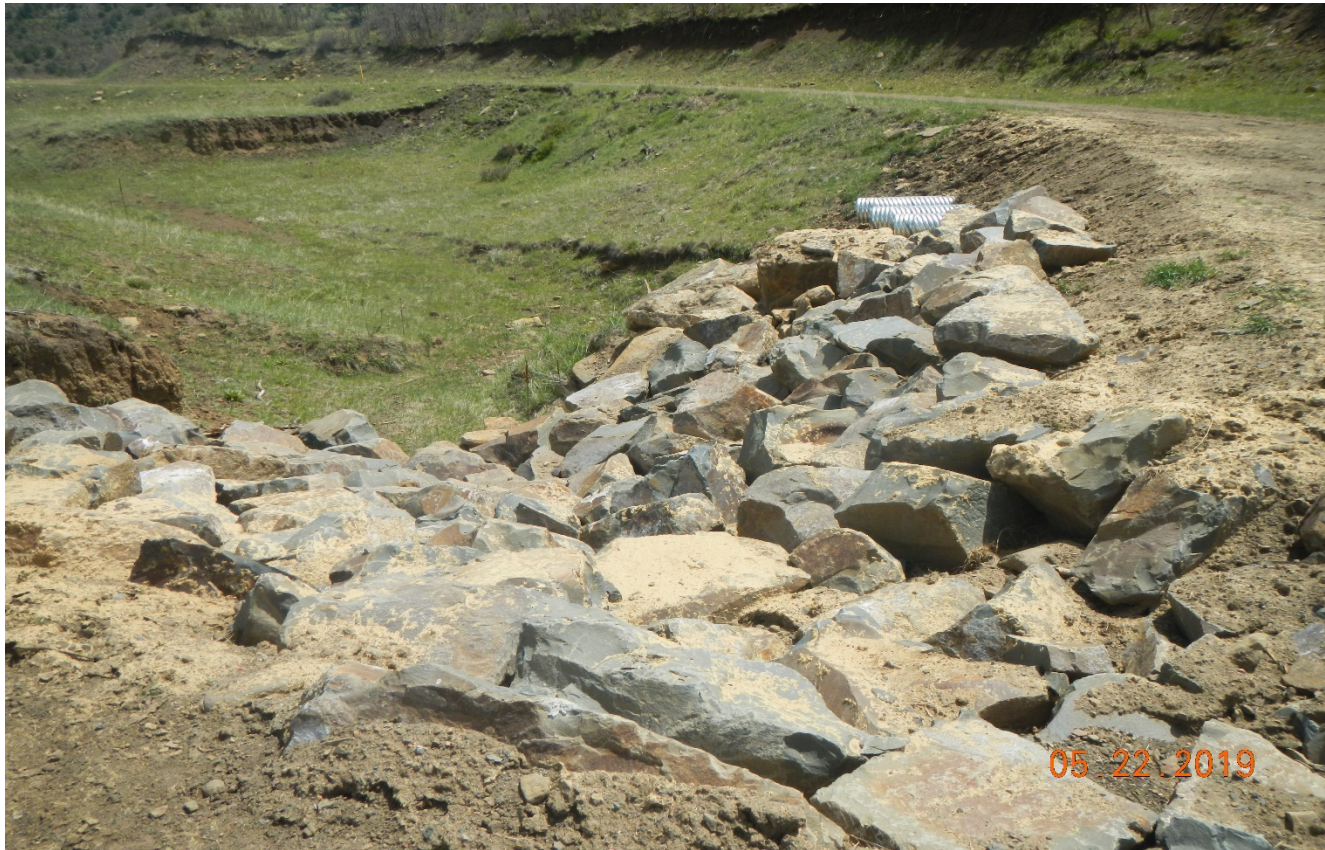
Photo 1. The erosion gully along the access road has been repaired and stabilized with rock rip/rap at Lat/Long:37.08649,-104.75026.

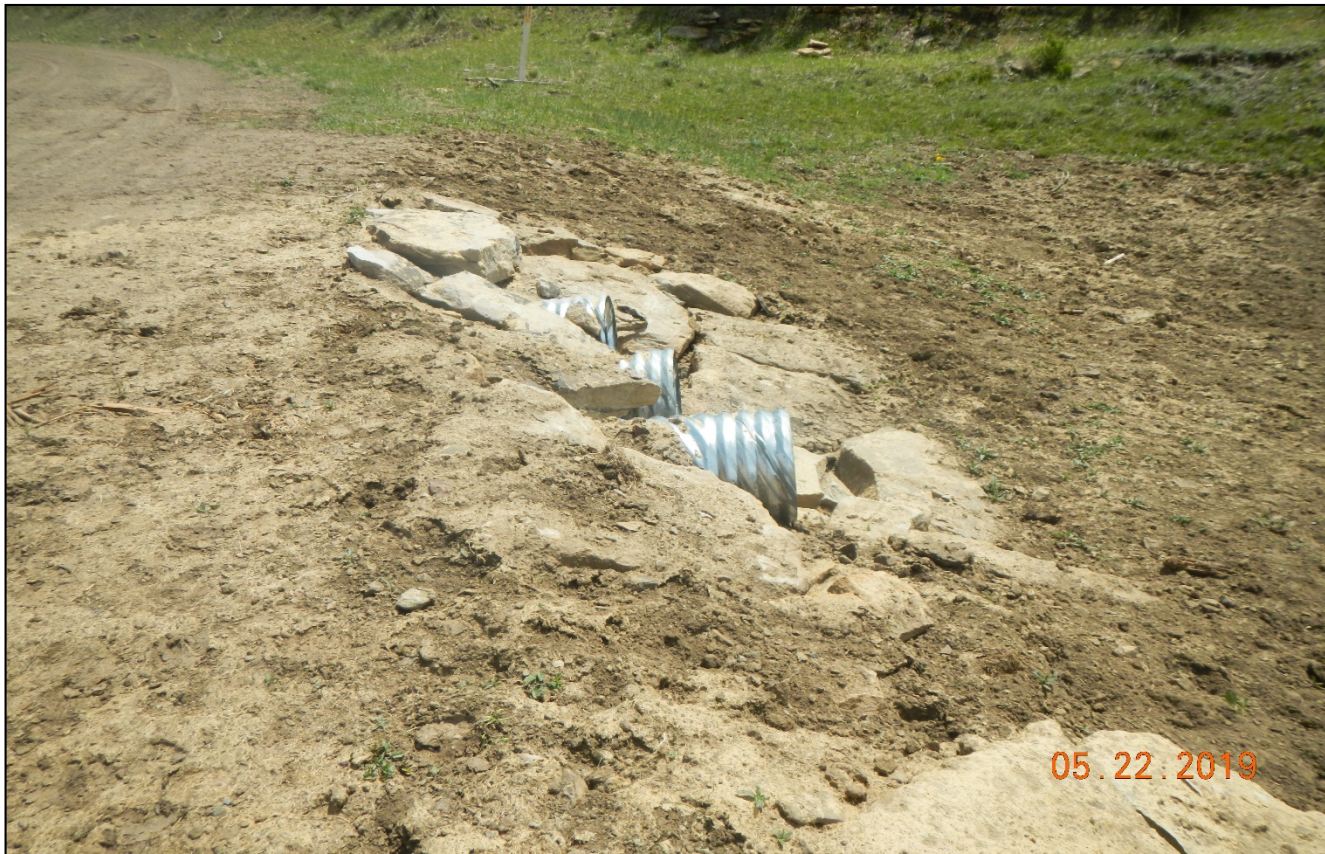
Photo 2. Three culverts have been installed at the access road at Lat/Long:37.08649,-104.75026.

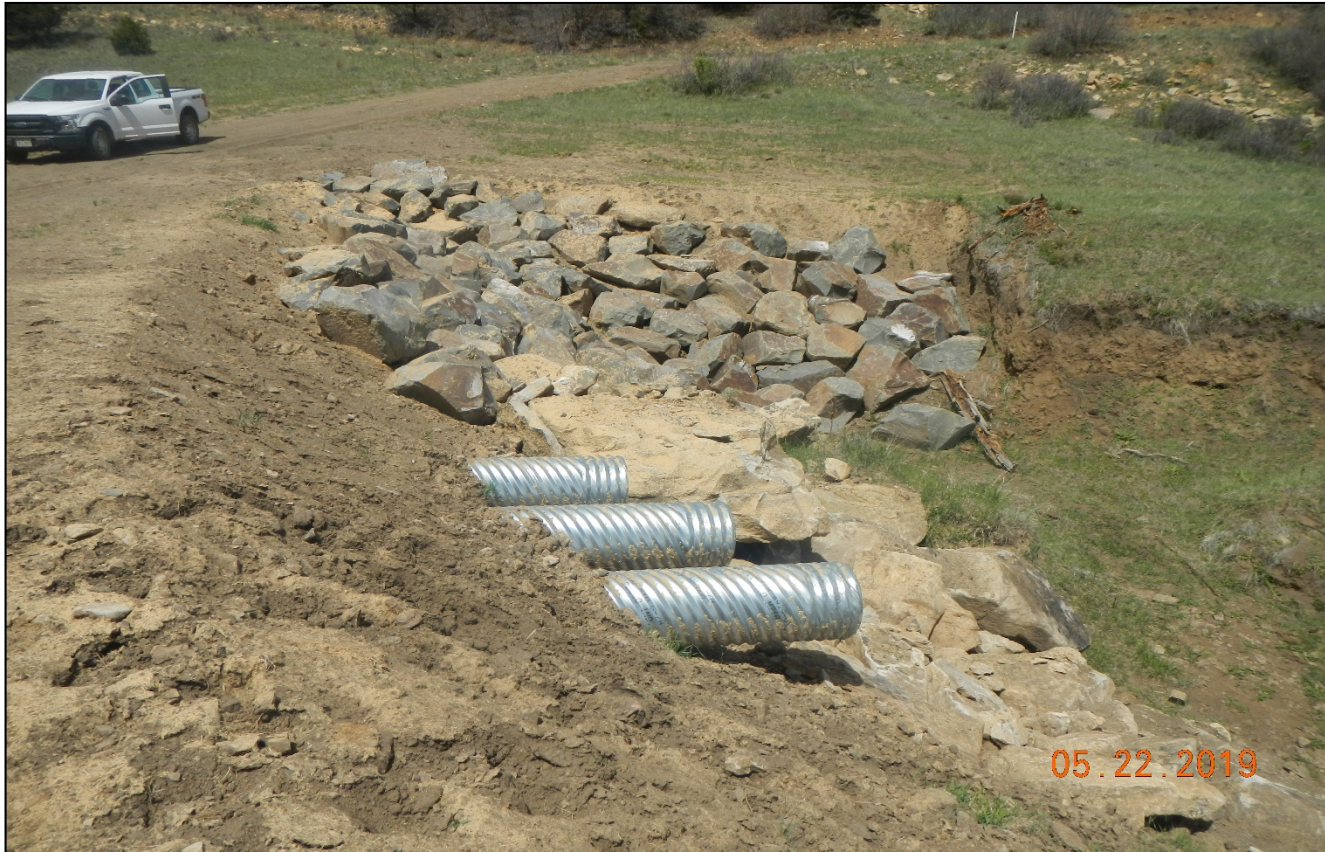
Photo 3. Facing toward the culvert outlet and gully repair.

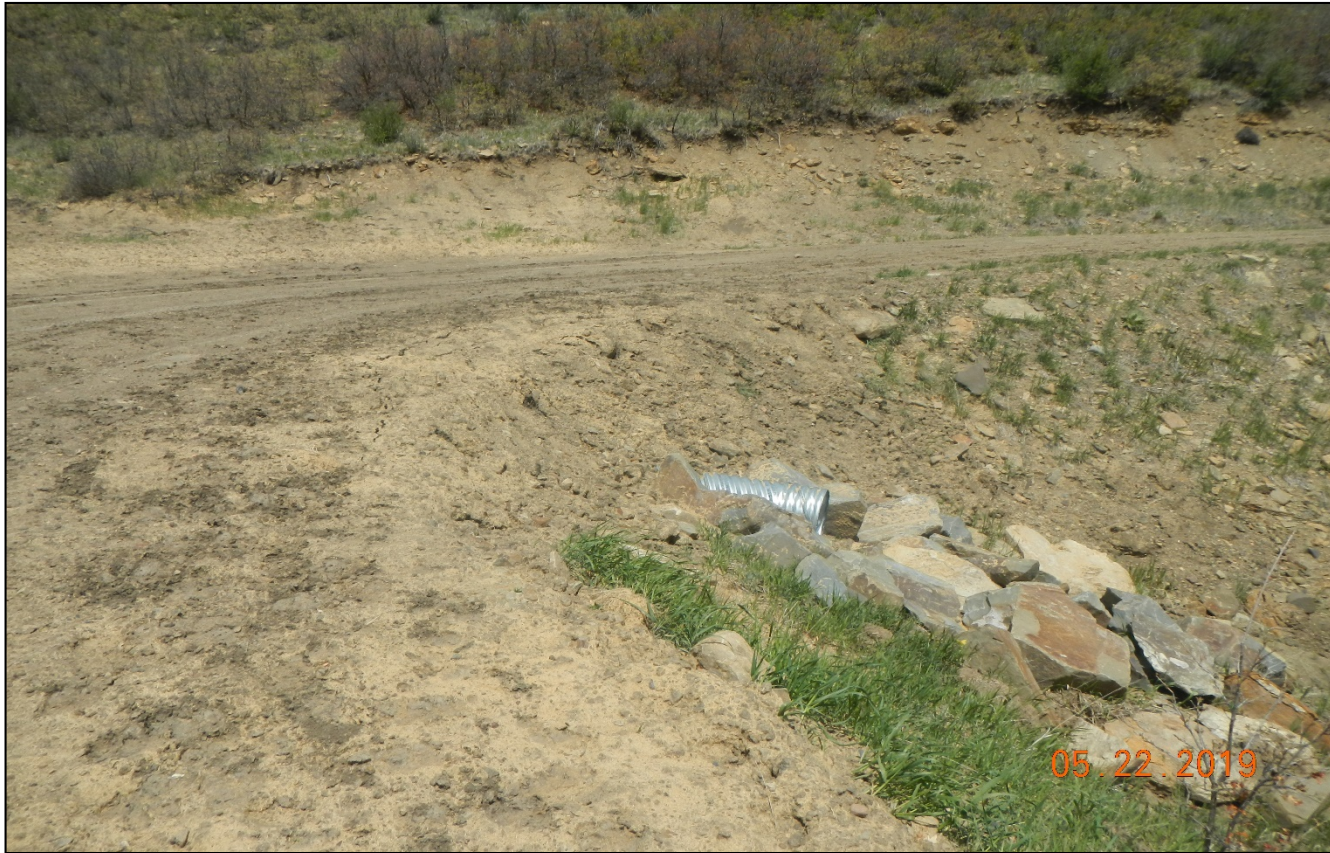
Photo 4. A new culvert was installed at Lat/Long:37.09338,-104.74751.
