Inspection Photos

API: 05-071-06598

Operator: Evergreen NATURAL RESOURCES

Inspection Date: 5/22/2019

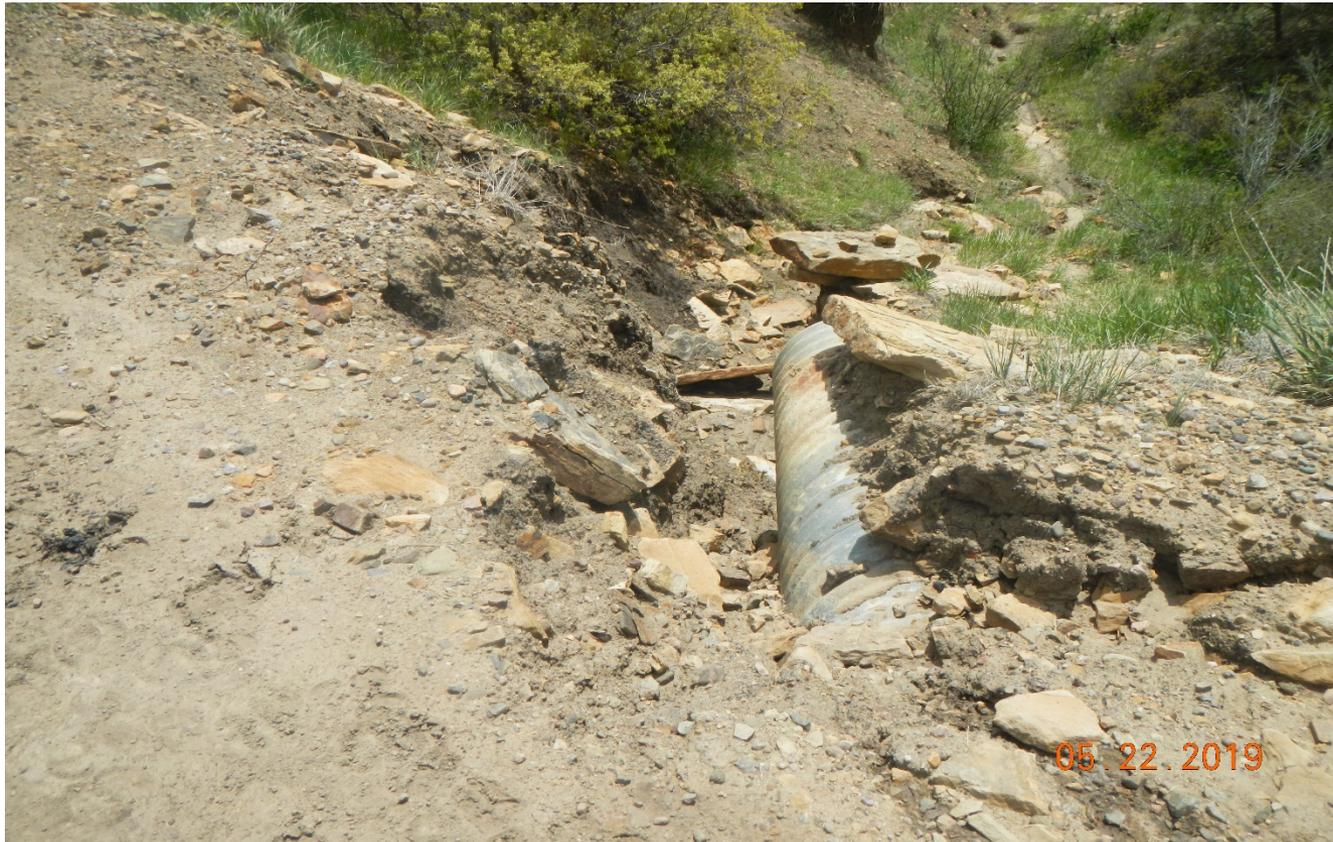
Photo 1. There is erosion issues at this outlet culvert at Lat/Long:37.09868,-104.74486. No outlet protection.

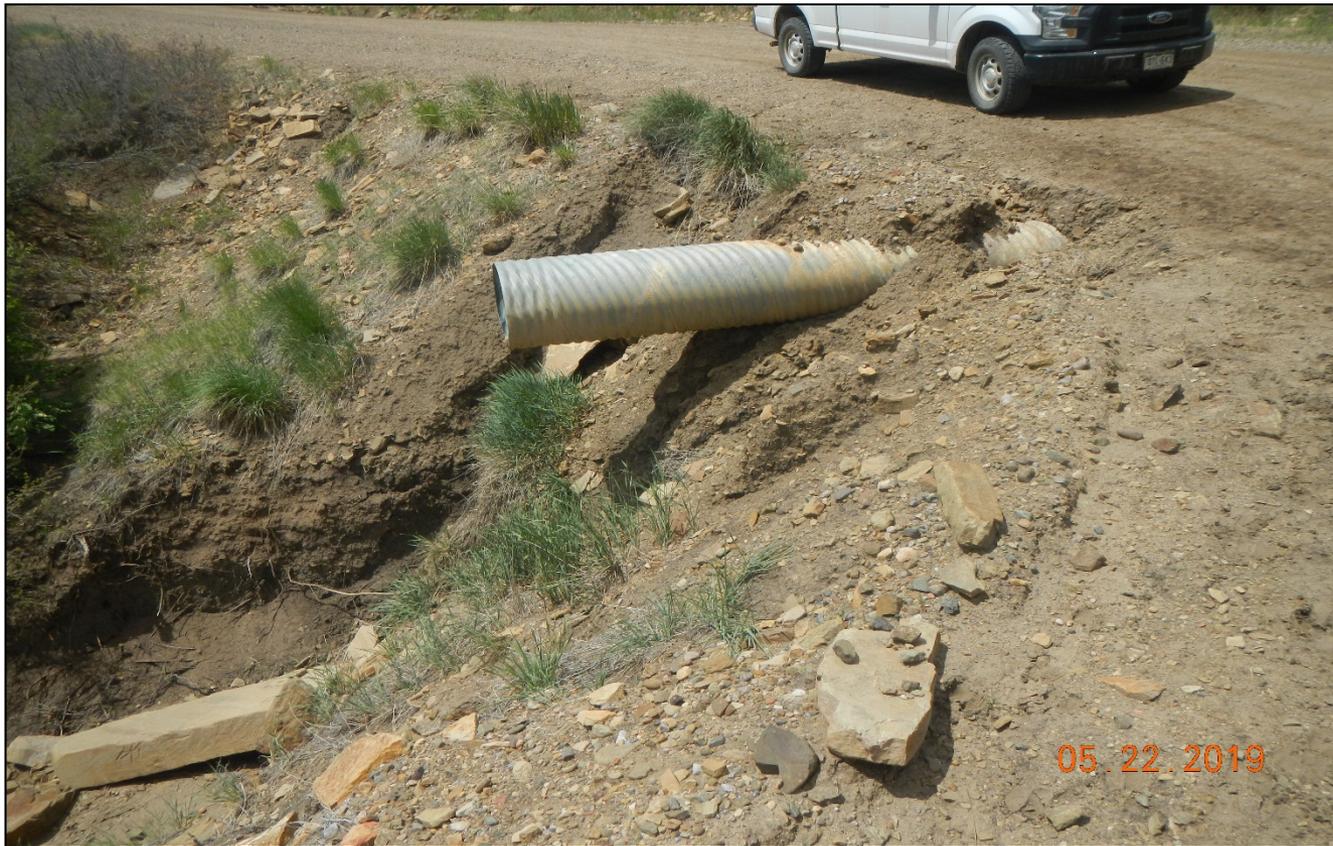
Photo 2. View of erosion around the culvert.

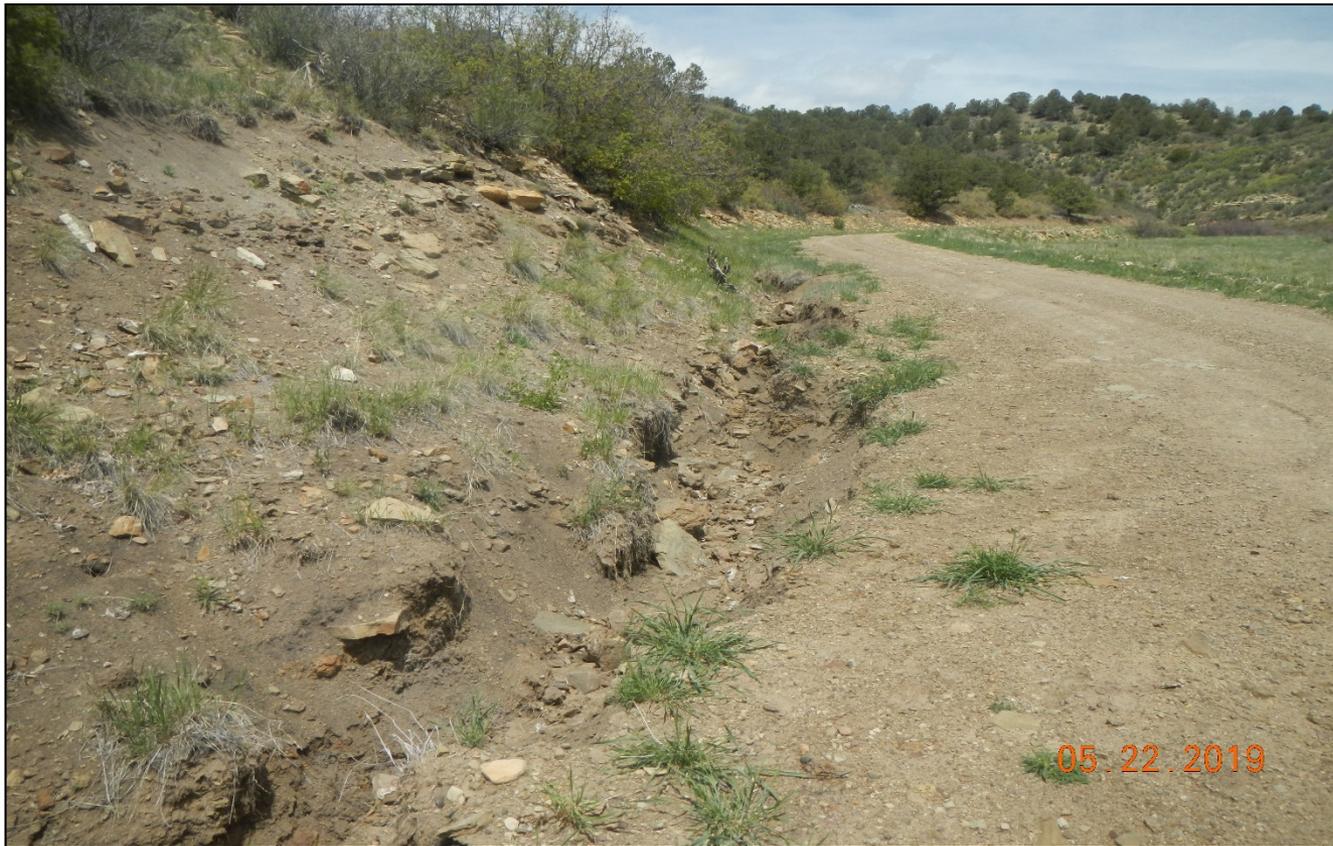
Photo 3. There is erosion channel along the access road at Lat/Long: 37.09935, - 104.74298.

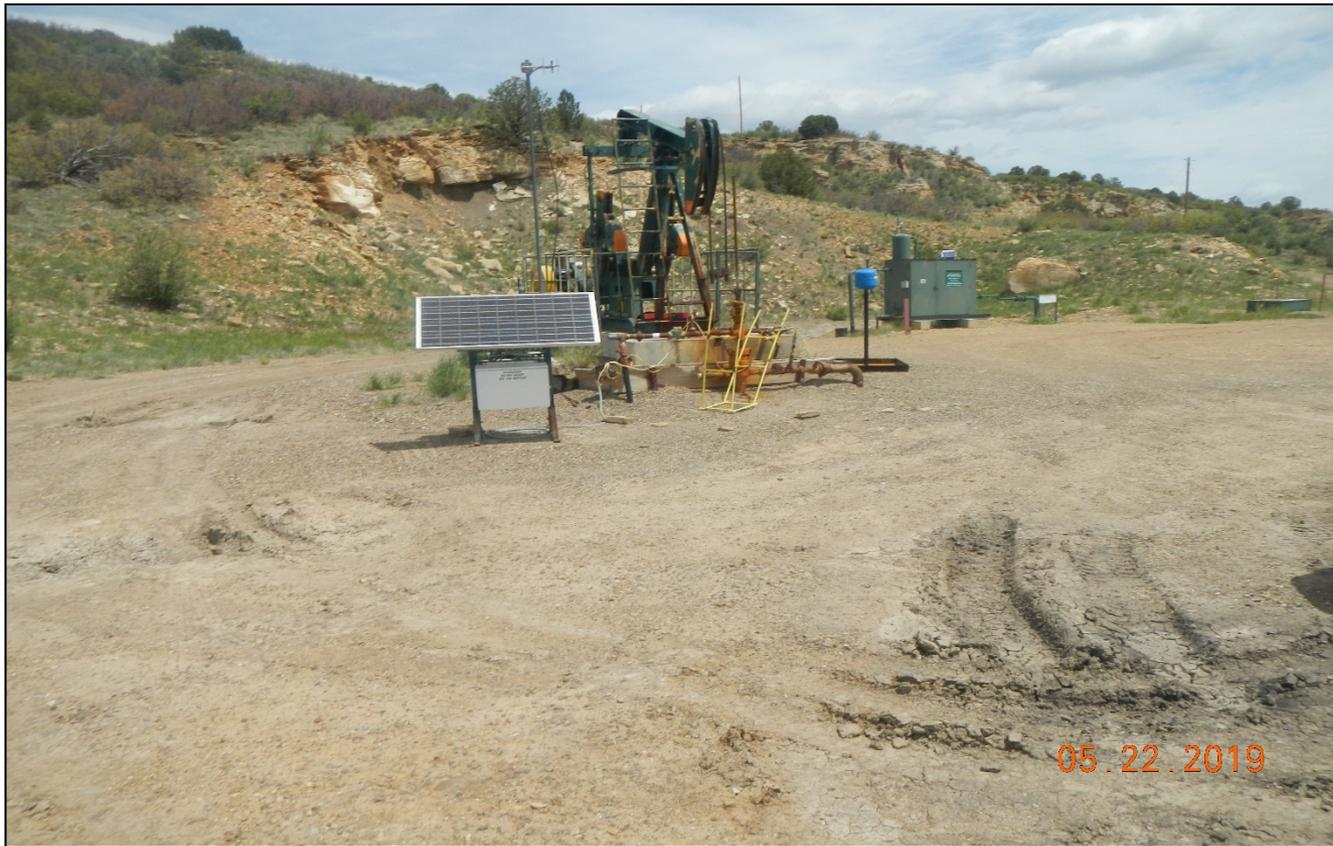
Photo 4. Facing toward the location.

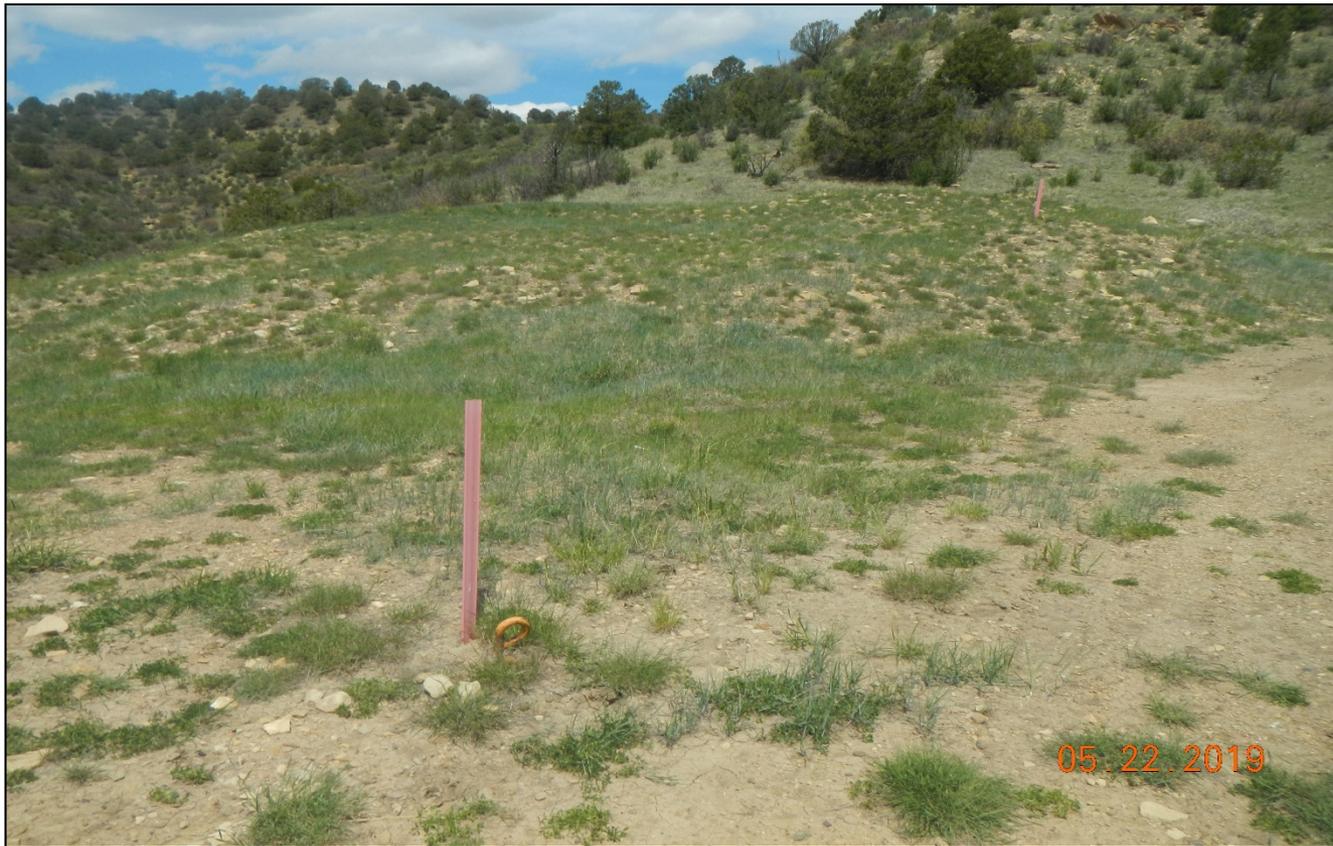
Photo 5. Vegetation is established in the interim area.
