Inspection Photos

API: 05-071-06678

Operator: Evergreen NATURAL RESOURCES

Inspection Date: 5/22/2019

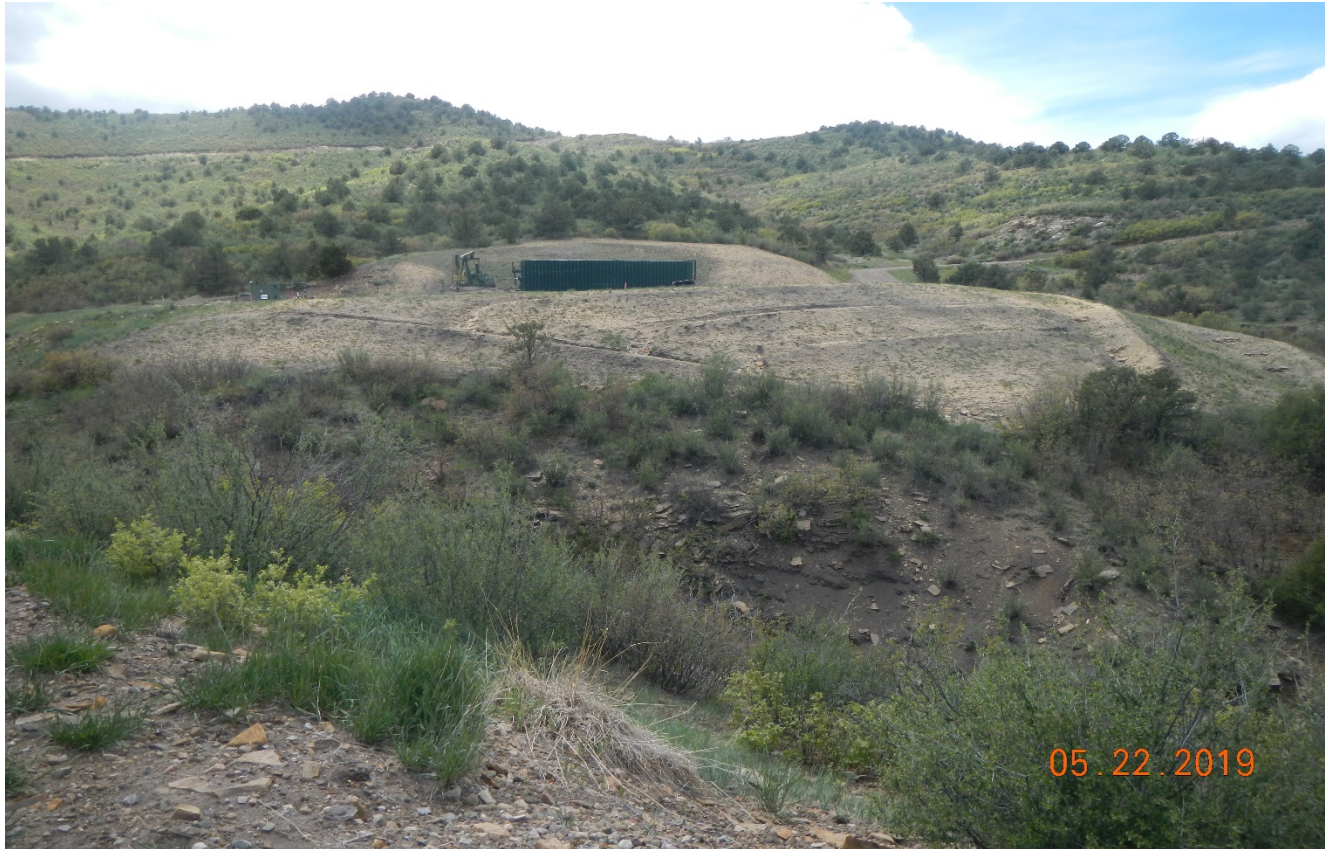
Photo 1. Facing south toward the location. The fill and cut slopes have been seeded and hydromulched.

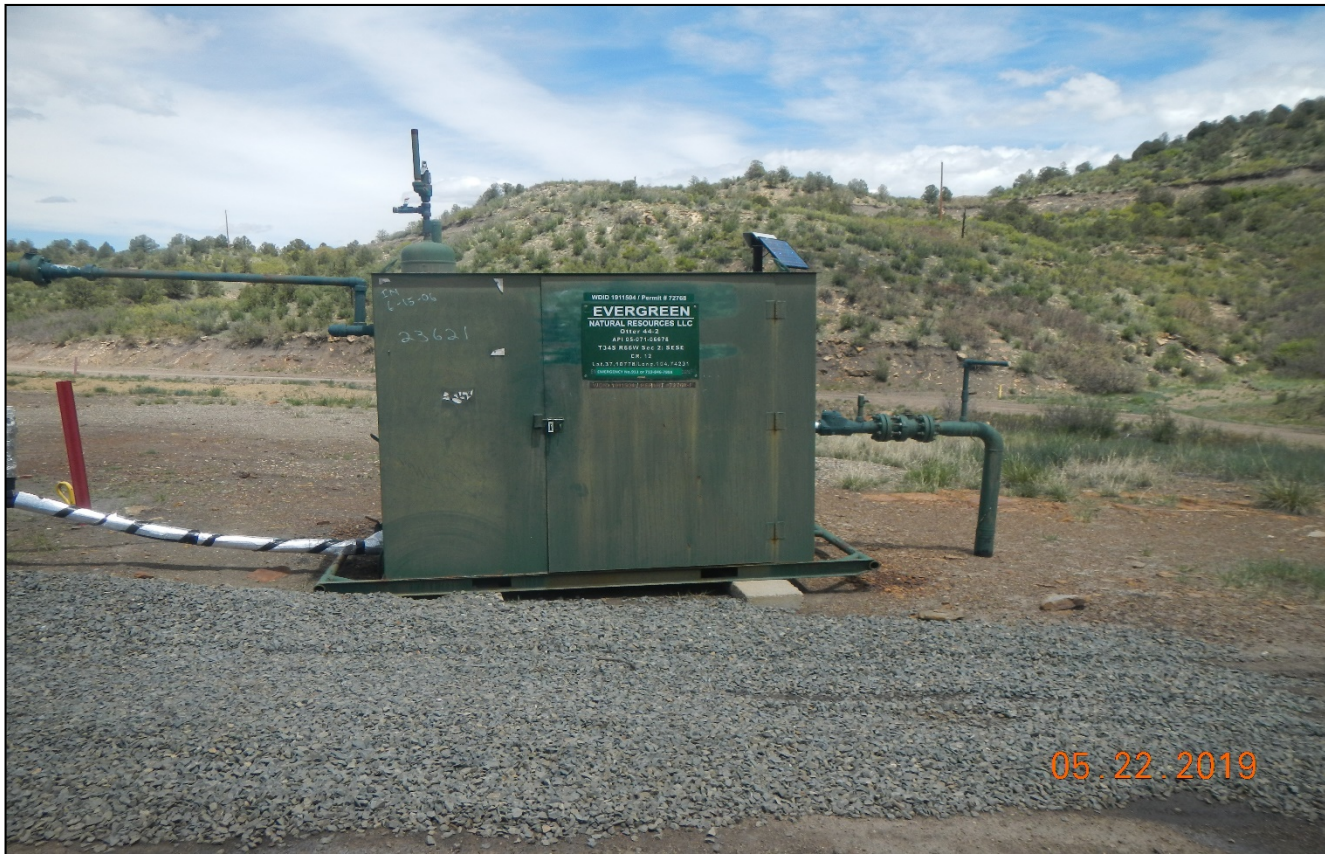
Photo 2. Sign is updated.

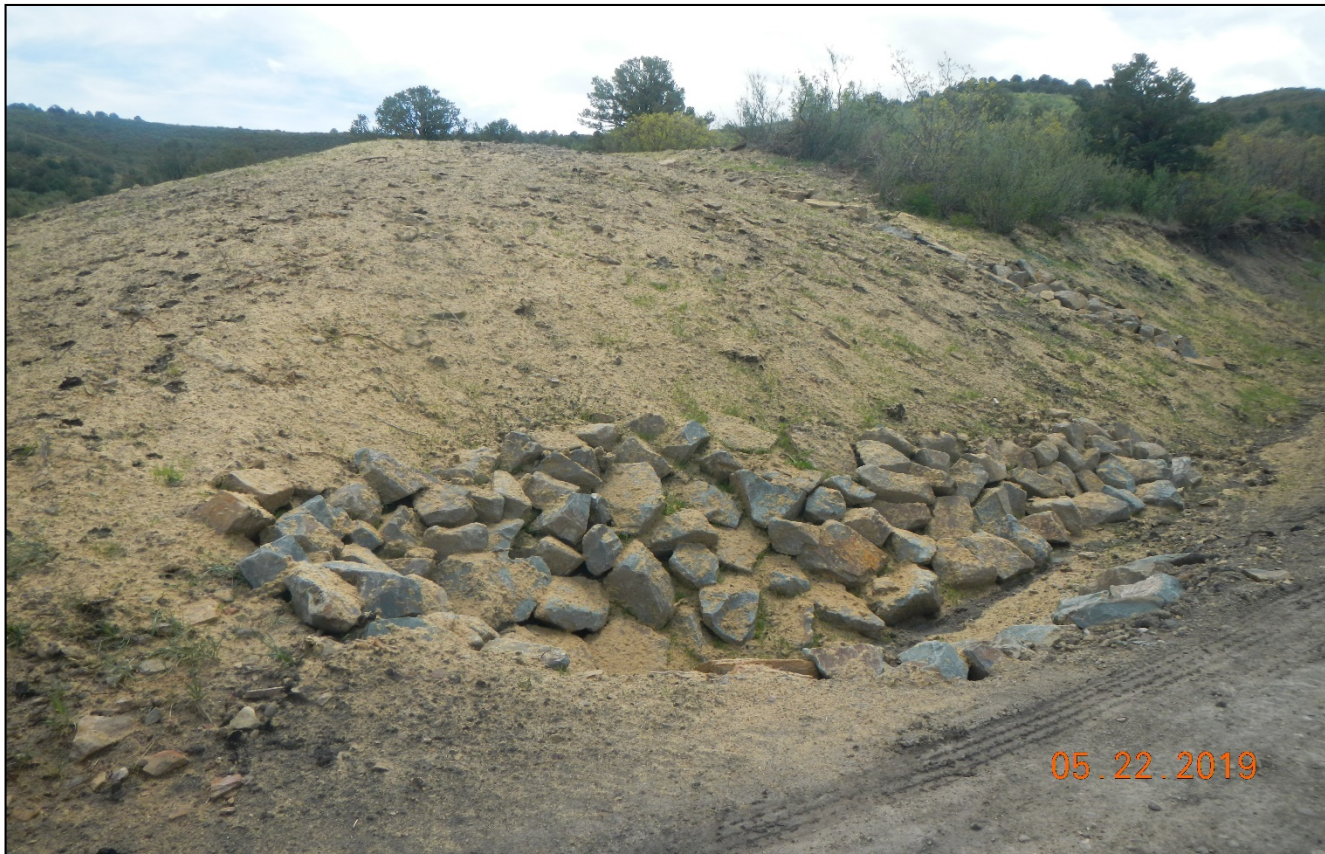
Photo 3. The cut slope has been stabilized with hydro mulch and rock rip/rap.

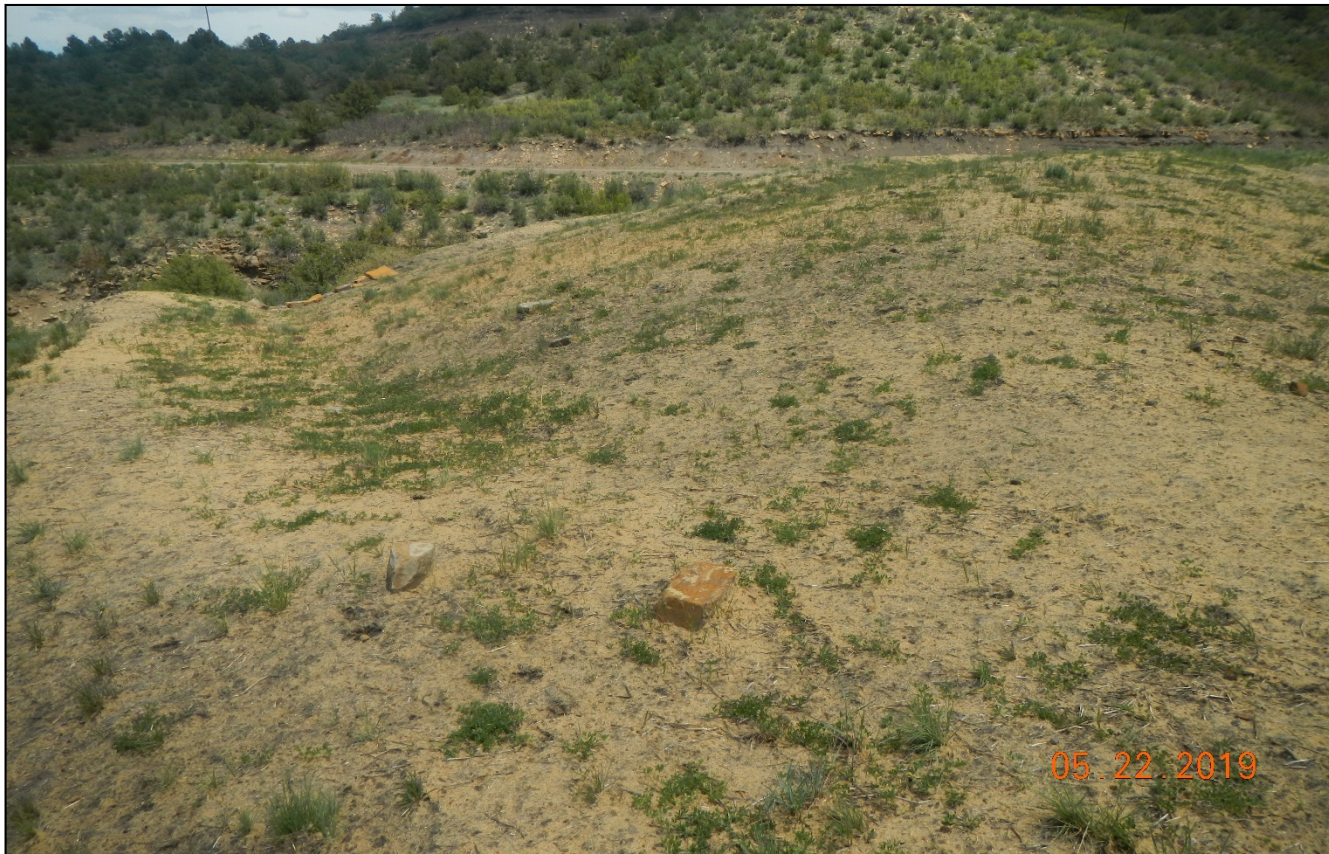
Photo 4. The fill slope has been hydromulched and seeded.

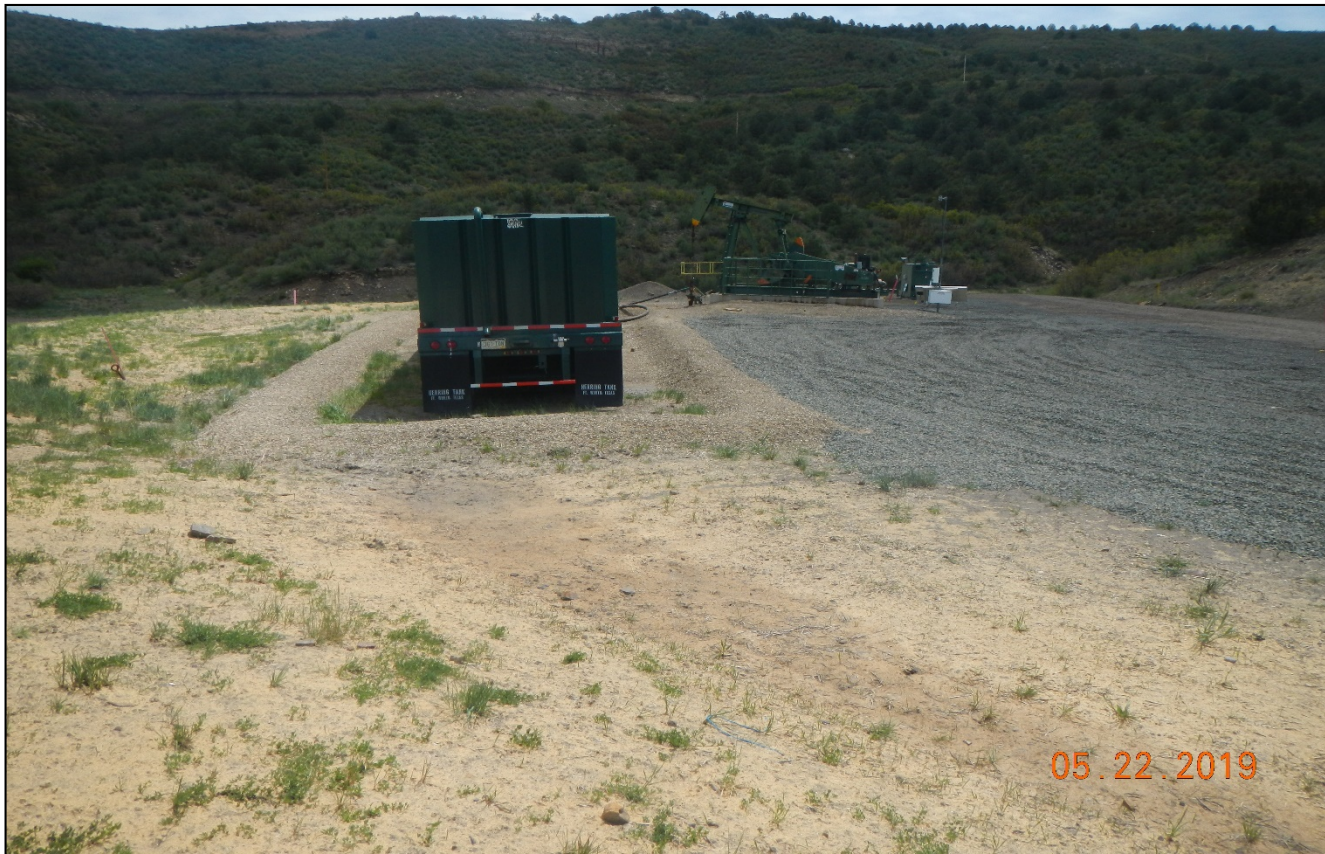
Photo 5. Gravel has been placed on pad surface. Berm is adequate around tank.
