Inspection Photos
Location Name: KEIDO 14-6
API #: 05-071-08150
INSP. #:695100651

Location Name: KEIDO 14-6 & TR WELL

API #: 05-071-08150 & 08629

INSP. #:695100651

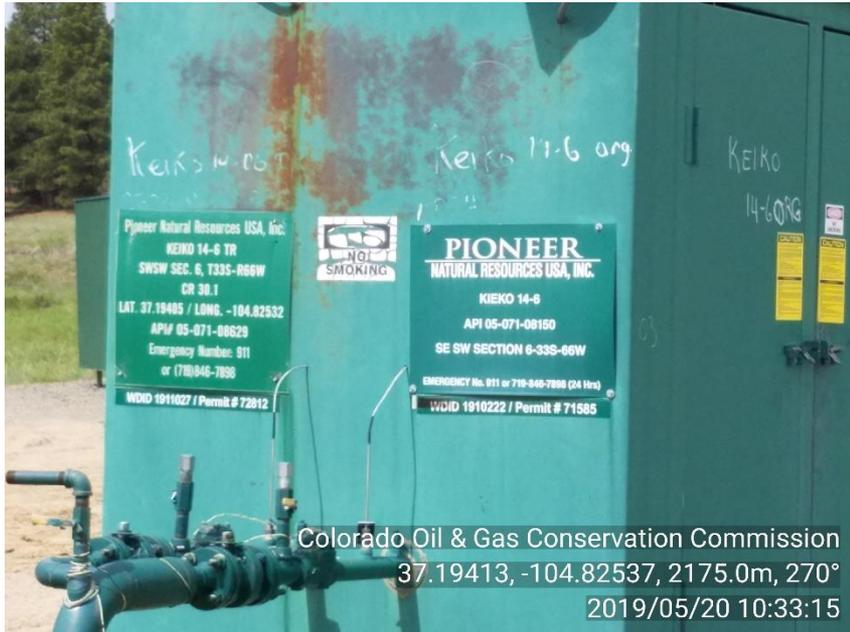
PHOTO 3: LOCATION SIGNS POSTED ON METER HOUSE

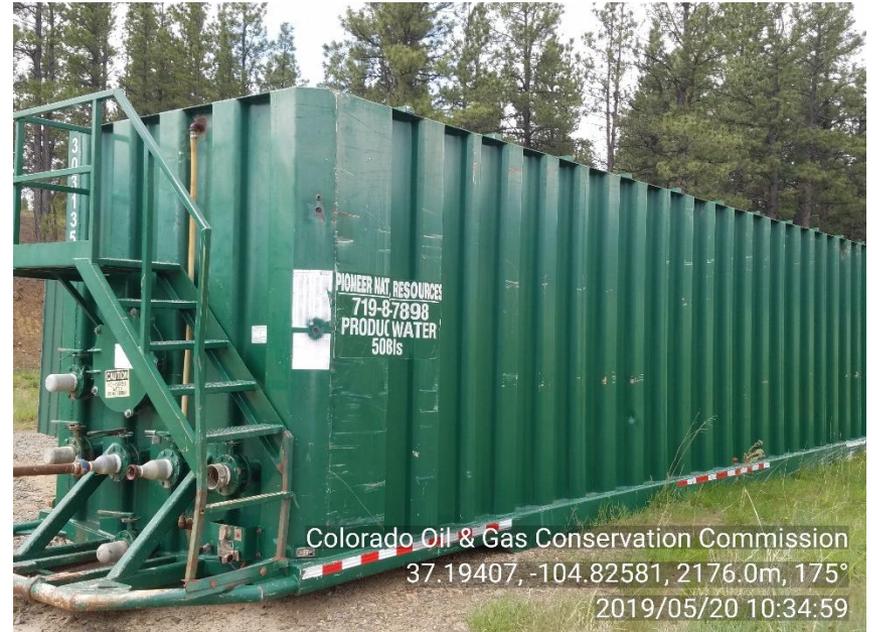
PHOTO 4: NO NFPA SIGNS POSTED ON PRODUCED WATER TANK. **Install sign to comply with Rule 210.d. CA DATE 7/20/19**

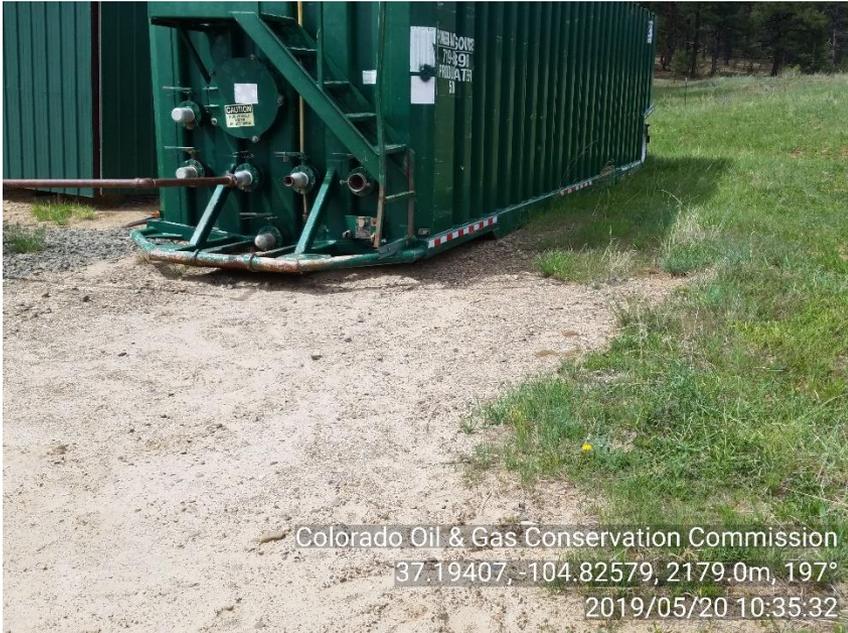
PHOTO 5: NO BERMS AROUND PRODUCED WATER TANK. Repair or install berms or other secondary containment devices per Rule 605. CA DATE 6/30/18

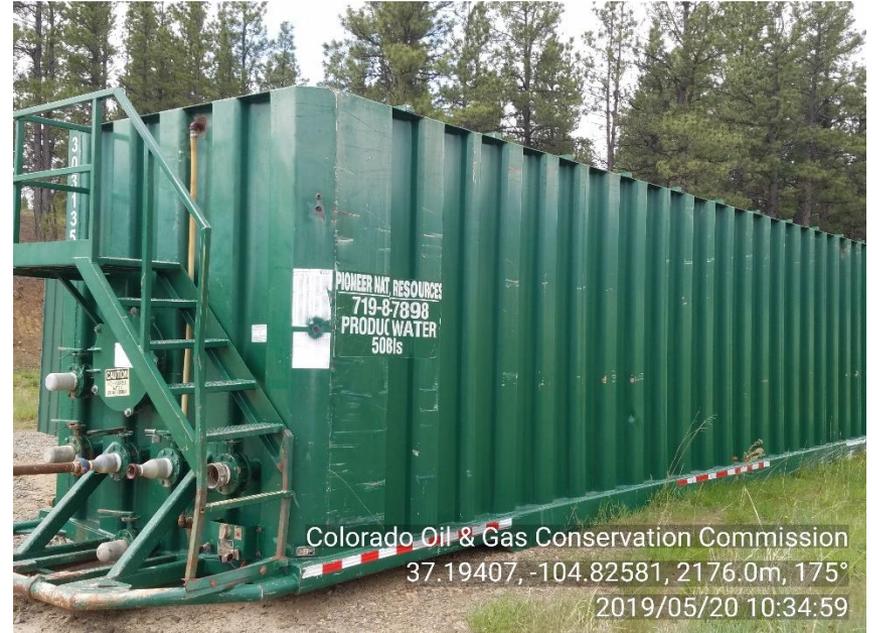
PHOTO 4: NO NFPA SIGNS POSTED ON PRODUCED WATER TANK. Install sign to comply with Rule 210.d. CA DATE 7/20/19
