Inspection Photos
Location Name: ELVIRIA 24-12
API #: 05-071-09528
INSP. #:695100655

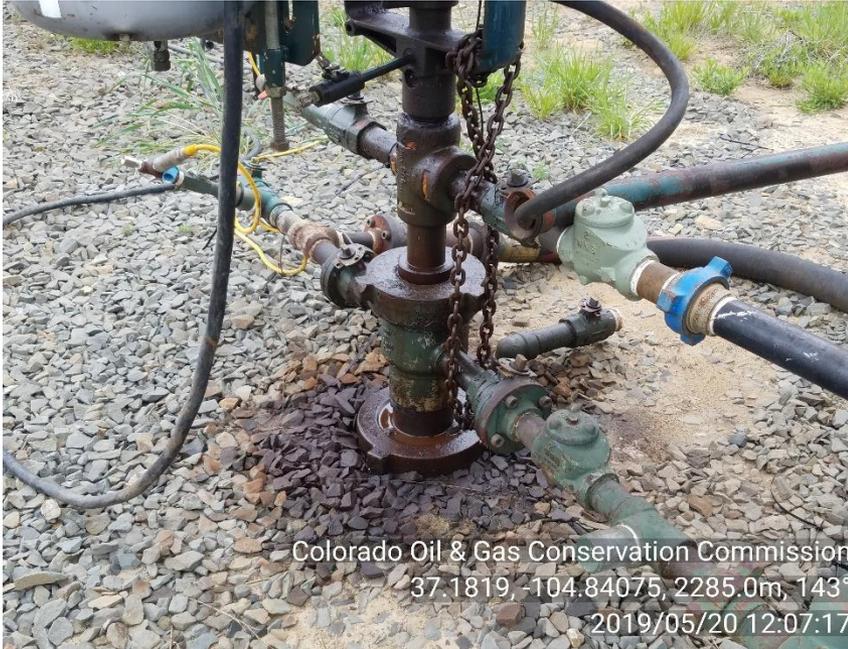
PHOTO 1: WELLHEAD/ IMPACTED SOIL. increase frequency of maintenance and self inspection schedule of equipment to prevent impacting surface materials and mixing of wastes with precipitation"
CA DATE 6/20/19

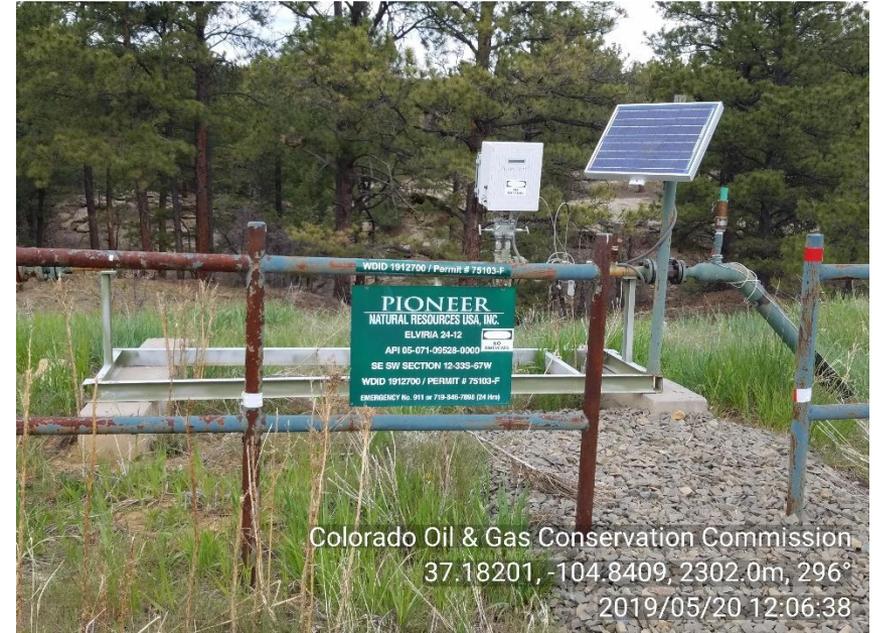
PHOTO 2: WELL SIGN NOT DEPICTING CURRENT OPERATOR. COMPLY WITH RULE 210. CA DATE 7/20/19
