Inspection Photos

Location Name: CC 0629-01 Pad & Central Water Handling Facility

Location ID: #323887 & Facility ID: #417559

Inspection Date: April 17, 2019 & May 10, 2019

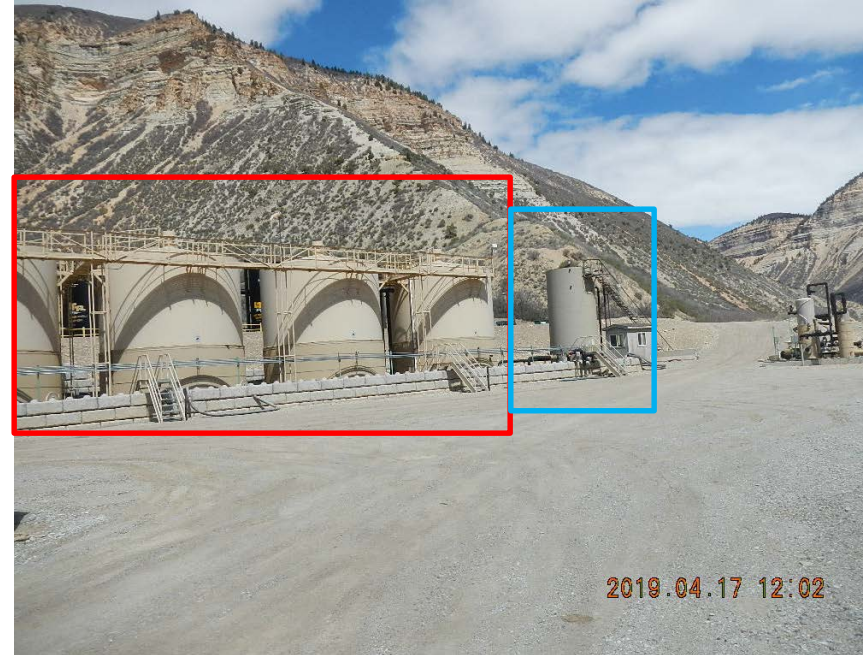
Photo #2 – Overview of central tank battery (four 1500 produced water ASTs inside of lined secondary containment) and attached tank battery for 500 bbl produced water/condensate AST.

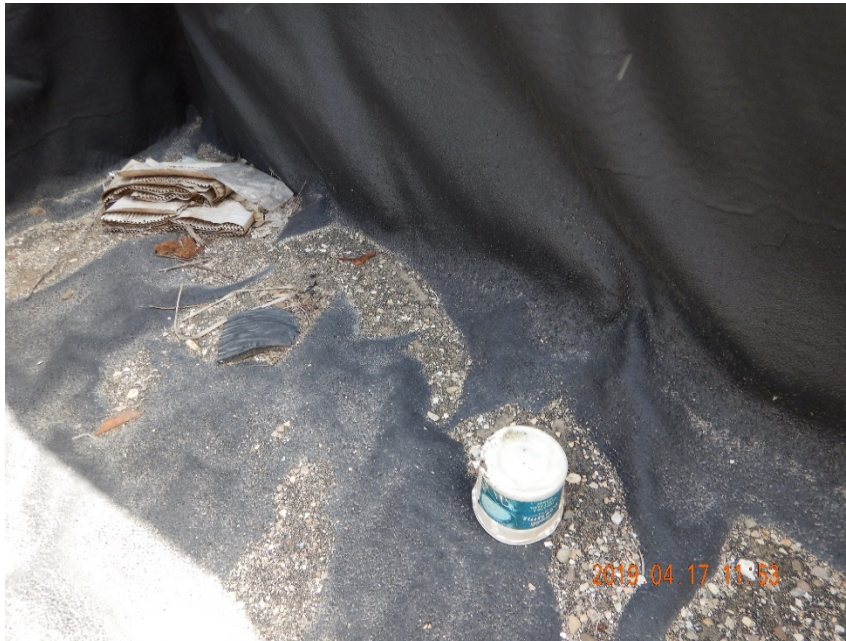
Photo #3 – Trash and wind-blown weeds accumulating inside of central tank battery secondary containment (1).

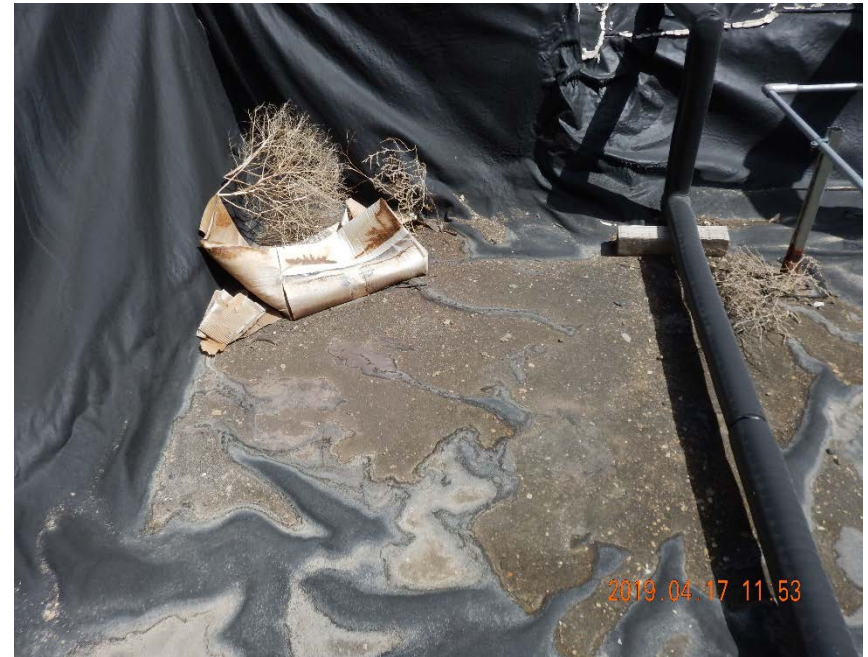
Photo #4 – Trash and wind-blown weeds accumulating inside of central tank battery secondary containment (2).

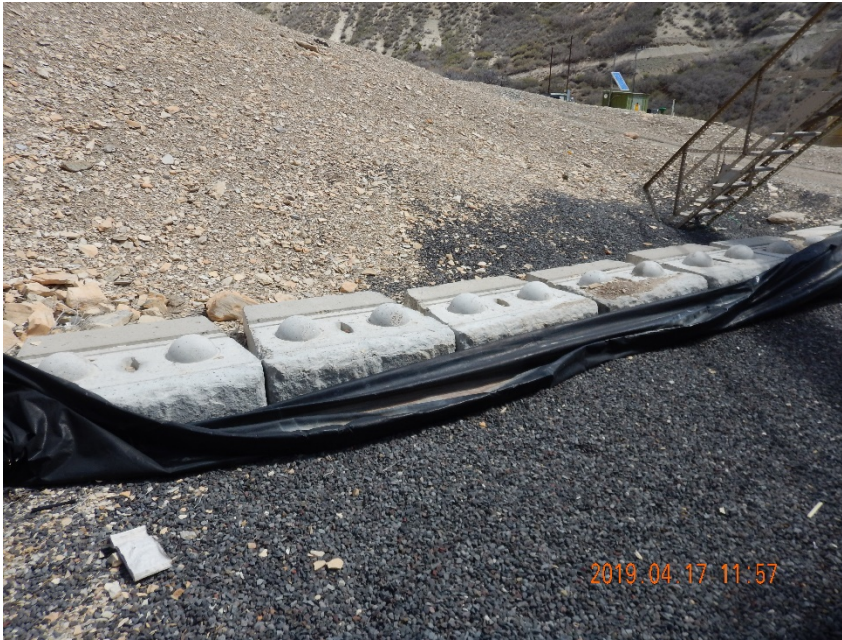
Photo #5 - View of tank battery liner NE of 500 bbl produced water/condensate AST. Note that liner is not secured along wall.

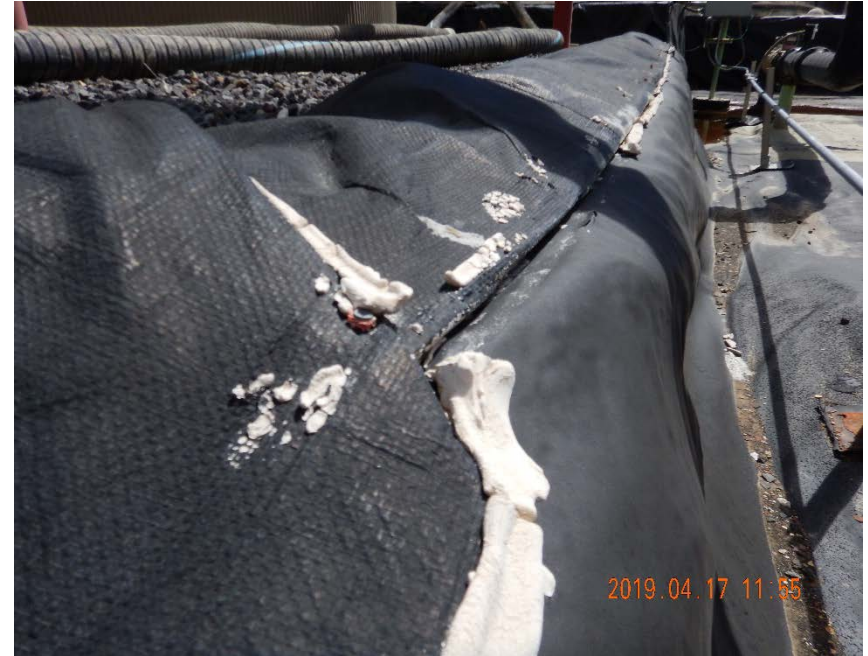
Photo #6 – View of liner seam between 500 bbl produced water/condensate AST battery from previous photo and central tank battery. Liner and seam in disrepair. Note liner is secured and punctured with nails in this area.

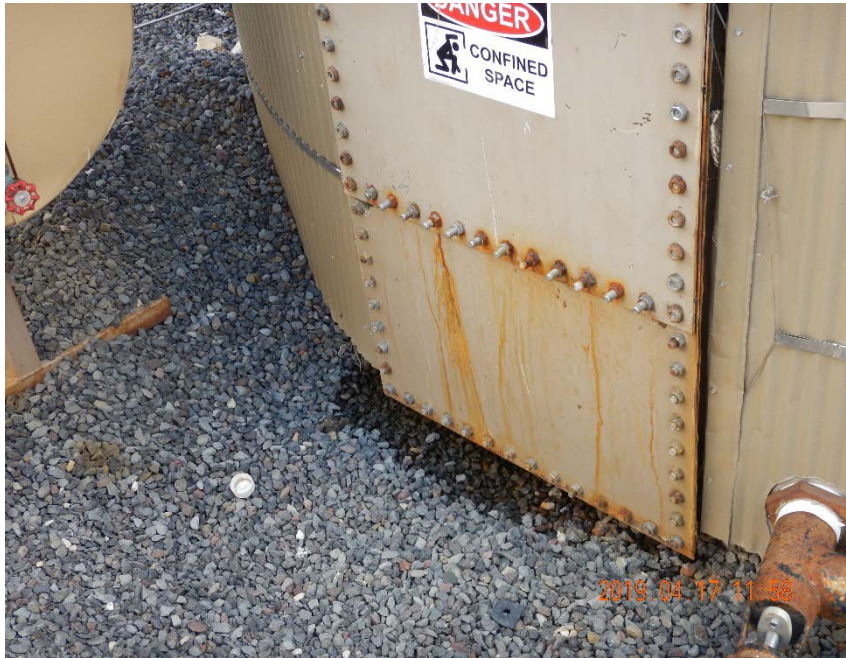
Photo #7 – View of access panel on west side of 500 bbl produced water/condensate AST (located NE of central tank battery).

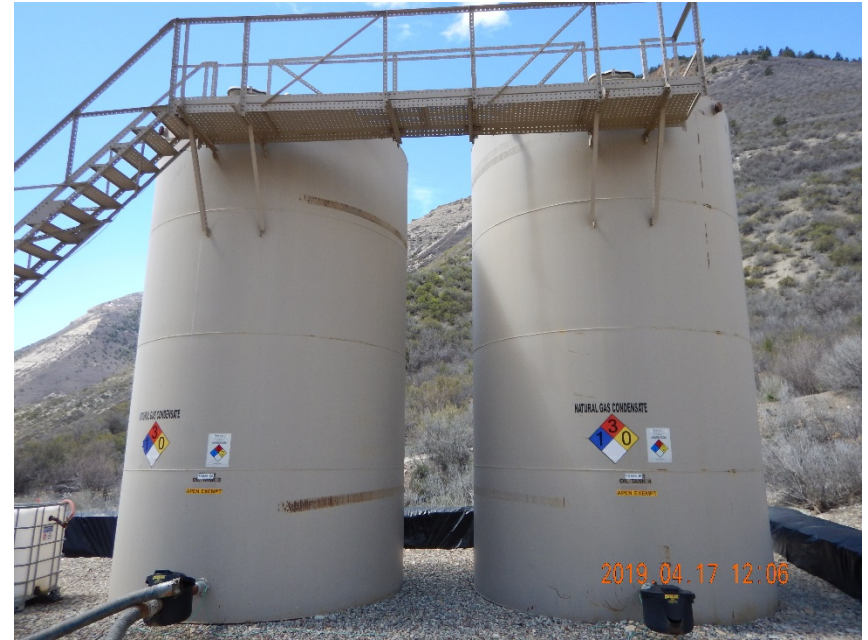
Photo #8 – View of condensate AST tank battery on west side of location, looking SW. Tank battery contained four water storage tanks on 4/17/2019 inspection date. Operator had decommissioned and removed entire tank battery prior to 5/10/2019 follow-up inspection.

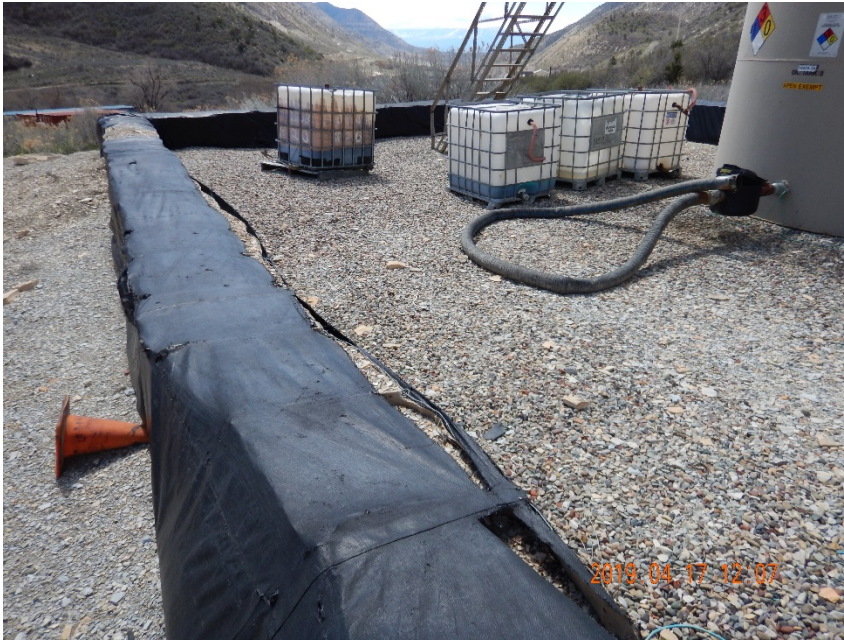
Photo #9 - View of shredded tank liner, looking south. Several holes in liner were observed on 4/17/2019 inspection date.

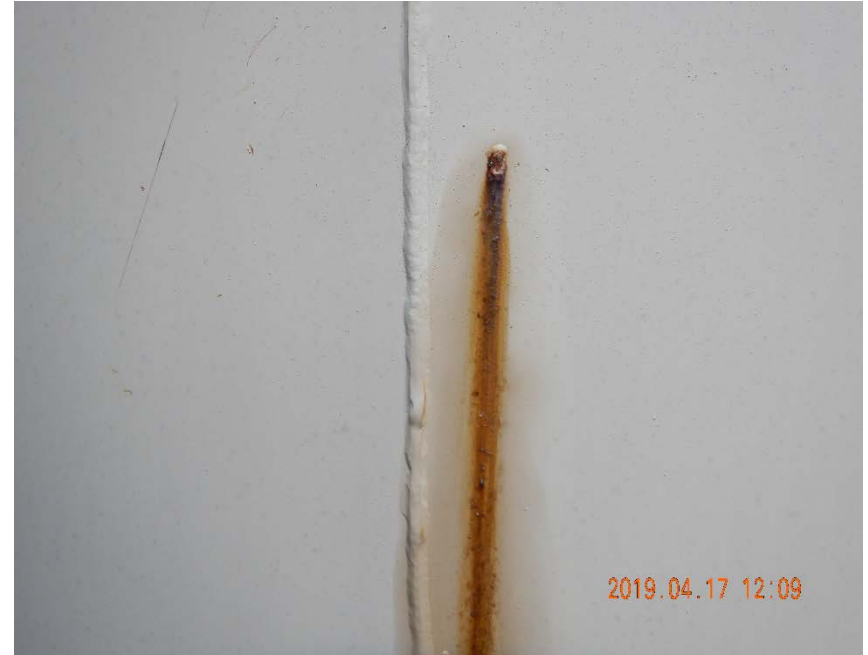
Photo #10 – Fluid and rust staining on southern crude oil AST. Operator was notified of potential fluid leak on 4/17/2019 via phone call. The suspect tank and tank battery were decommissioned and removed prior to 5/10/2019 follow-up inspection.

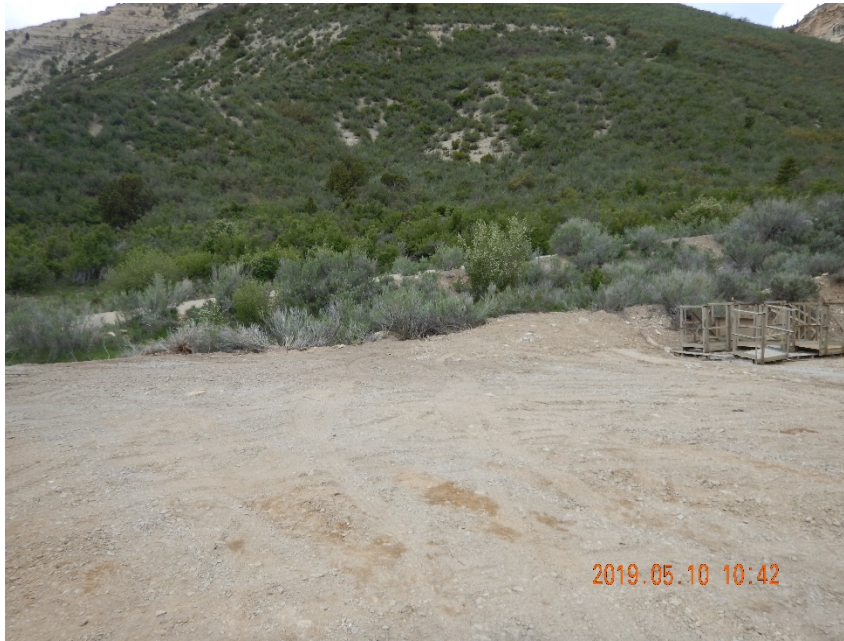
Photo #11 – View of former condensate tank battery location, looking west, during 5/10/2019 follow-up inspection. Compare to Photo #8 in this report.

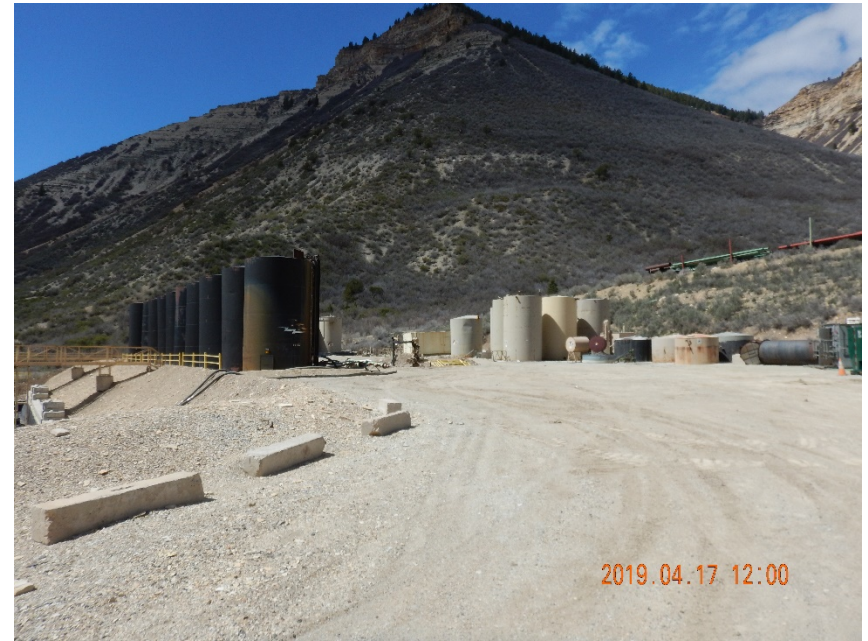
Photo #12- View of fresh water tank battery and steel AST storage yard, looking southwest.

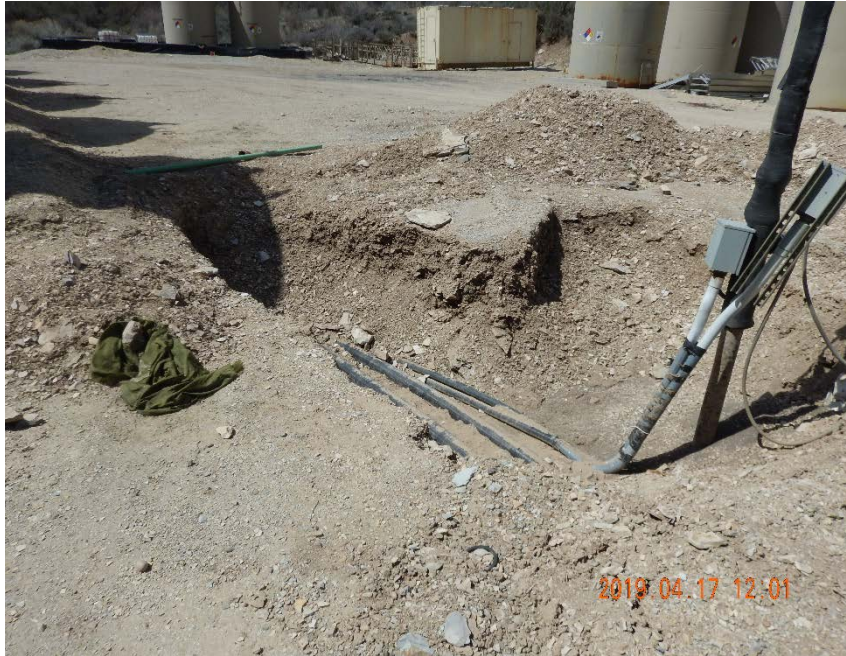
Photo #13 – View of open excavation at wellhead during 4/17/2019 wellhead.

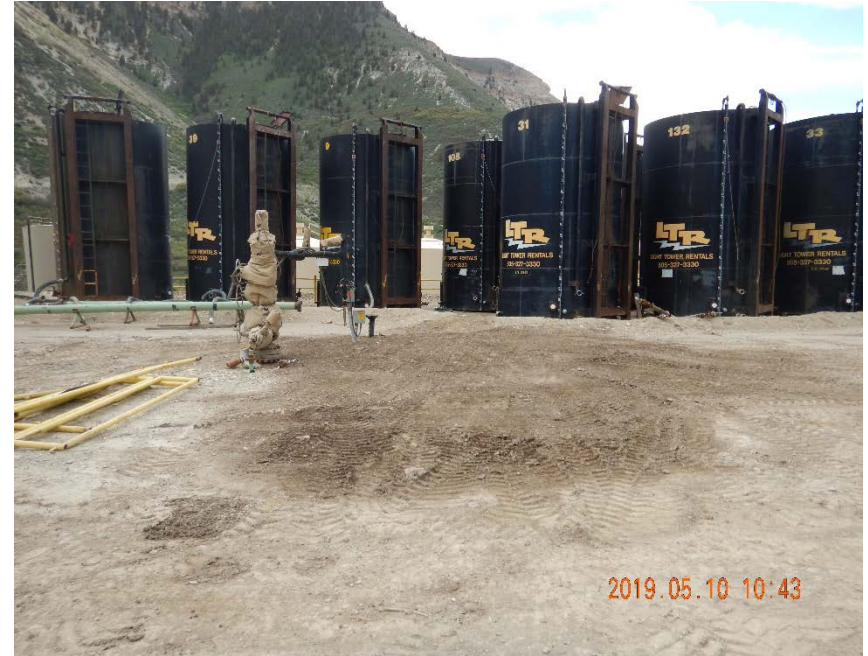
Photo #14 – Flowline excavation from previous photo had been backfilled prior to 5/10/2019 follow-up inspection.

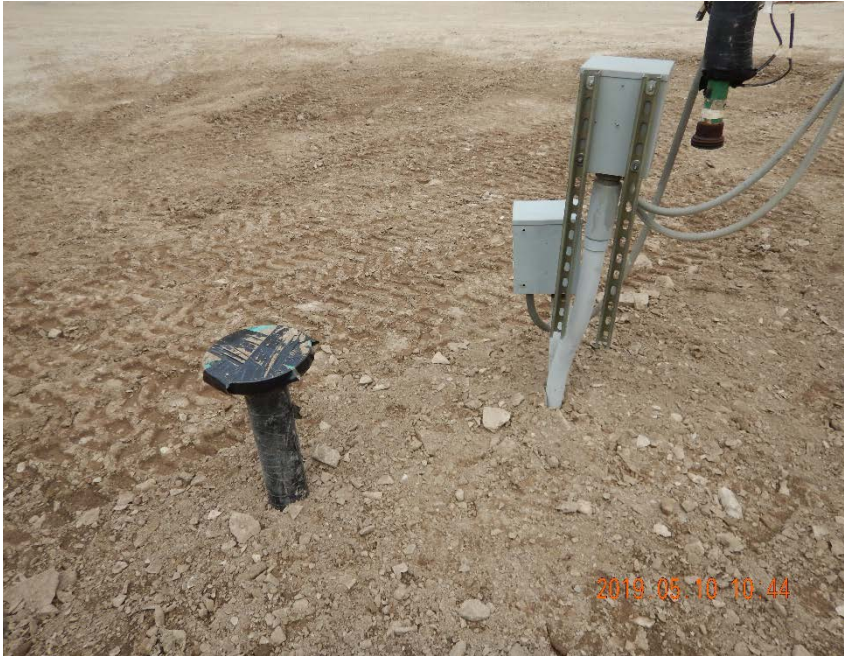
Photo #15 – Unmarked, unused flowline riser near wellhead.

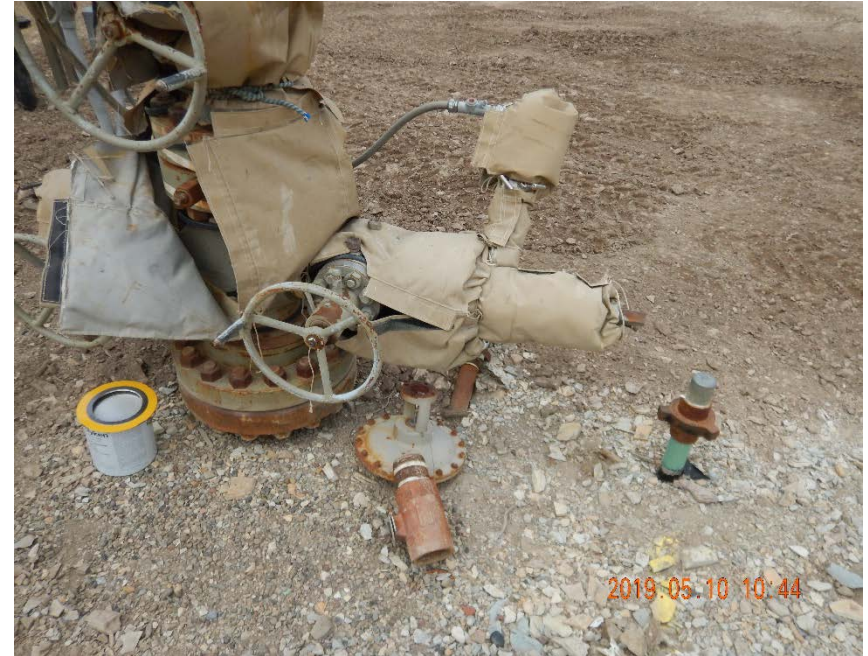
Photo #16 – Unmarked, unused flowline riser with bullplug near wellhead.

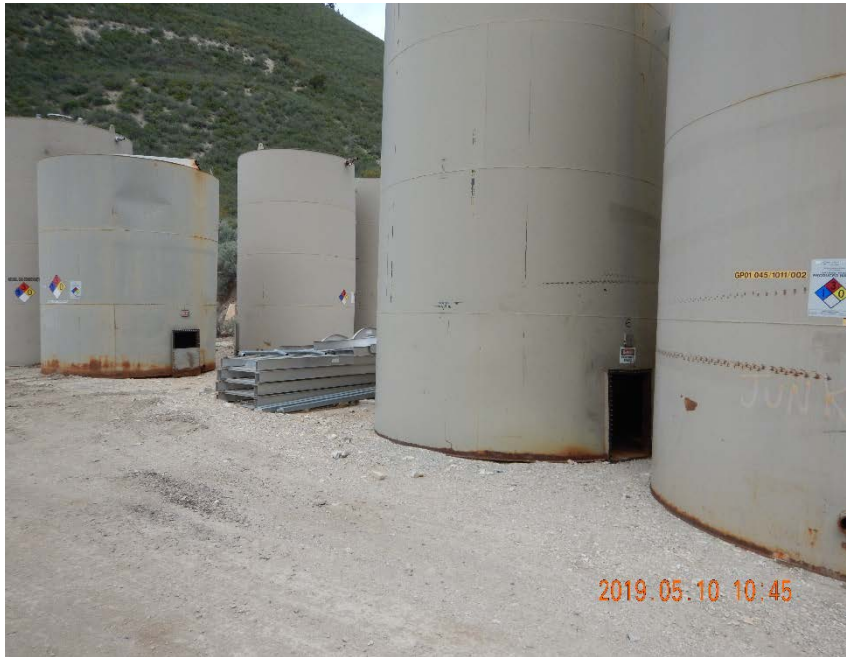
Photo #17 – View of unused tanks inside of storage area in NW corner of location. Note uncovered access panels on unused ASTs.

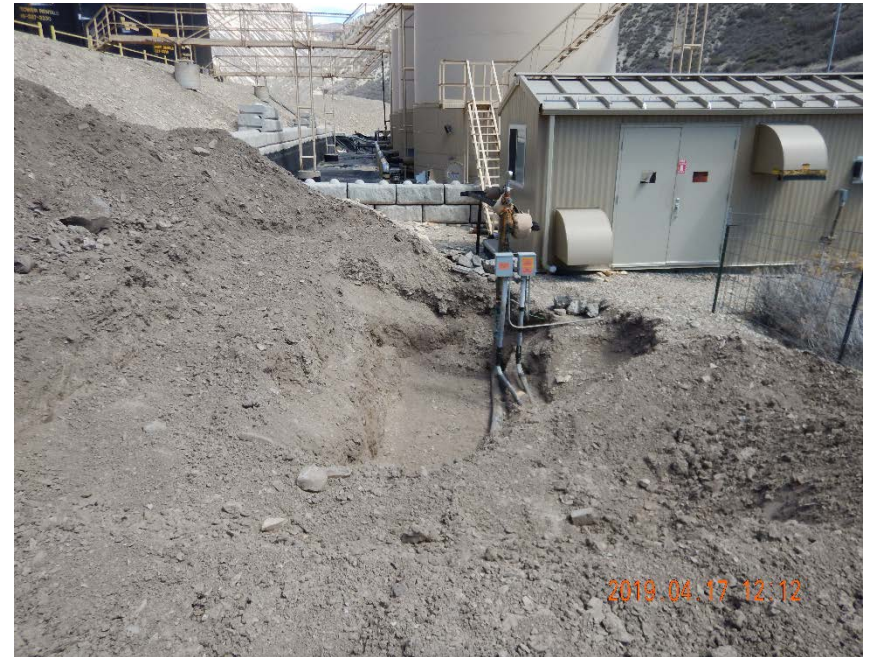
Photo #18 – View of open excavation located ~40' southwest of central tank battery.

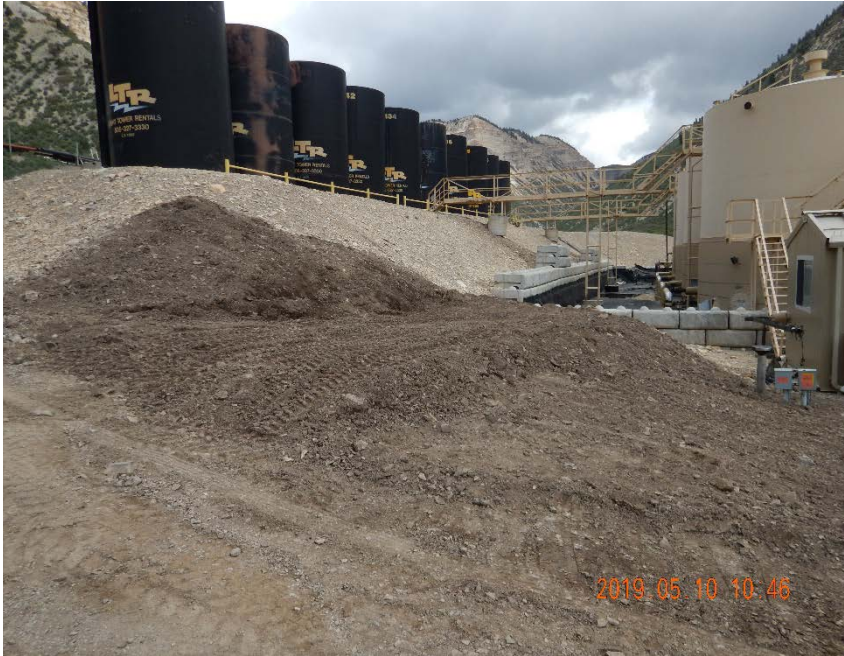
Photo #19 – Open excavation from previous photo had been backfilled prior to 5/10/2019 follow-up inspection.

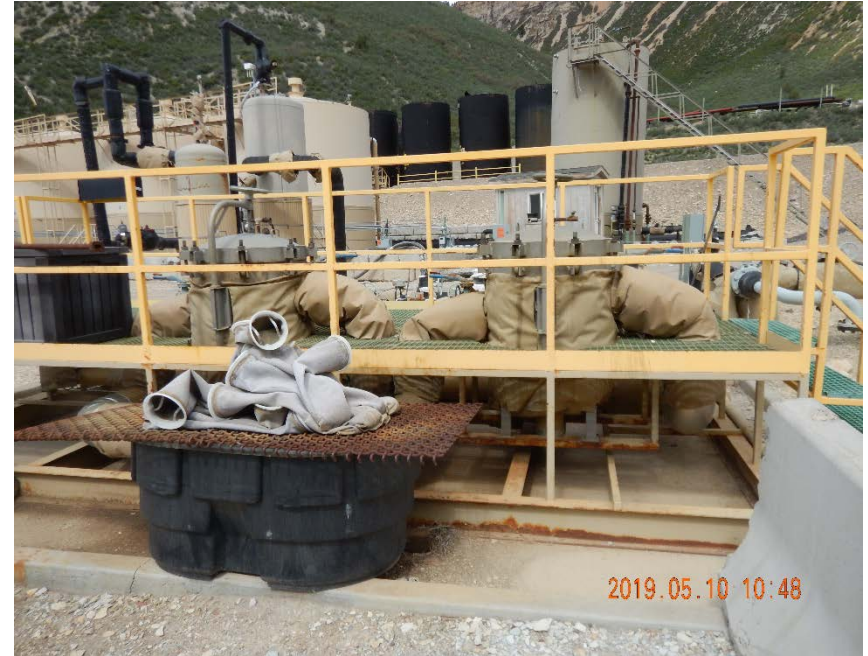
Photo #20 – View of filter pots and filter socks, looking west. Note storage of filter socks atop secondary containment device.

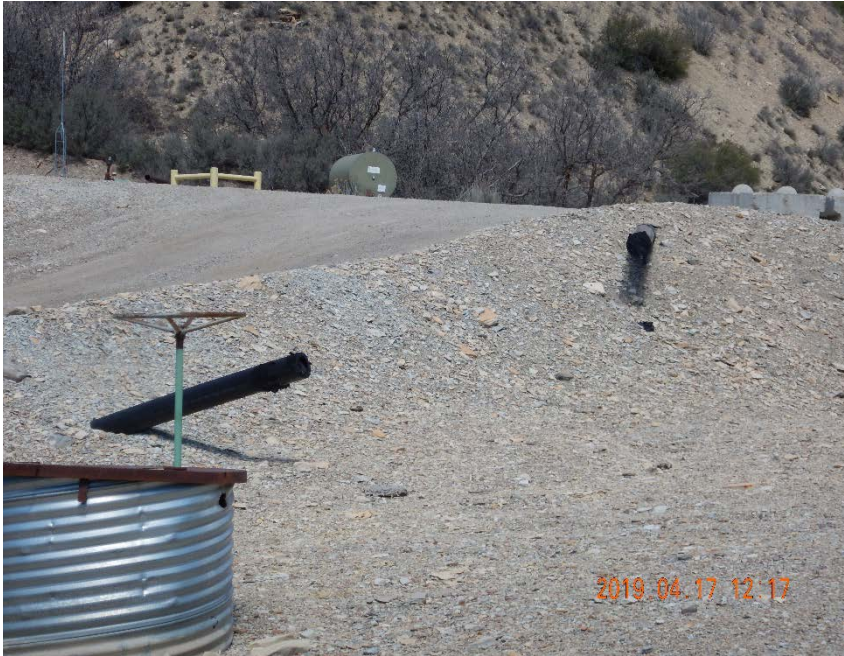
Photo #21 – View of unmarked HDPE flowlines located ~70' NE of central tank battery.

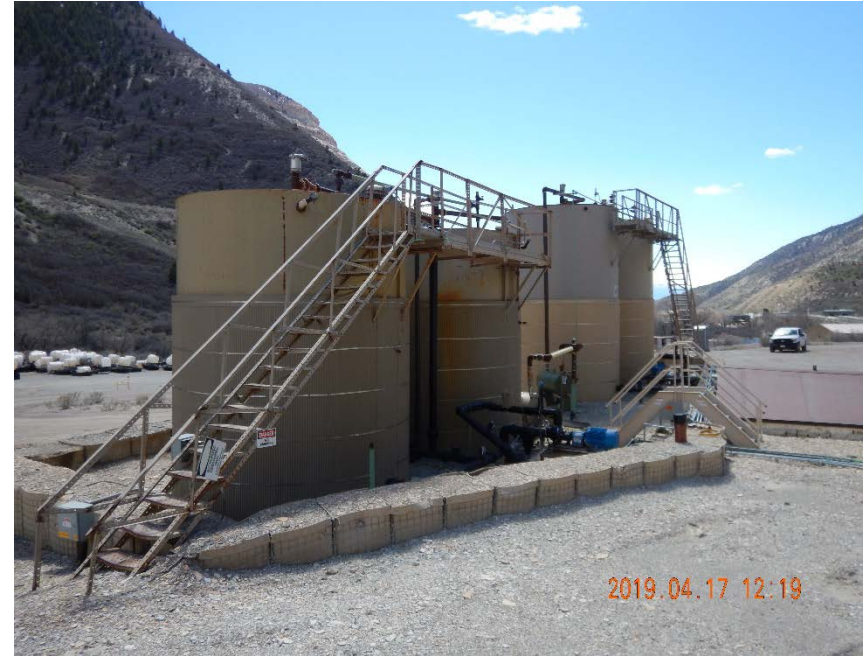
Photo #22 – View of truck loadout tank battery on east side of location, looking south. Note unlined secondary containment.

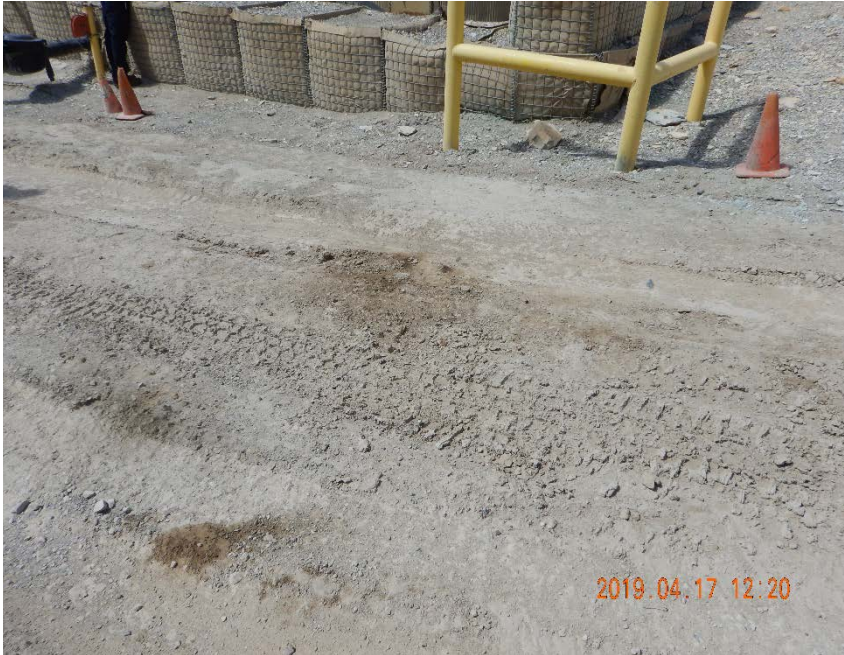
Photo #23 – Localized accumulations of oil-stained soil and truck ruts located NE of truck loadout tank battery. Operator should consider a concrete apron or liner system at the truck loadout.

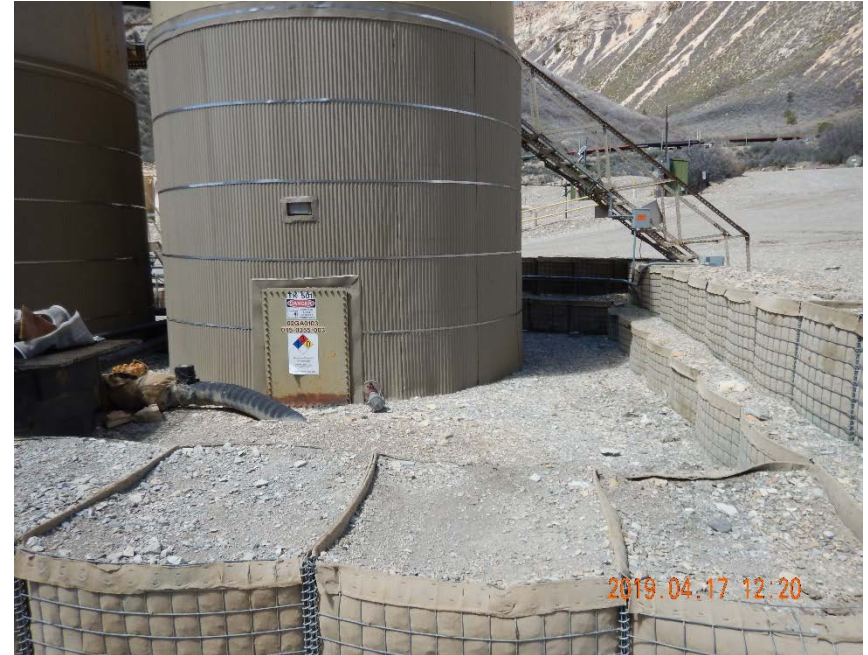
Photo #24 – View of north side of truck loadout tank battery, looking west. Note berm is constructed of unconsolidated material inside of canvas and mesh crates. Secondary containment area did not have a liner installed on either inspection date.

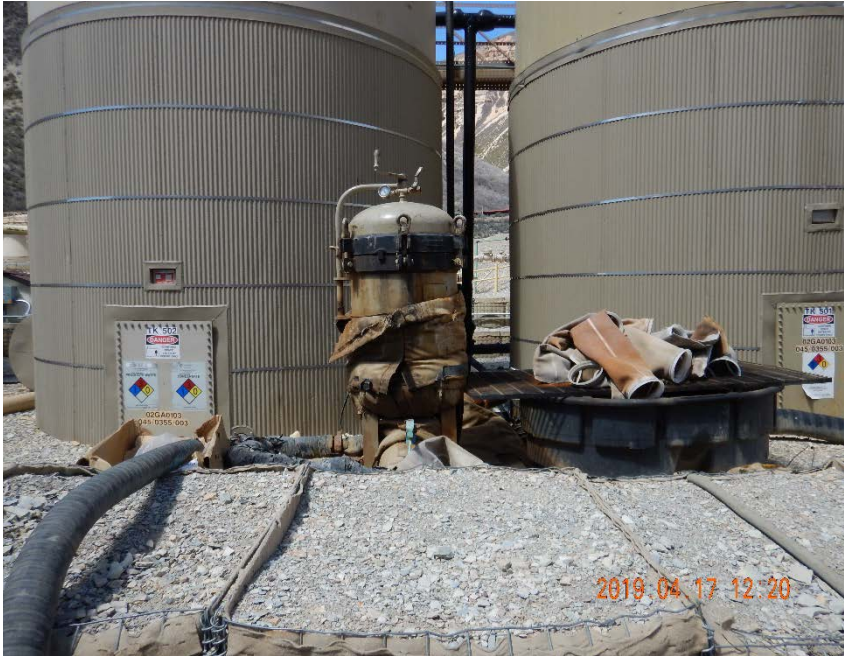
Photo #25 – View of filter pot on east side of truck loadout tank battery. Note storage of filter socks atop secondary containment device.

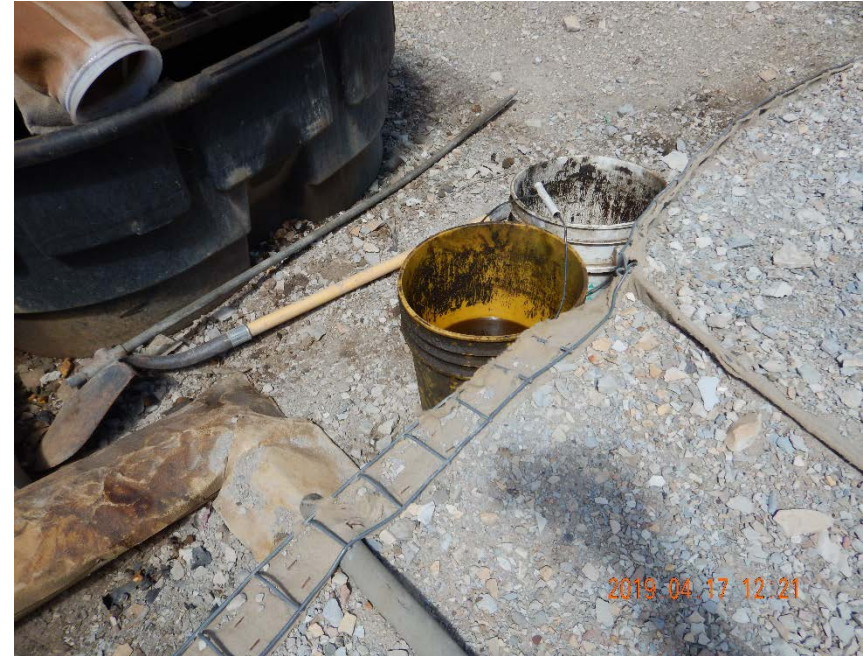
Photo #26 – Uncovered buckets of oily fluid stored inside of truck loadout tank battery.
