MARALEX RESOURCES, INC.– 53255
API # 05-067-09621 ARTFGANCE 33-7-14 #2A
API # 05-067-09623 ARTFGANCE 33-7-14 #3C
Inspection Date : 05/14/2019

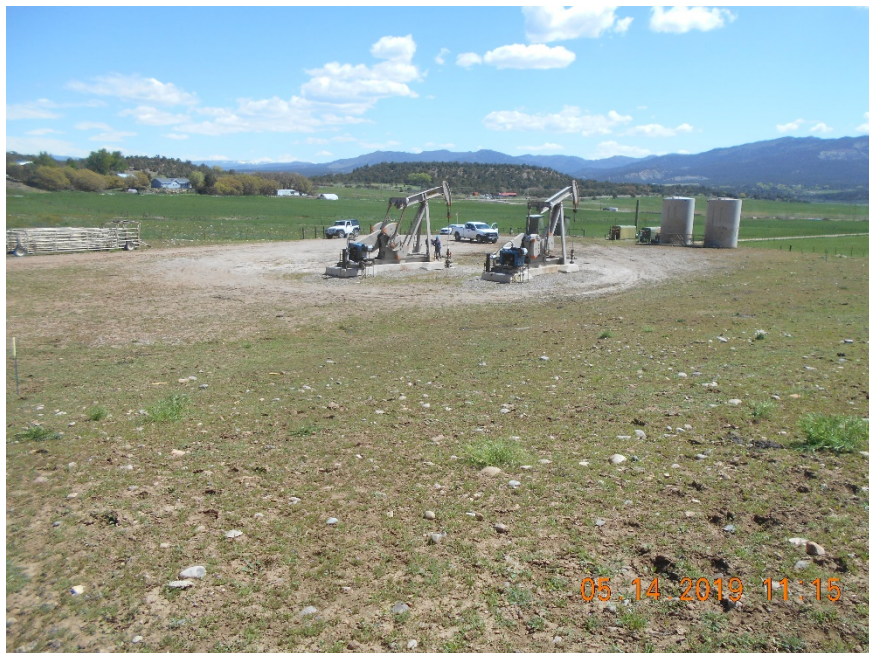
**Overview of location from SW corner of pad
looking NE**

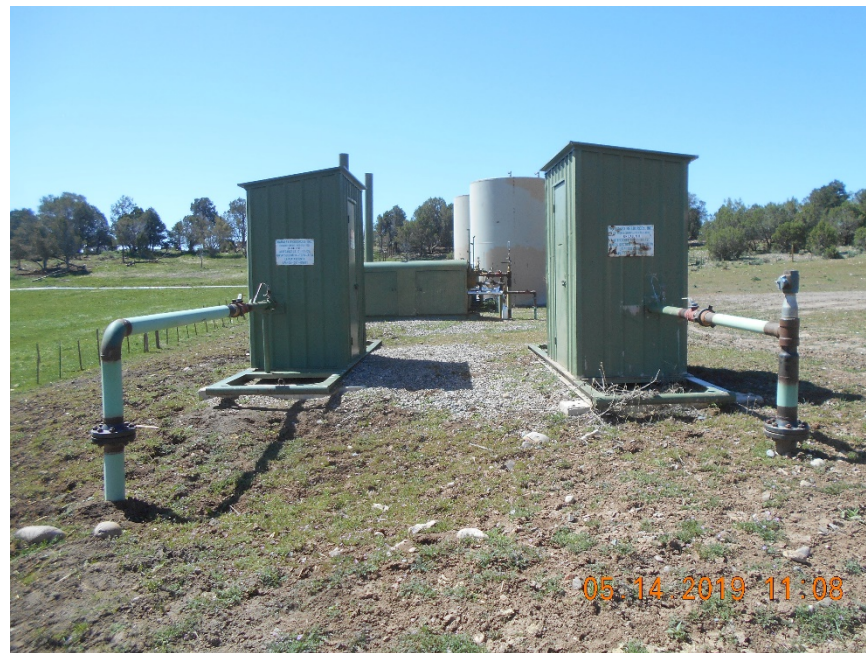
Meter housings with signs

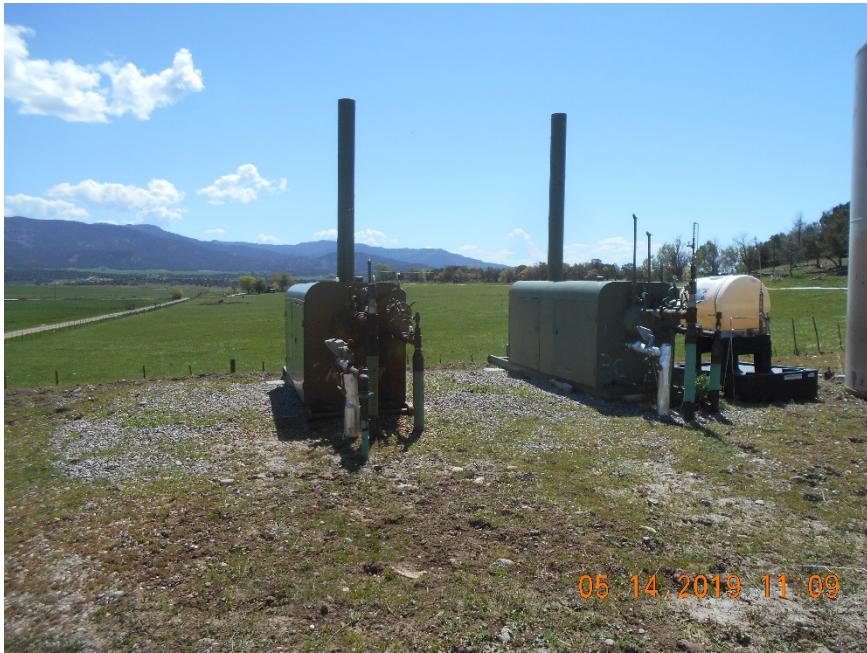
Separators with chemical injector in secondary containment

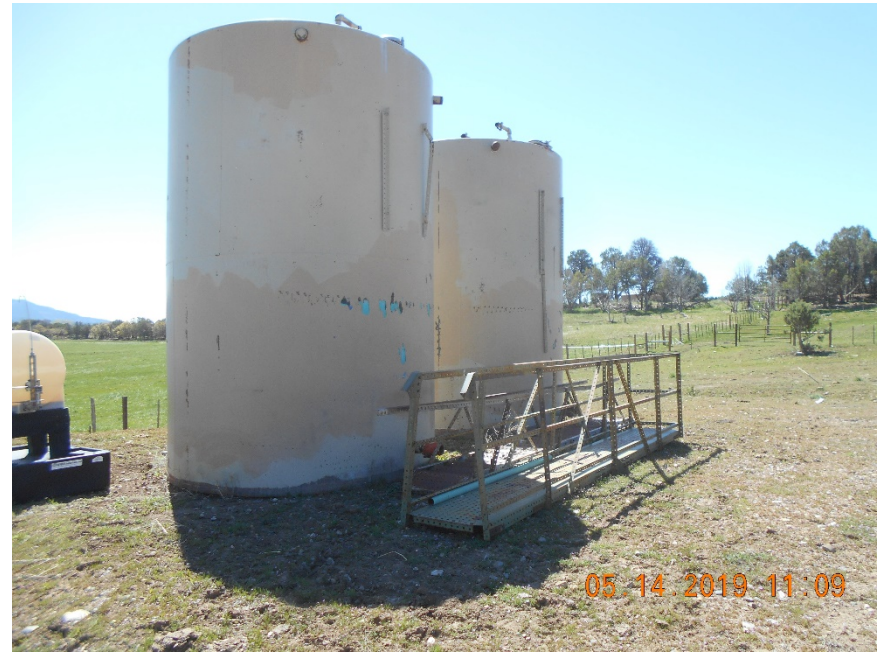
Unused tanks and walkway sections

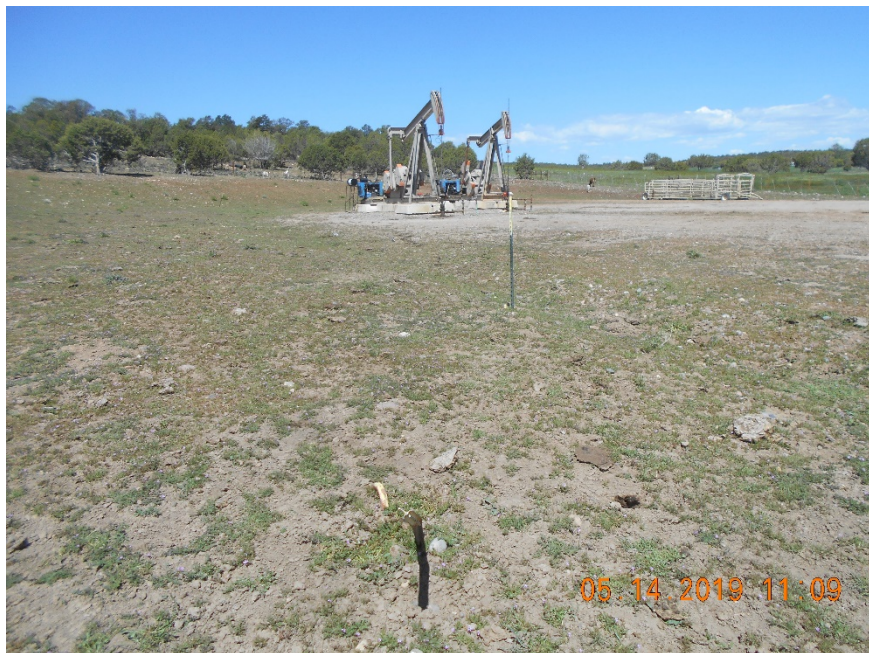
API # 05-067-09623 ARTFGANCE 33-7-14 #3C
API # 05-067-09621 ARTFGANCE 33-7-14 #2A
Pumpjacks and guyline anchor with marker.

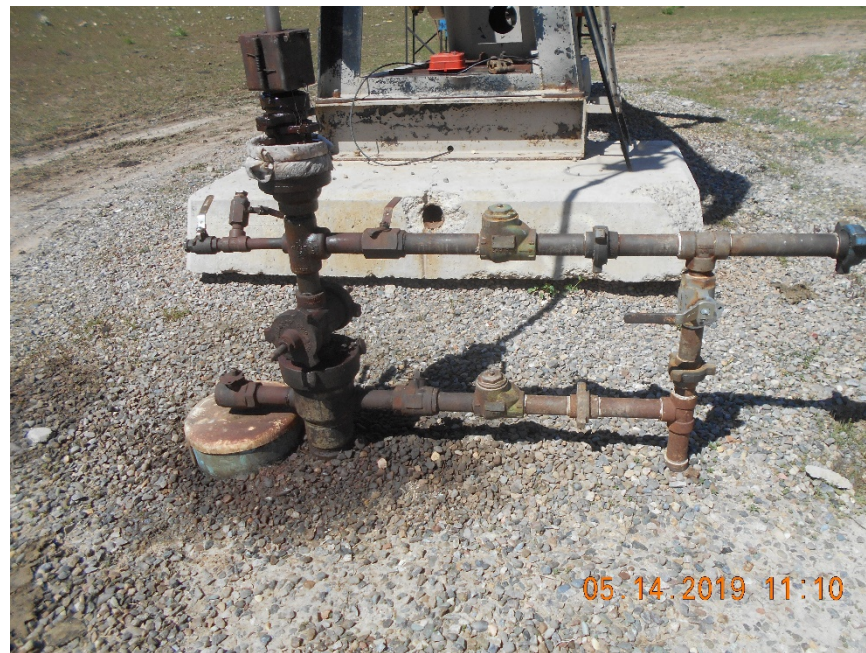
API # 05-067-09623 ARTFGANCE 33-7-14 #3C
Wellhead with stained soil

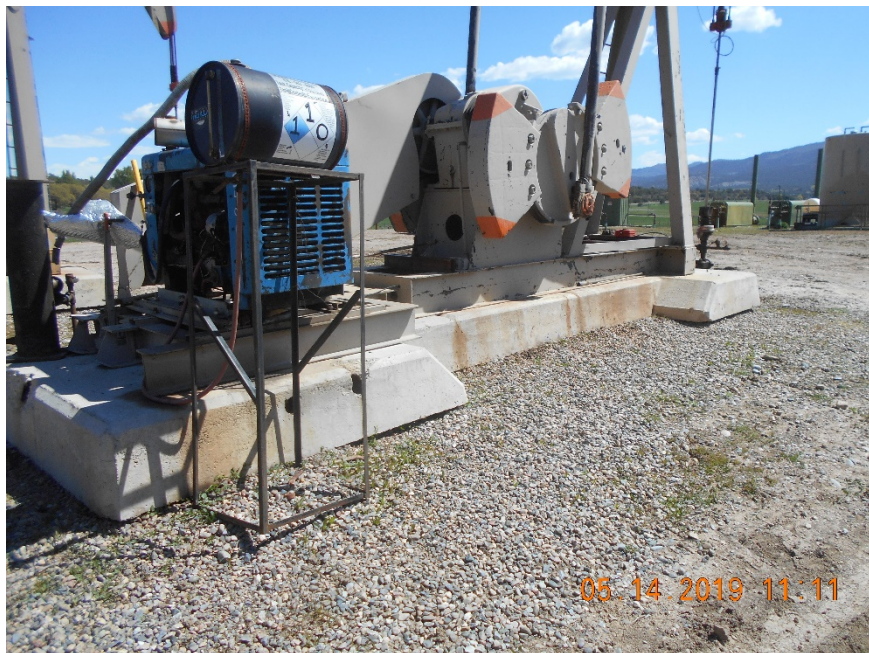
API # 05-067-09623 ARTFGANCE 33-7-14 #3C
Motor oil container with no secondary containment

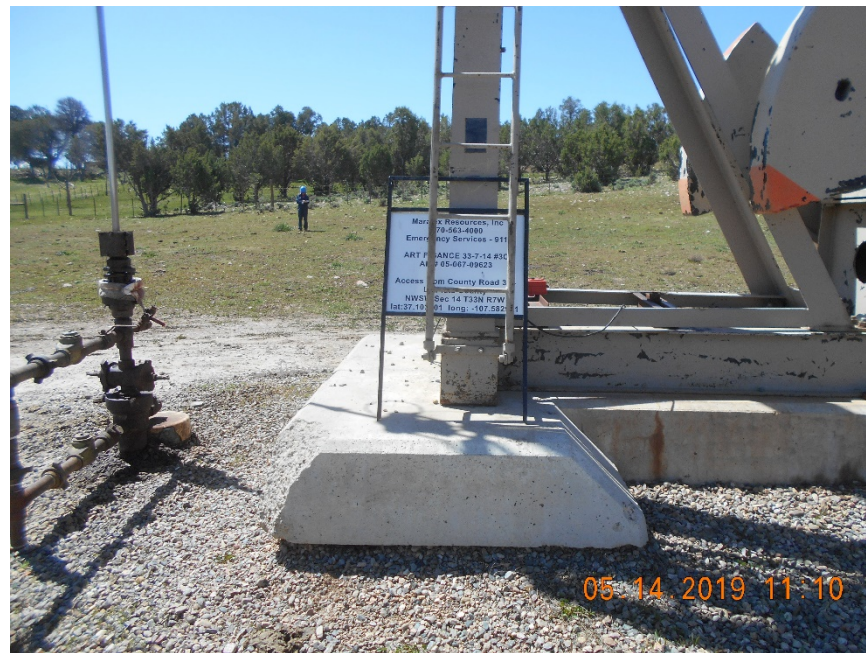
API # 05-067-09623 ARTFGANCE 33-7-14 #3C
Wellhead sign

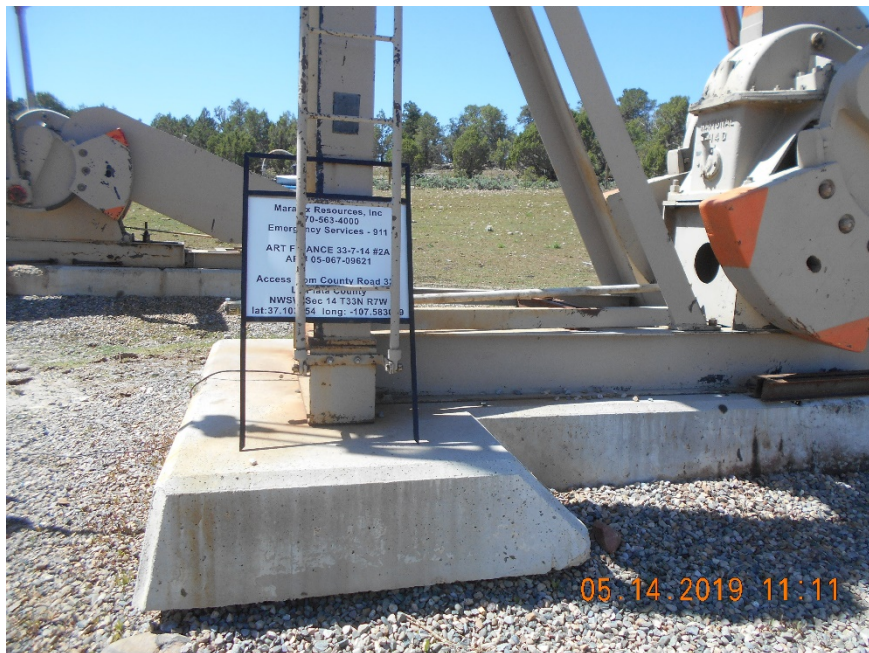
API # 05-067-09621 ARTFGANCE 33-7-14 #2A
Wellhead sign

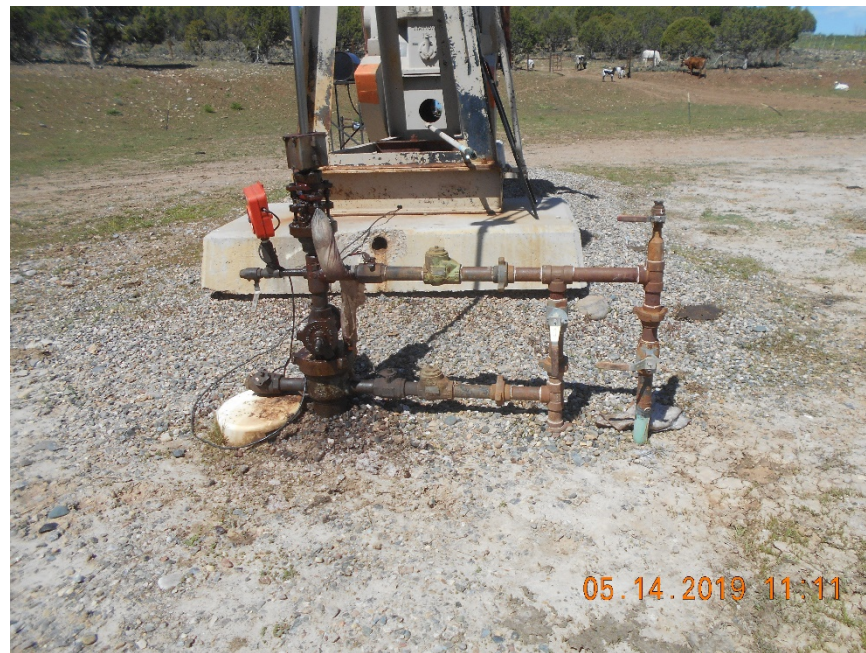
API # 05-067-09621 ARTFGANCE 33-7-14 #2A
Wellhead with stained soil

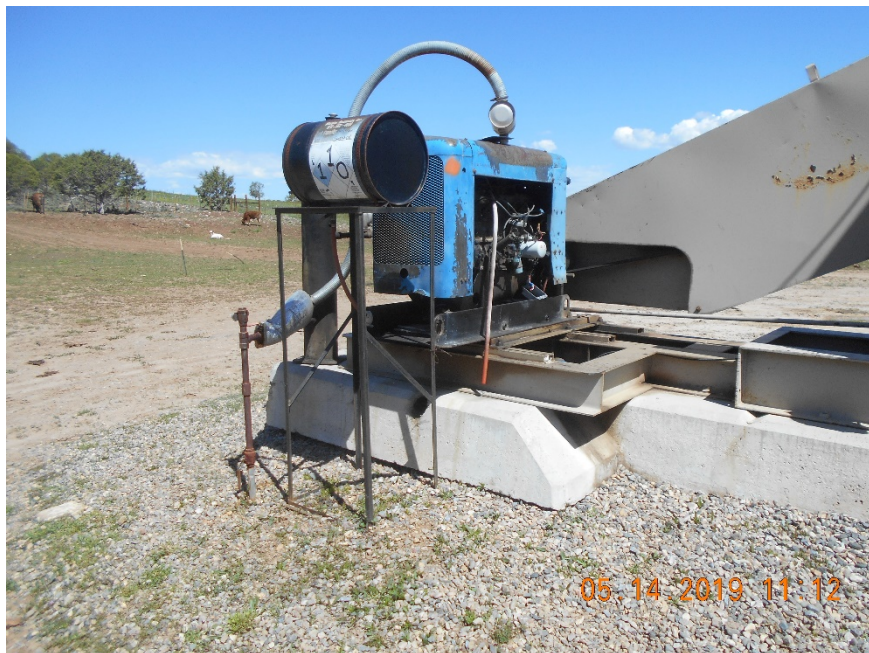
API # 05-067-09621 ARTFGANCE 33-7-14 #2A
Motor oil container with no secondary containment

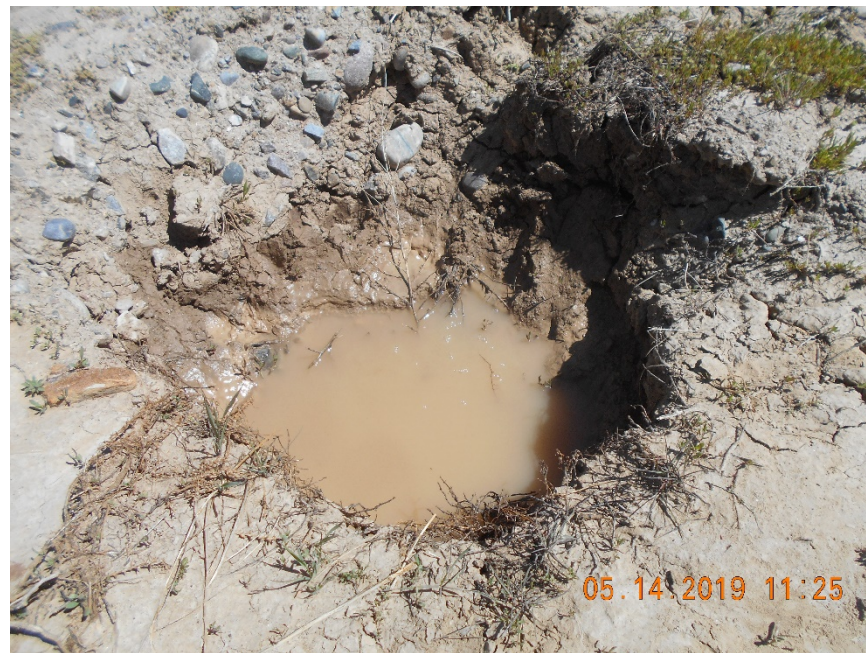
API # 05-067-09621 ARTFGANCE 33-7-14 #2A
Washed out 10" diameter hole ~20' NE of wellhead.
Noted changing fluid levels and intermittent bubbles.
