MARALEX RESOURCES, INC.– 53255

Location ID # 311950

Inspection Date : 05/14/2019

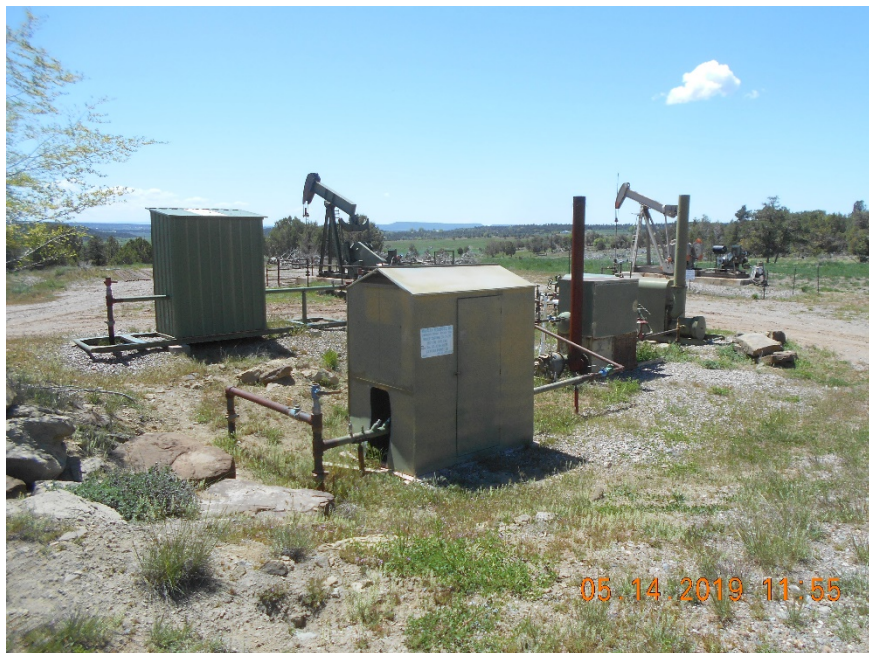
Overview of location from NE corner of pad
looking SW

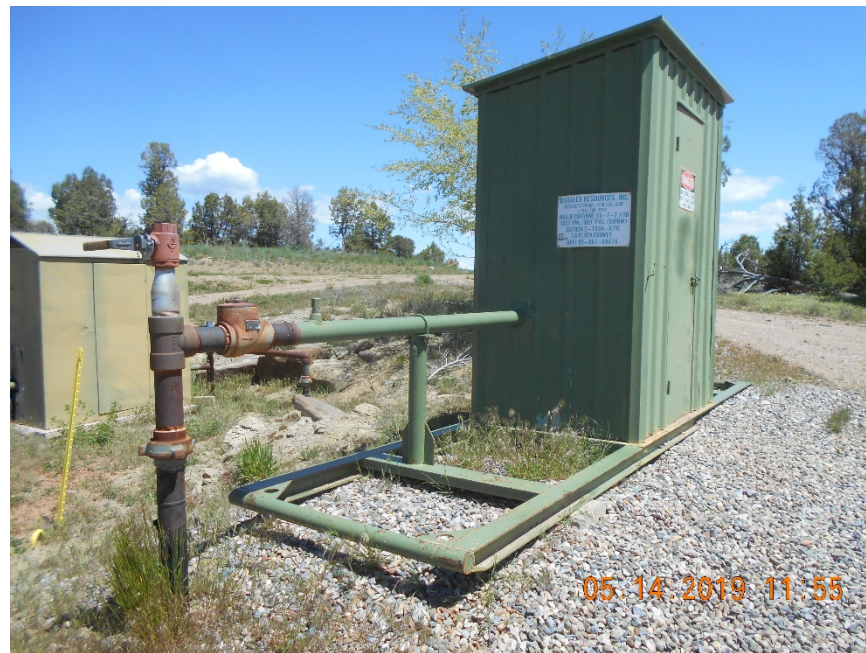
Meter housings with signs

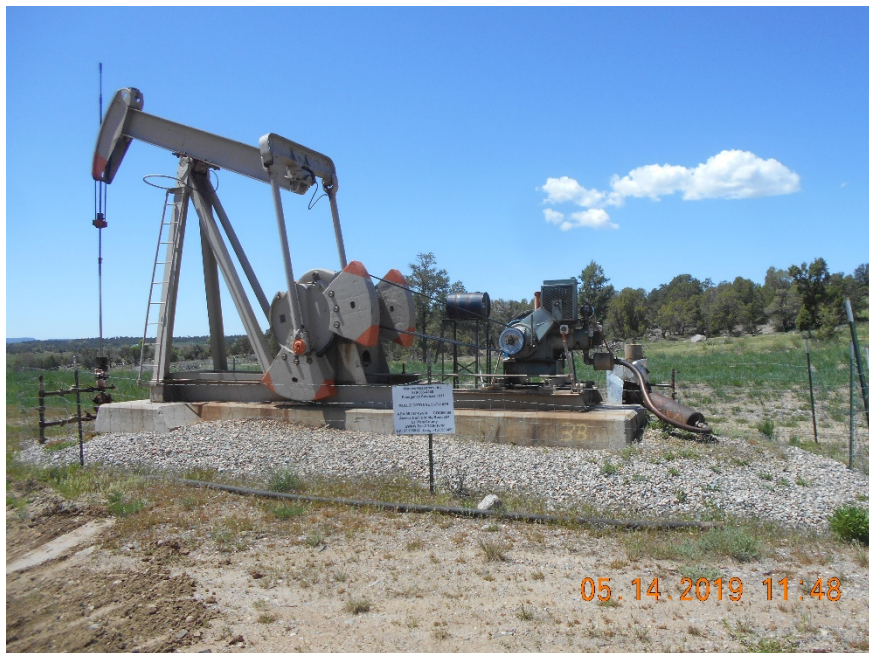
API# 05-067-09474 Mollie Corynne 33-7-2 #3B

Wellhead with pump jack

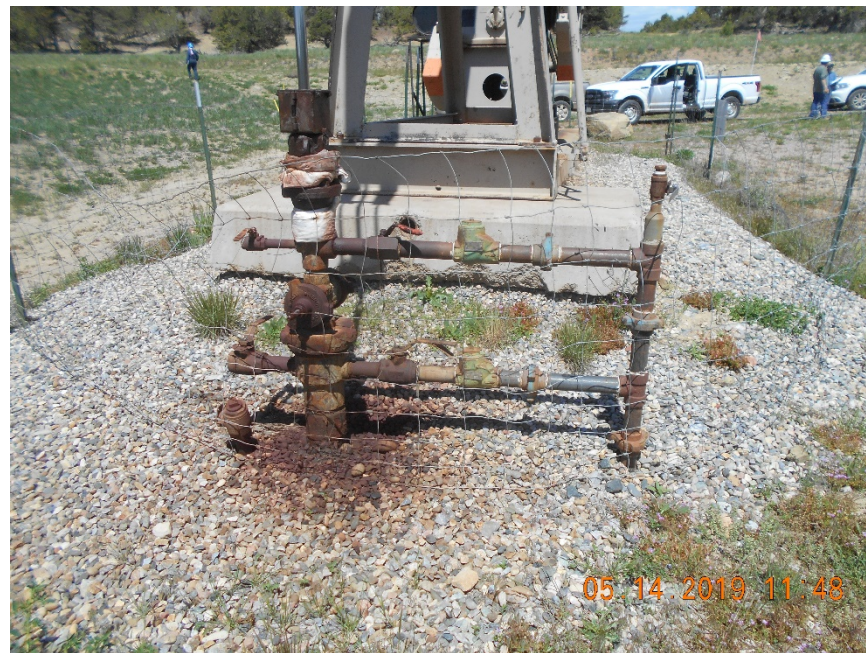
API# 05-067-09474 Mollie Corynne 33-7-2 #3B

Stained soil around wellhead requires remediation.

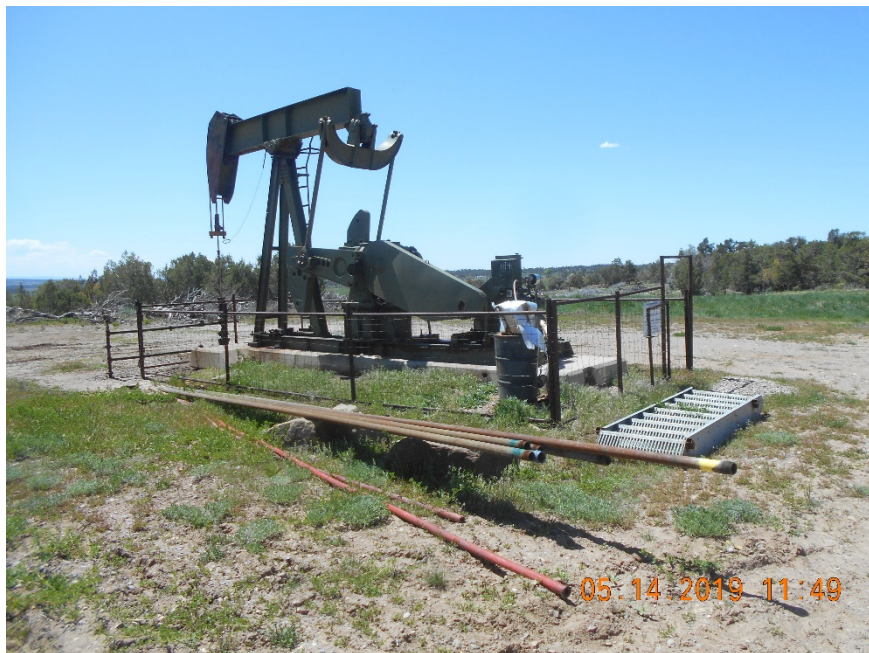
API# 05-067-08039 Mollie Corynne 33-7-2 #1

Wellhead with pump jack.

Unused tubing and stair section needs removal.

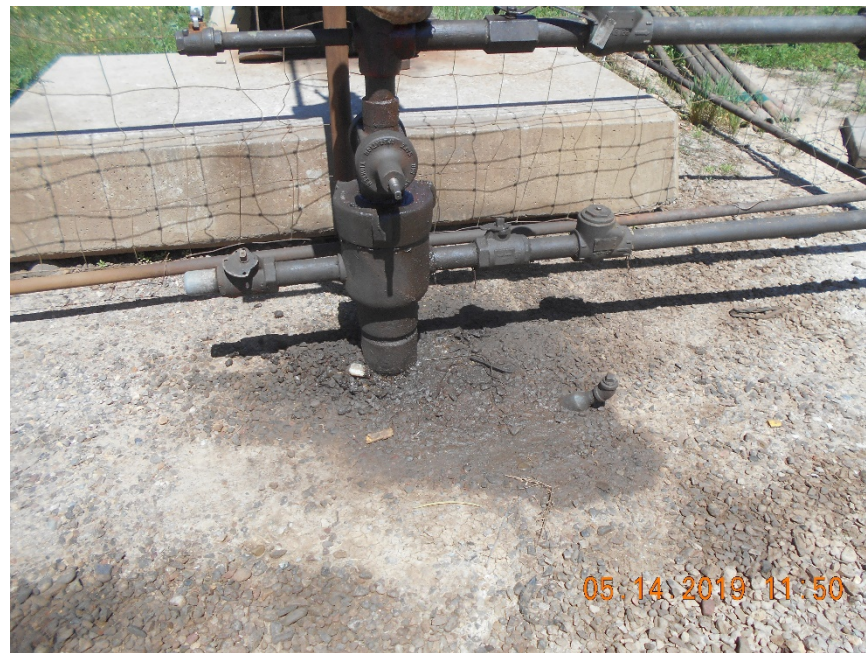
API# 05-067-08039 Mollie Corynne 33-7-2 #1

Stained soil around wellhead requires remediation.

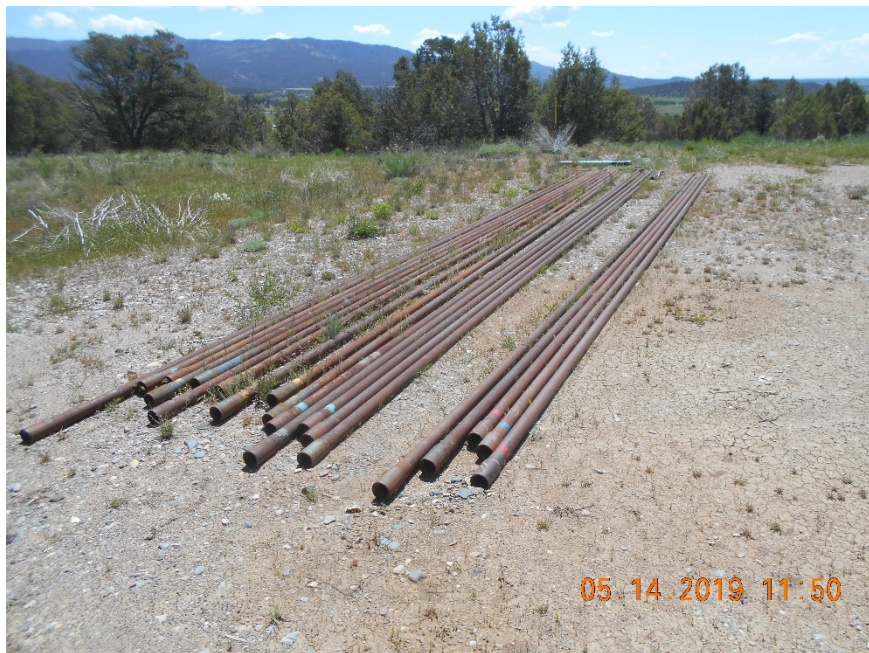
Unused tubing on SE corner of pad needs removal.

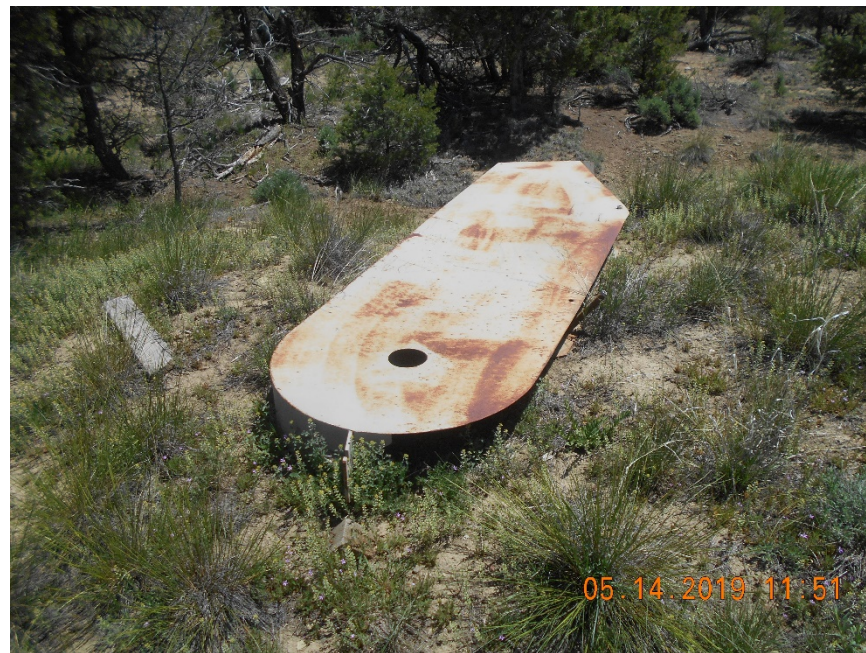
Pump jack belt cover on SE edge of pad need removal.

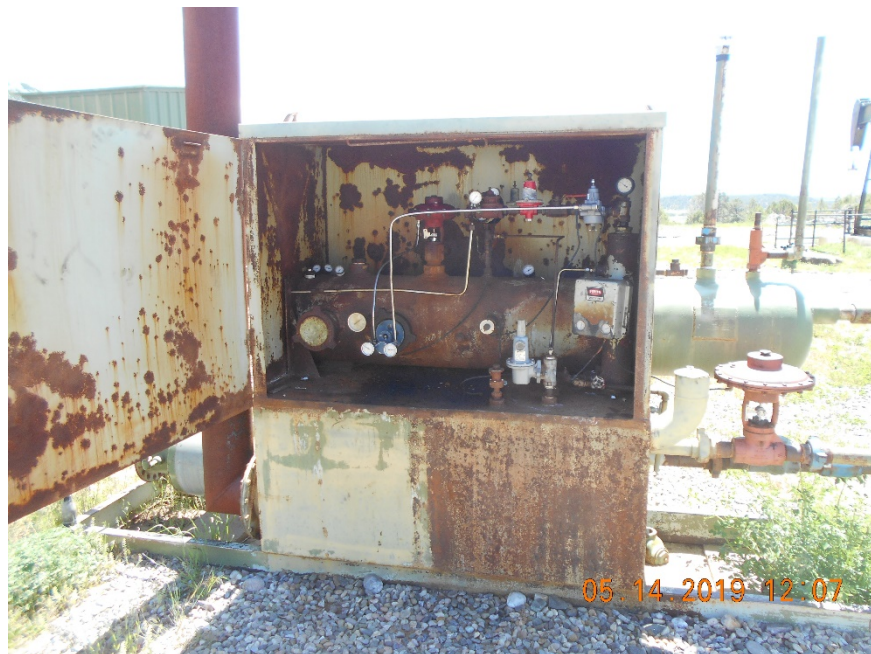
**E side separator. Possible leaks detected.
See FLIR photos for leak inspection.**

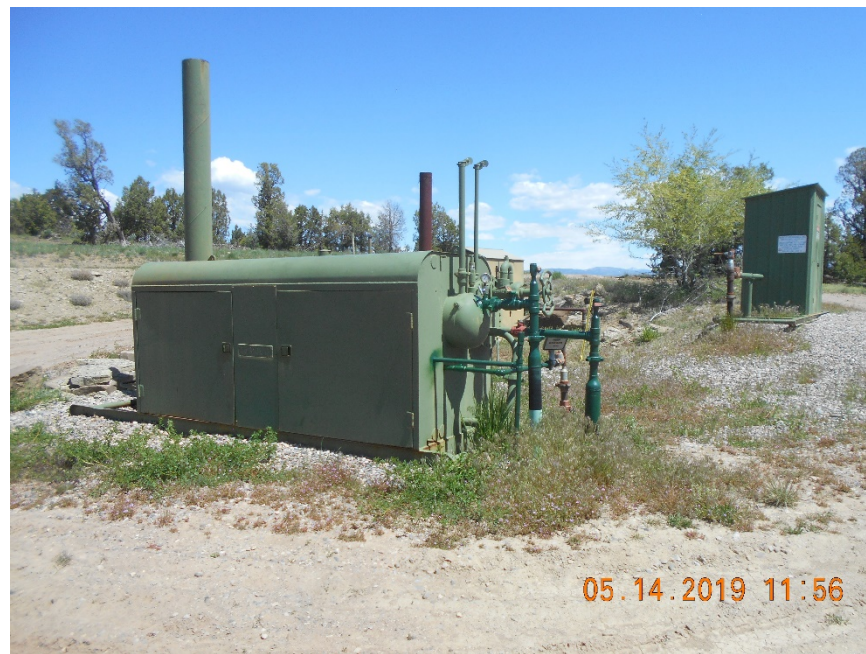
W side separator.

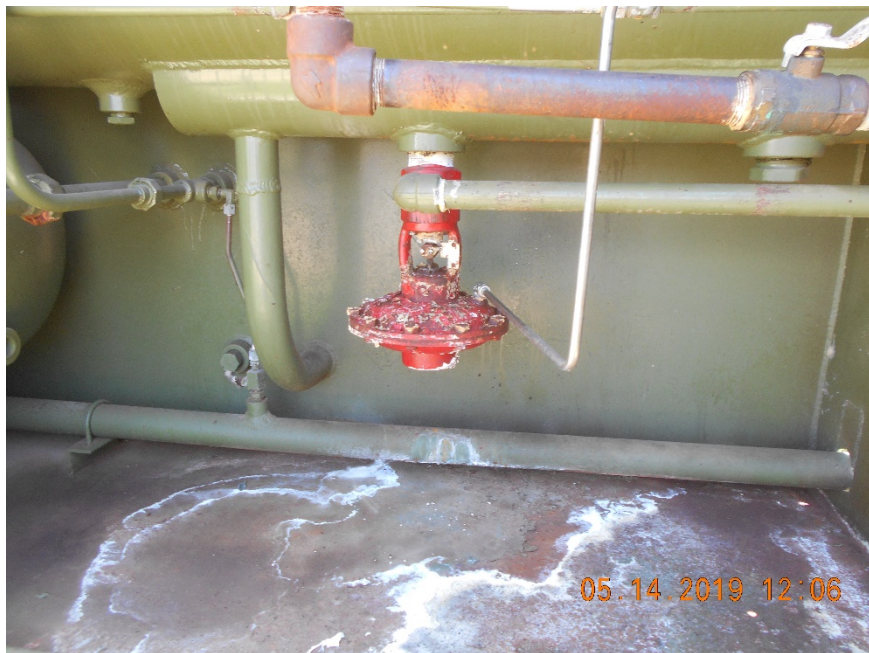
W side separator. Control valve with corrosion and staining.

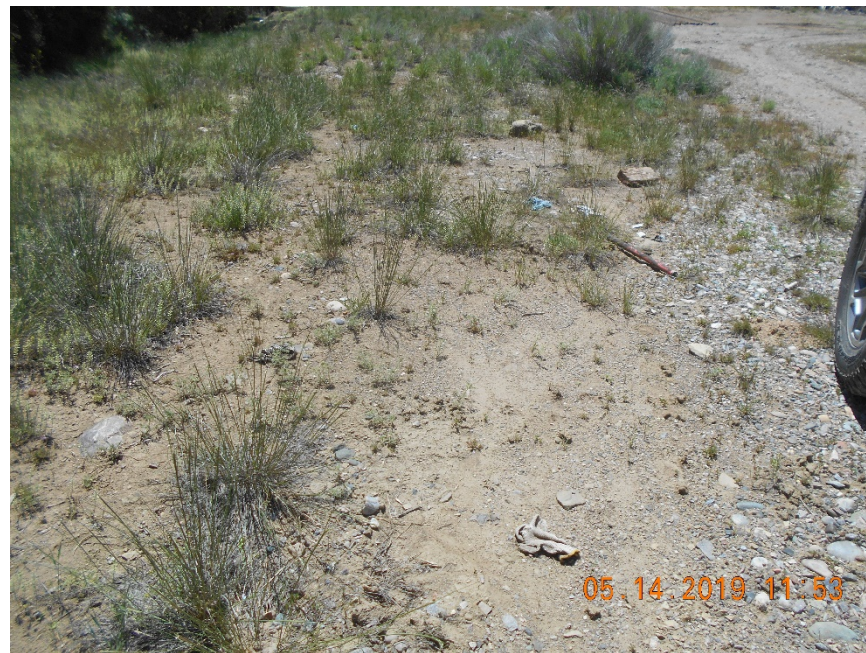
Trash and junk along NE side of location.
