Inspection Photos

API: 05-071-07956

Operator: PRESCO INC

Inspection Date: 5/24/2019

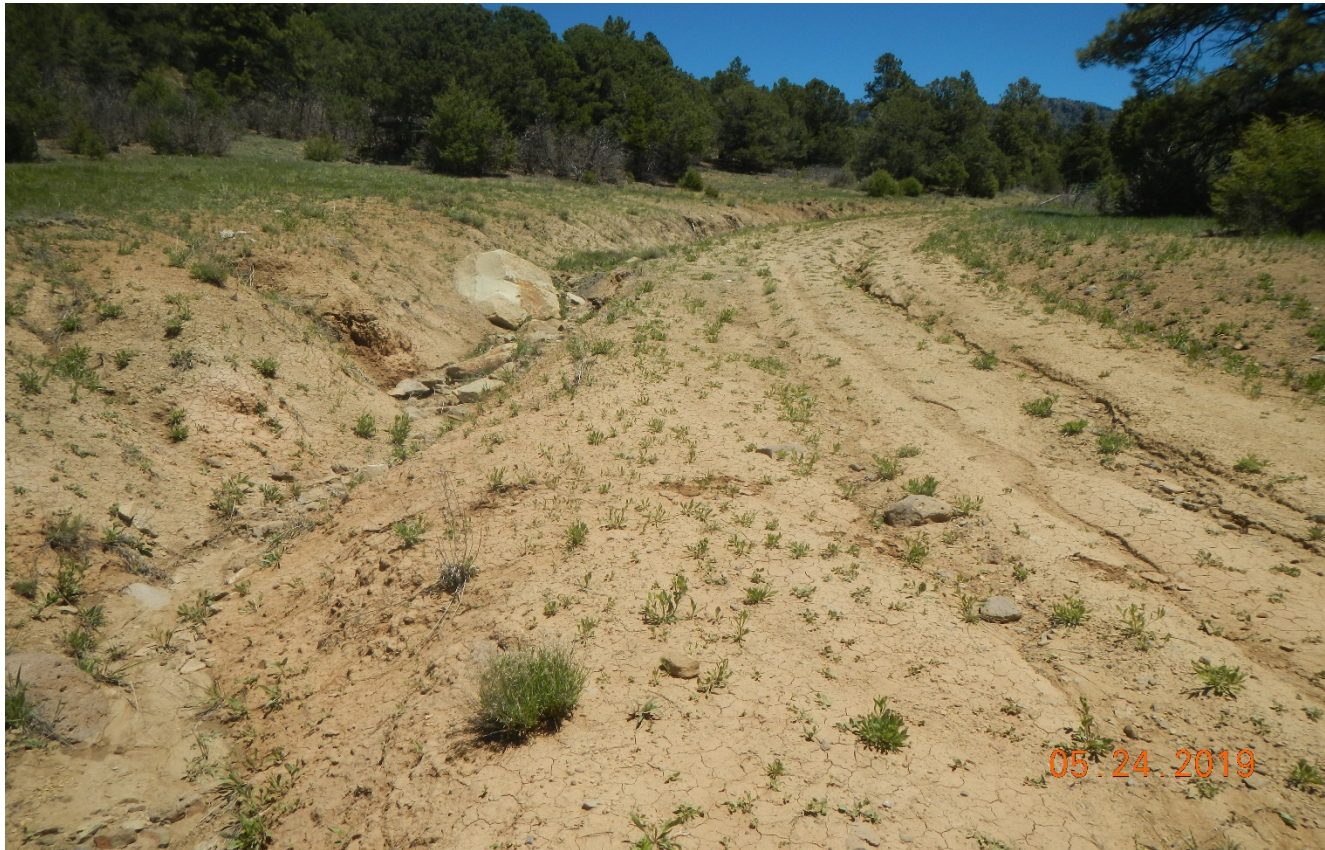
Photo 1. There is erosion issues along the main road to the location.
Lat/Long:37.02250,-104.48266. The road was widened during operations.

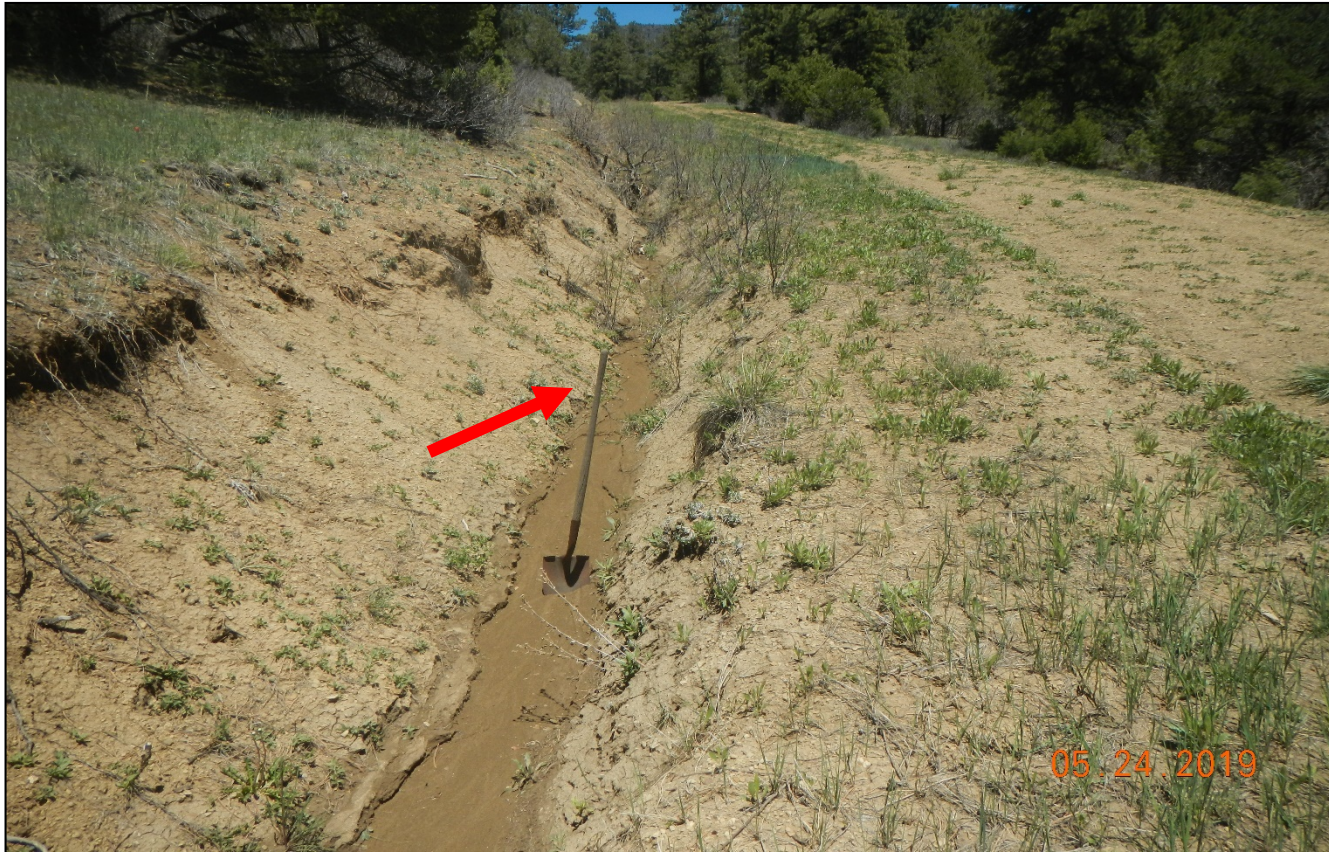
Photo 2. There is a deep channel that developed along the side of road. Arrow points to 4.5 ft. shovel to show depth.

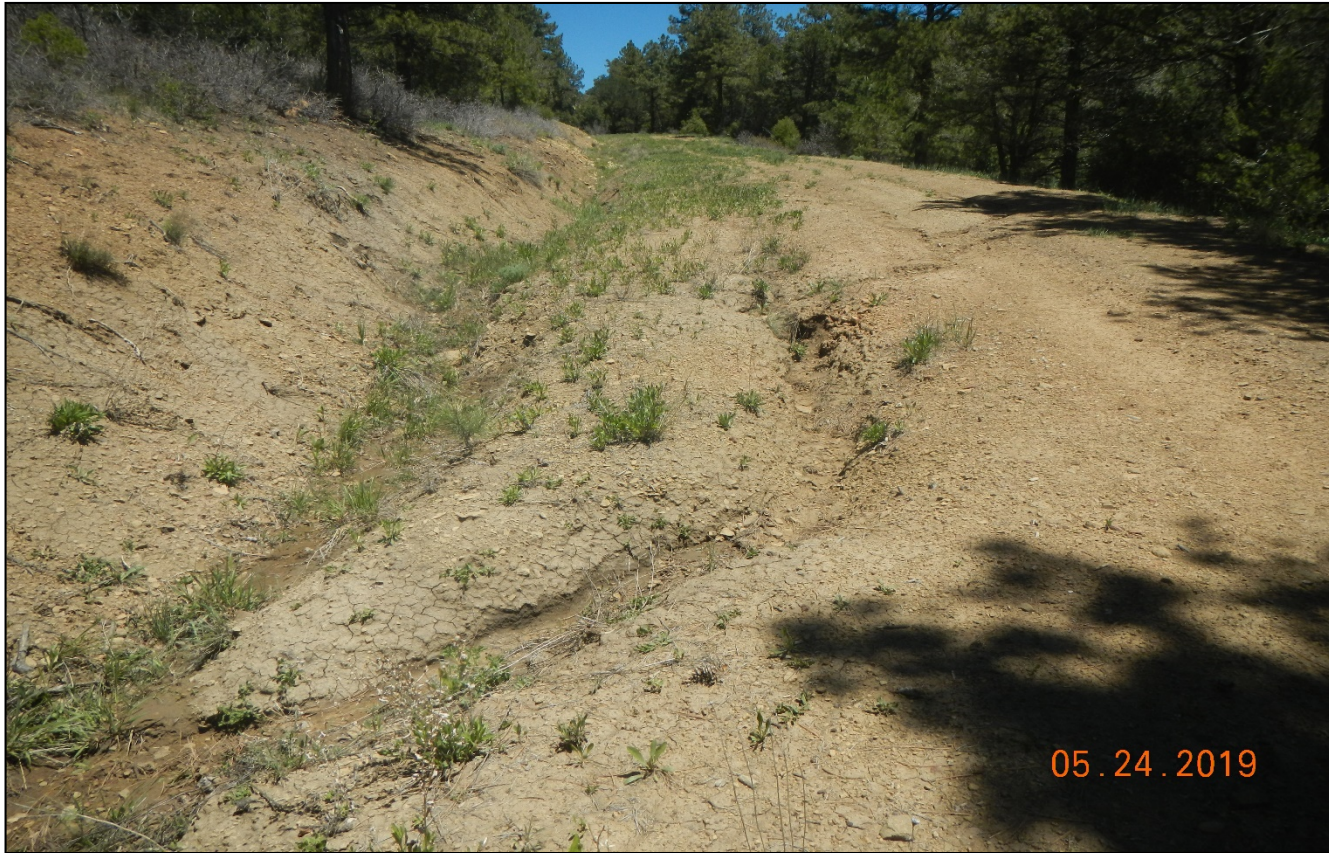
Photo 3. There is erosion issues along the road traveling toward the location.

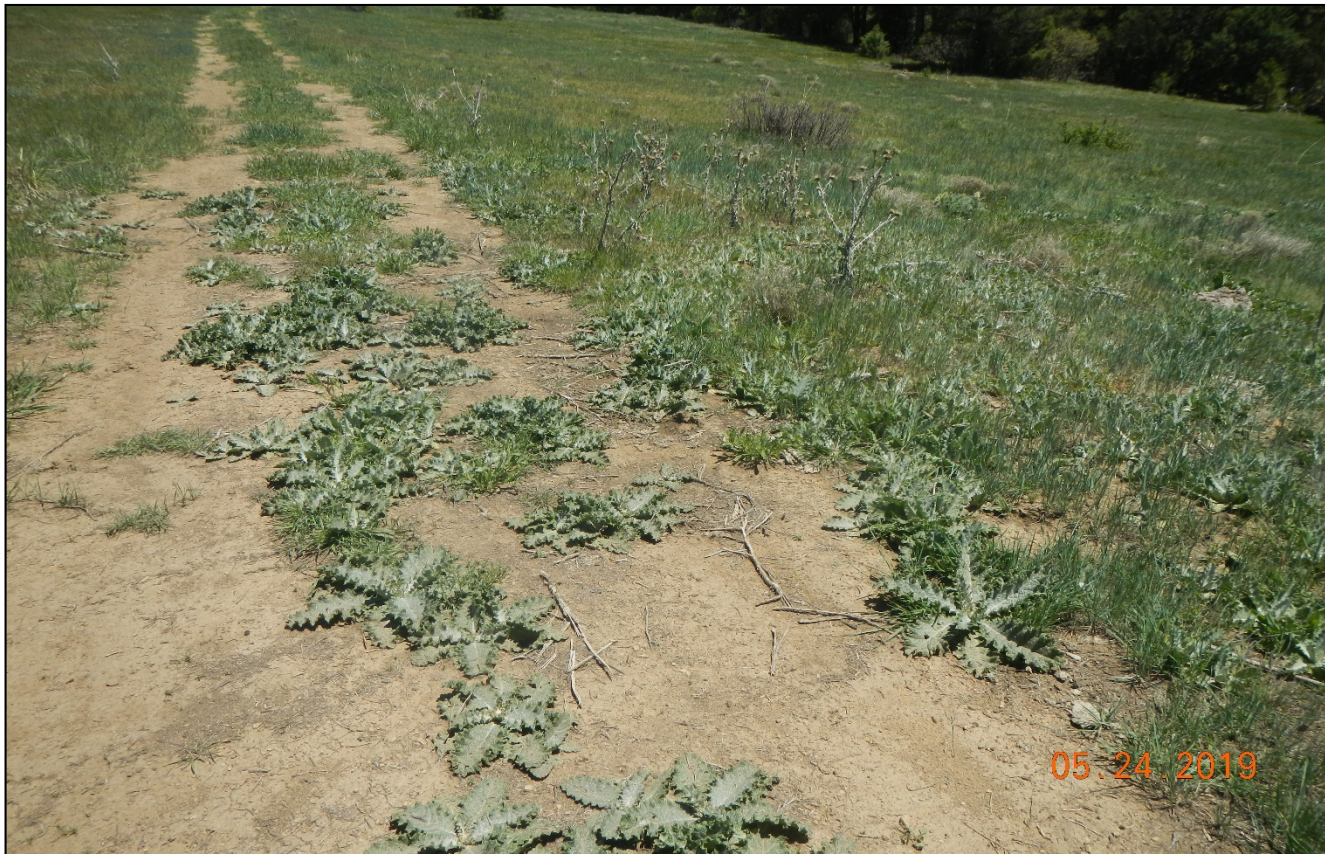
Photo 4. There are numerous noxious weeds along the road. (Scotch thistle)

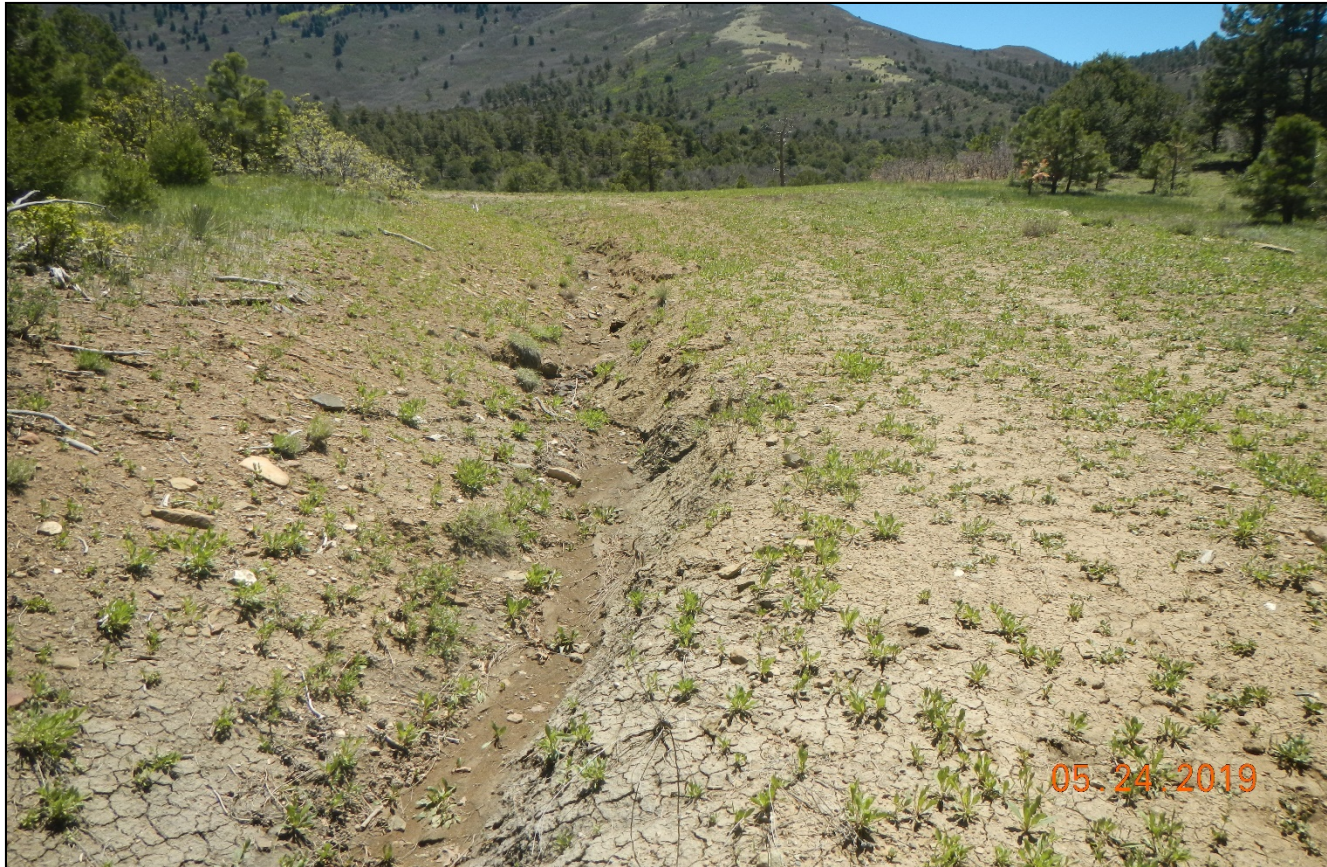
Photo 5. There is an erosion channel near the location along the road..

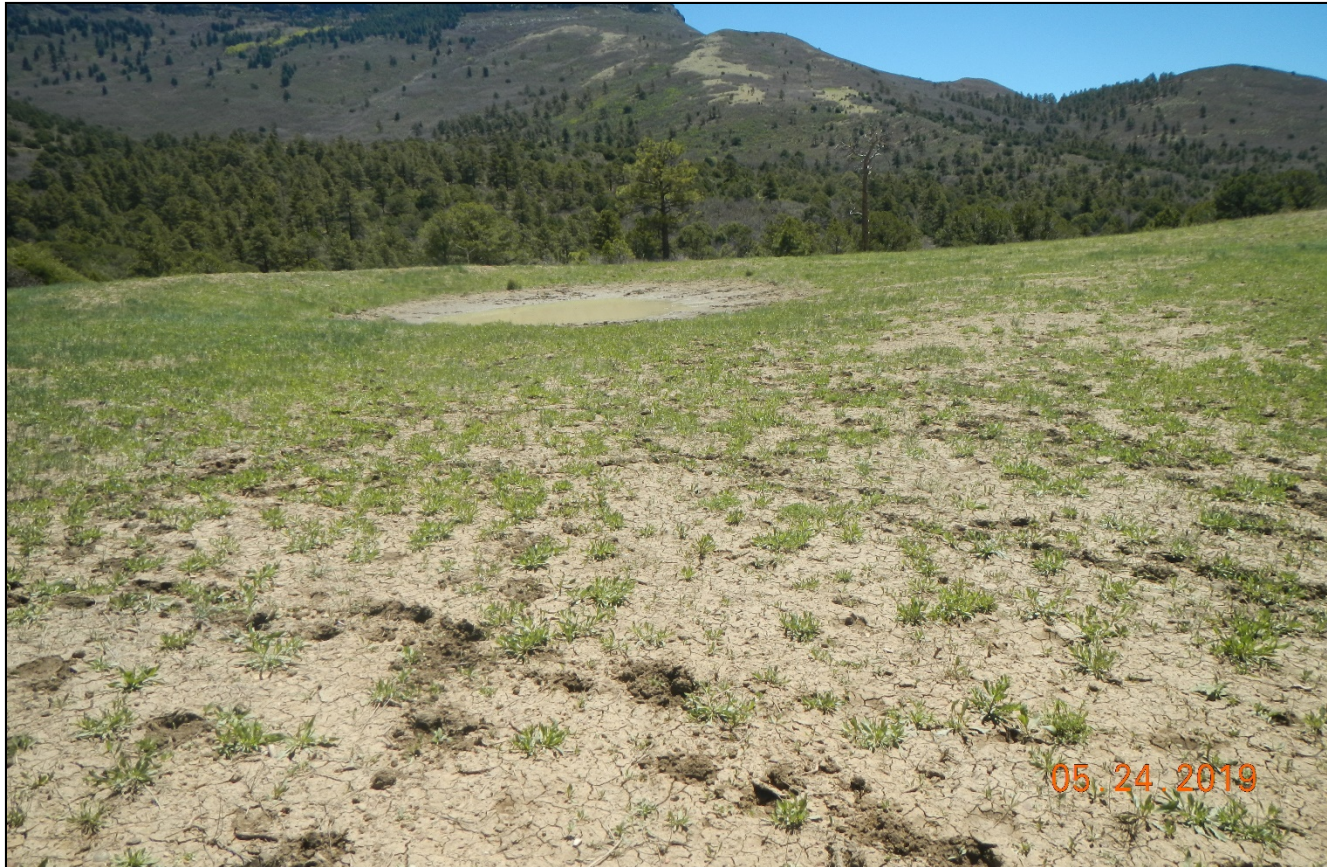
Photo 6. Facing east toward the location.

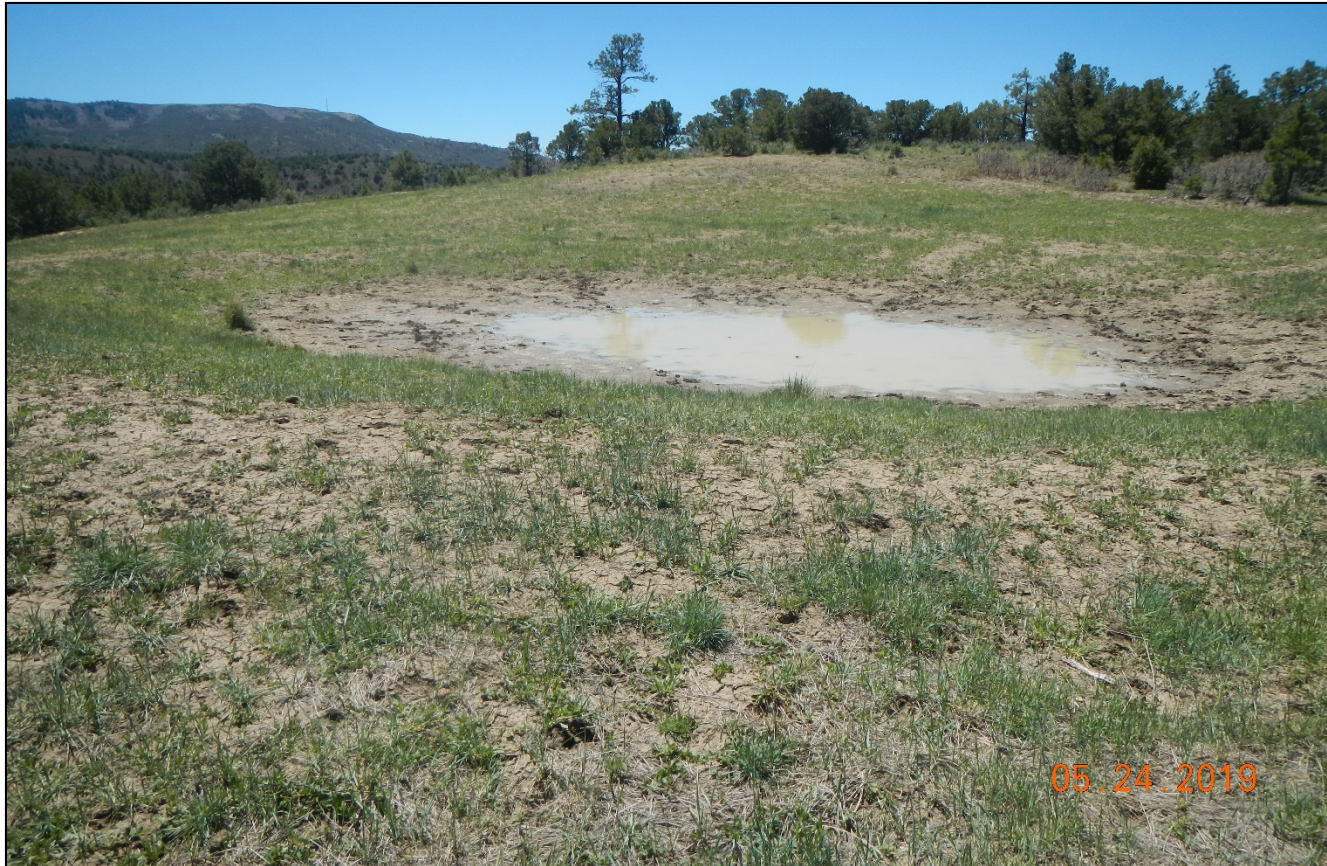
Photo 7. A shallow pit remains per approved variance request.

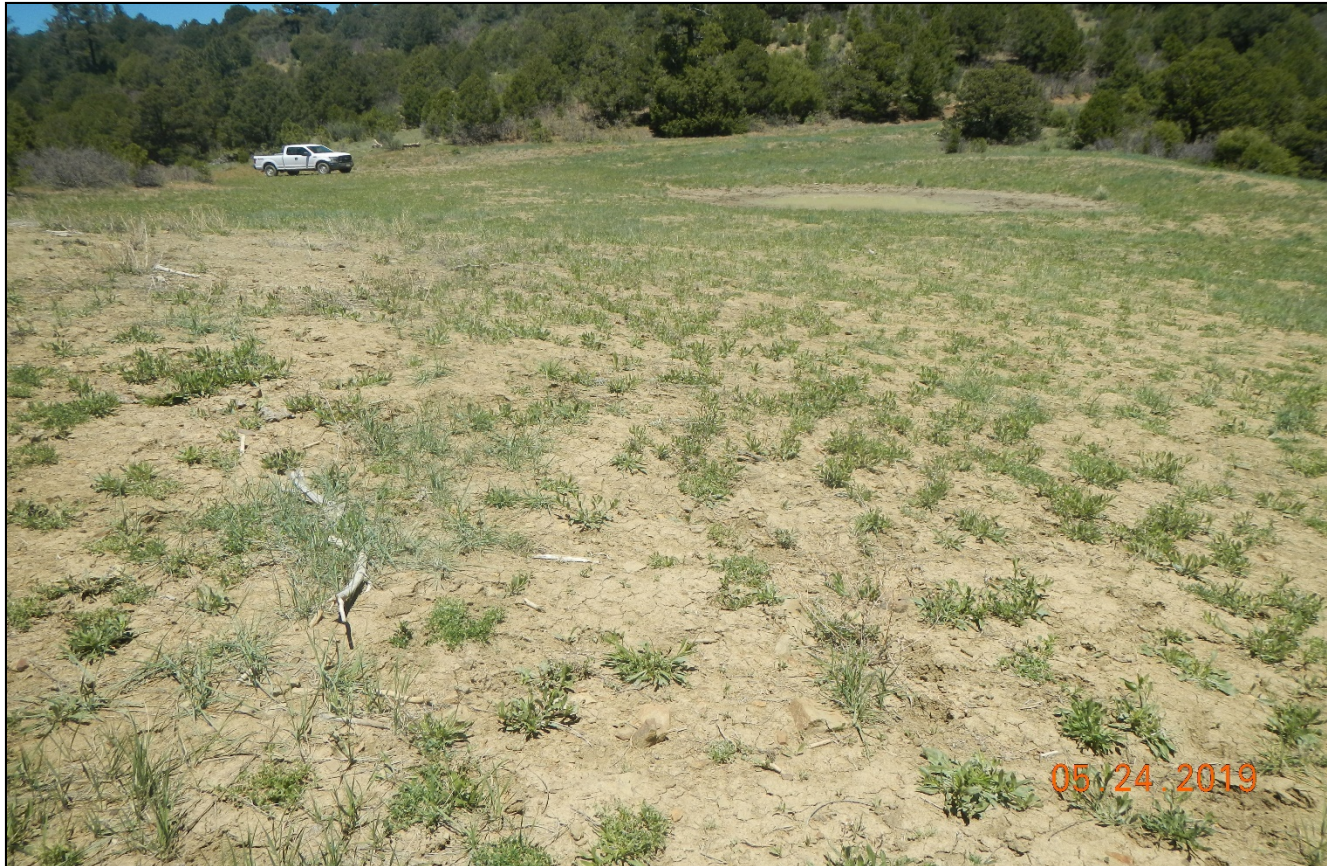
Photo 8. East side of the location facing west.
