Pit Status Evaluation Form

Pit Name: TANAKA BROTHERS 1	Facility ID: 114787
Current Status: Unknown	Status Date: 9/23/1999
Current Operator: NONE LISTED	
Updated Operator: TOP OPERATING COMPANY / 39560	
Form 15 Pit Permit Doc #: NA	Permit Date: NA
Related Facilities: API # 05-013-06036, Location 321259

County: Boulder

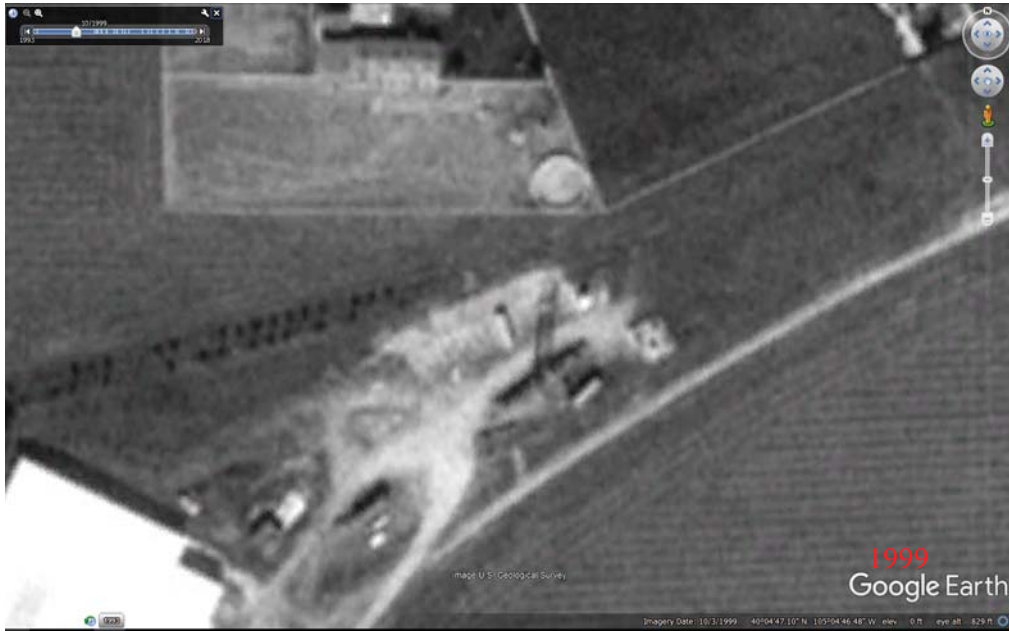
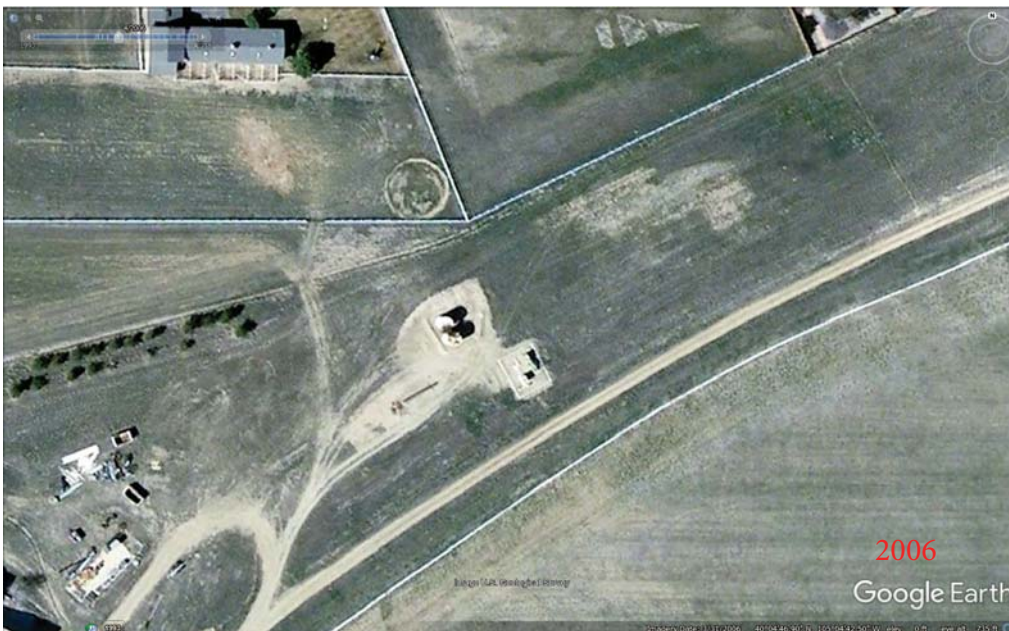
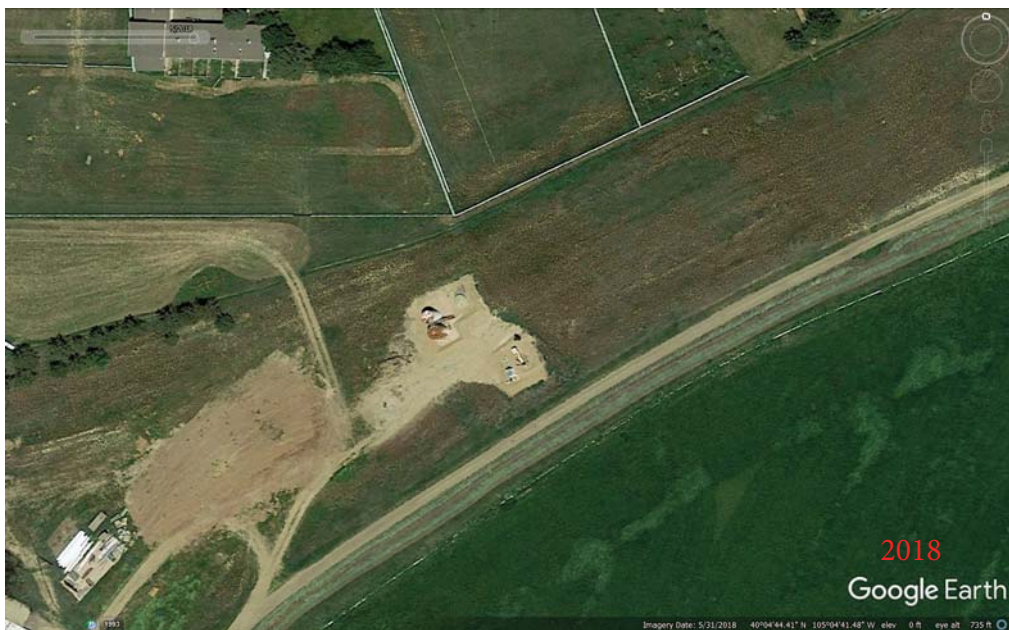
Field inspection (doc #689500978) found no surface indication of a pit on location. Records review and aerial photos found no evidence that there was a produced water pit on location; historic inspection reports document a concrete water vault on location. Pit status changed to closed.
