Construction and Stormwater Inspection

May 24, 2019

Operator: KERR MCGEE OIL & GAS ONSHORE LP #47120

Location ID: 460362

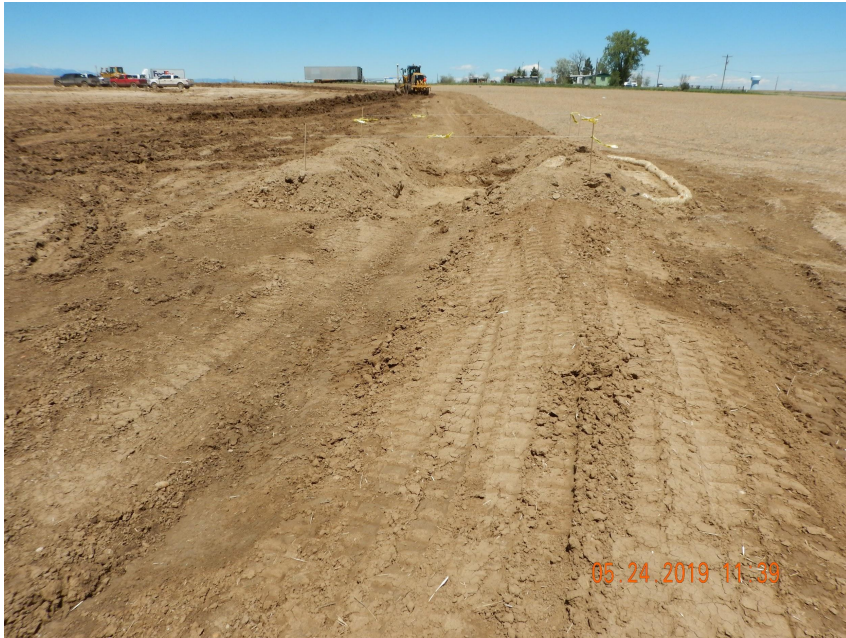
Photo 1. Photo taken from the southeastern location, facing North. Ditch and berm BMP has been installed around the entire perimeter of the location in conjunction with other BMPs (i.e., sediment traps). Operator plans to install a larger permanent sediment trap prior to drilling operations.

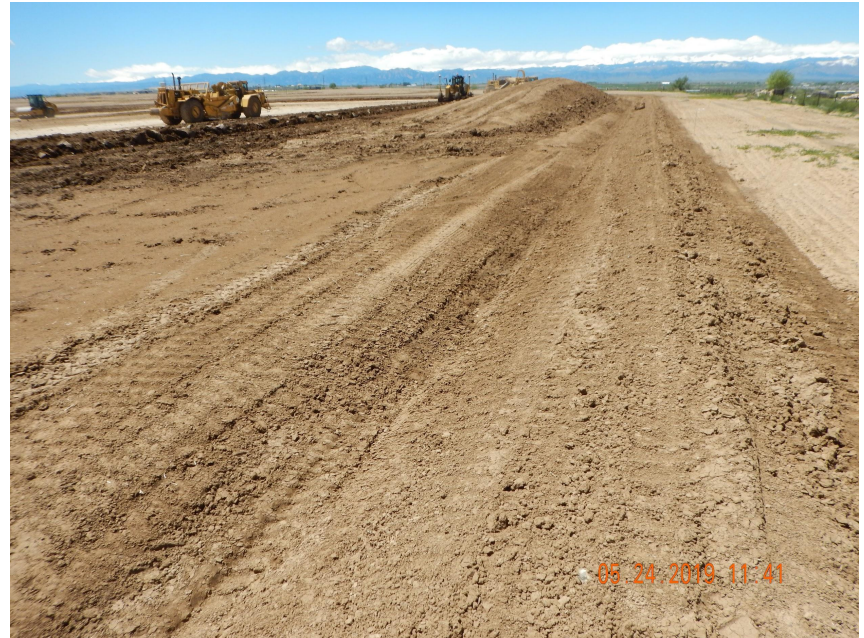
Photo 2. Photo taken from the northeastern location, facing West. See comments under Photo 1. Photo also illustrates one of two topsoil stockpiles.

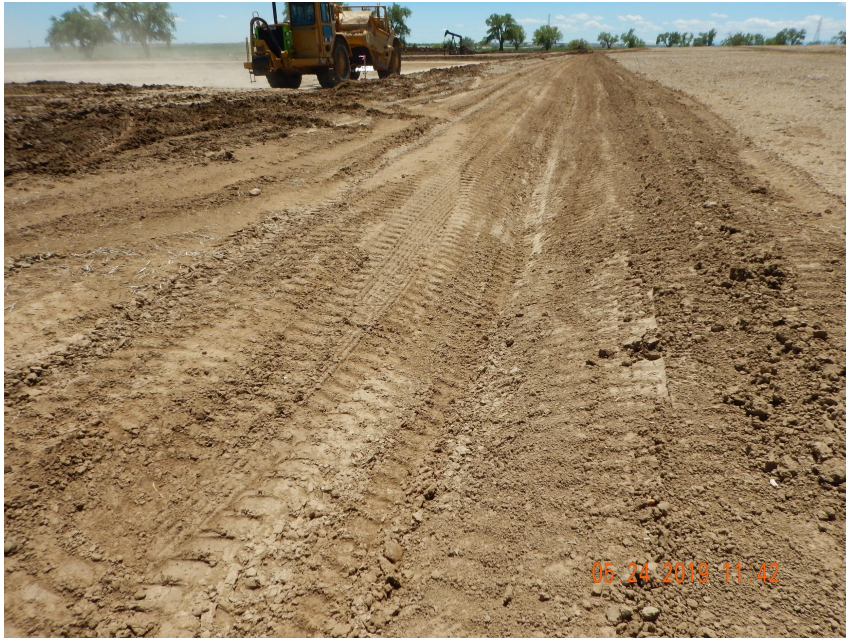
Photo 3. Photo taken from the northeastern location, facing South. See comments under Photo 1.

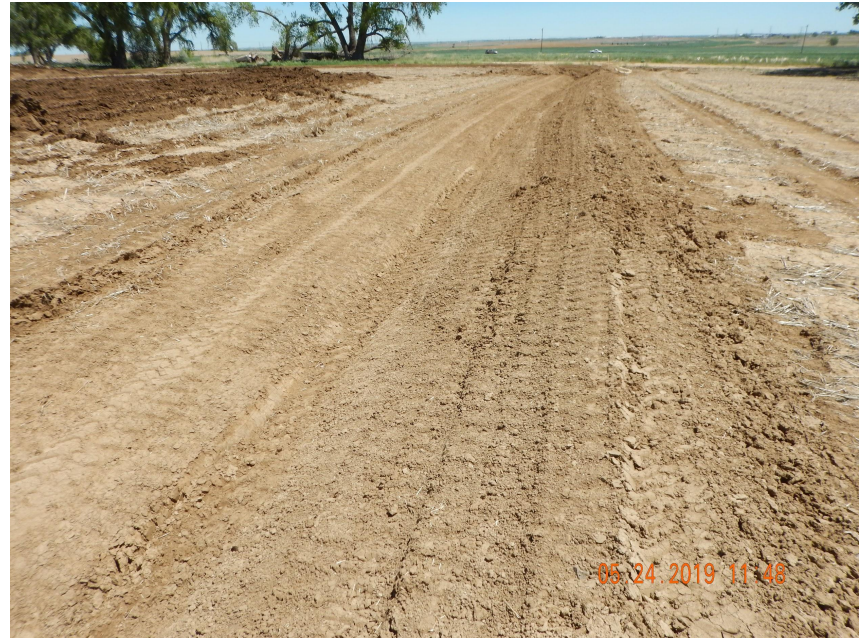
Photo 4. Photo taken from the southern location, facing East. See comments under Photo 1.

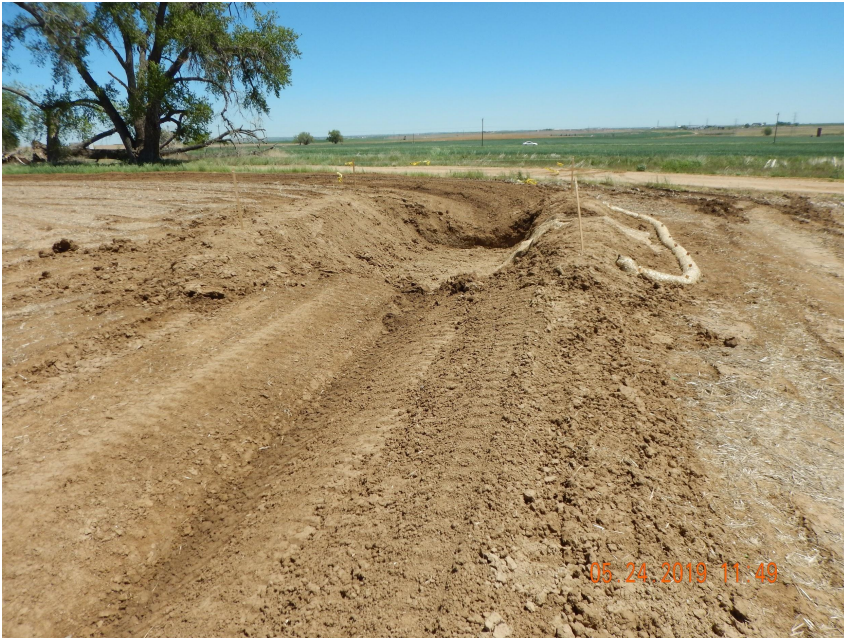
Photo 5. Photo taken from the southeastern sediment trap, facing East. See comments under Photo 1.

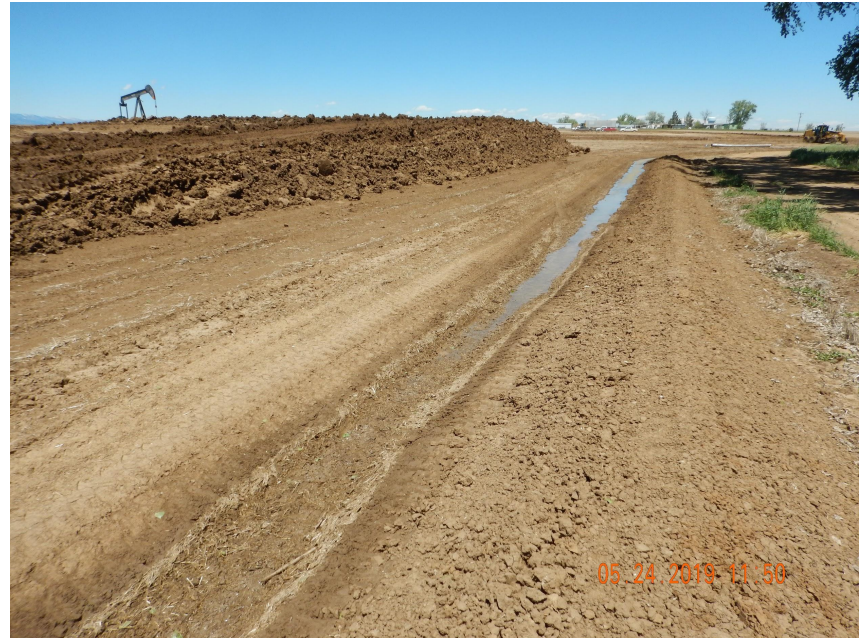
Photo 6. Photo taken from the southeastern location, facing North. See comments under Photo 1.

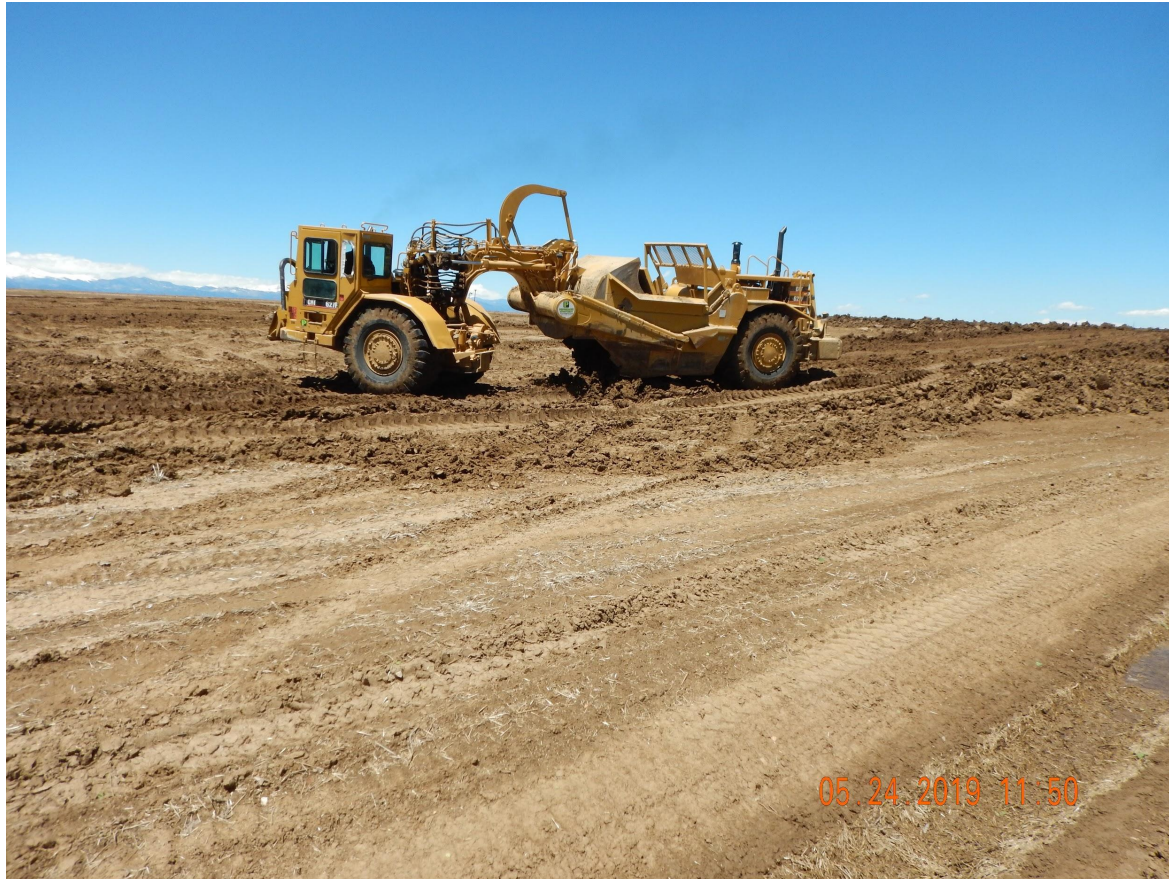
Photo 7. Photo taken from the second topsoil stockpile, facing Northwest.
Topsoil salvage operations were in process during the time of this inspection.

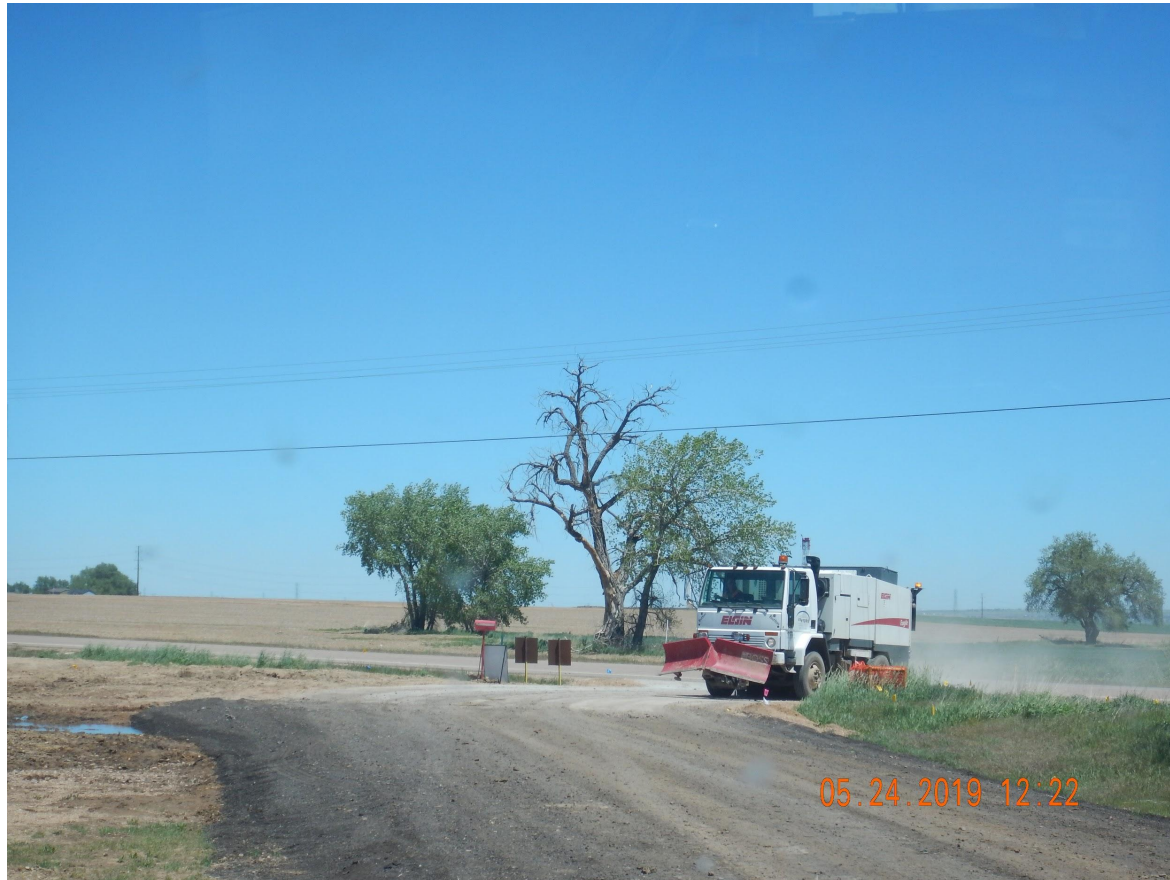
Photo 8. Photo taken from the entrance of location, facing East. Street sweeper was cleaning entrance to location.
