**Inspection Photos**  
**Location Name: GREEN MONSTER 12-25**  
**API #: 05-071-09289**  
**INSP. #:695100727**

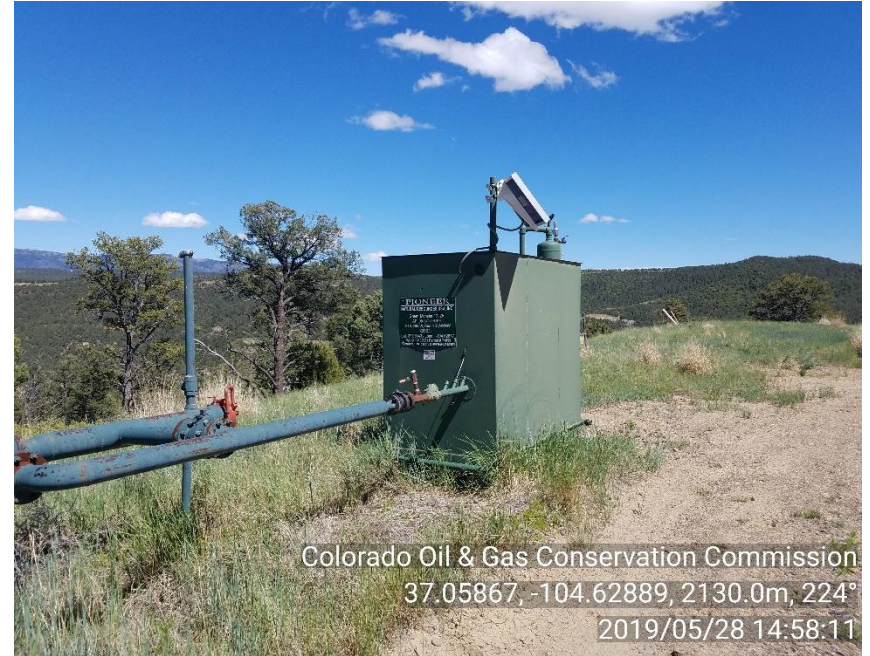
**PHOTO 2: CURRENT OPERATOR NOT POSTED ON WELL SIGN.**  
**CHANGE OPERATOR NAME TO CURRENT OPERATOR IN**  
**ACCORDANCE WITH RULE 210. CA DATE 7/28/19**

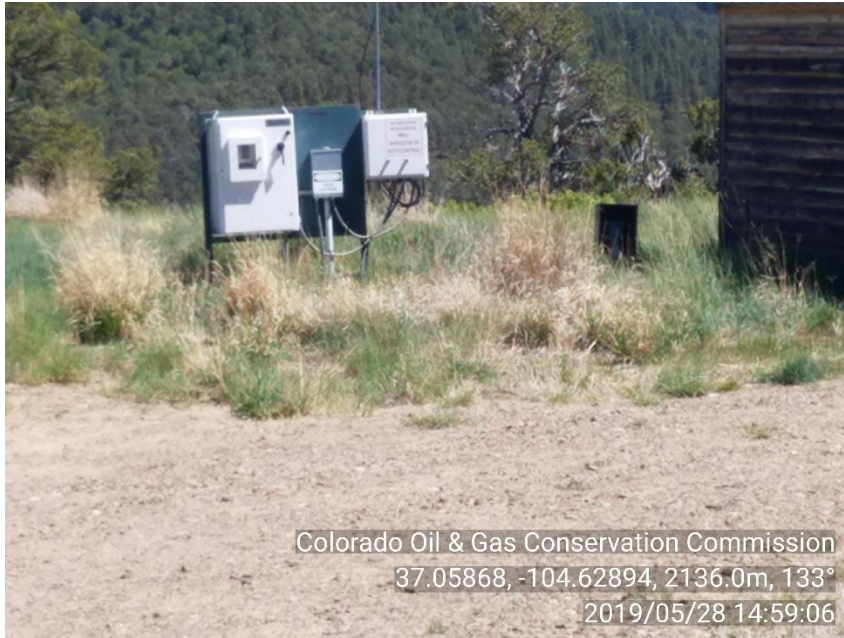
**PHOTO 3: GRASS/WEEDS TO NORTH OF WELLHEAD HOUSE AROUND TELEMETRY EQUIPMENT IS OVERGROWN. CUT OR REMOVE WEEDS IN ACCORDANCE WITH 603. SERIES RULES. CA DATE 6/28/19**

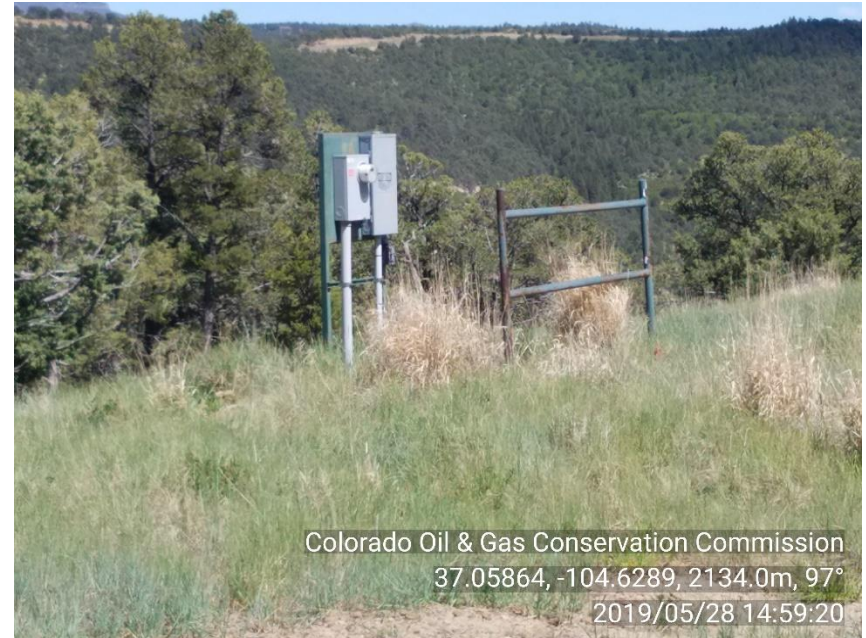
**PHOTO 4: GRASS/WEEDS ON NORTH SIDE OF LOCATIO AROUND ELECTRIC PANEL/METER IS OVERGROWN. CUT OR REMOVE WEEDS IN ACCORDANCE WITH 603. SERIES RULES. CA DATE 6/28/19**

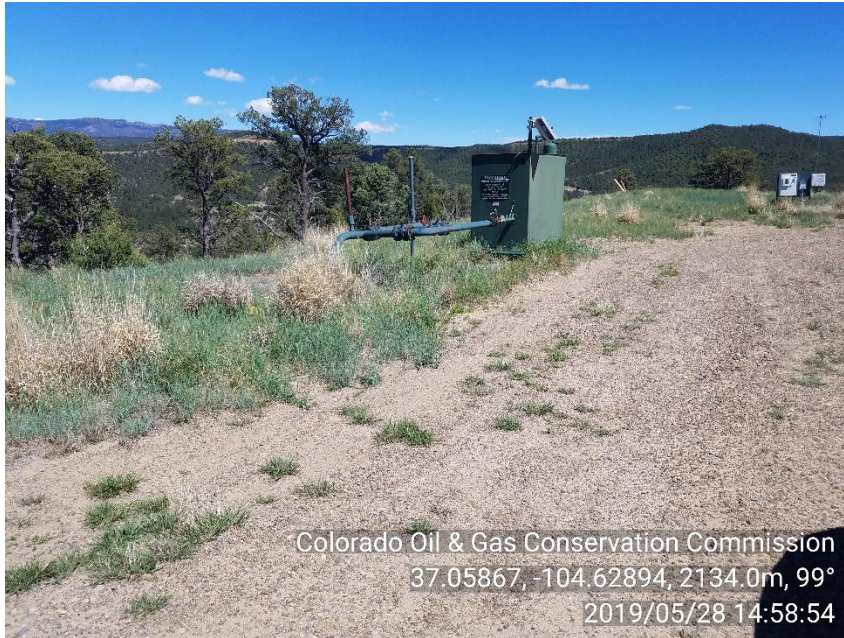
**PHOTO 5: GRASS/WEEDS ON WEST SIDE OF LOCATIO  
AROUND METER HOUSE IS OVERGROWN. CUT OR REMOVE  
WEEDS IN ACCORDANCE WITH 603. SERIES RULES. CA DATE  
6/28/19**

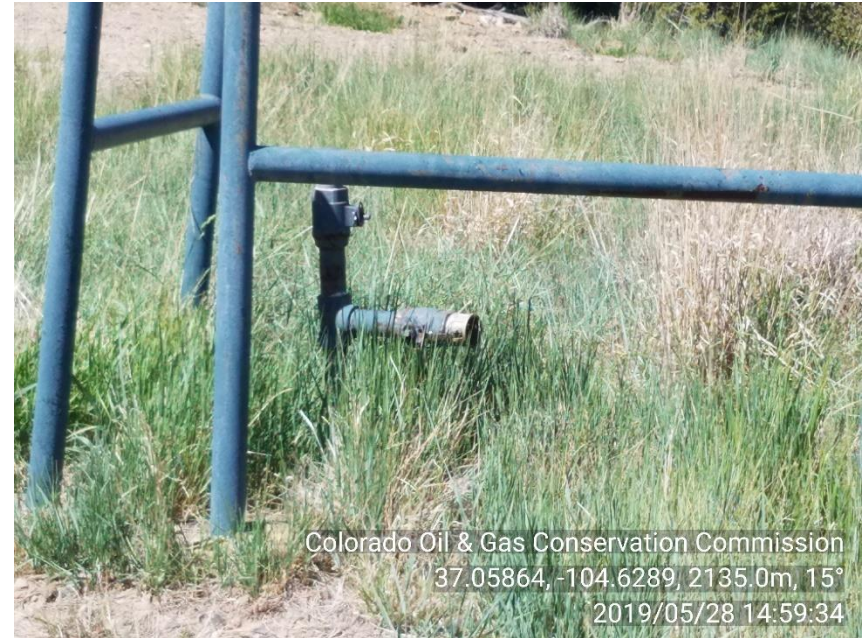
**PHOTO 6: GRASS/WEEDS NEAR ENTRANCE OF LOCATIO  
AROUND 2" DRIP IS OVERGROWN. CUT OR REMOVE WEEDS  
IN ACCORDANCE WITH 603. SERIES RULES. CA DATE 6/28/19**

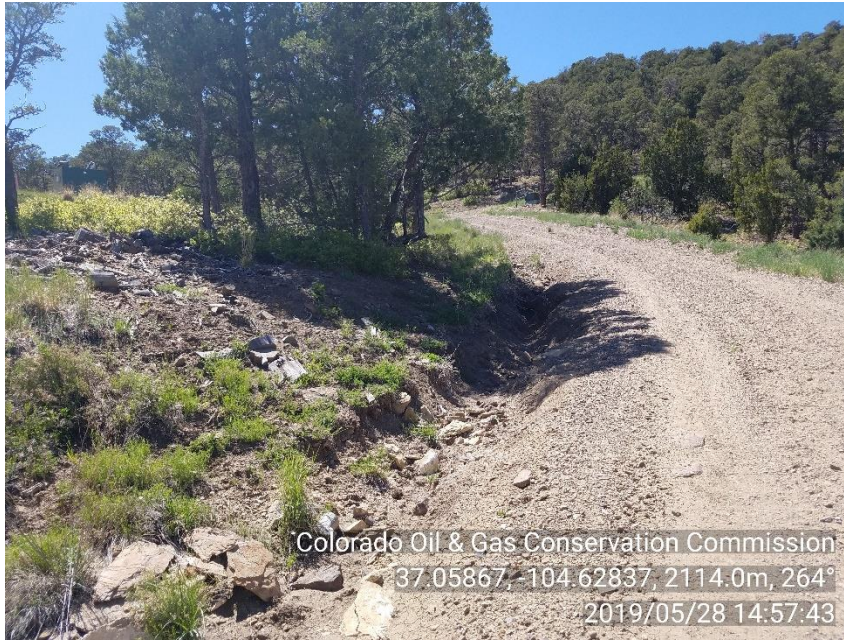
**PHOTO 7: DRAINAGE DITCH ON ROW JUST EAST OF LOCATION ENTRANCE HAS NO BMP'S OR BMP'S OR INADEQUATE. REPAIR OR INSTALL BMP'S TO PREVENT EROSION IN ACCORDANCE WITH 1002 SERIES RULES. CA DATE 6/28/19.**

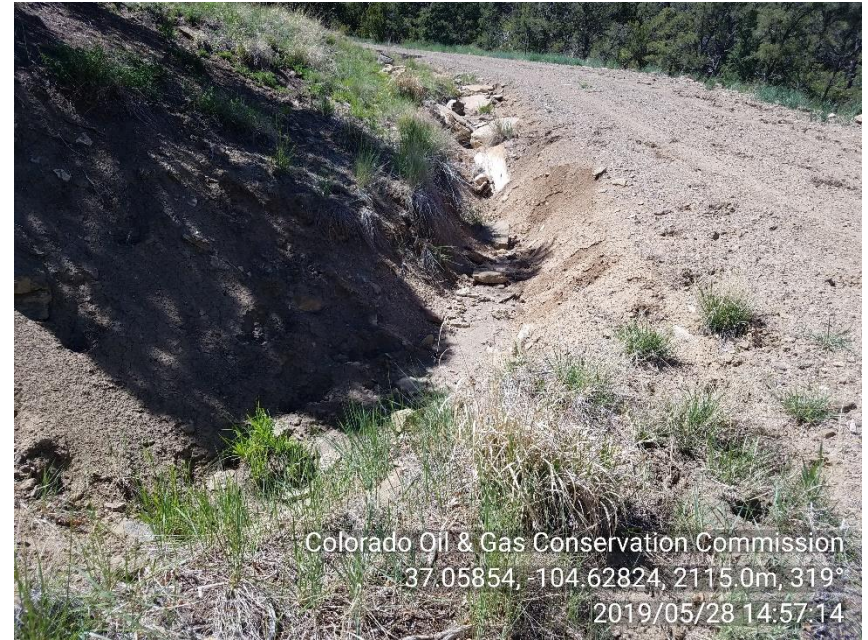
**PHOTO 8: DRAINAGE DITCH ON ROW FURTHER EAST OF LOCATION ENTRANCE HAS NO BMP'S OR BMP'S OR INADEQUATE. REPAIR OR INSTALL BMP'S TO PREVENT EROSION IN ACCORDANCE WITH 1002 SERIES RULES. CA DATE 6/28/19.**

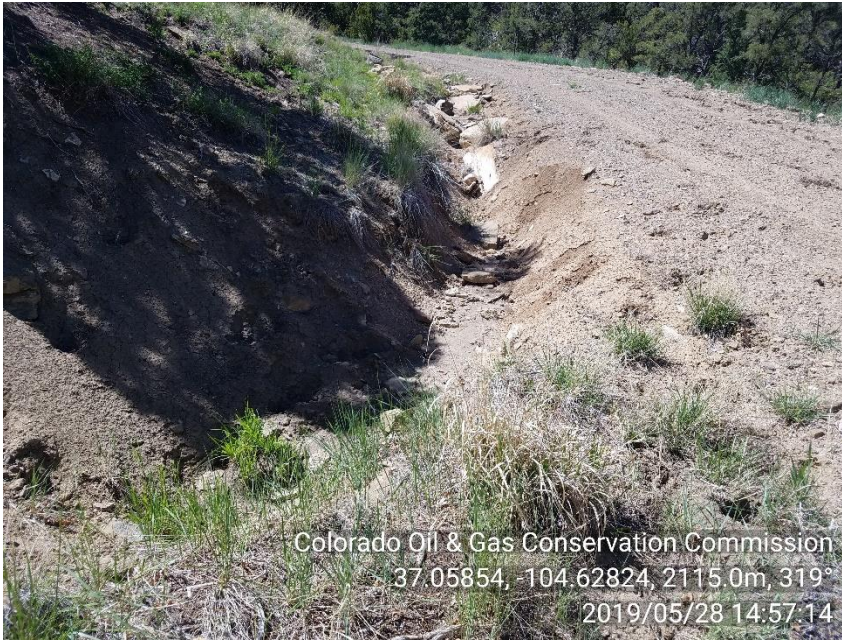
**PHOTO 9: DRAINAGE DITCH ON ROW EAST/SOUTHEAST OF LOCATION ENTRANCE HAS NO BMP'S OR BMP'S OR INADEQUATE. REPAIR OR INSTALL BMP'S TO PREVENT EROSION IN ACCORDANCE WITH 1002 SERIES RULES. CA DATE 6/28/19.**

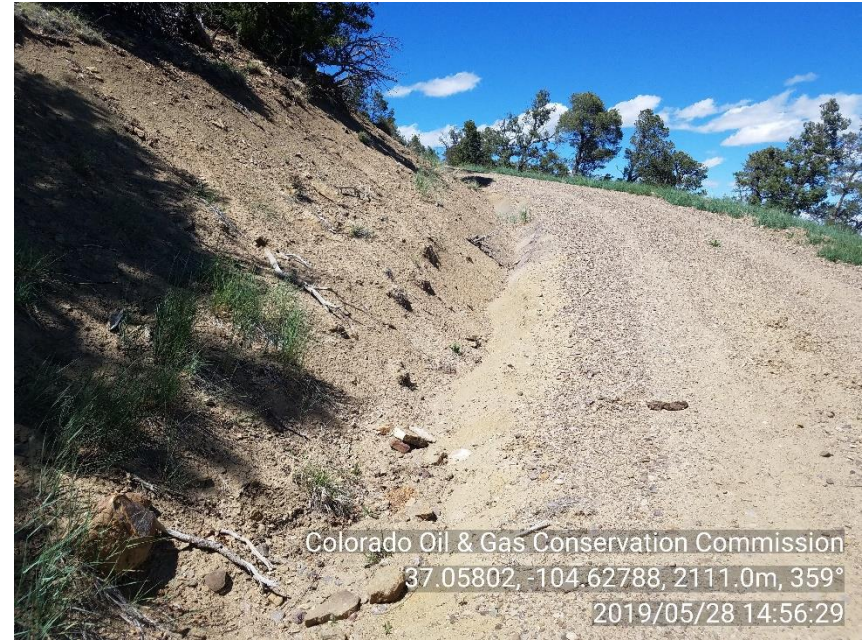
**PHOTO 8: DRAINAGE DITCH ON ROW SOUTH OF LOCATION ENTRANCE HAS NO BMP'S OR BMP'S OR INADEQUATE. REPAIR OR INSTALL BMP'S TO PREVENT EROSION IN ACCORDANCE WITH 1002 SERIES RULES. CA DATE 6/28/19.**
