Inspection Photos

Location Name: Clough Production Pit 44-16-694

Location ID 421192, Pit Facility ID 414560

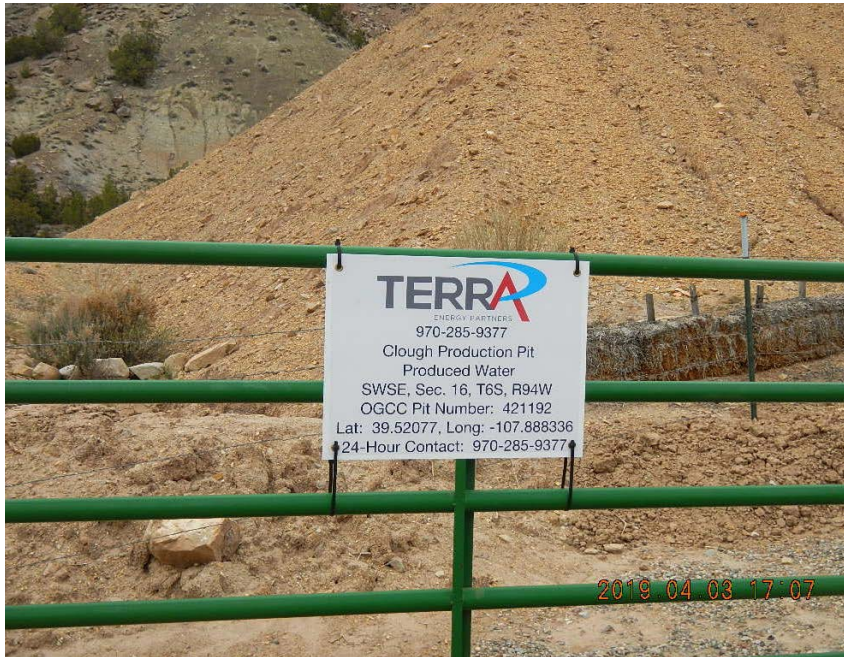
Location 421192. OGCC Pit Number should read 414560.

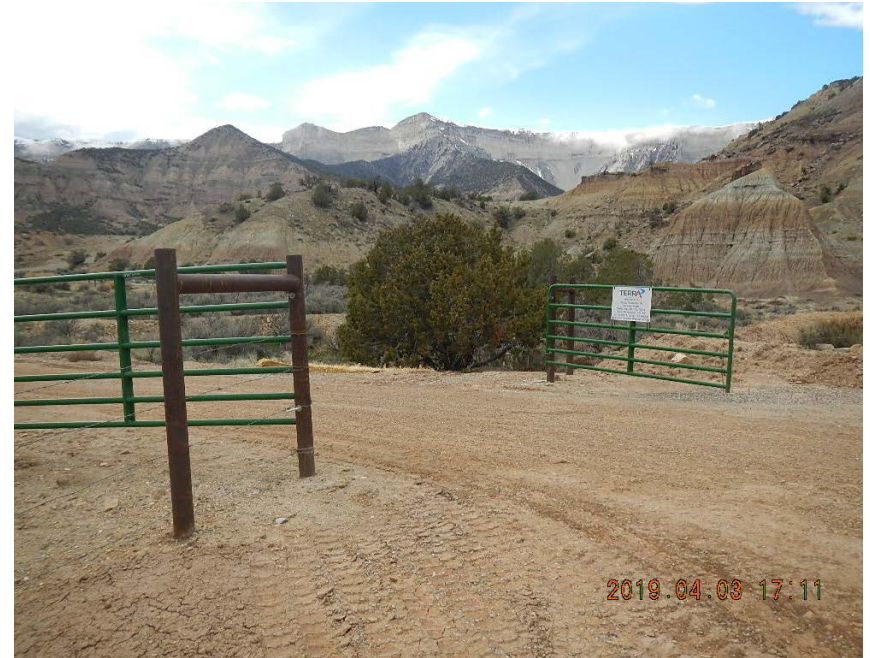
Gates open at time of inspection.

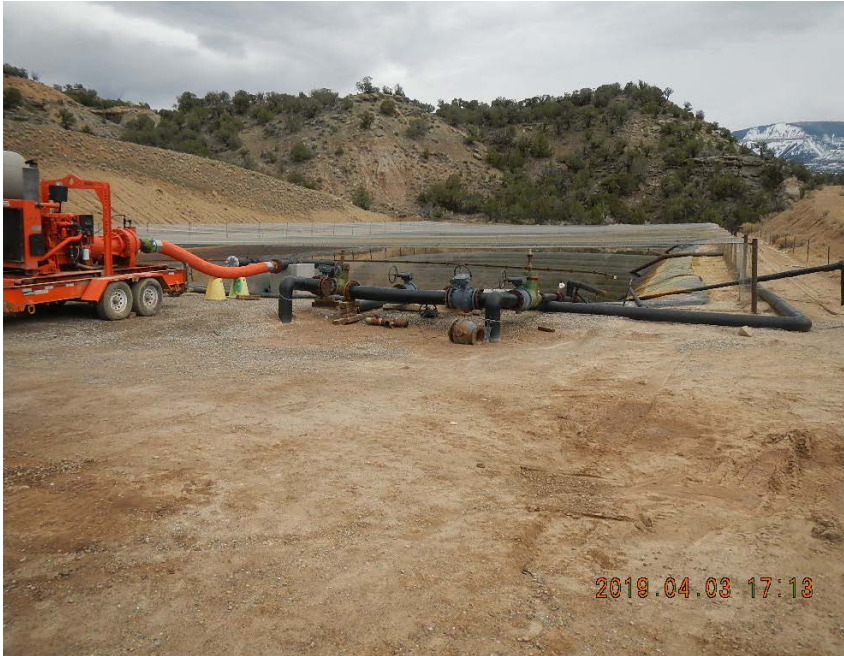
Manifold system cribbed with wood blocks, unused equipment, flow line directly on pit liner

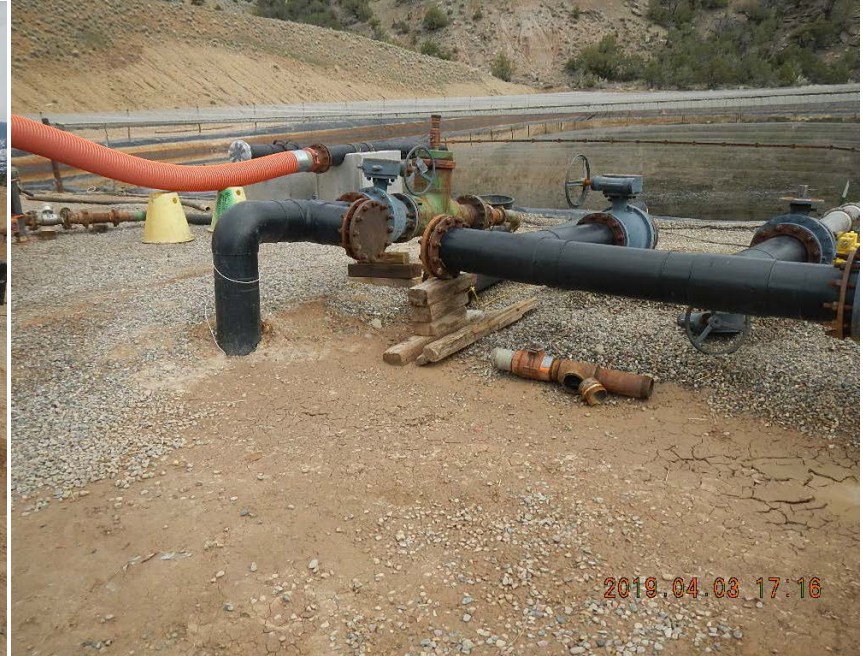
Manifold system cribbed with wood blocks, unused equipment.

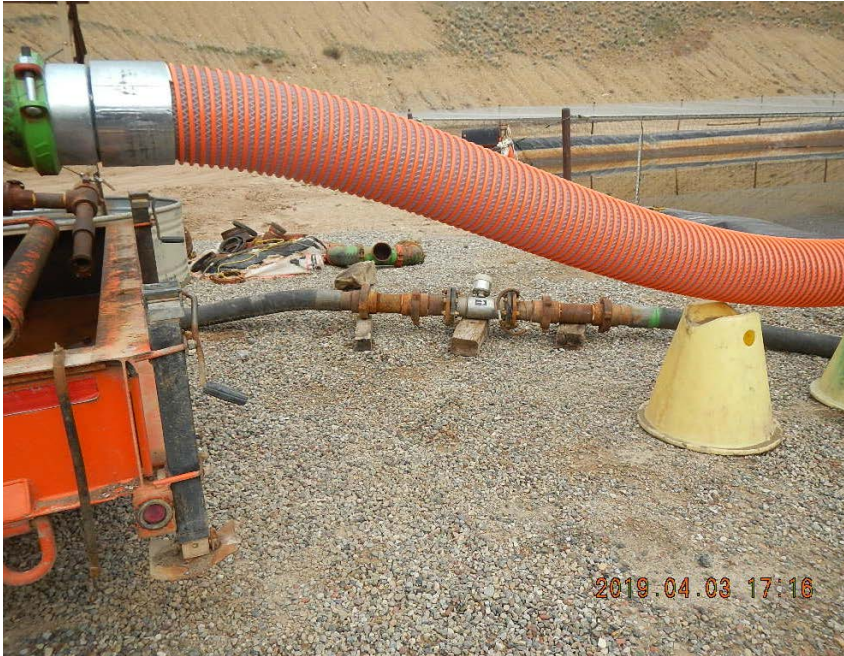
Unused equipment. Flow meter supported by wood blocks.

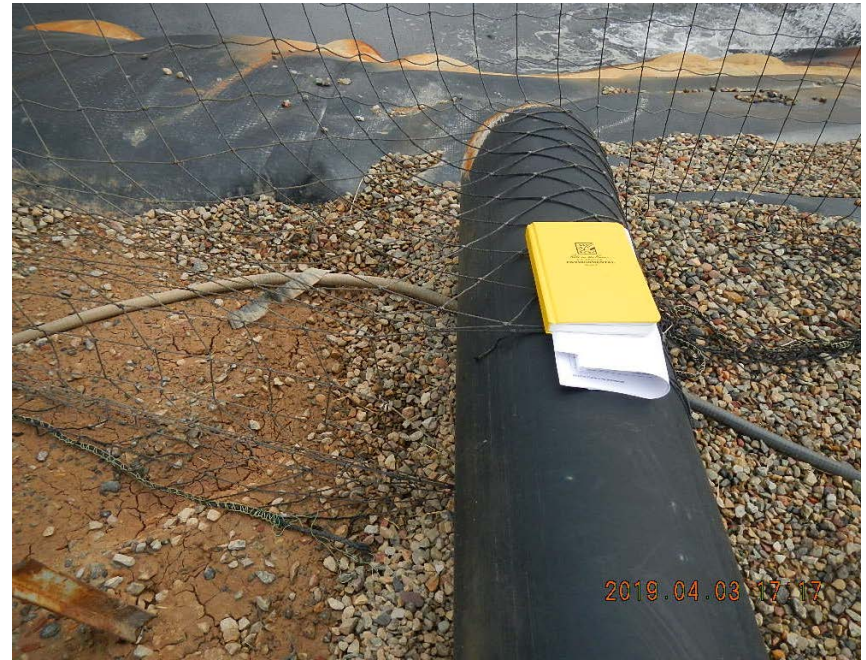
Gap in netting around pipe penetration.

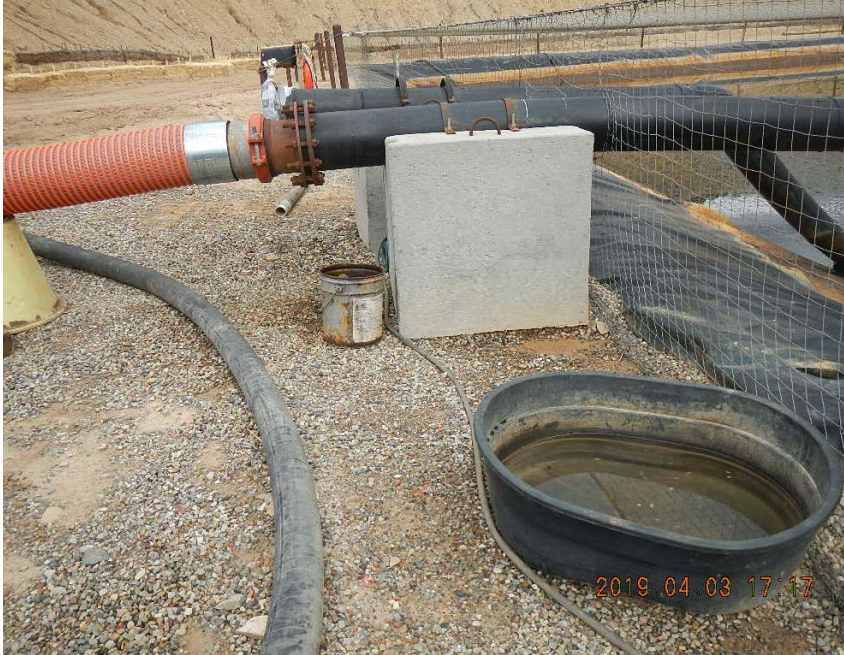
Staining/discolored gravel by 5-gallon pail.

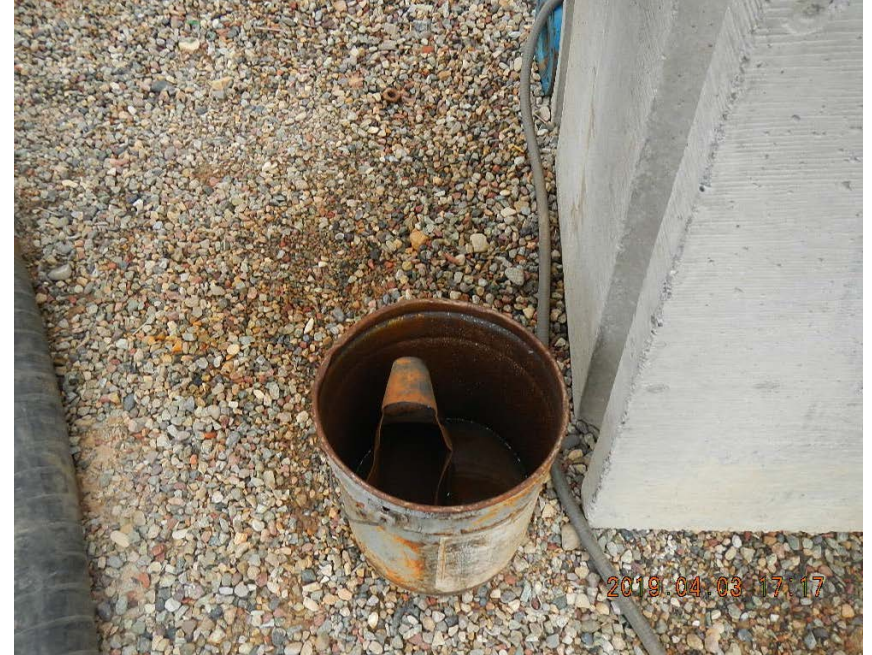
Staining/discolored gravel by 5-gallon pail.

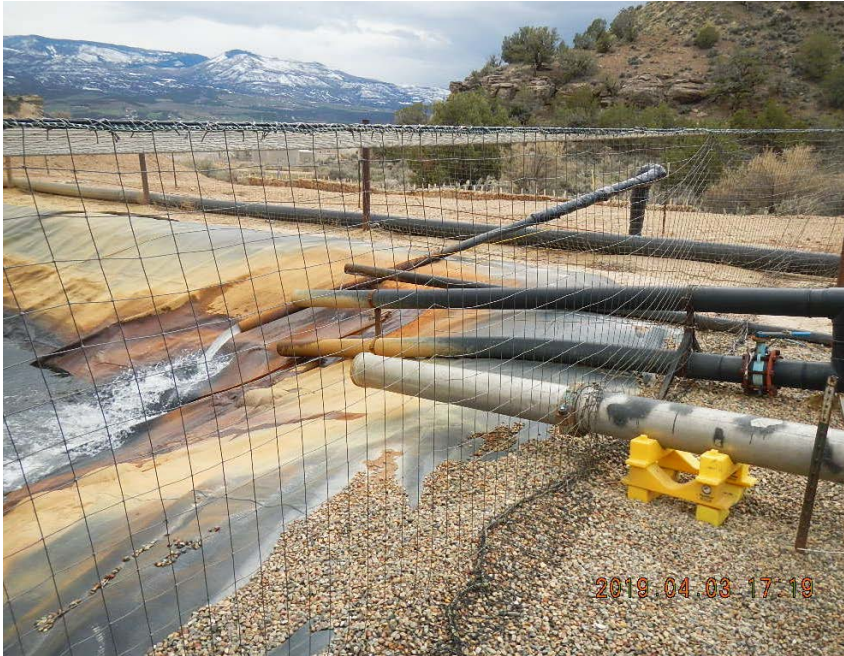
Lines directly on the pit liner. Gaps in net around pipeline penetrations. Gravel migration into the pit.

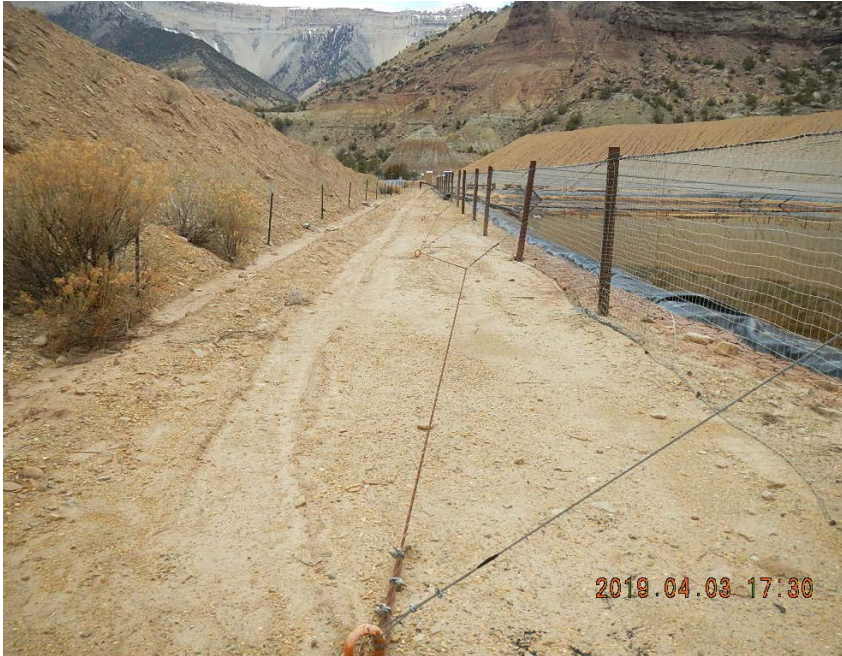
View is to the north to northwest. Four strand wire fence.
Fire lane and buffer lane absent.

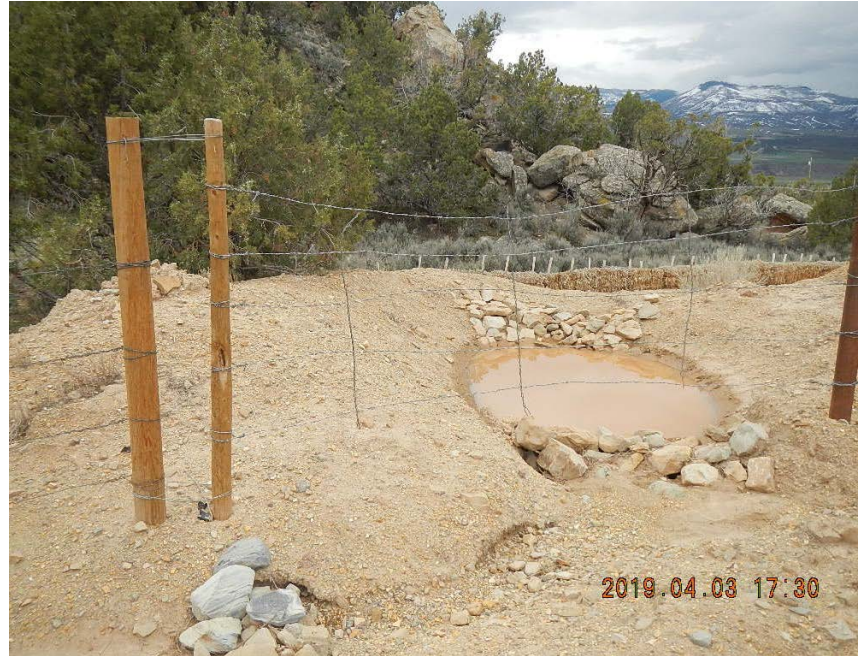
Sediment trap located at the southwest corner of the pit.
Gaps in fence below gate and at gate closure.

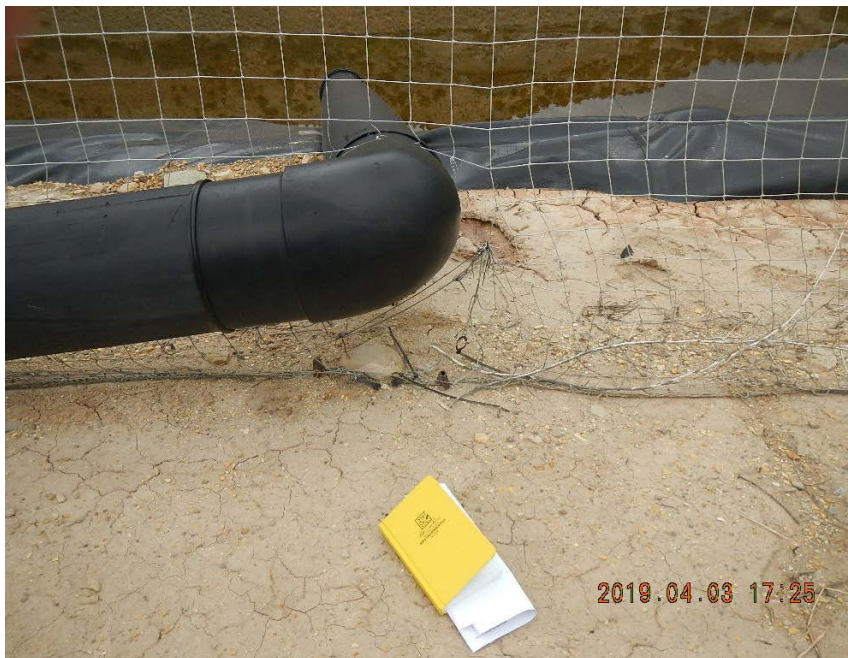
Gap in fence at pipeline penetration and sediment encroaching towards pit.

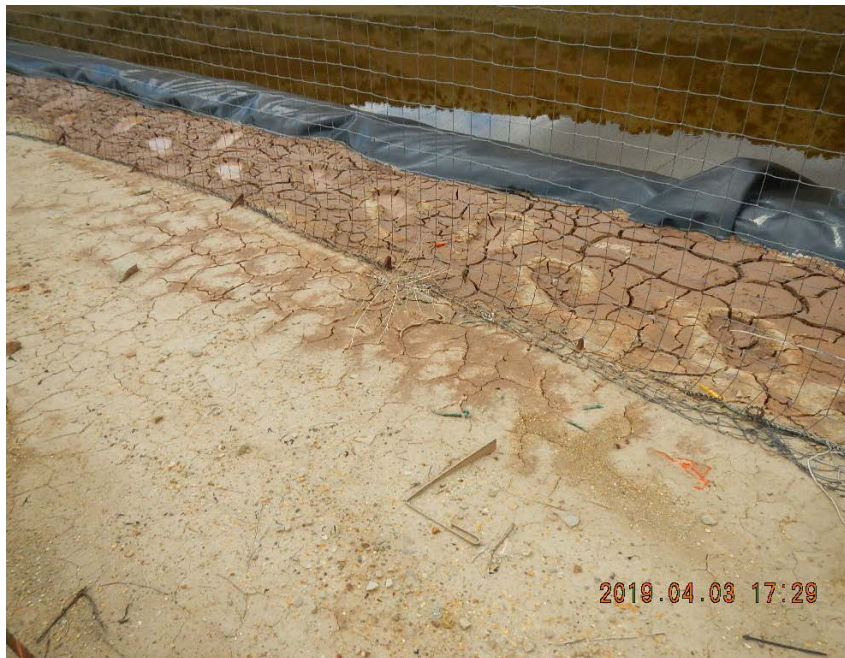
Sediment encroaching towards pit. Metal debris.

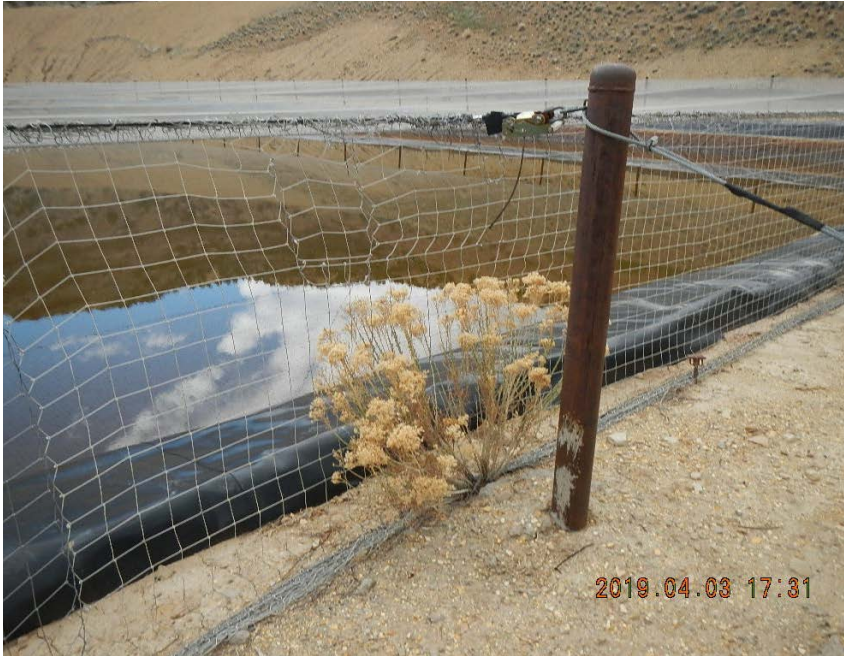
Vegetation in netting and netting repair.

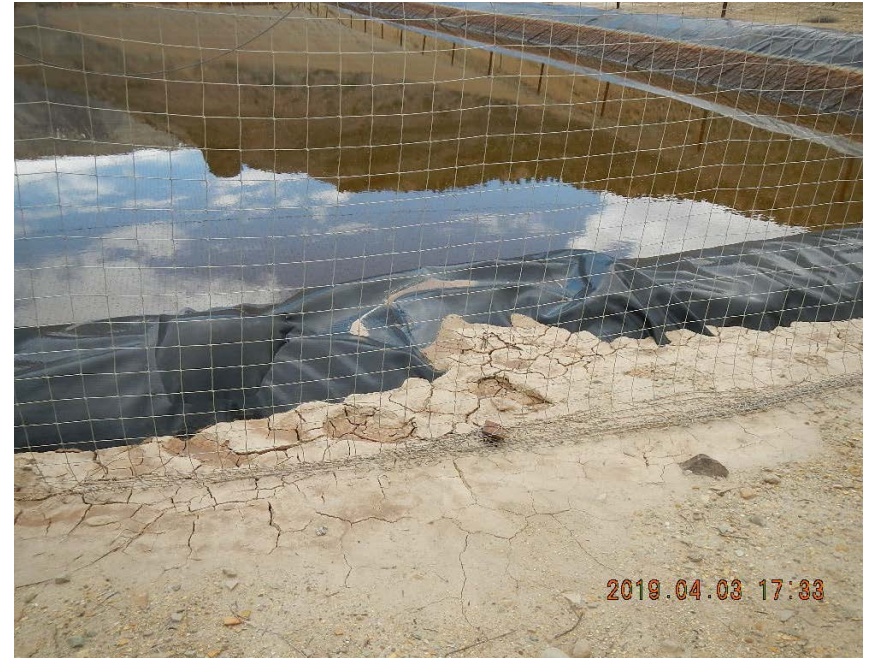
Sediment encroaching towards pit.

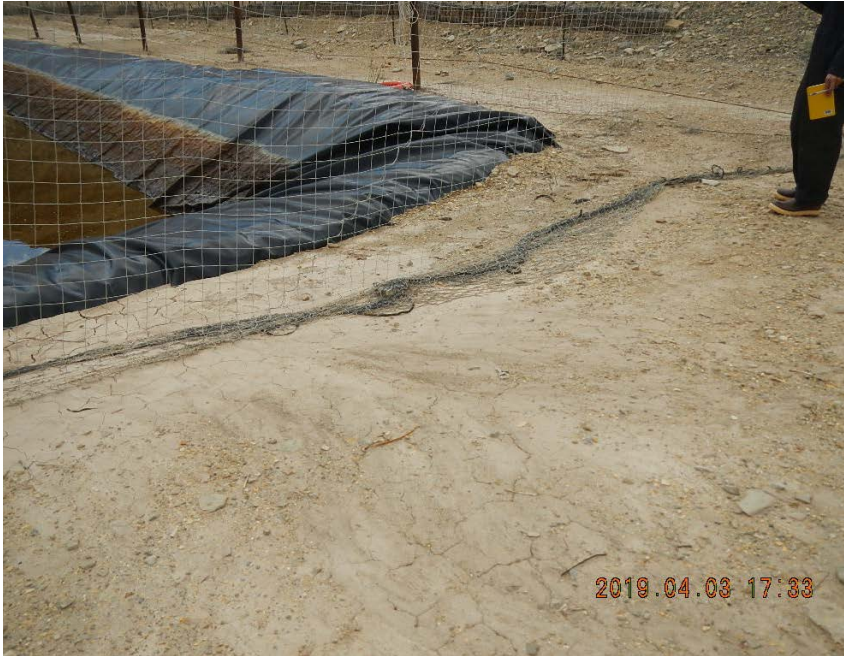
Sediment encroaching towards pit. Gaps in netting.

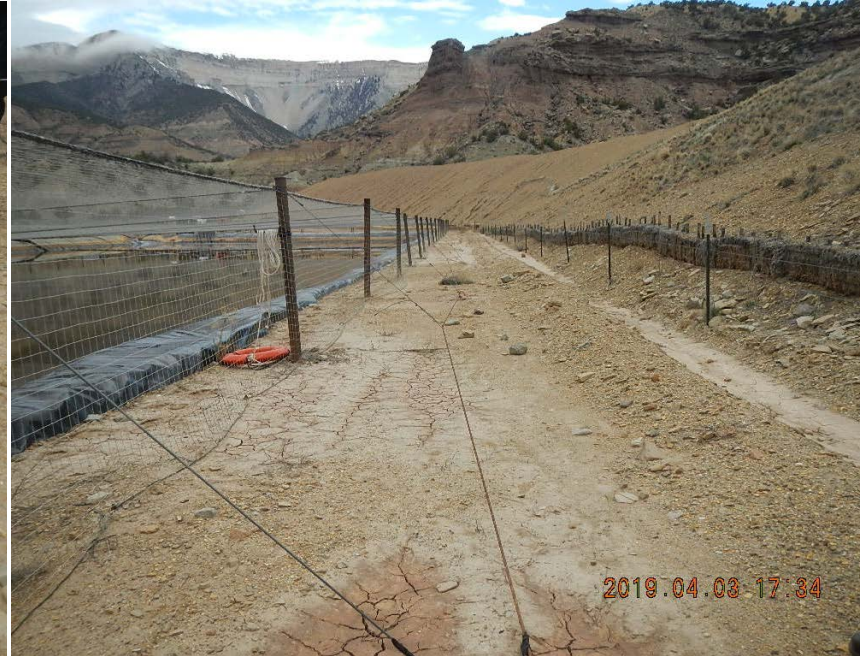
Looking north to northwest. Rock migration toward pit from adjacent hill side.

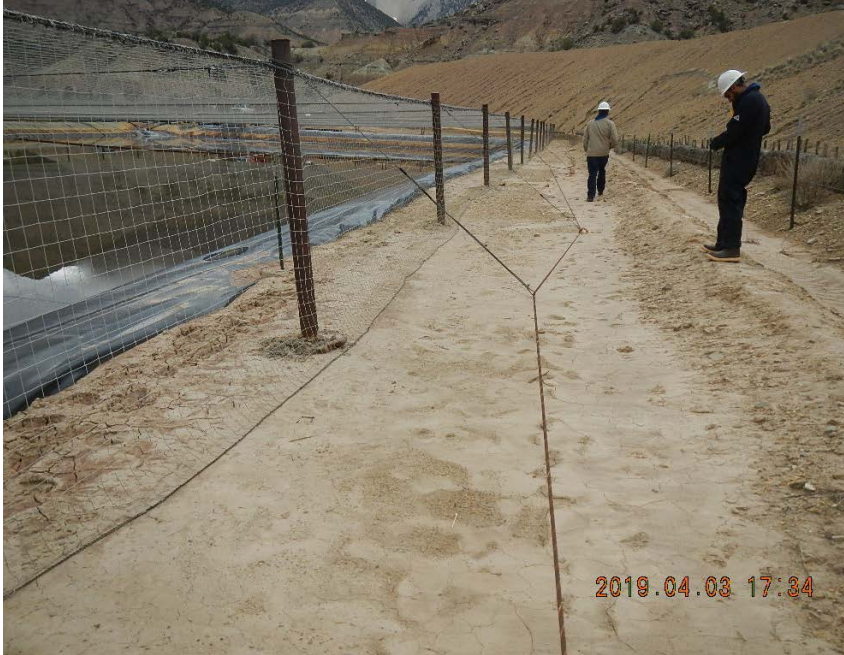
Sediment migration toward pit. Fire lane and buffer lane absent.

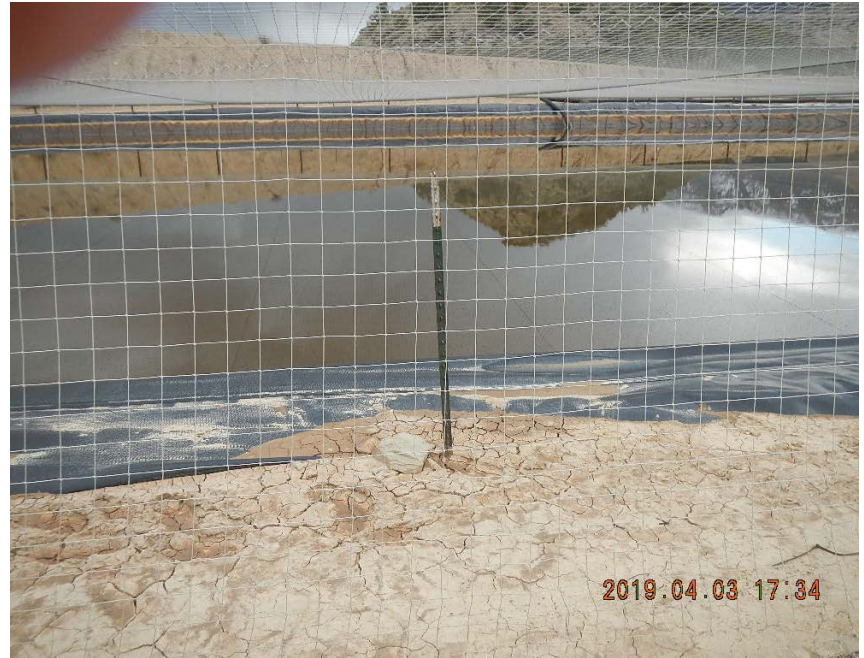
Sediment migration into pit, "T" post potentially penetrating liner near anchor trench.

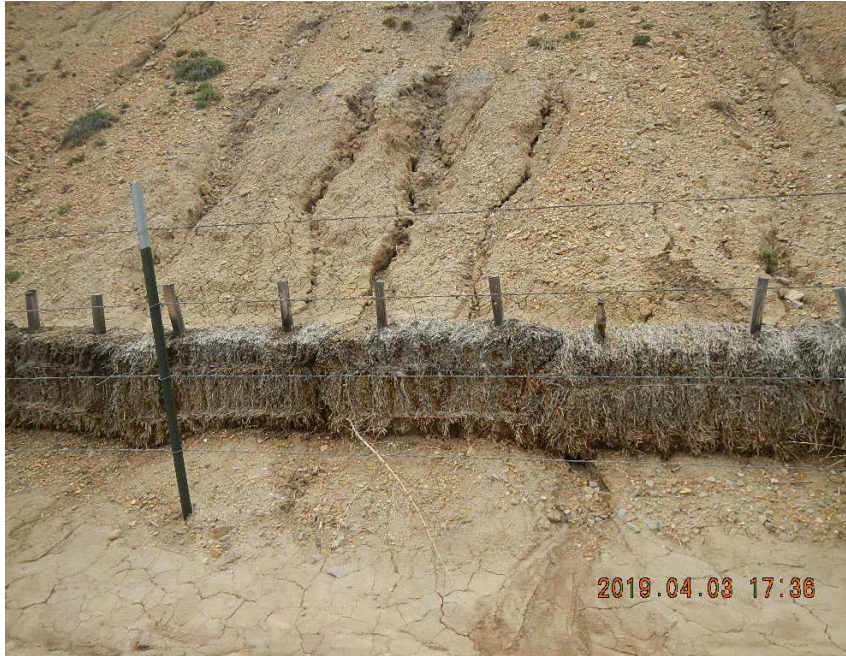
Erosional rills and failed BMPs (apparent storm water with sediment migration beneath straw bails).

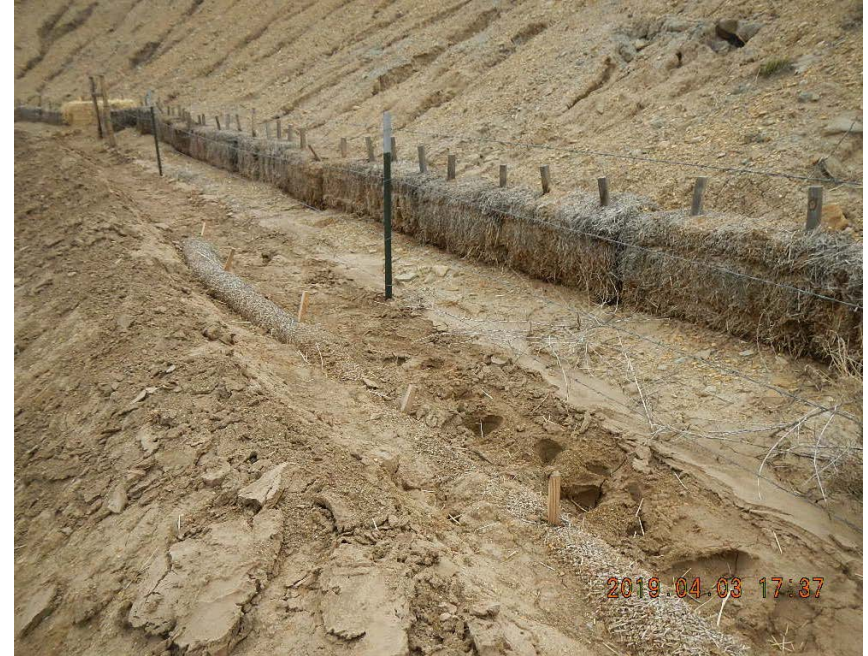
Erosional rills and evidence of livestock inside of fence.

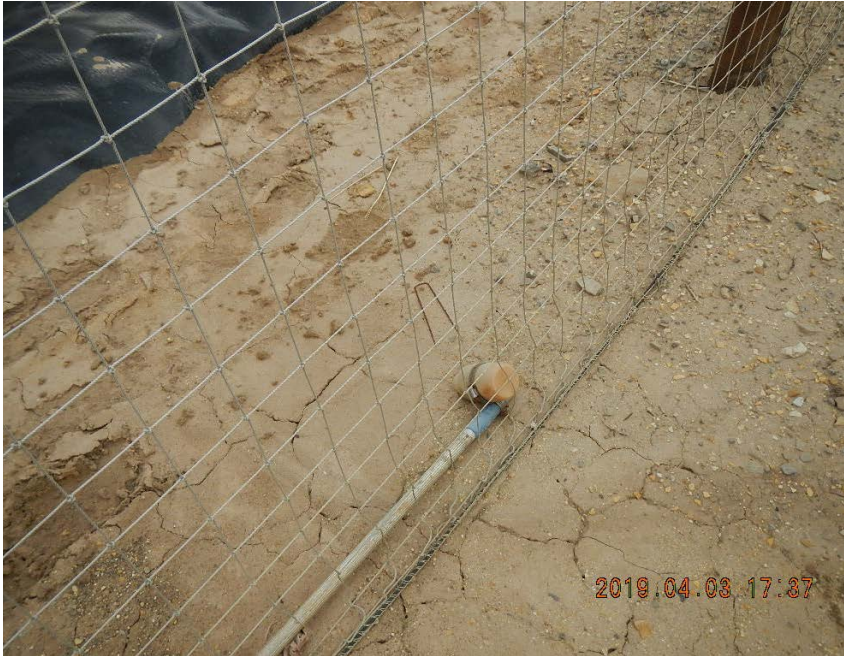
Sampler and wire anchor pin inside of pit complex.

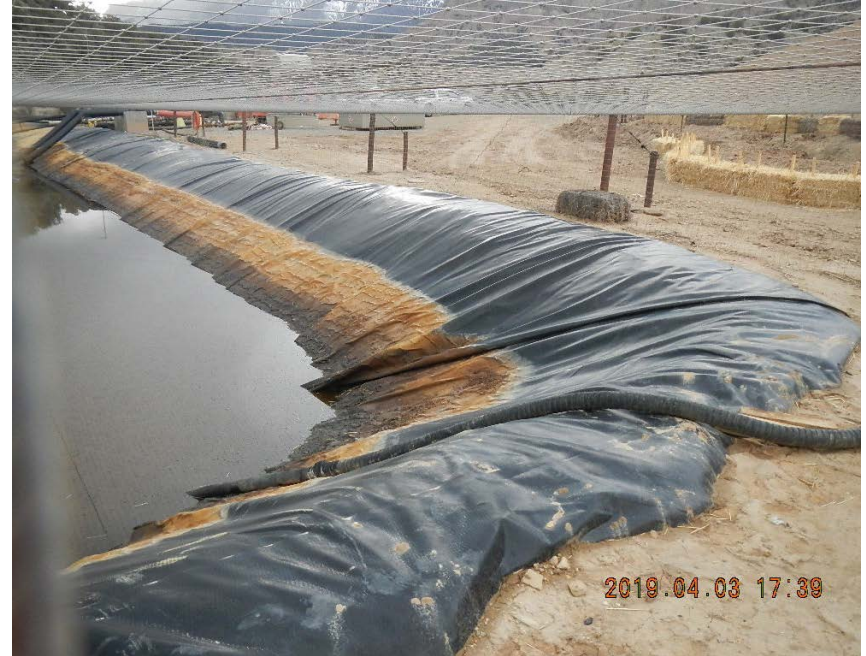
Hose directly on pit liner. Cam lock appears to have been taped.

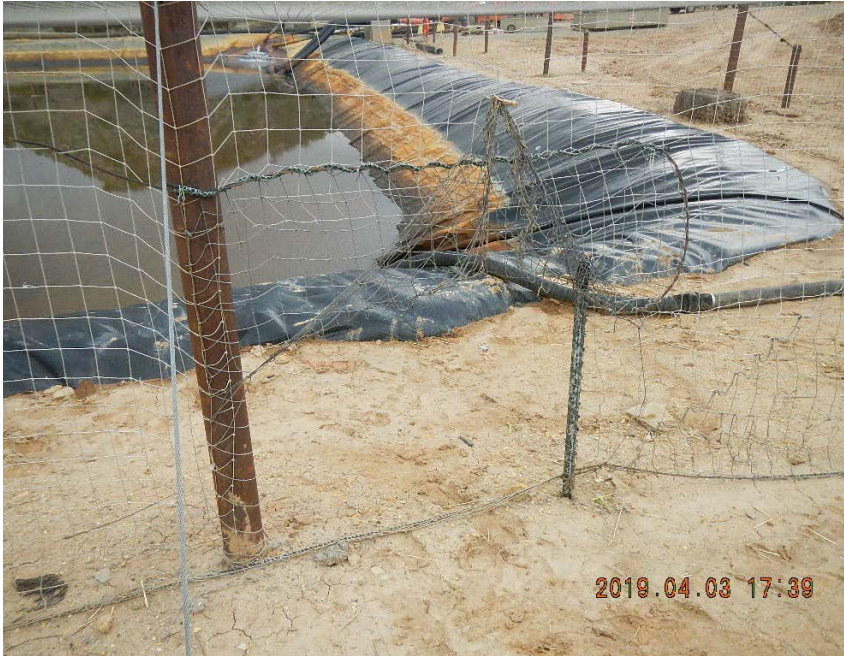
Two to three foot gap in fence/netting, hose directly on pit liner.

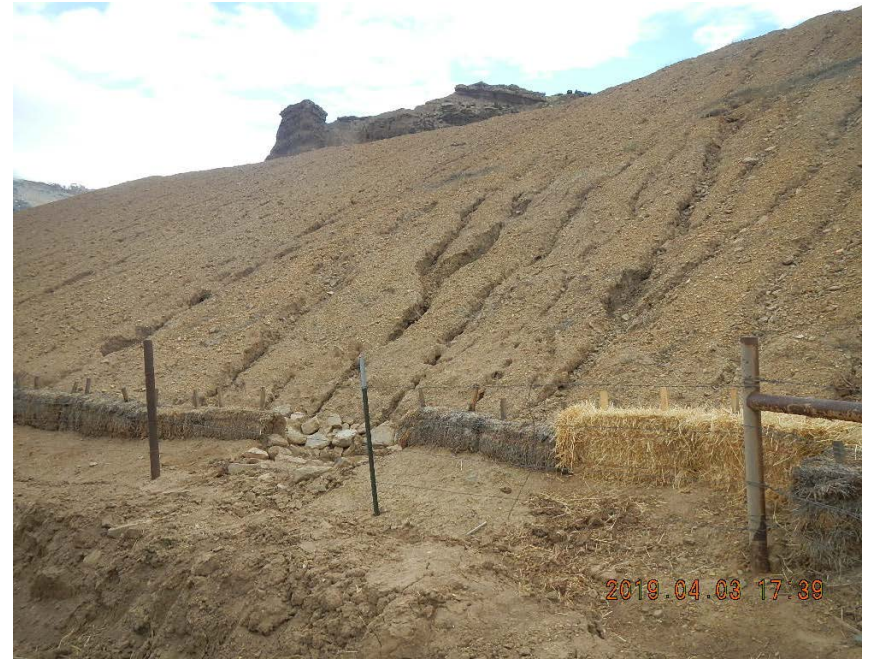
Erosional rills and recently replaced BMPs.

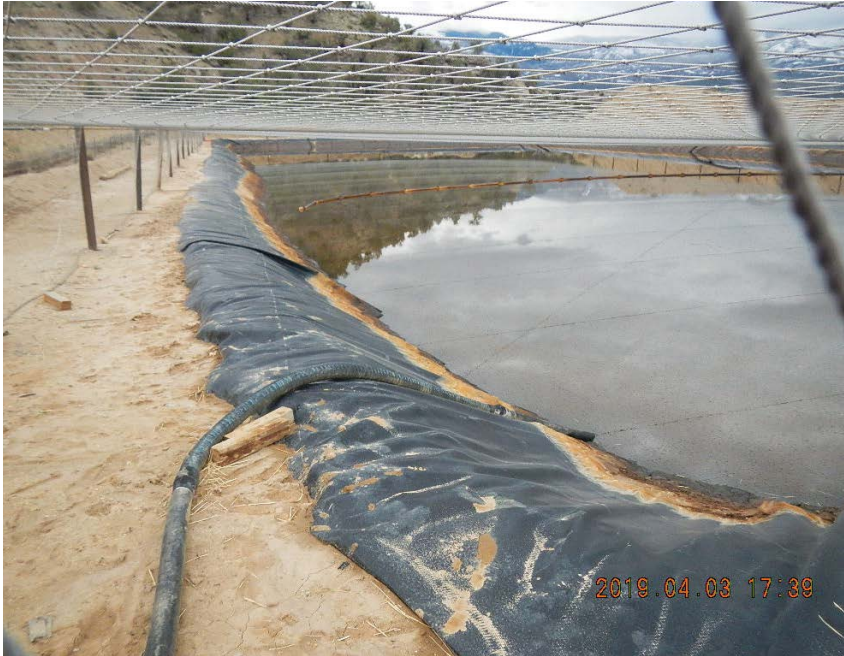
Hose and wood blocks on pit liner.

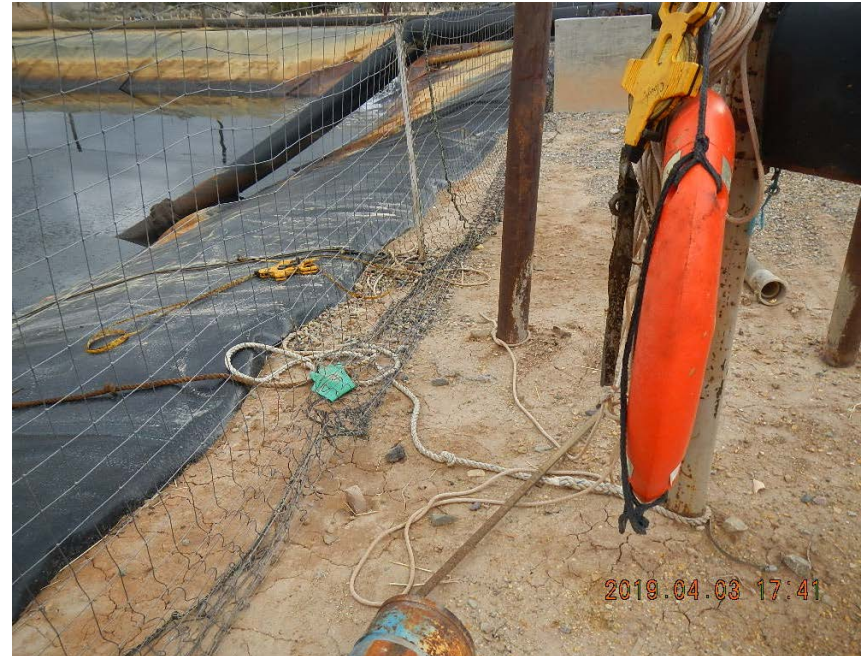
Excess equipment near manifold area. Rope safety line on liner and rescue buoy located on the outside of the netted pit.

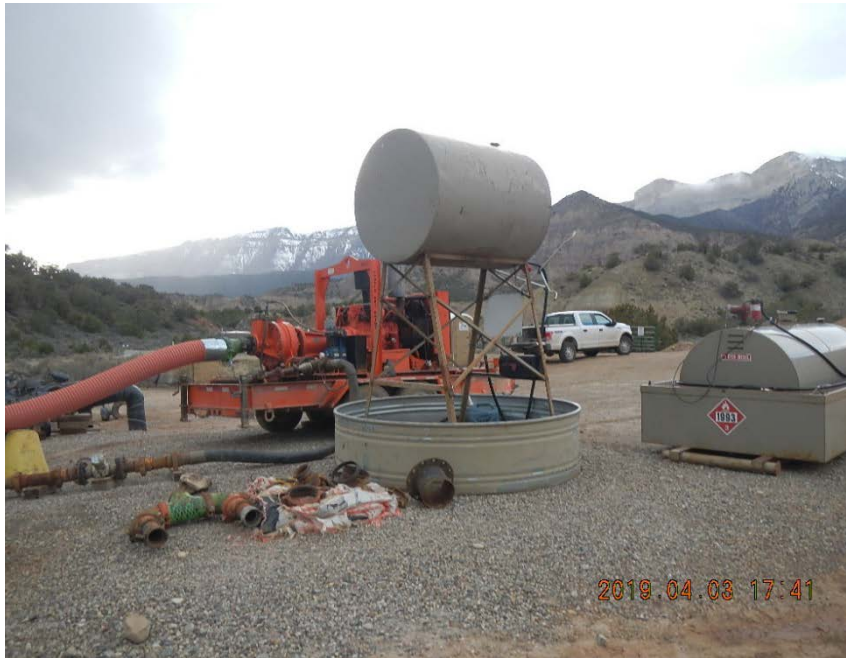
Excess equipment near manifold area.

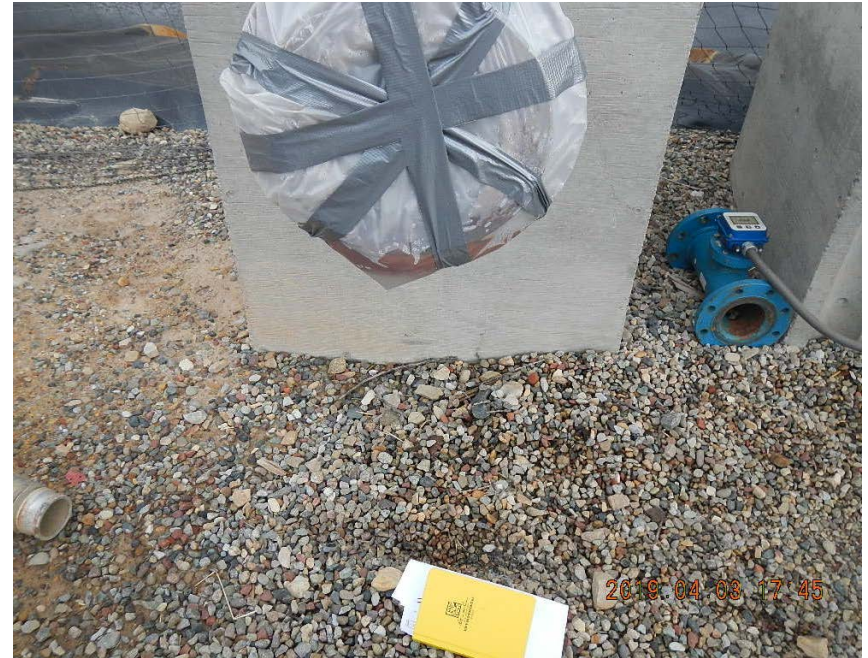
Gravel discoloration and appears to be a drip from the pipe with plastic sheeting and duct tape. Unused equipment between concrete supports.

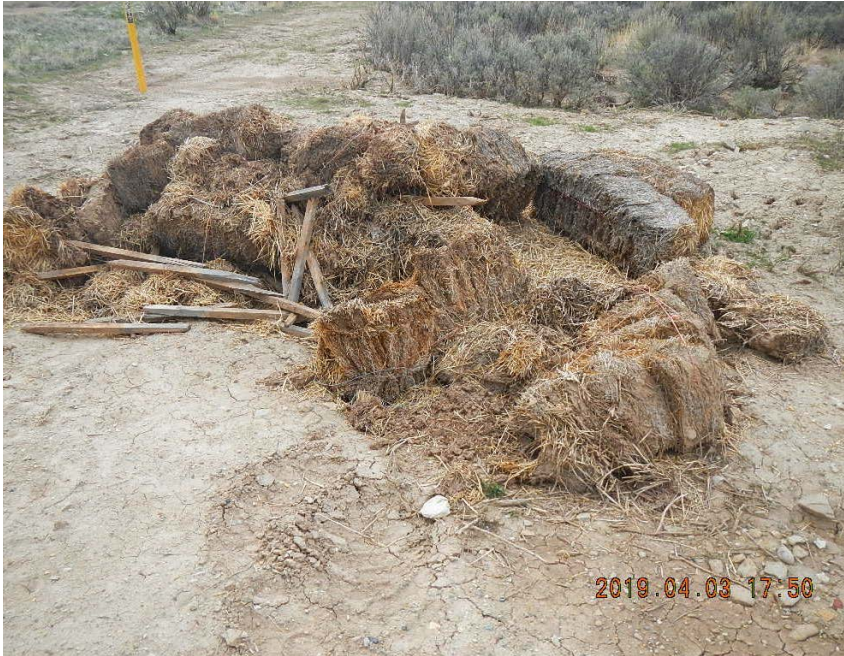
Straw bails just off of Location near entrance to the Pit Facility.

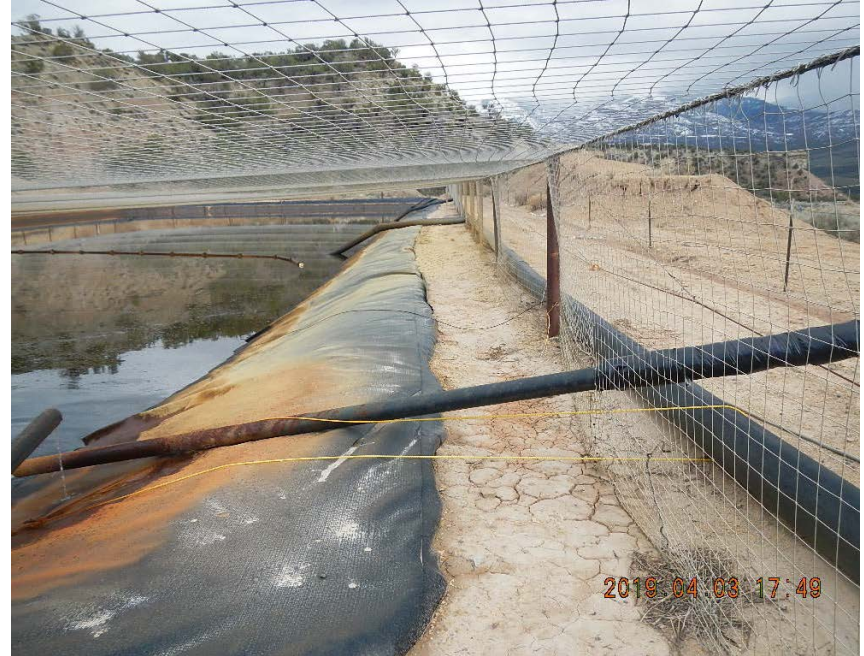
Pipe on pit liner. Yellow rope secured around poly pipe line.

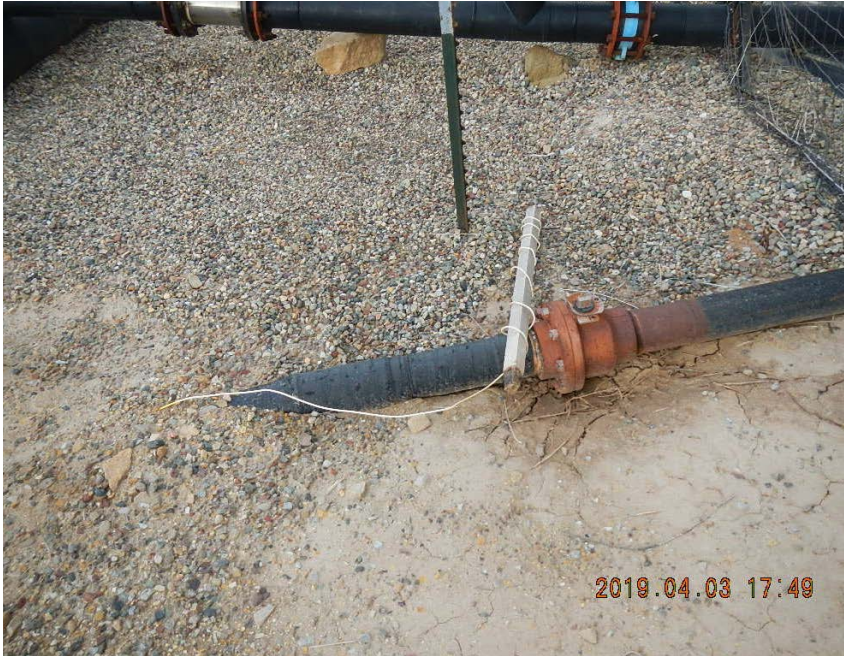
Tracer wire with stake on the ground.

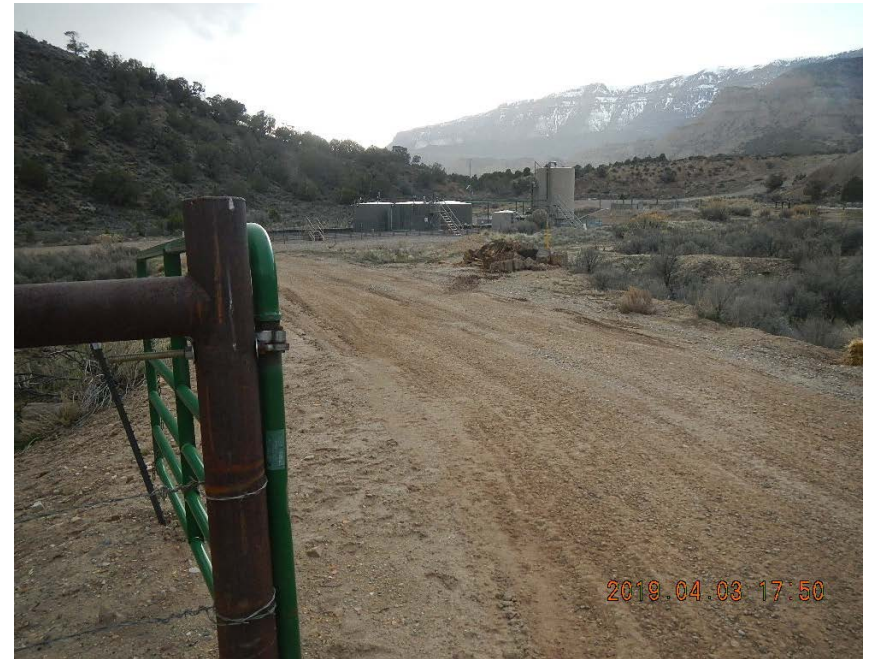
Entrance to Pit Facility open. Note used straw bails just off of Location.
