Inspection Photos
Operator: BP America
Location/API #: 067-06753
Date: 5-23-2319

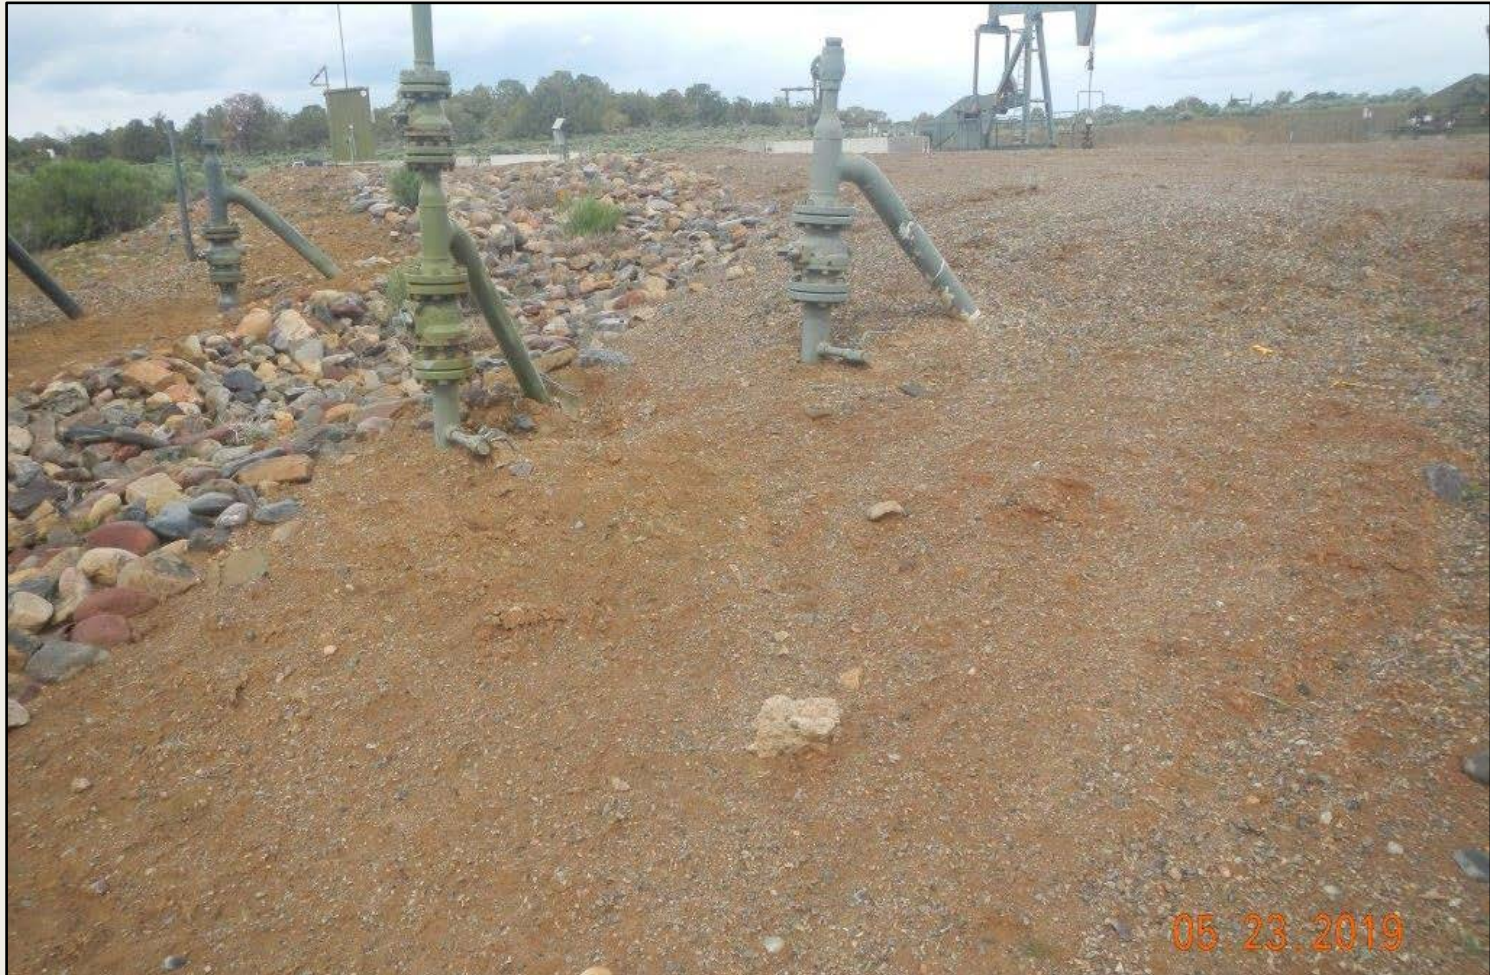
Photo 1. View of erosional scouring around cobble run-down and facilities within the southeastern project area.

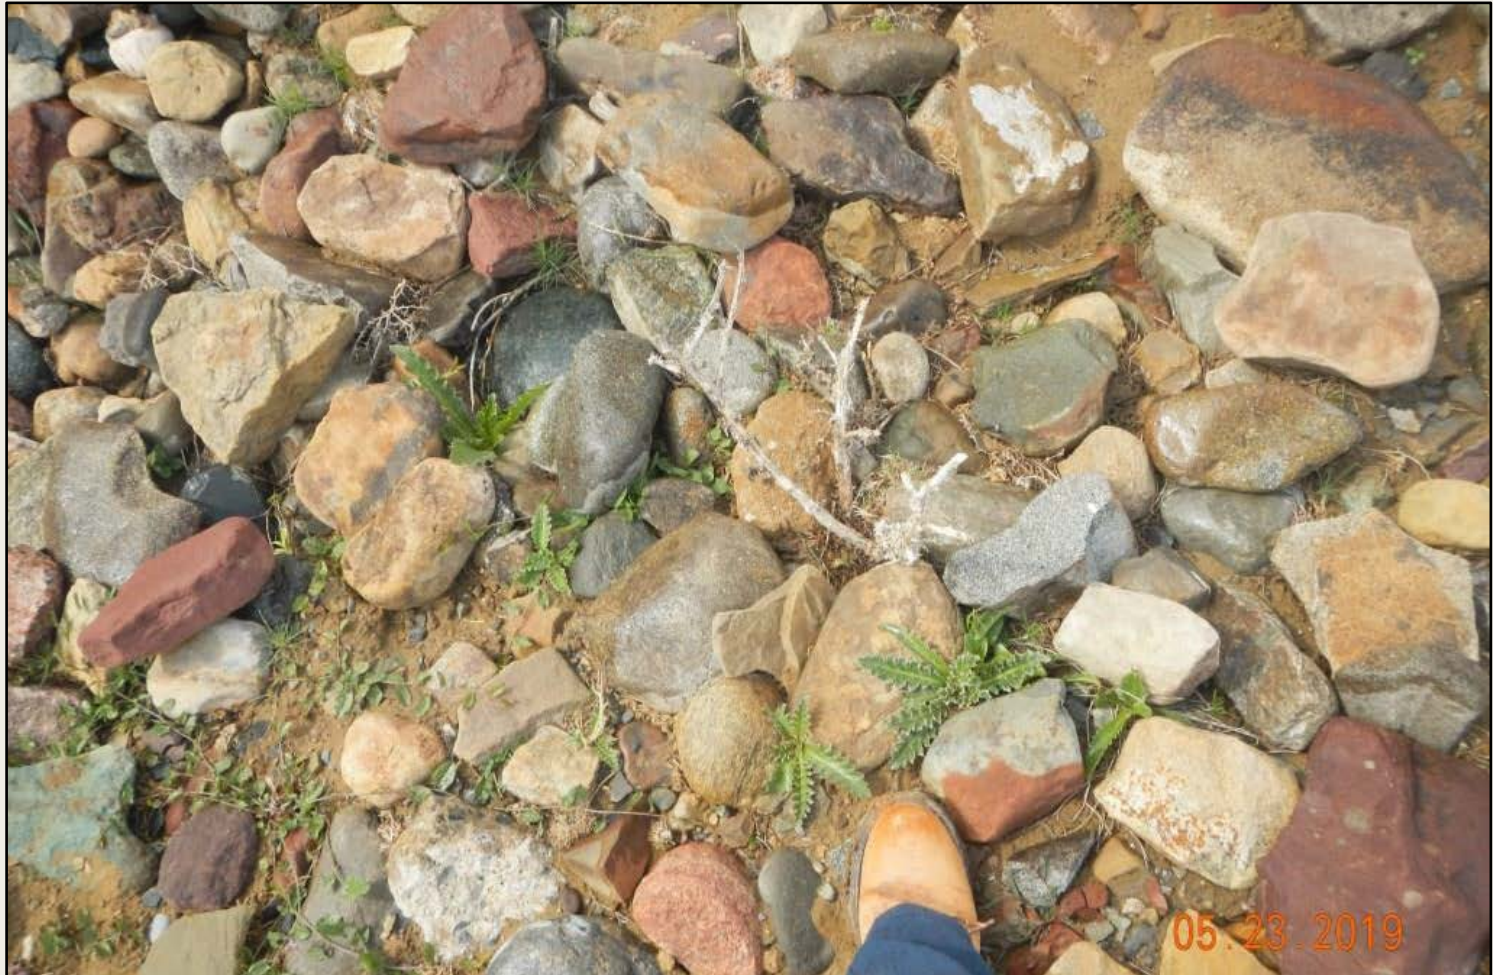
Photo 2. View of musk thistle (*Carduus nutans*) rosettes within the interim reclamation area.

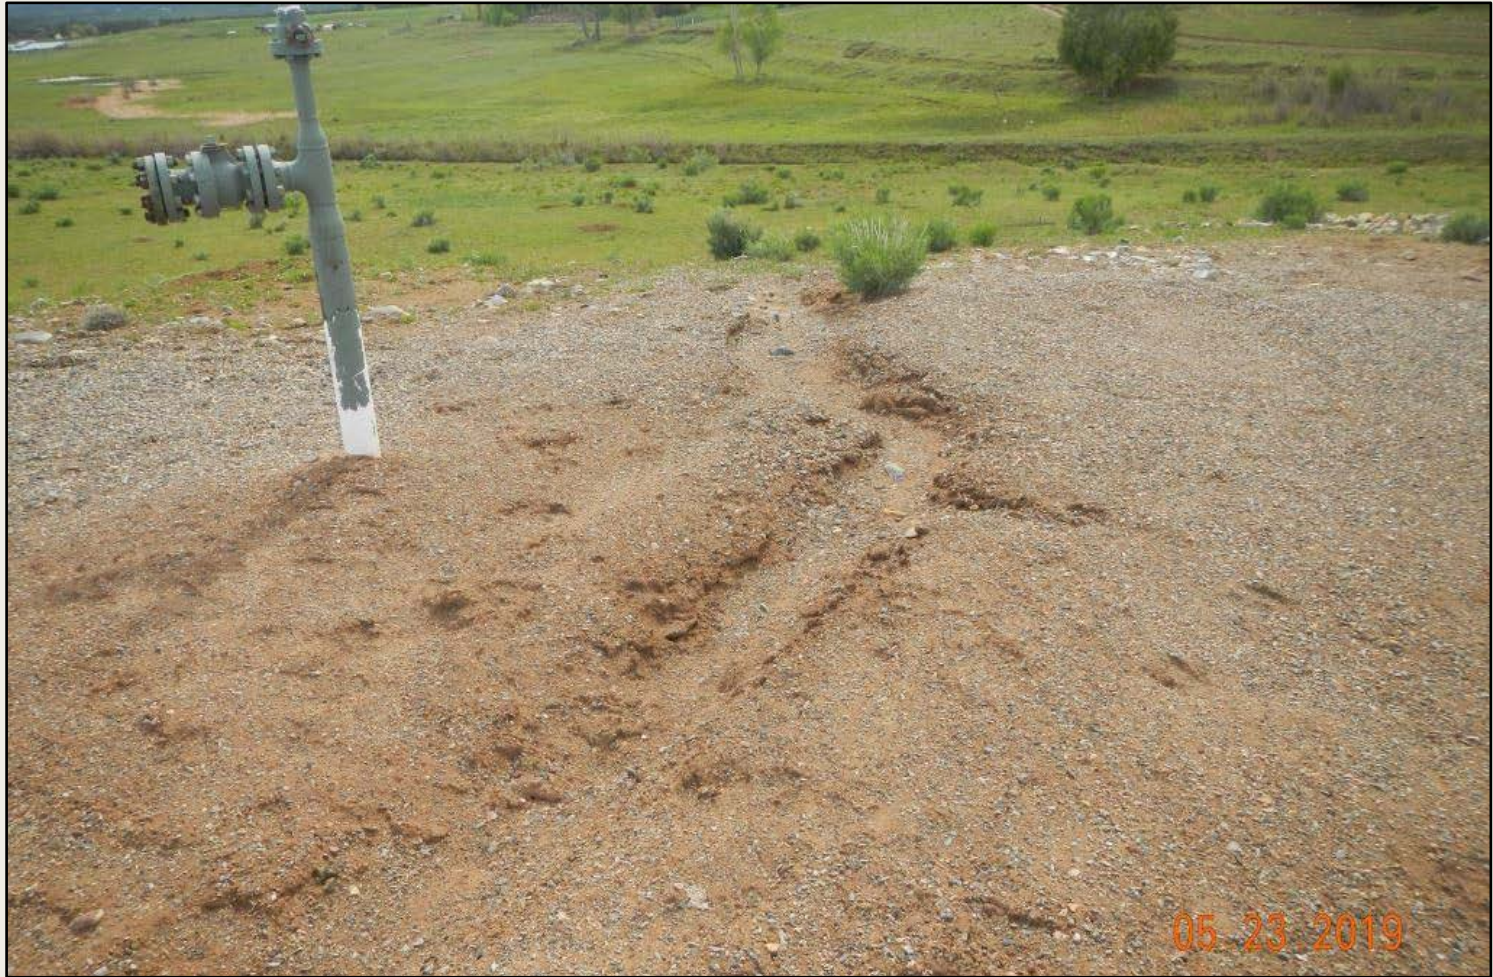
Photo 3. View of erosional channel forming within the eastern project area.
