Inspection Photos  
Location Name: BLACK BUCK 21-6  
API #: 05-071-08864  
INSP. #:695100768

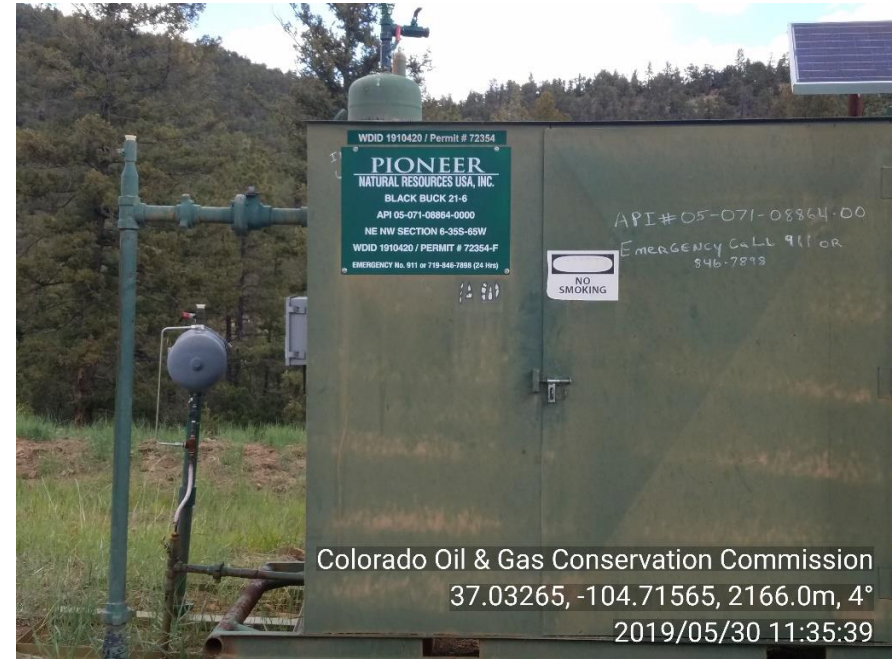
**PHOTO 2: CURRENT OPERATOR NOT POSTED ON WELL SIGN.  
CHANGE OPERATOR NAME TO CURRENT OPERATOR IN  
ACCORDANCE WITH RULE 210. CA DATE 7/30/19**

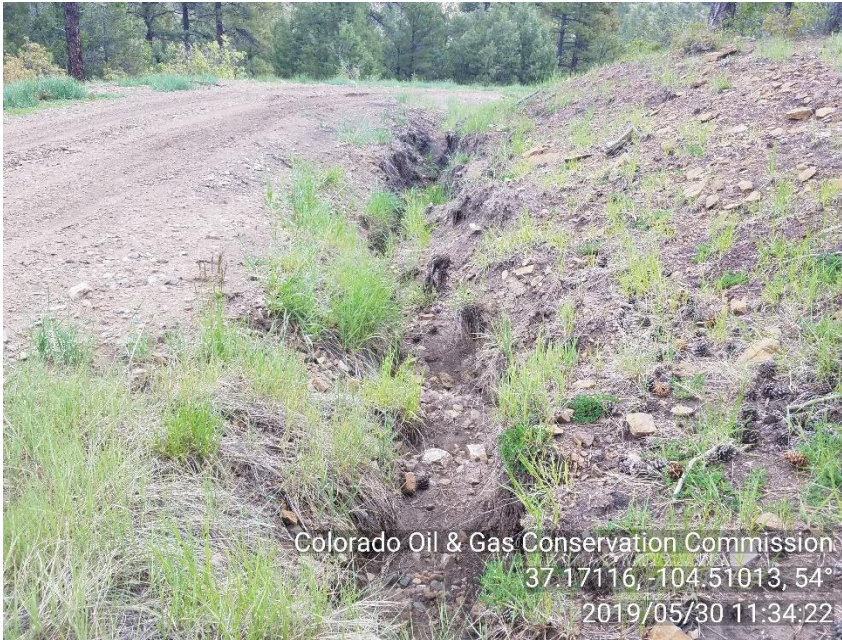
**PHOTO 3: DRAINAGE DITCH ON ROW JUST WEST OF LOCATION ROW ENTRANCE HAS NO BMP'S OR BMP'S OR INADEQUATE. REPAIR OR INSTALL BMP'S TO PREVENT EROSION IN ACCORDANCE WITH 1002 SERIES RULES. CA DATE 6/30/19.**
