**Inspection Photos**  
**Operator: Catamount Energy**  
**Location/API #: 067-07933**  
**Date: 5-23-2319**

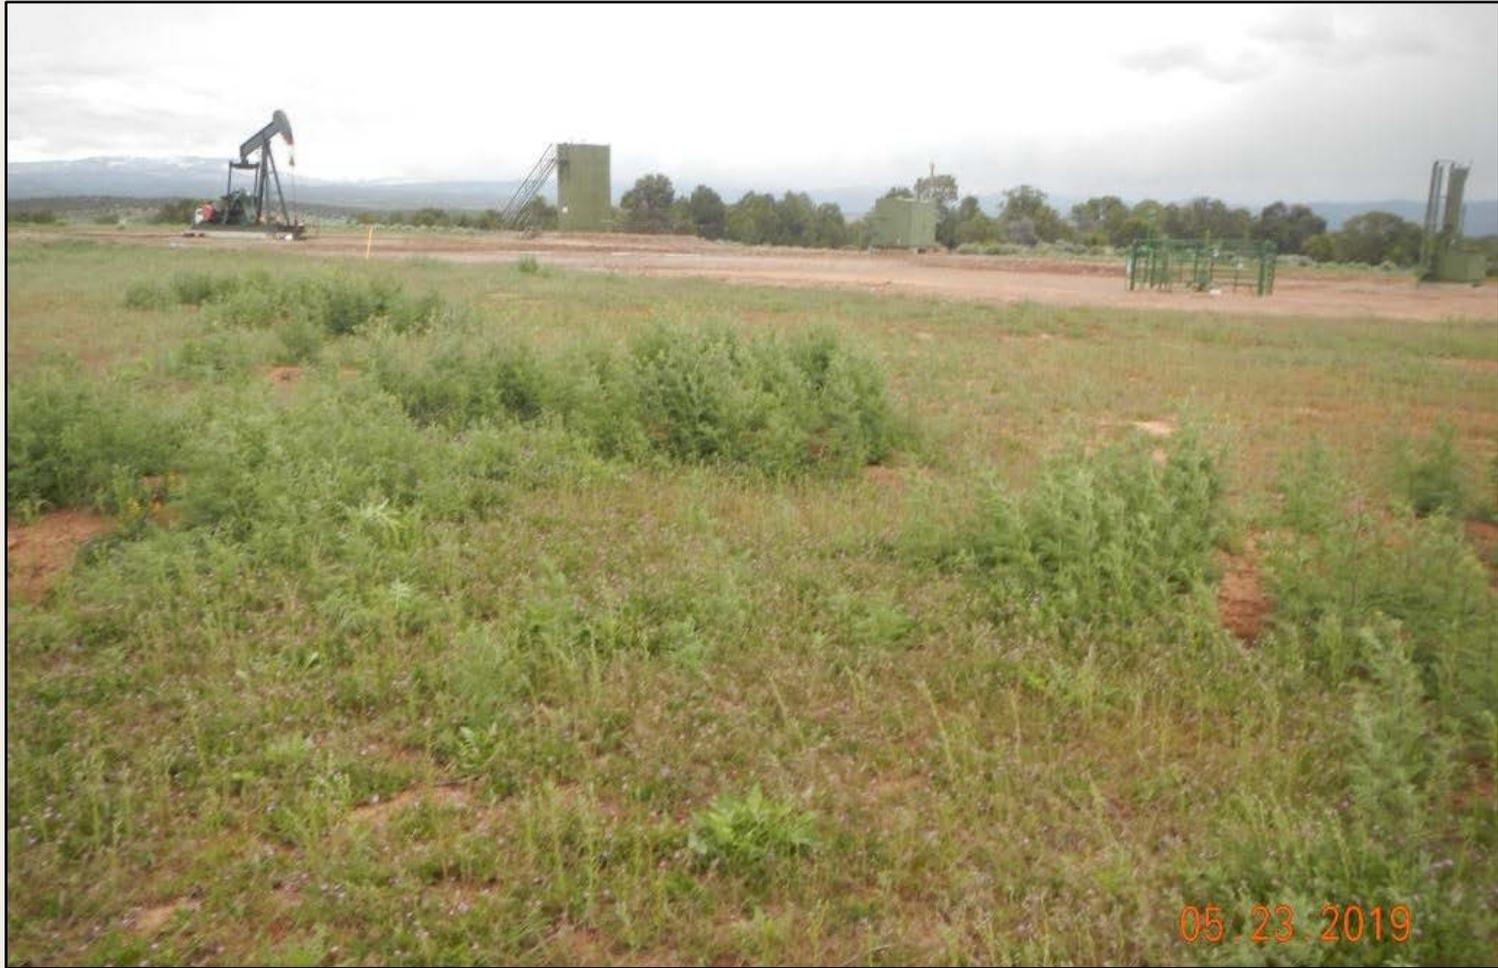
Photo 1. View of the project area from the southwestern corner facing center.

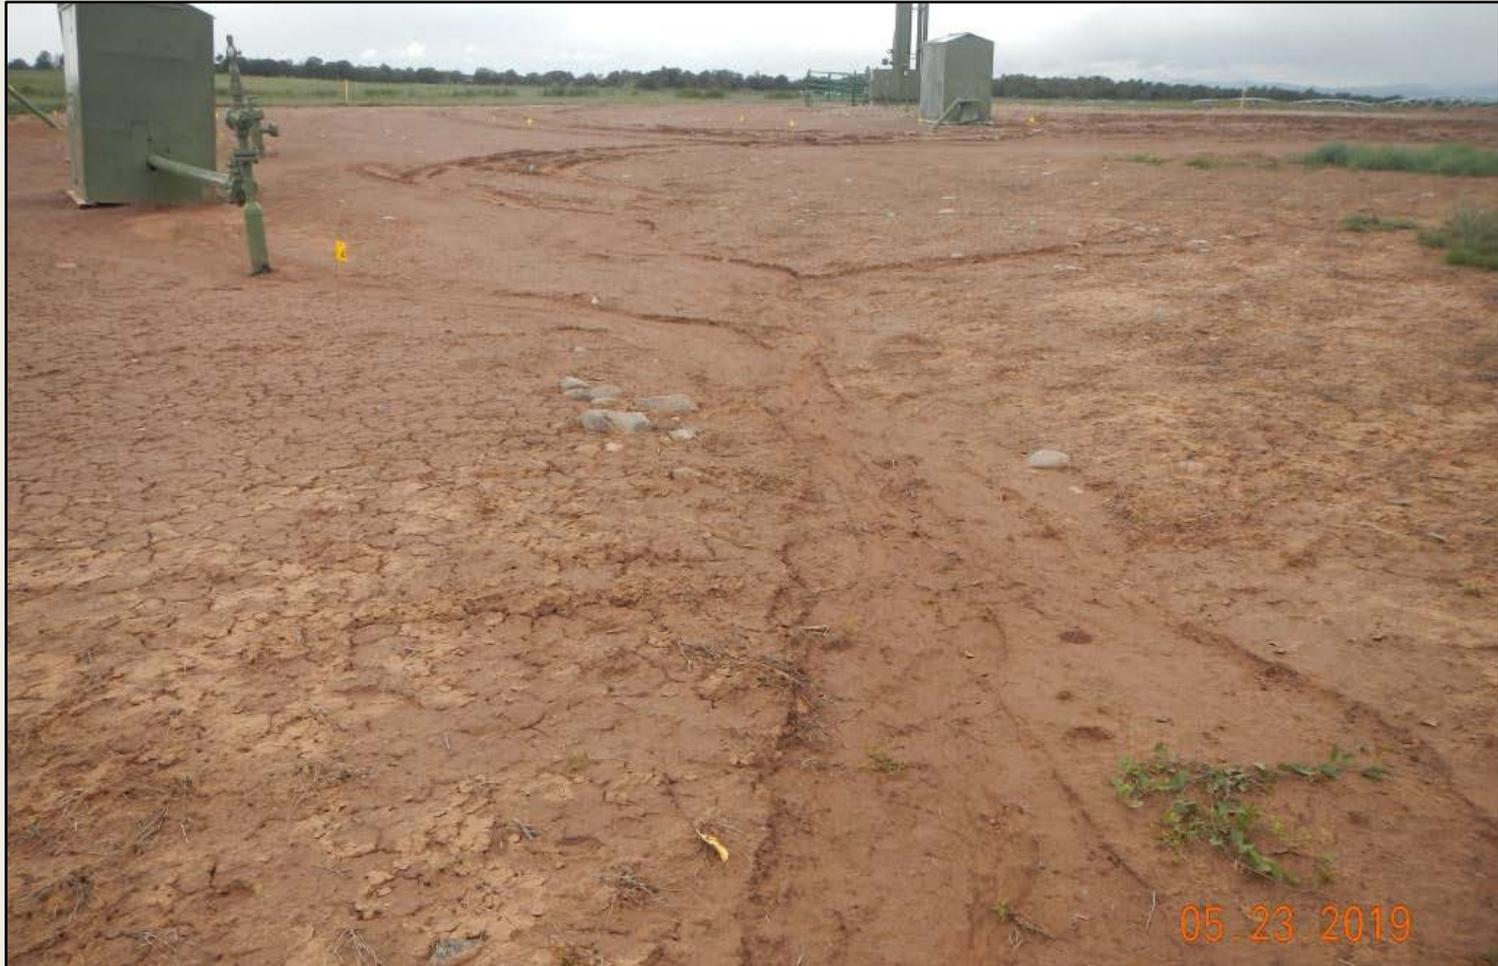
Photo 2. View of an erosional channel forming within the southeastern project area.

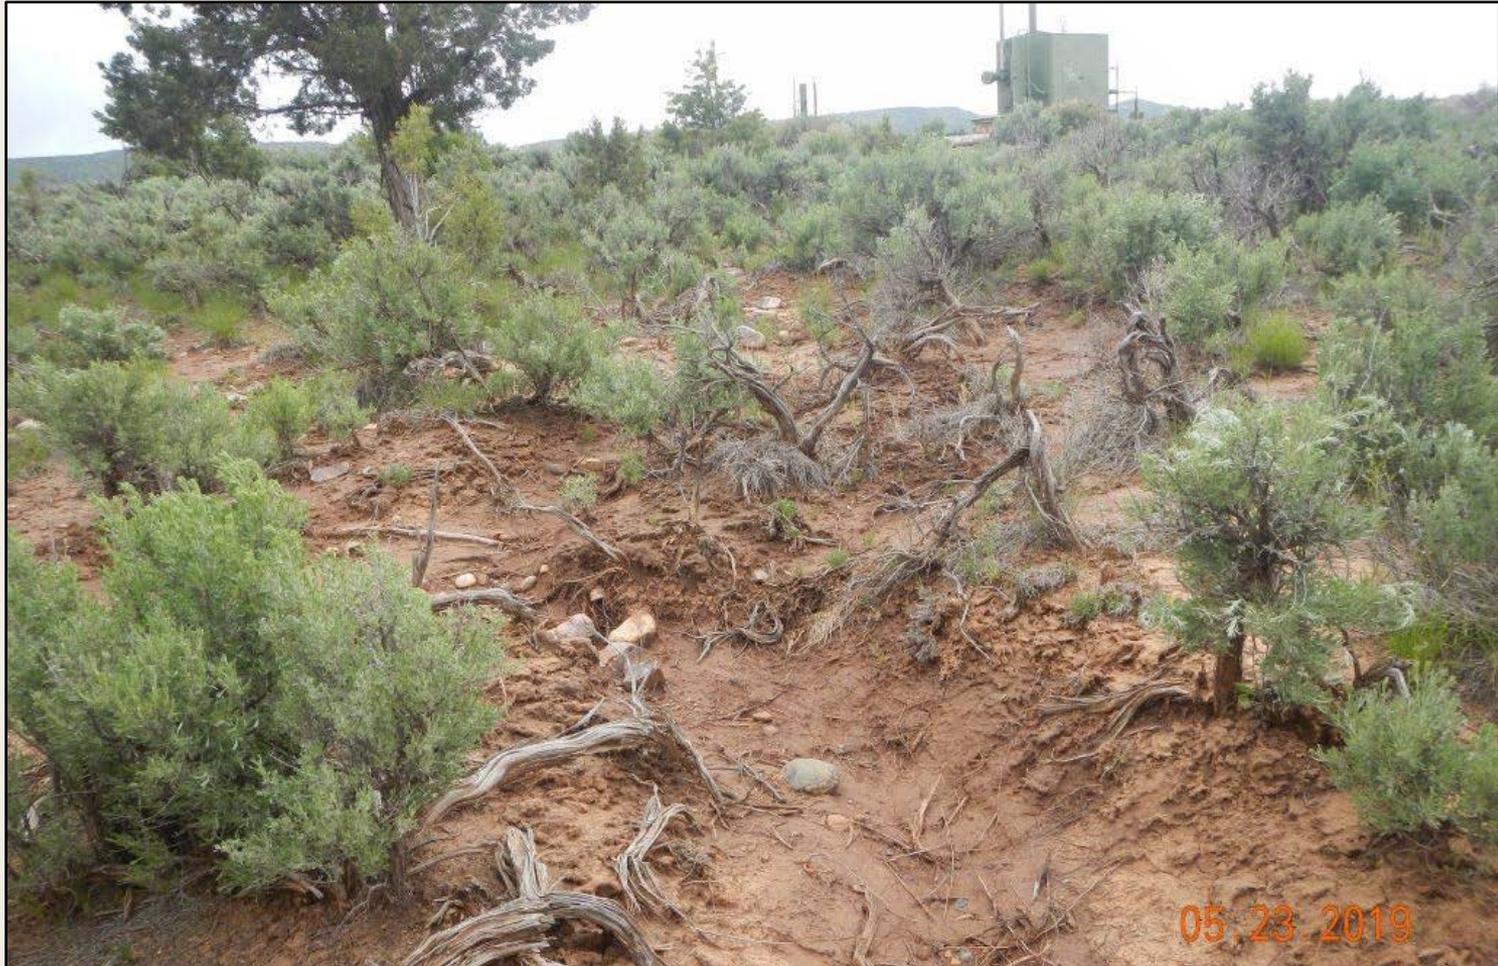
Photo 3. View of what appears to be active head-cut erosion down-slope from the eastern edge of the project area where concentrated stormwater flows off of the well pad.
