Inspection Photos  
Location Name: William D Lansdown #1  
Location ID: 317613

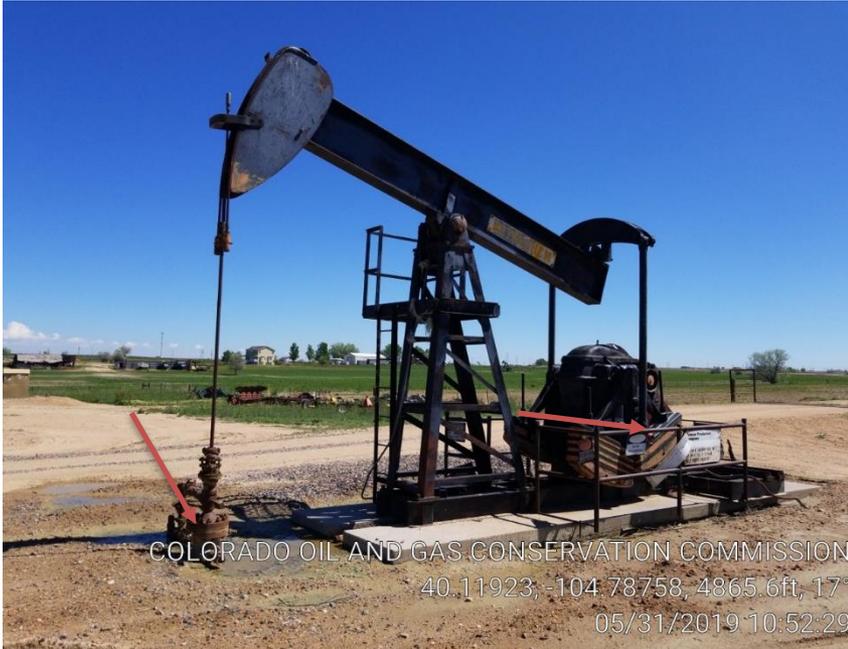
**Pic 1 no cap on casing valve sign faded**

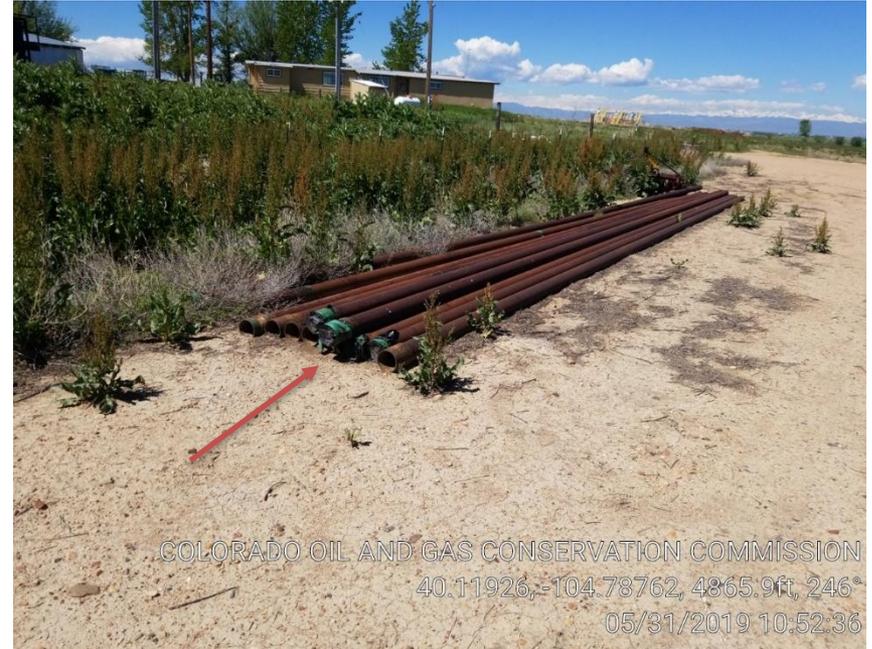
**Pic 2 unused tubulars on location**

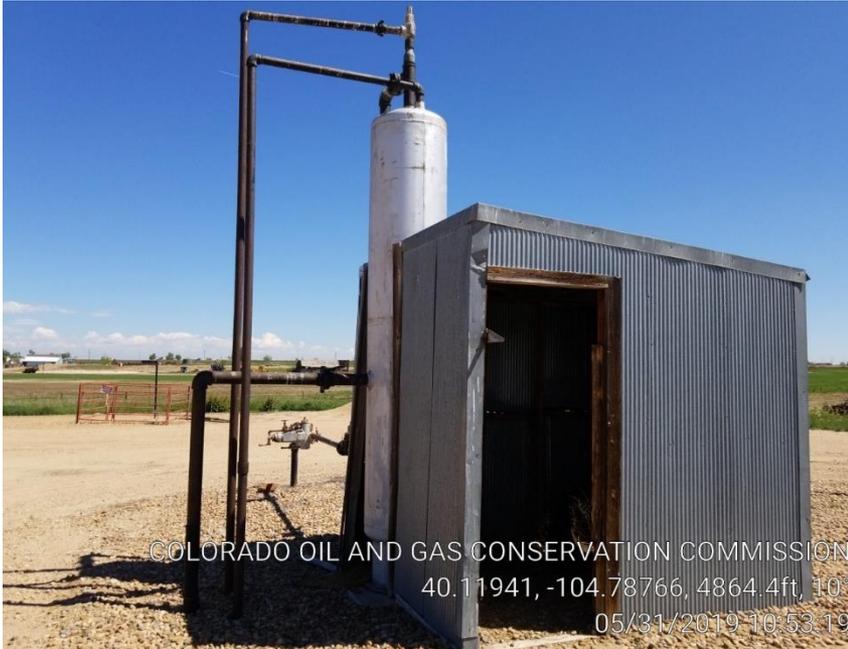
**Pic 3 separator house in poor condition**

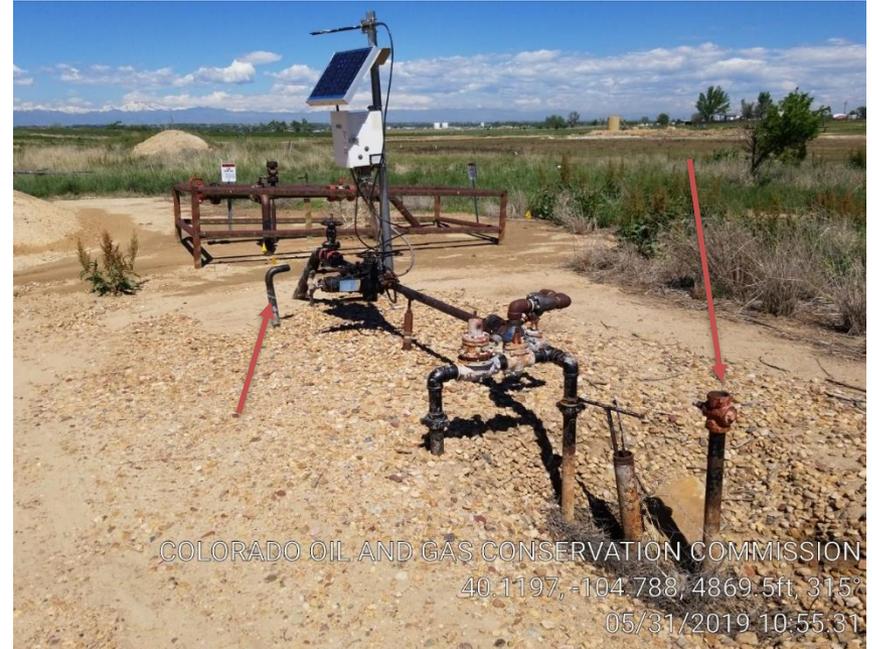
Pic 6 uncapped unmarked risers

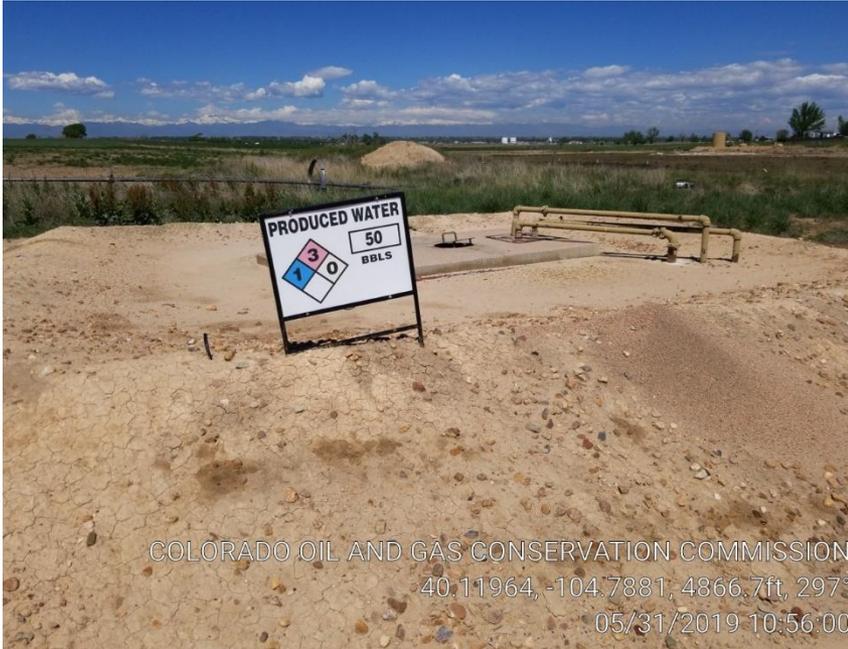
**Pic 7 inadequate berms around water tank**

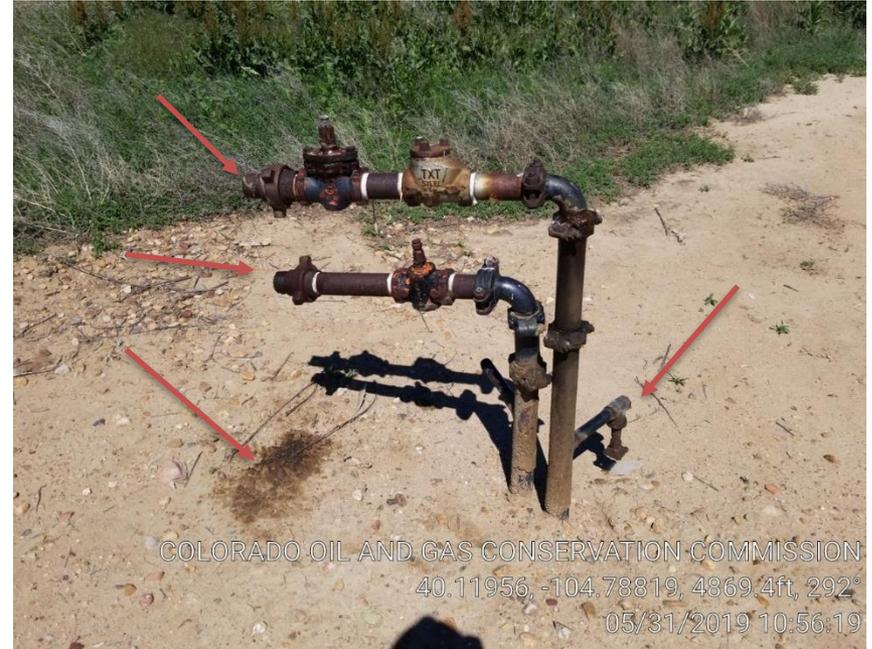
**Pic 8 unused unmarked uncapped risers on location/stained soil**

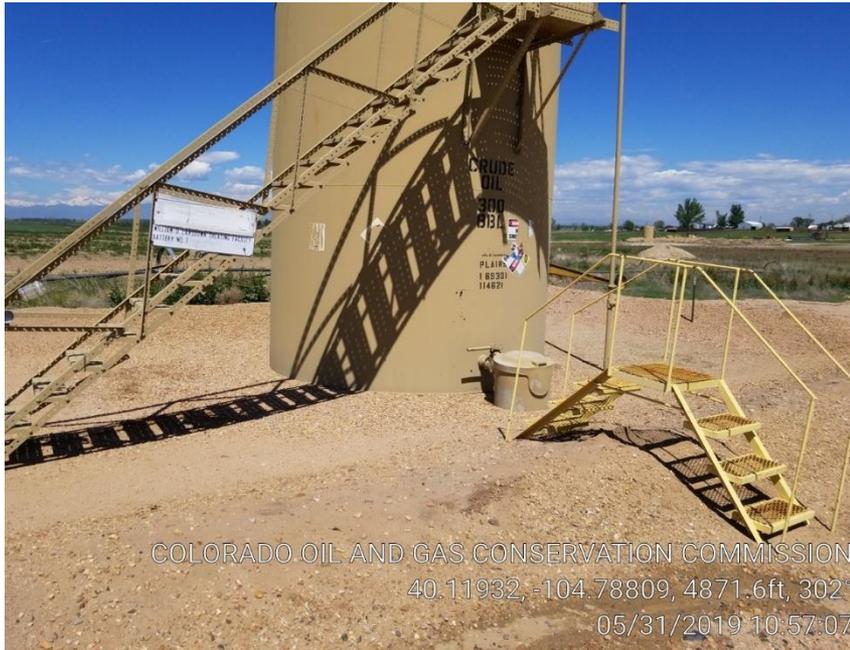
**Pic 9 inadequate berms around oil tank, placards and sign is not legible**
