Inspection Photos

API: 05-071-06340

Operator: TIMBER CREEK OPERATING LLC

Inspection Date: 6/3/2019

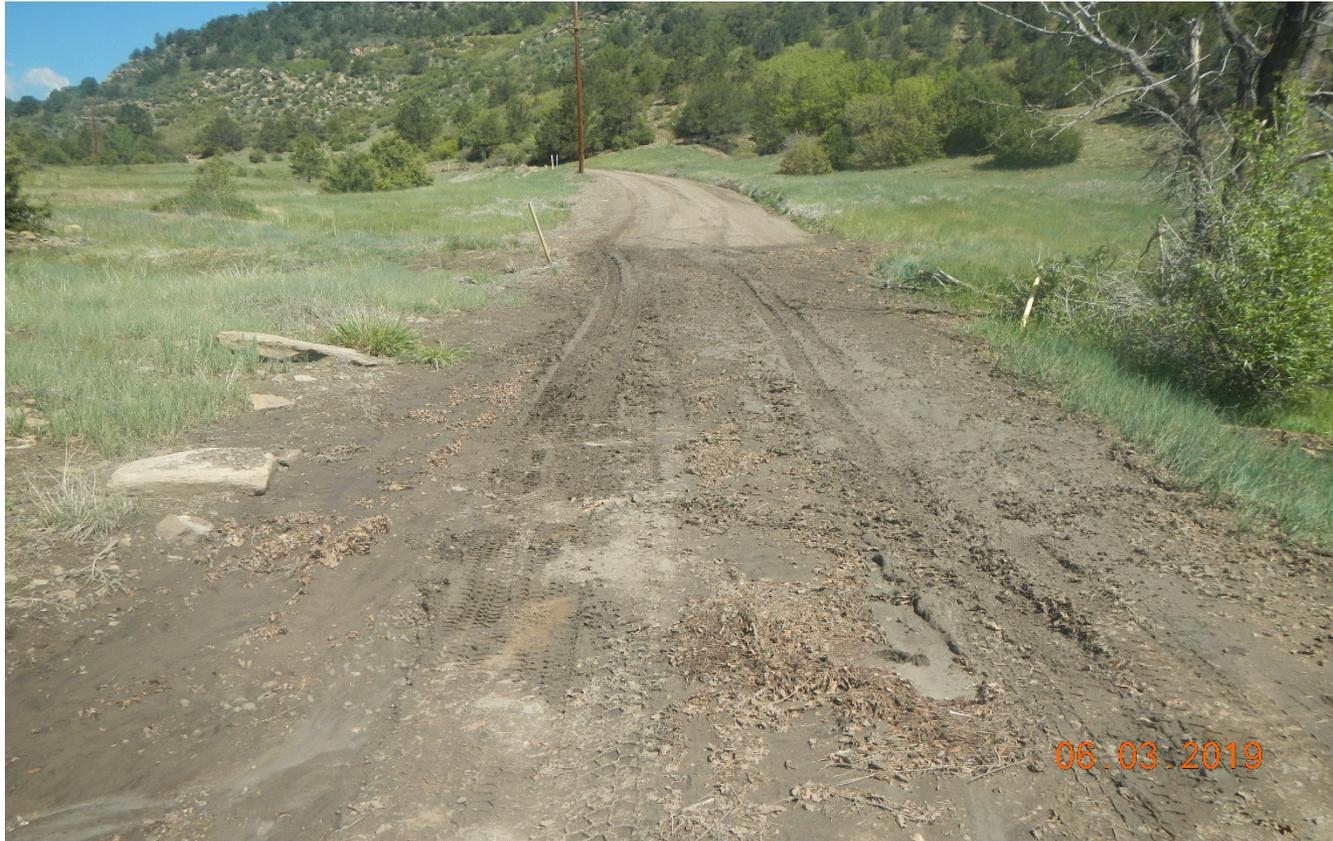
Photo 1. Facing northwest at mouth of the canyon. It appears stormwater has flowed across the road at this point causing damage.

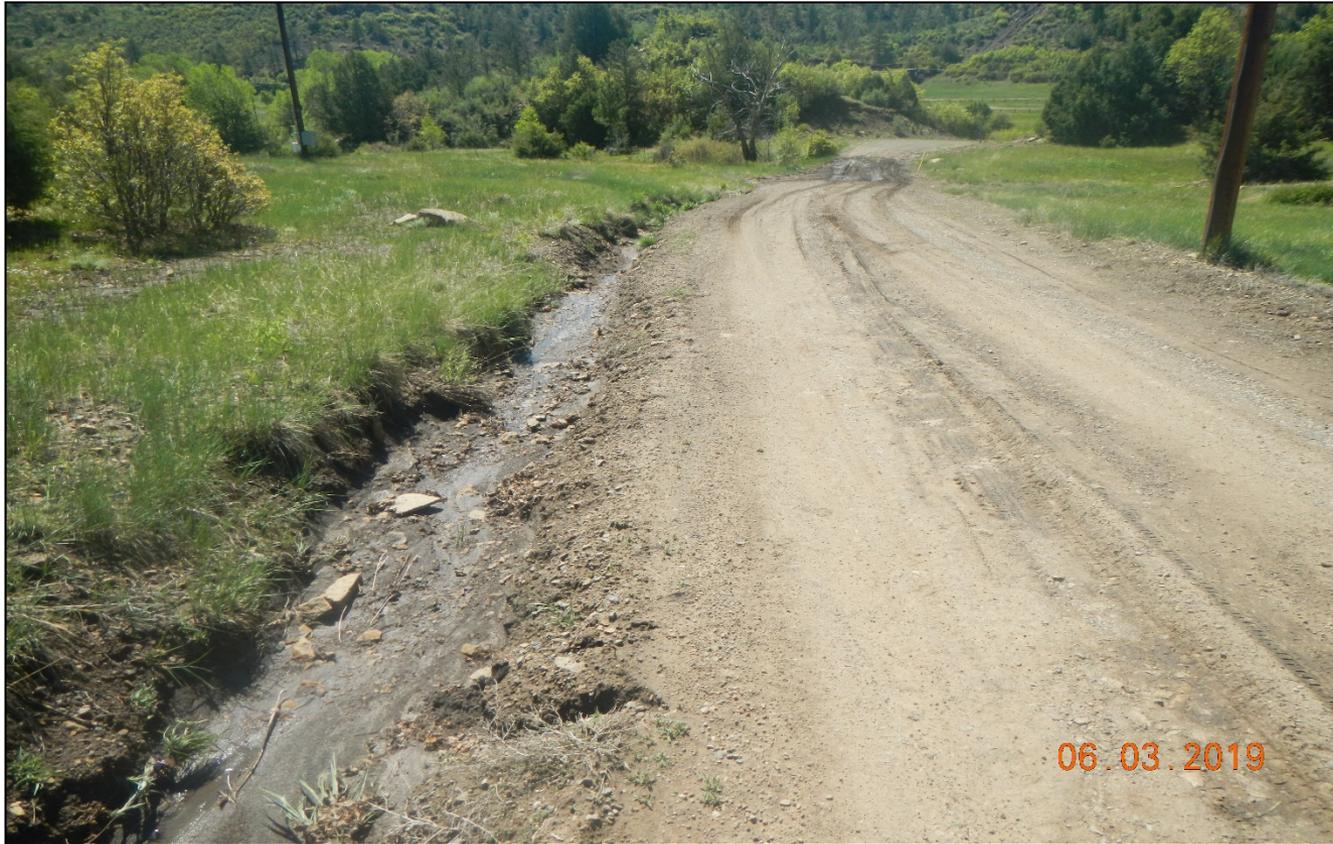
Photo 2. Facing back to the southeast. Erosion is occurring along the side of the road and no BMPs are installed (checkdamns).

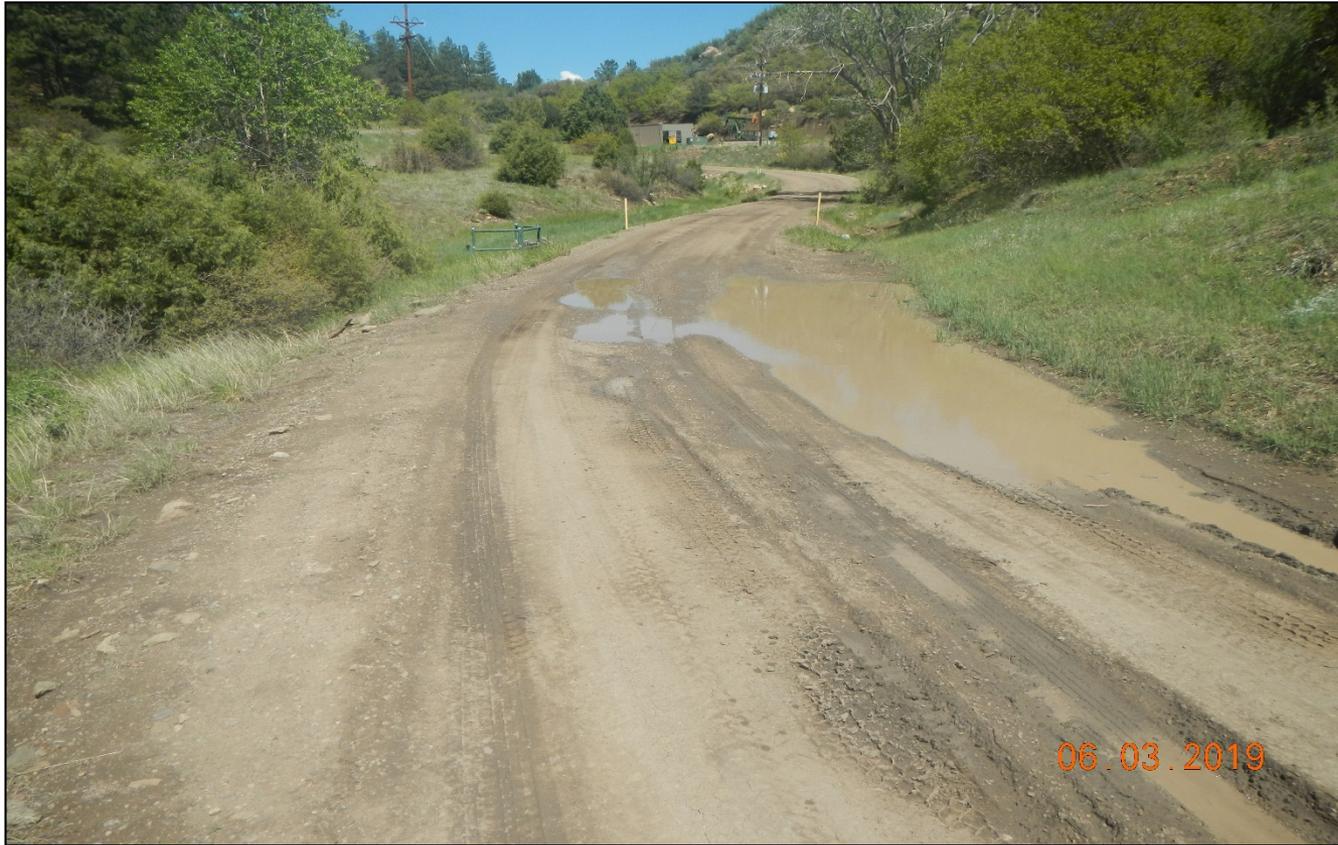
Photo 3. Stormwater is pooling onto the road and is not properly diverted.

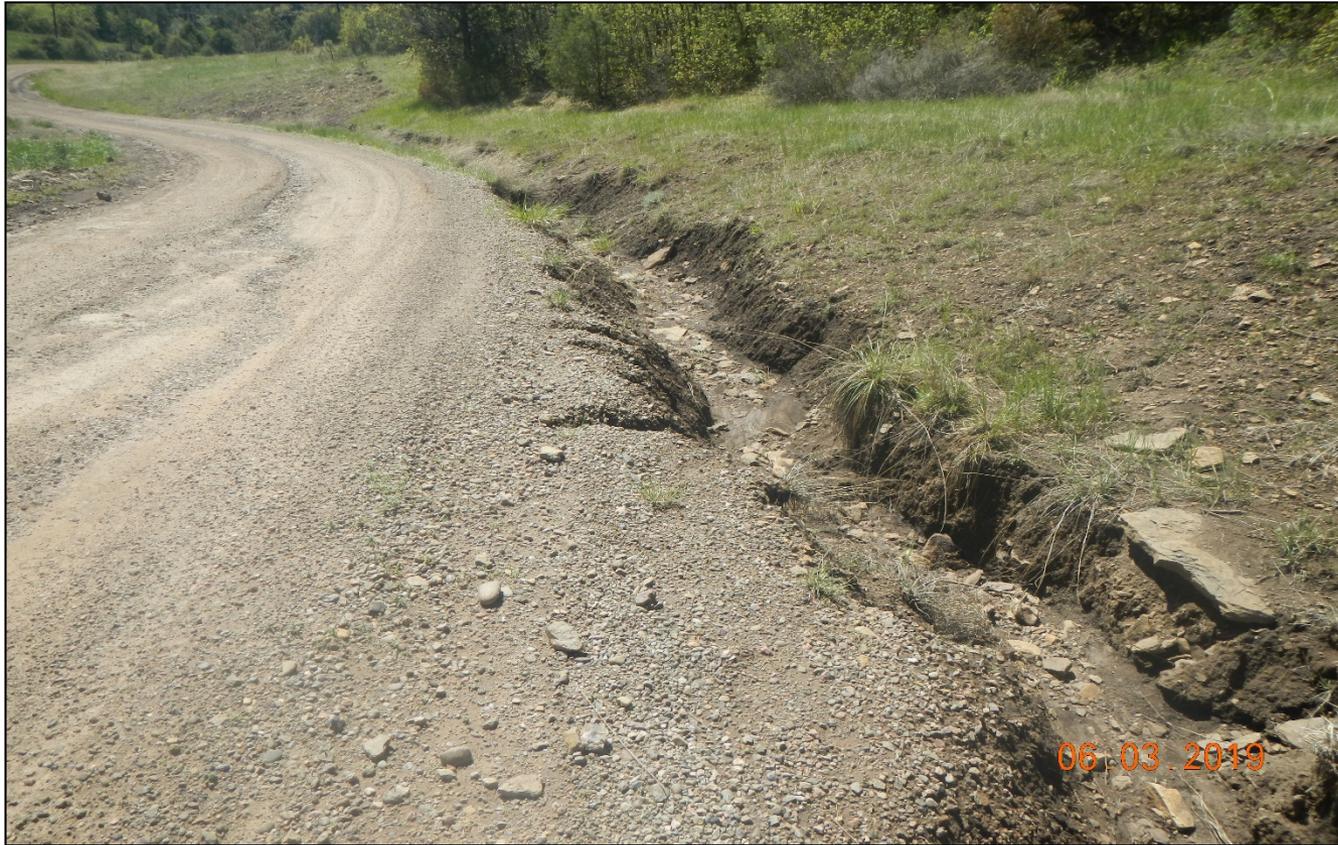
Photo 4. The erosion channel at the southeast side of the location has not been repaired.

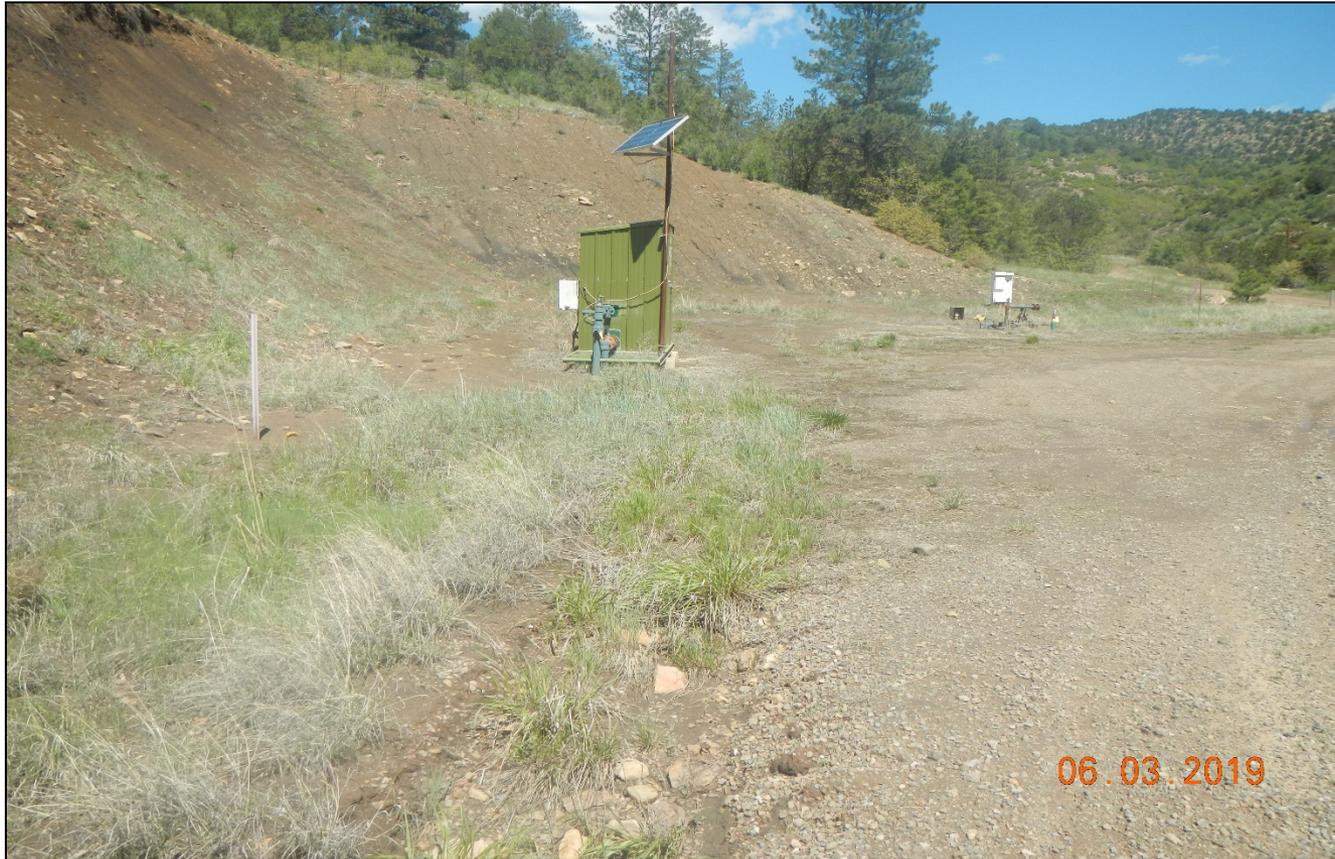
Photo 5. Facing toward the location.
