Inspection Photos

API: 05-071-08419

Operator: TIMBER CREEK OPERATING LLC

Inspection Date: 6/3/2019

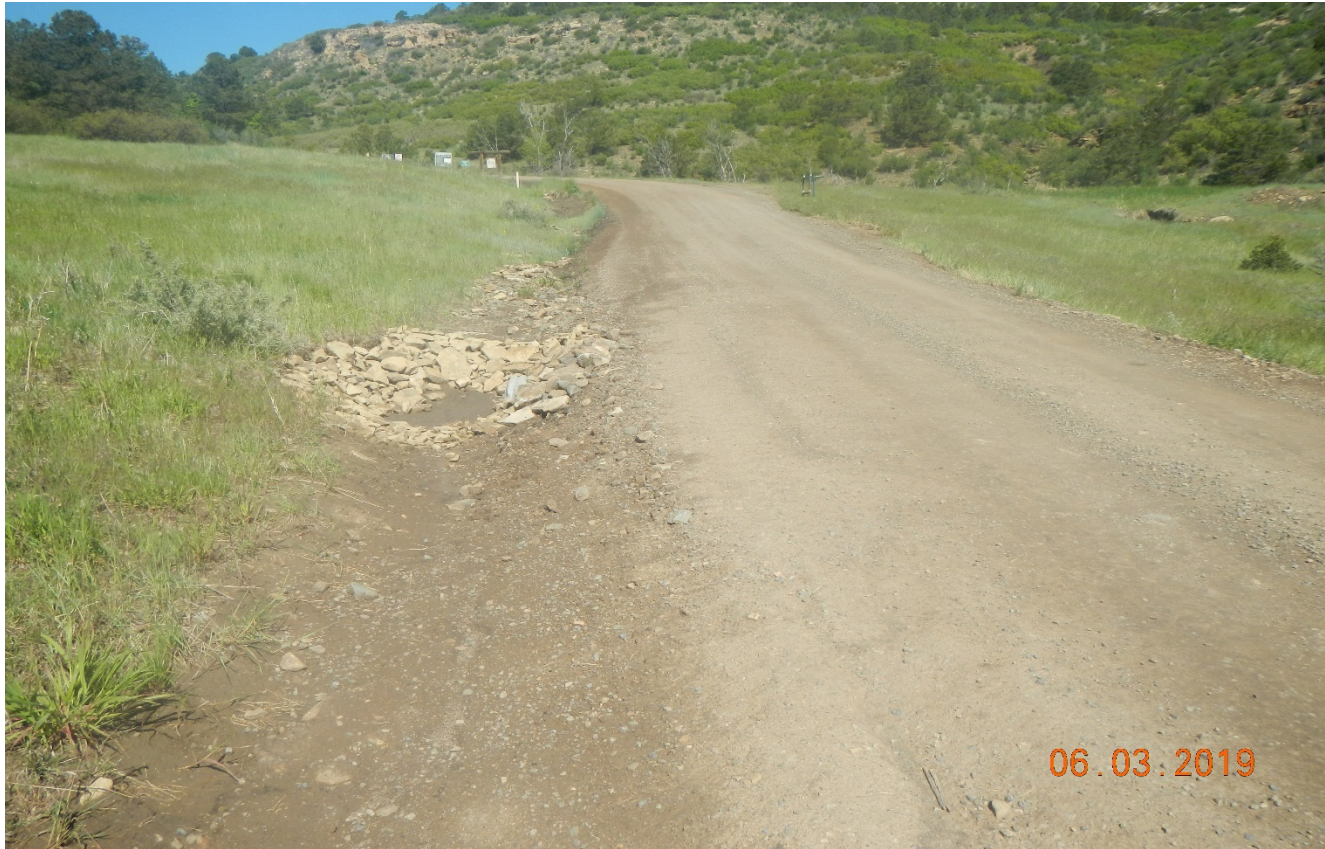
Photo 1. Facing west along the main road near the gate of Cherry canyon. Erosion issues have been repaired in this area.

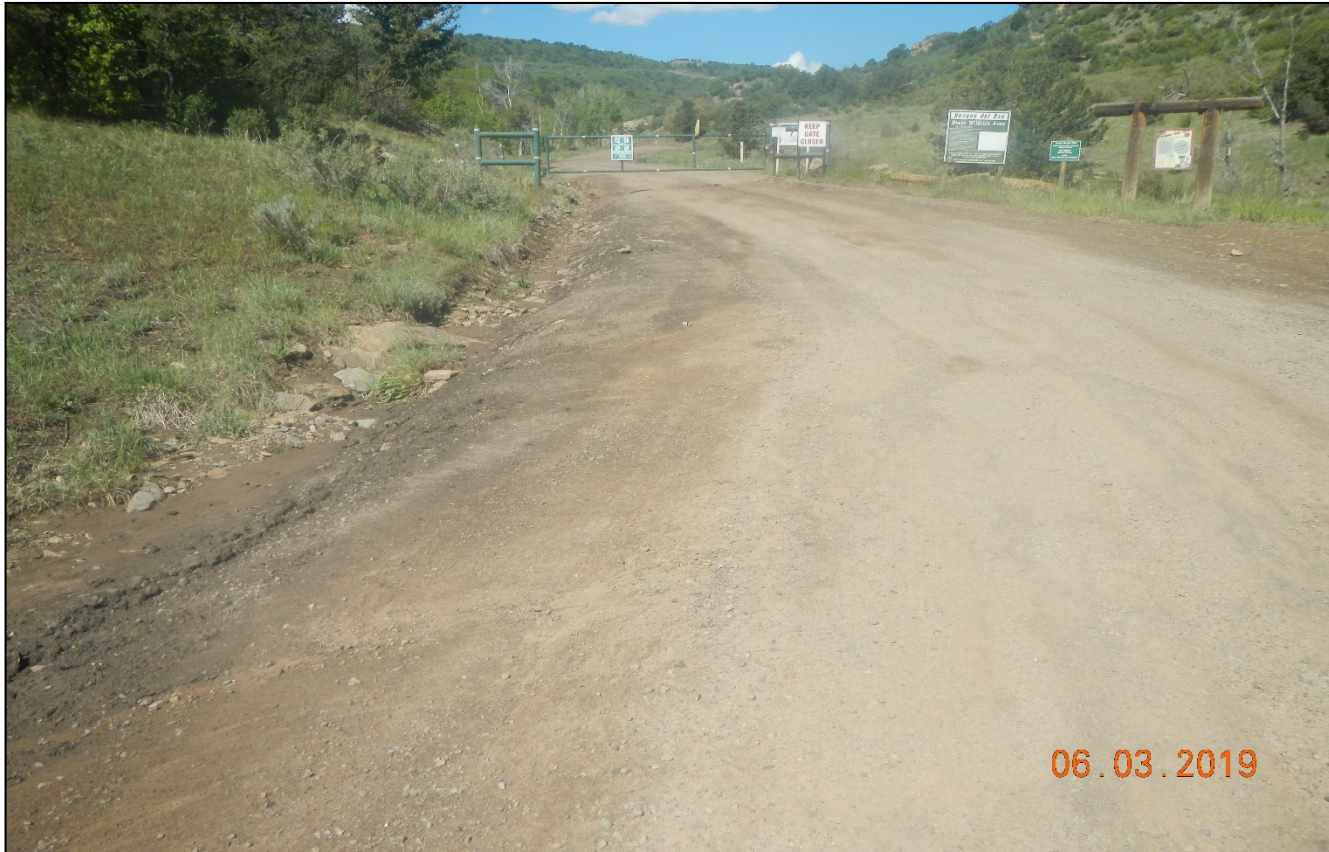
Photo 2. Facing northwest along the main road at the gate of Cherry canyon. Erosion issues have been repaired in this area.

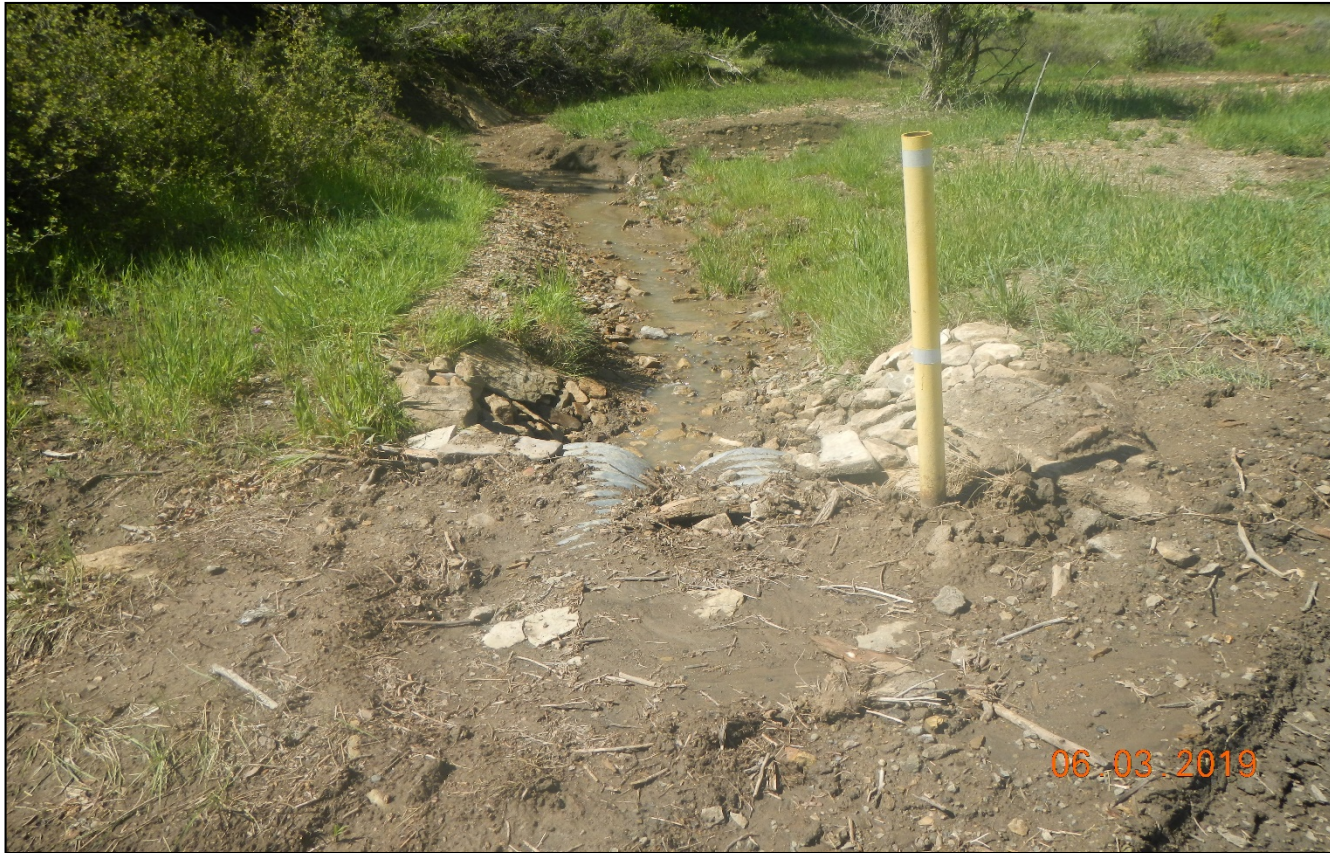
Photo 3. The culvert has been cleaned out and repaired.

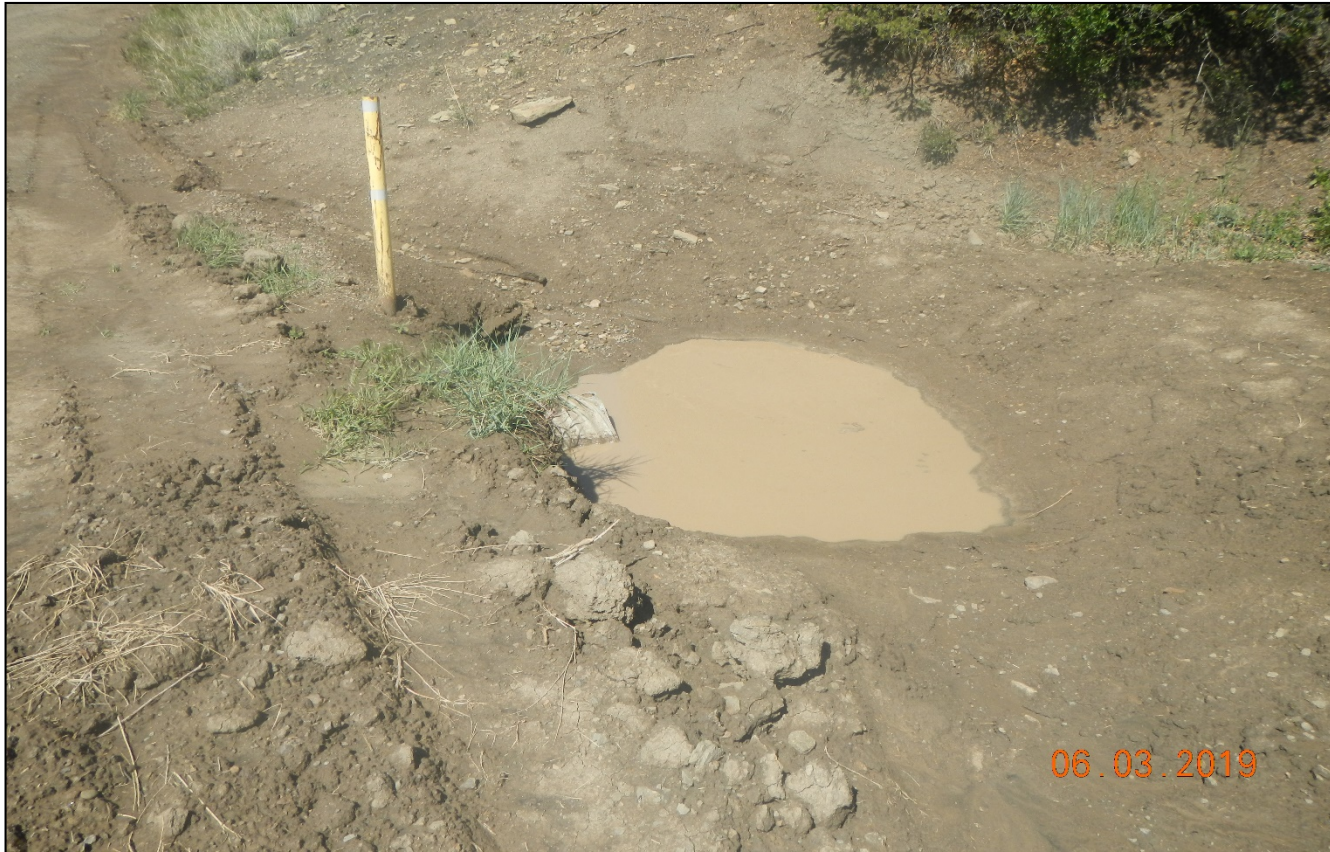
Photo 4. Culvert up the road has been cleaned out. Water shown in the photo is not draining well thru the culvert. This may create issues in the future.

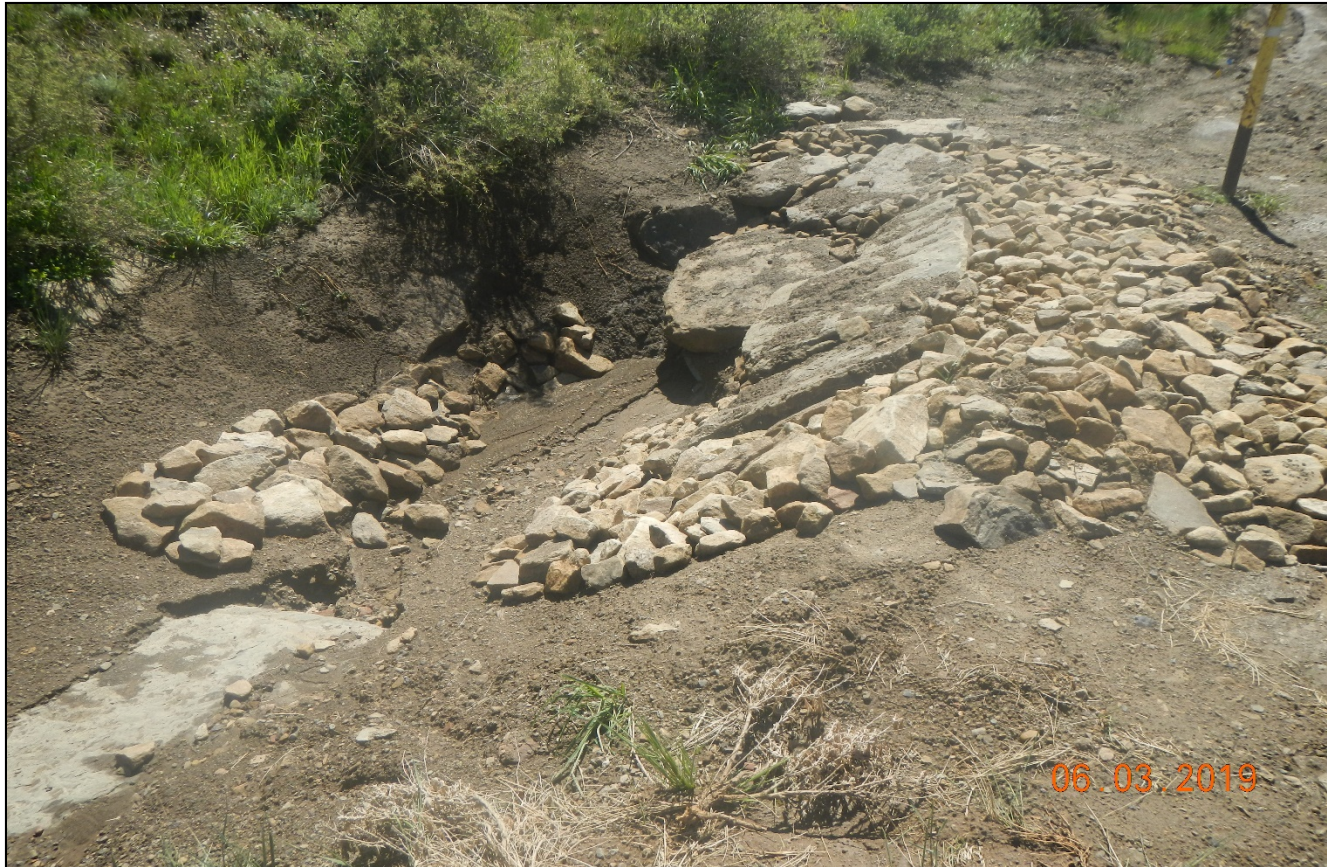
Photo 5. Culvert was repaired however, sediment is already filling up the culvert. Check dams may need to be installed up the road further.

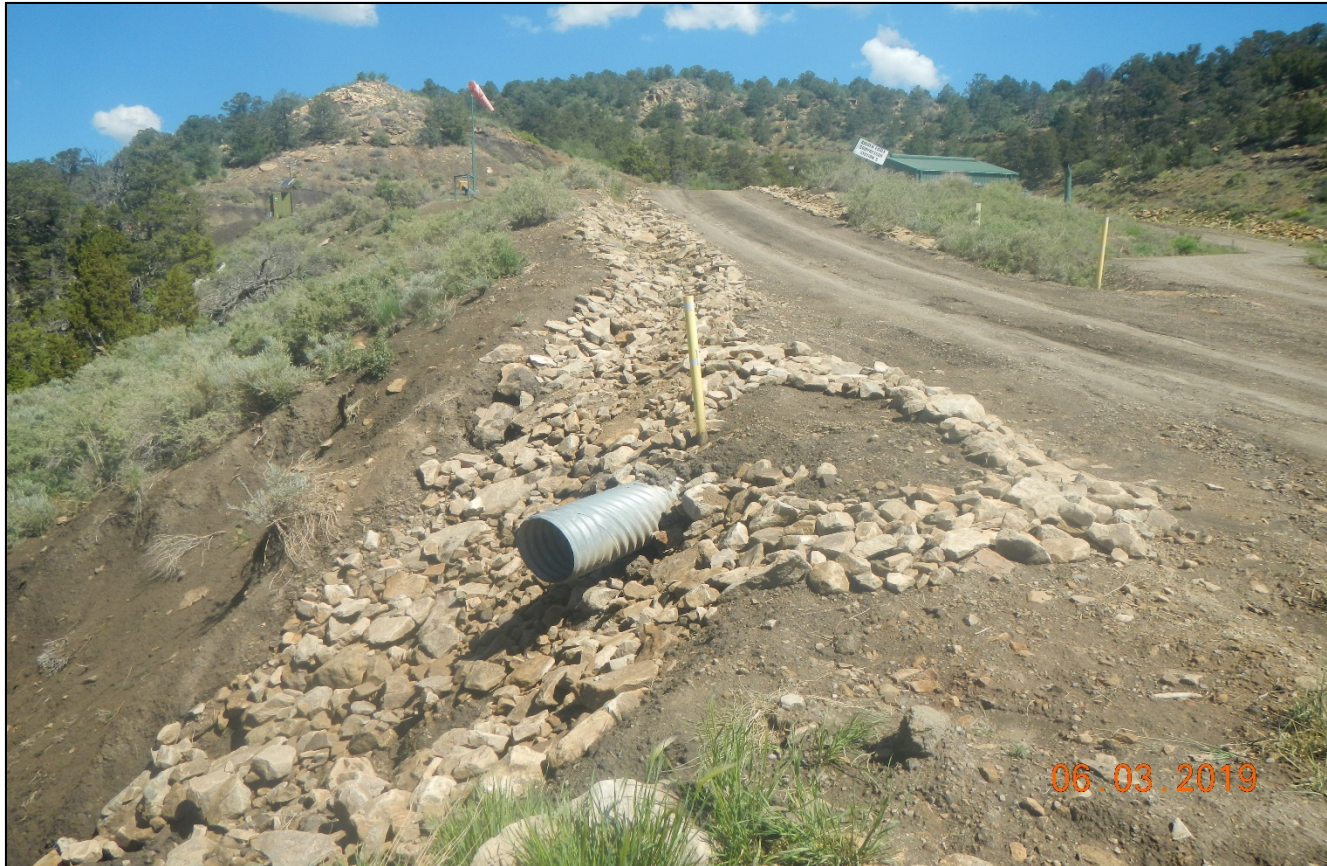
Photo 6. Additional rip/rap has been added to the outlet of the culvert.

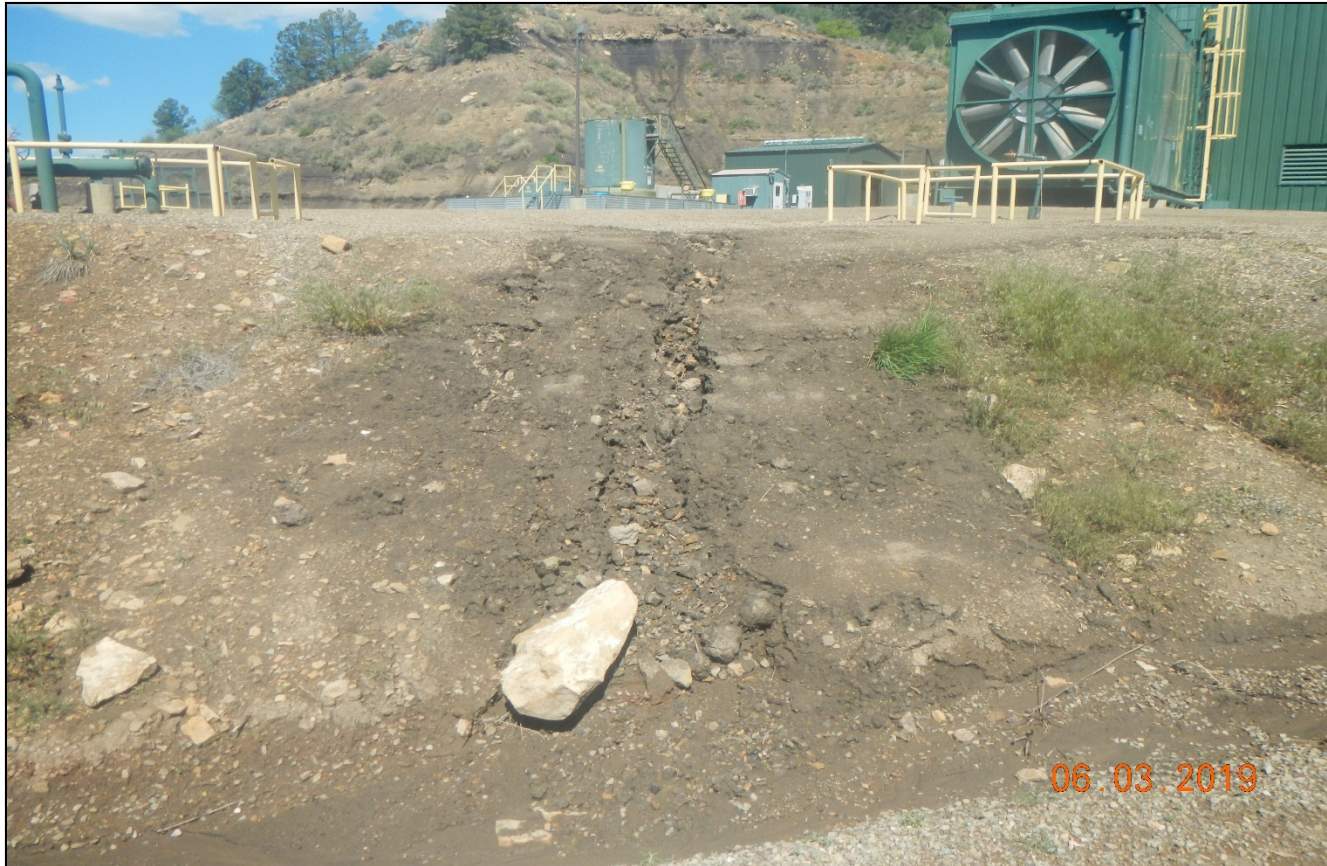
Photo 7. There is still erosion issues at the east side of the pad.

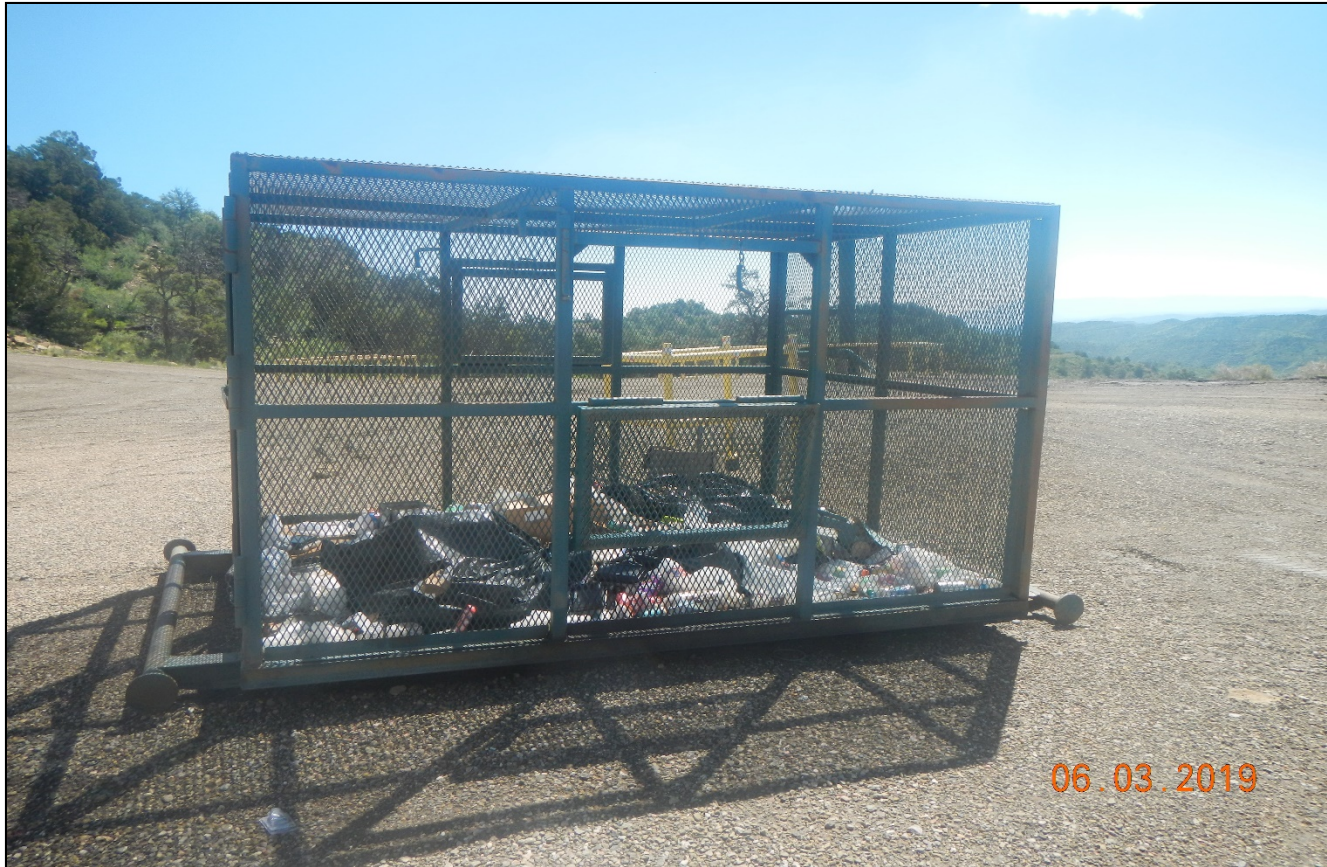
Photo 8. The door on the trash container was open.

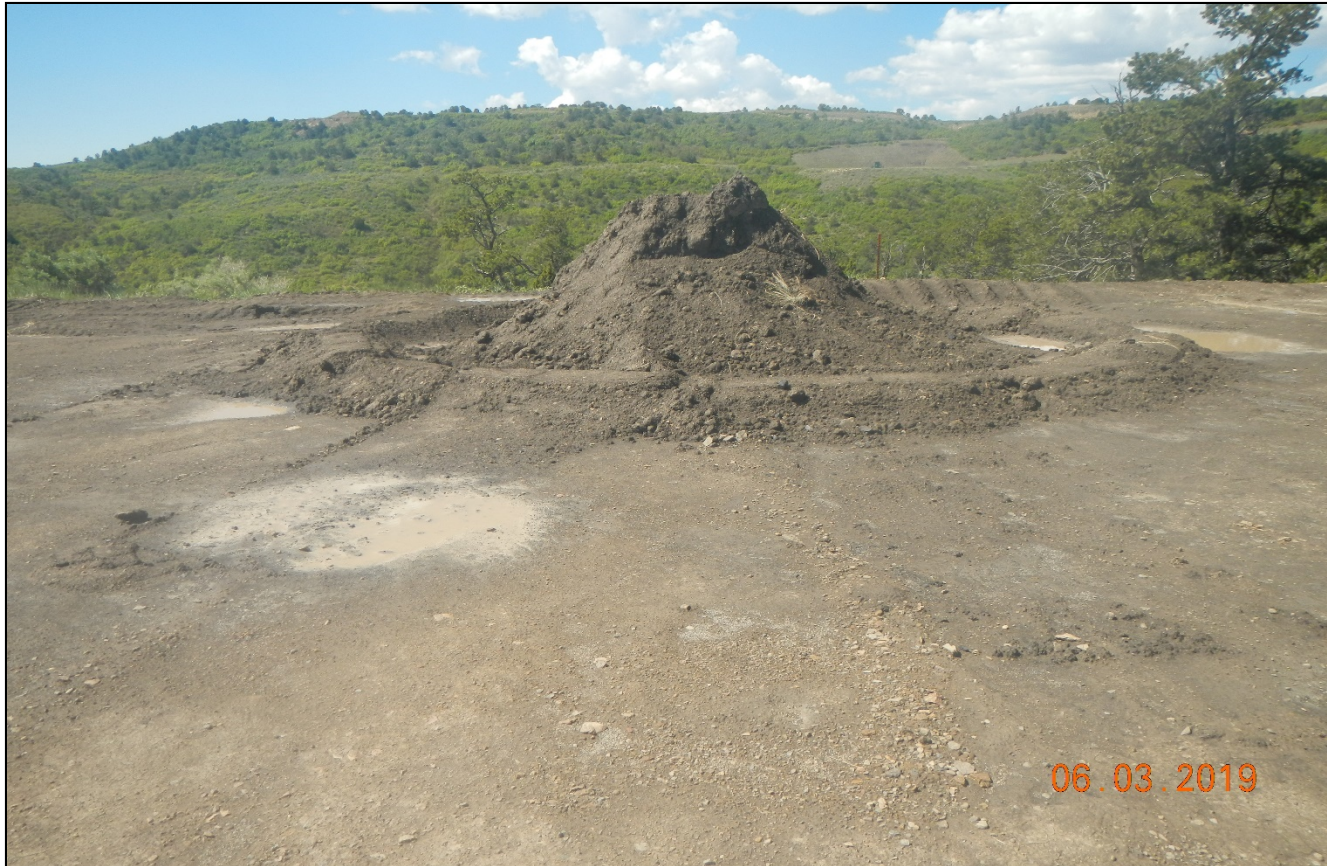
Photo 9. Berm was added around soil pile.

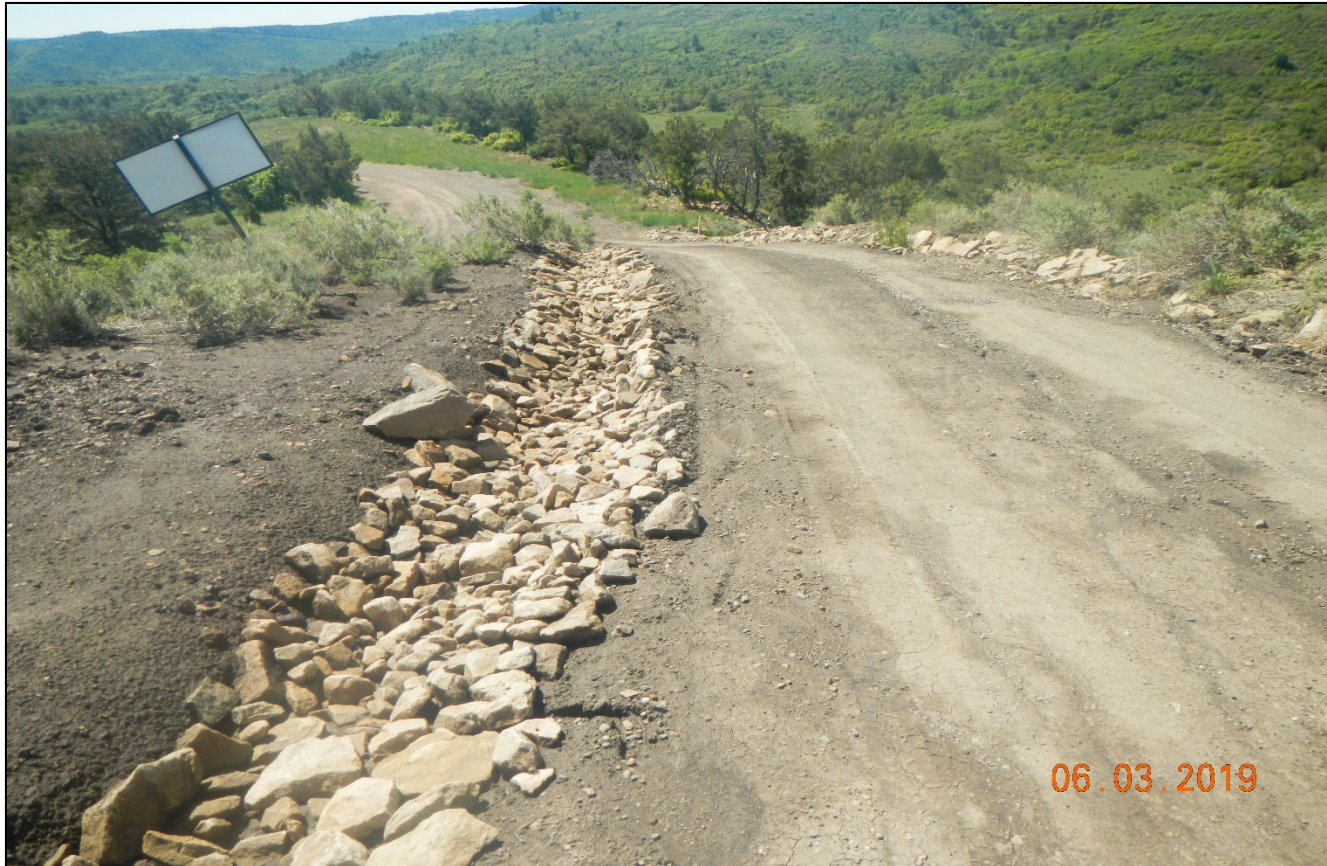
Photo 10. Rip/rap was added to control erosion.
