Inspection Photos
Loc#335019
Operator: Caerus
Insp#692401029
Inspection Date: 5/22/2019

Inspection Photos: Caerus Schideler Loc#335019

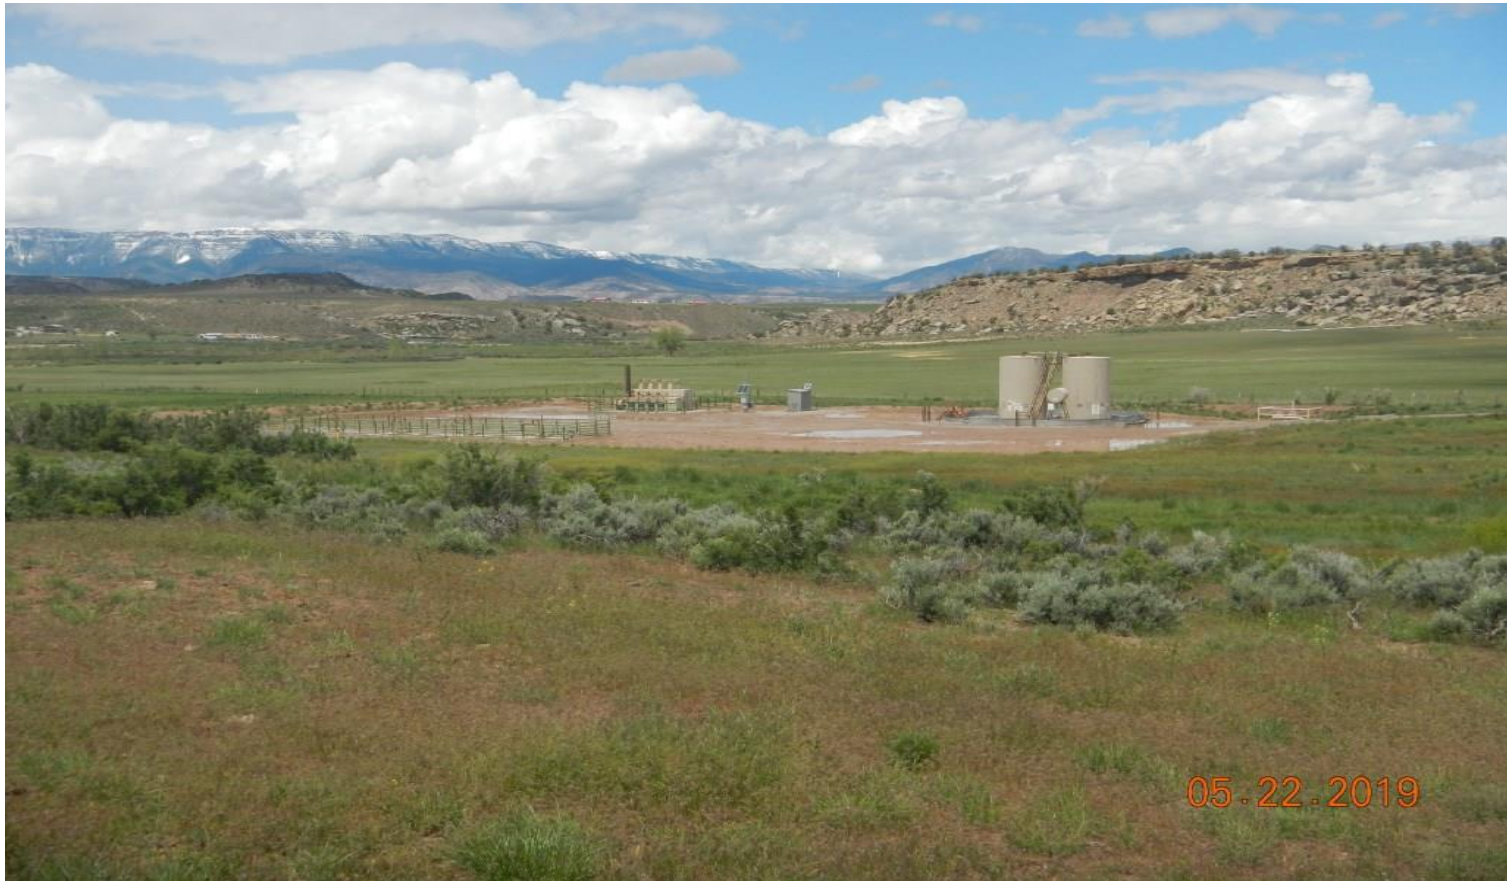
Photo#1:
Overview of Location to Northwest.

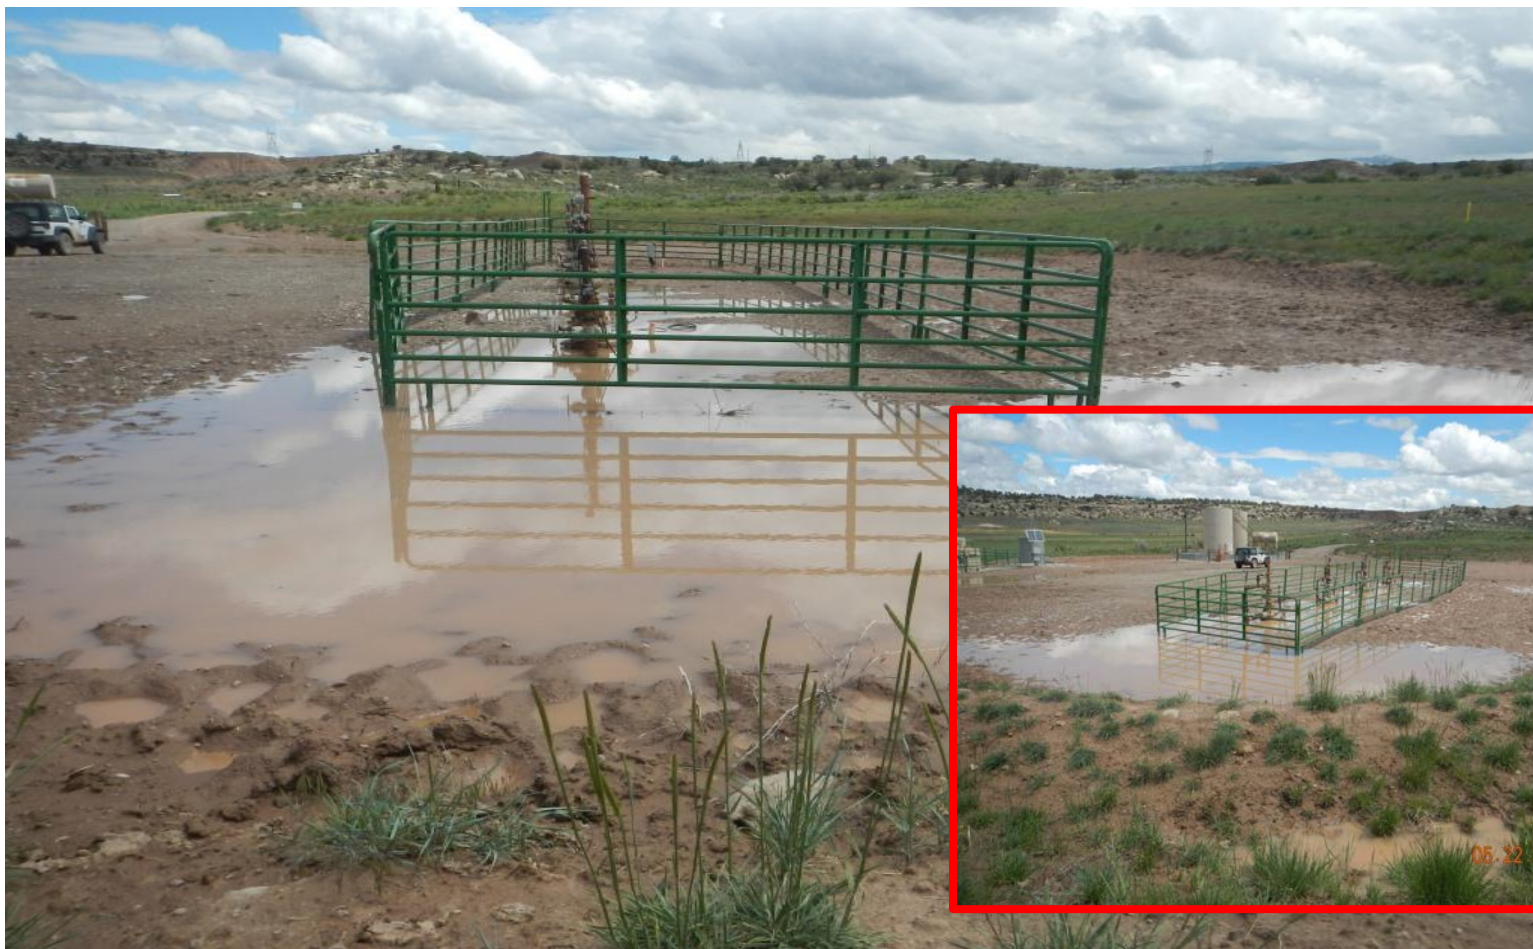
Photo#2:
Views of Ponding at Wellhead area

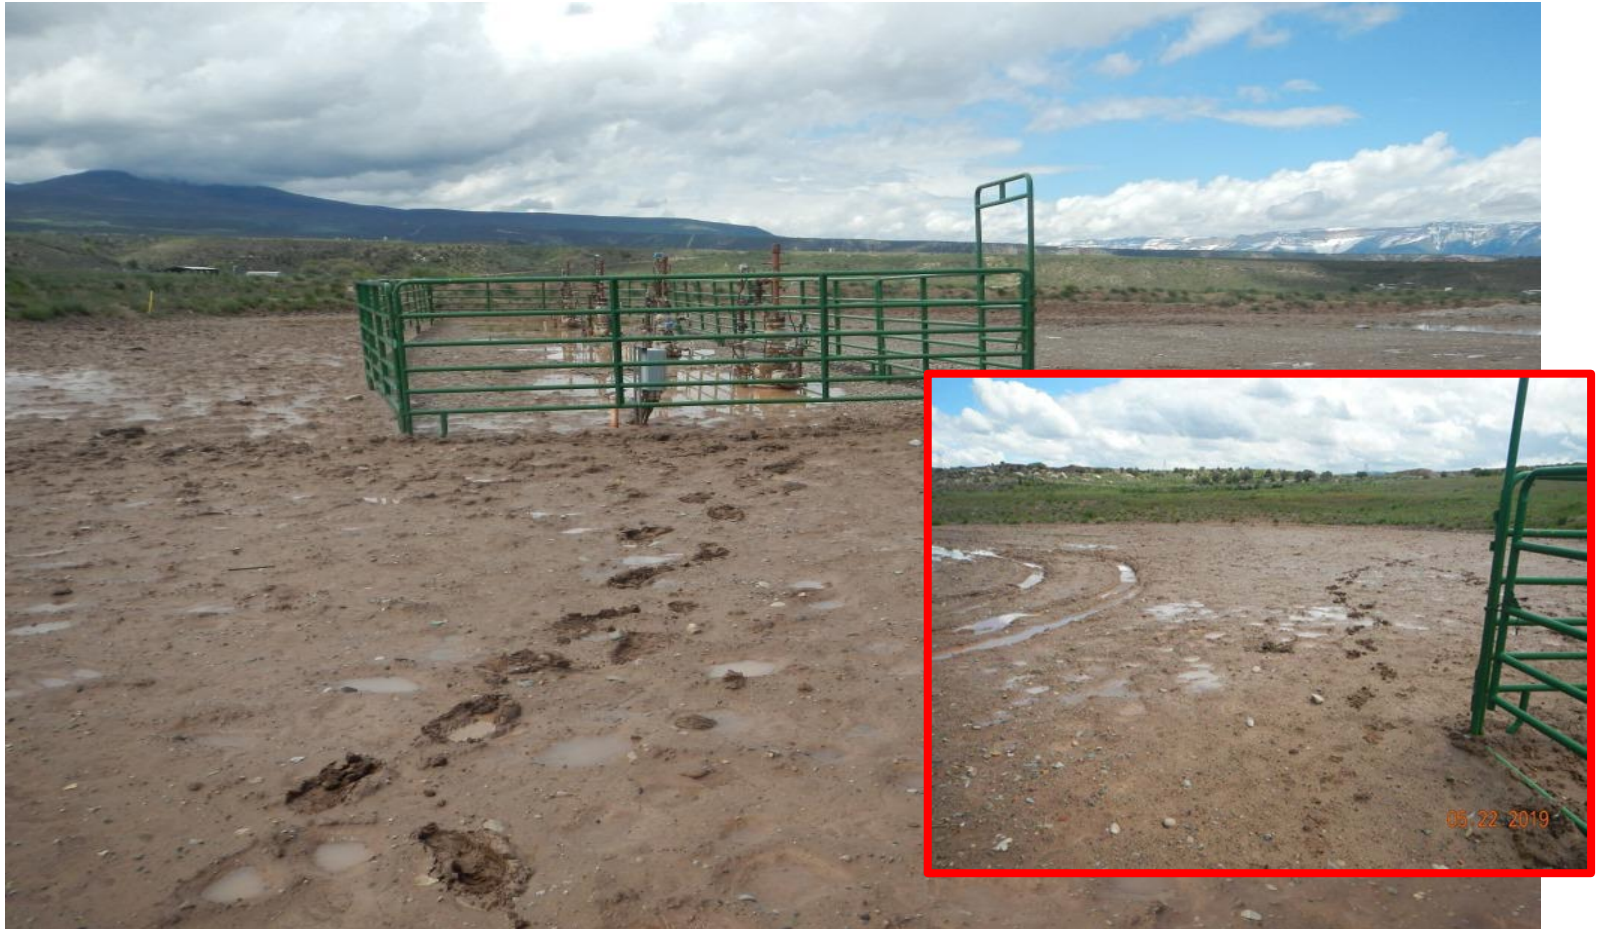
Photo#3:
View East to West over Wellhead lineup.

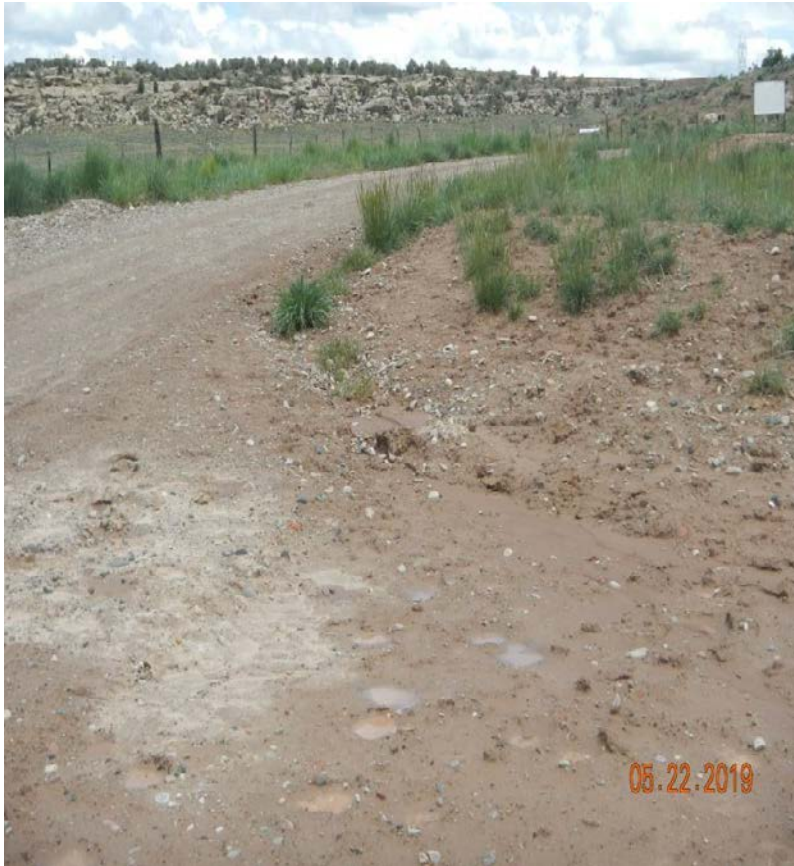
Photo#4:
Run-on is occurring at access road entry

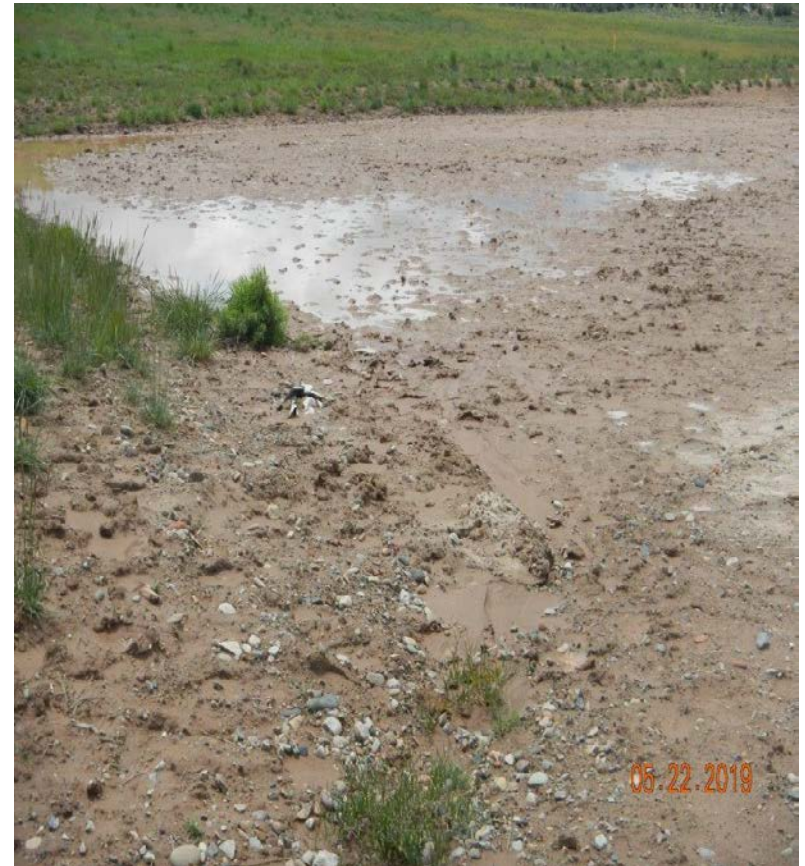
Photo#5:
Run-on is occurring at access road entry.
