## Inspection Photos

Location Name: STATE OF COLORADO AS 42-36V

API#: 05-071-07274

INSP. #: 695100789

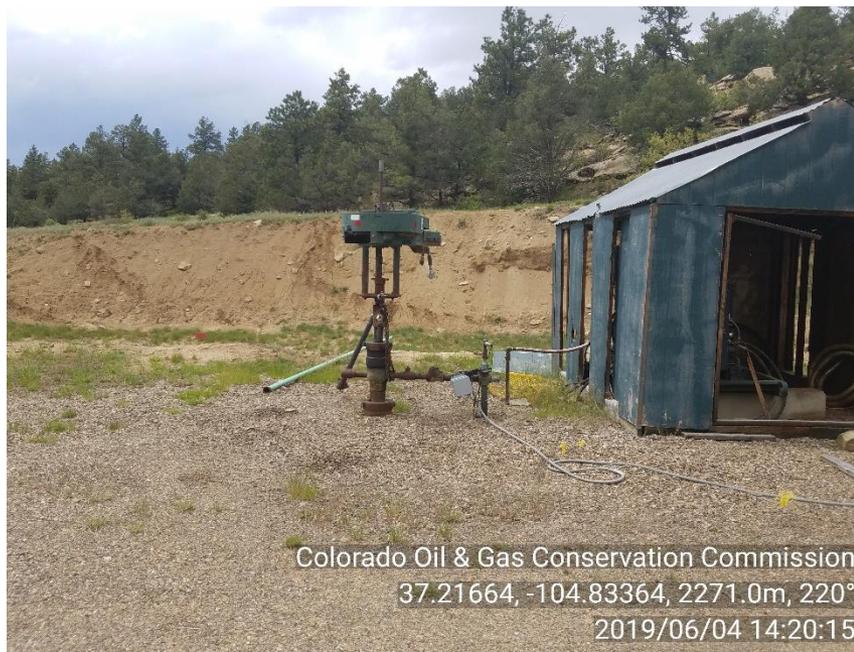
**PHOTO 1: ORIGINAL WELLHEAD**

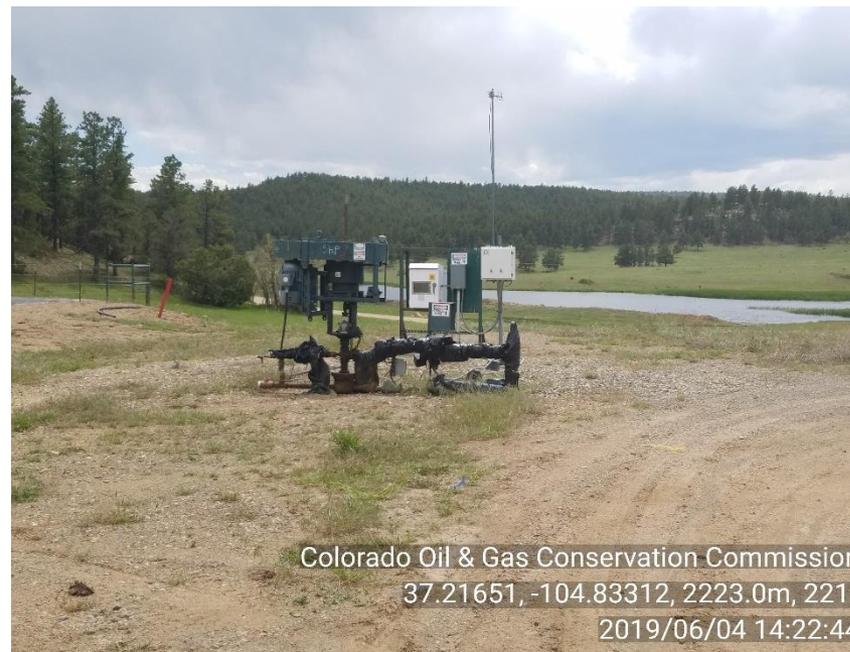
**PHOTO 2: V WELLHEAD**

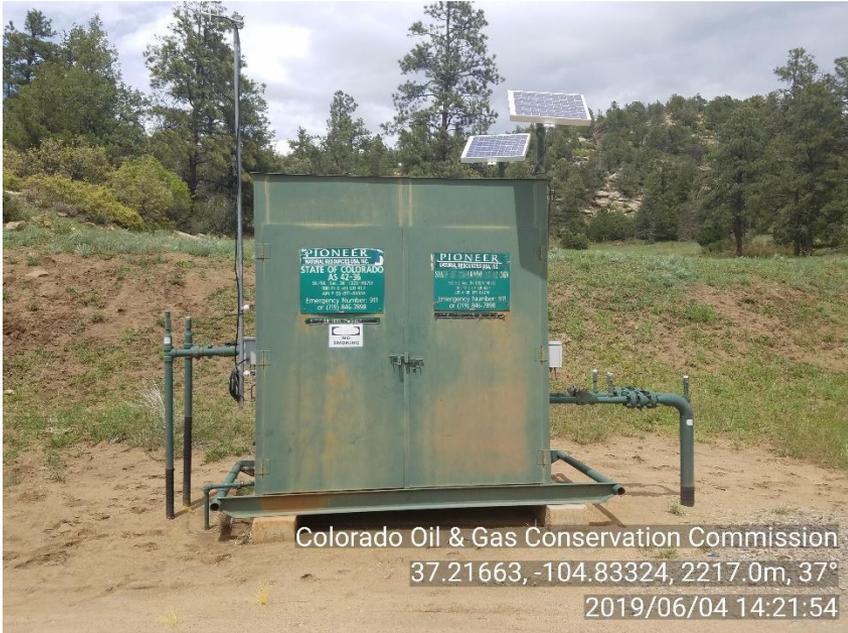
**PHOTO 3: WELL SIGNS/ CURRENT OPERATOR IS NOT POST ON WELL SIGN. COMPLY WITH 210 SERIES RULES. CA DATE 7/4/19.**

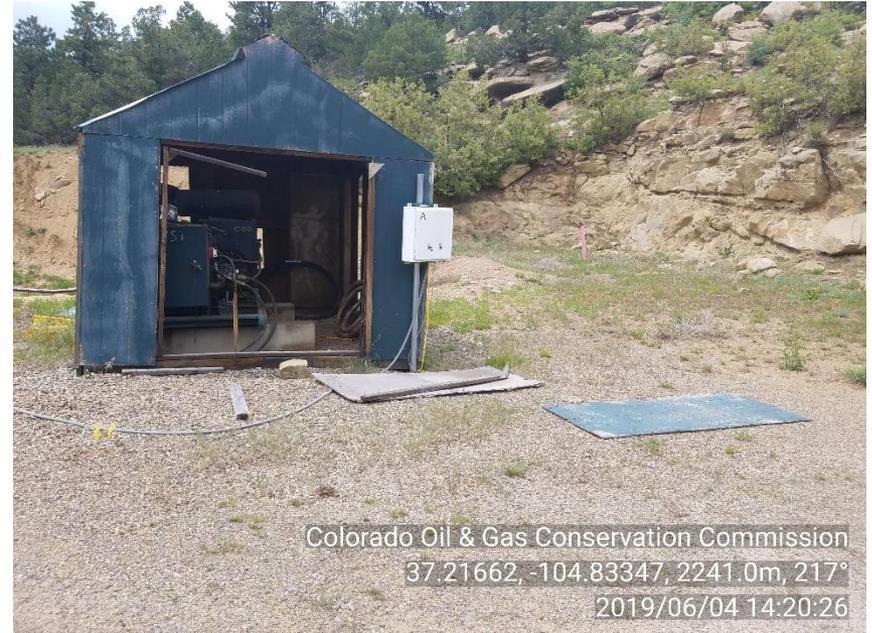
**PHOTO 4: TRASH SHOWN IN PHOTO 3: OF INSP. DOC# 691401803 ORIGINAL CA DATE 2/8/19 HAS NOT BEEN REMOVED. (TRASH SHOWN IN PHOTO 4 OF PREVIOUS INSPECTION IS NO LONGER ON LOCATION). COMPLY WITH RULE 603.f. CA DATE IMMEDIATELY.**

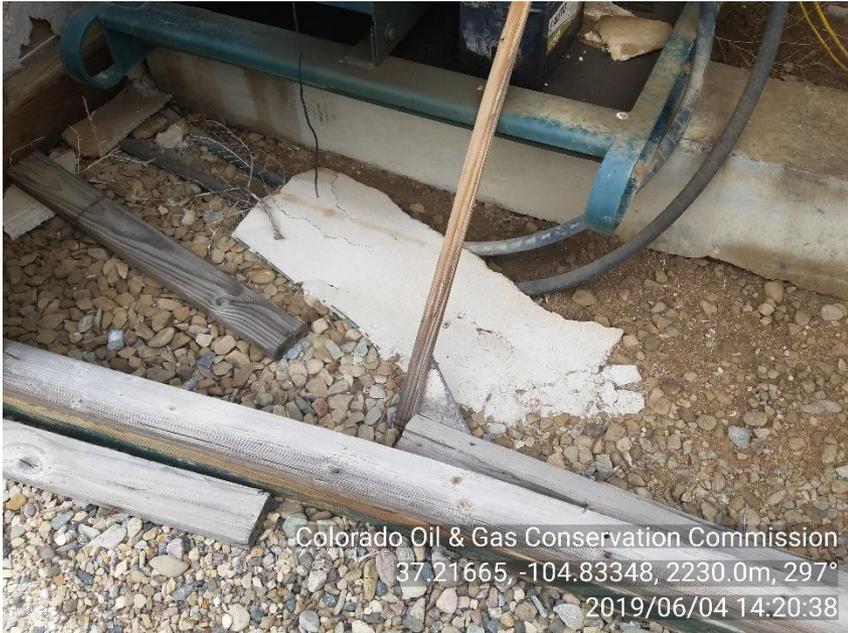
**PHOTO 5: TRASH INSIDE ENGINE HOUSE. (WAS NOT NOTED ON PREVIOUS INSPECTION). COMPLY WITH RULE 603.f. CA DATE 7/4/19**

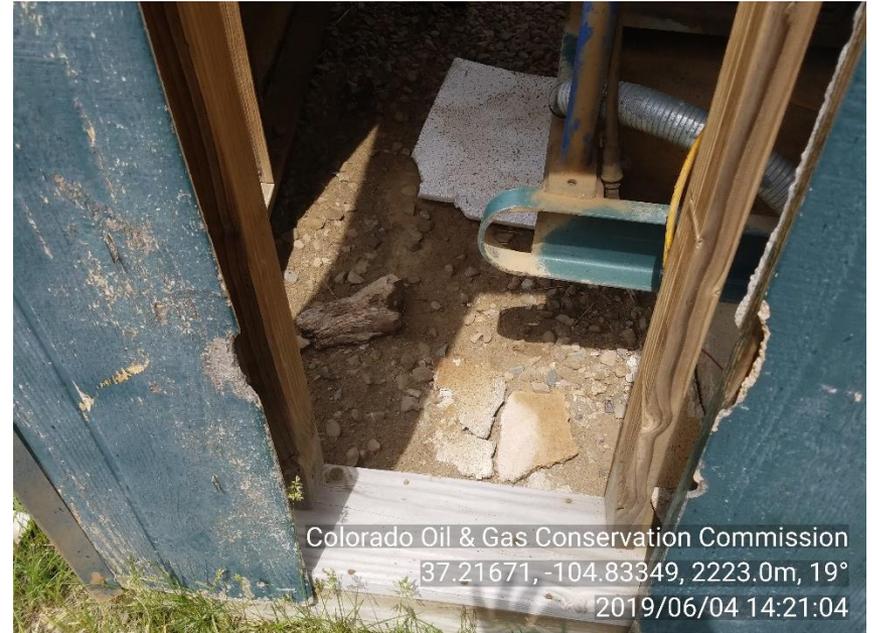
**PHOTO 6: TRASH INSIDE ENGINE HOUSE. (WAS NOT NOTED ON PREVIOUS INSPECTION). COMPLY WITH RULE 603.f. CA DATE 7/4/19**

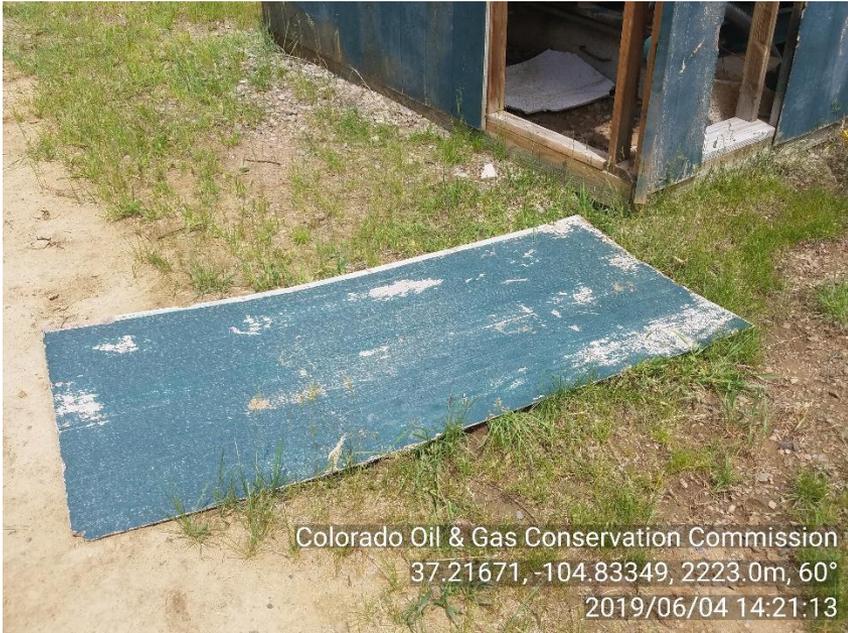
**PHOTO 7: TRASH ON NORTH SIDE OF ENGINE HOUSE. (WAS NOT NOTED ON PREVIOUS INSPECTION). COMPLY WITH RULE 603.f. CA DATE 7/4/19**
