Inspection Photos
Operator: Hilcorp Energy
Location/API #: 067-08150
Date: 6-4-2019

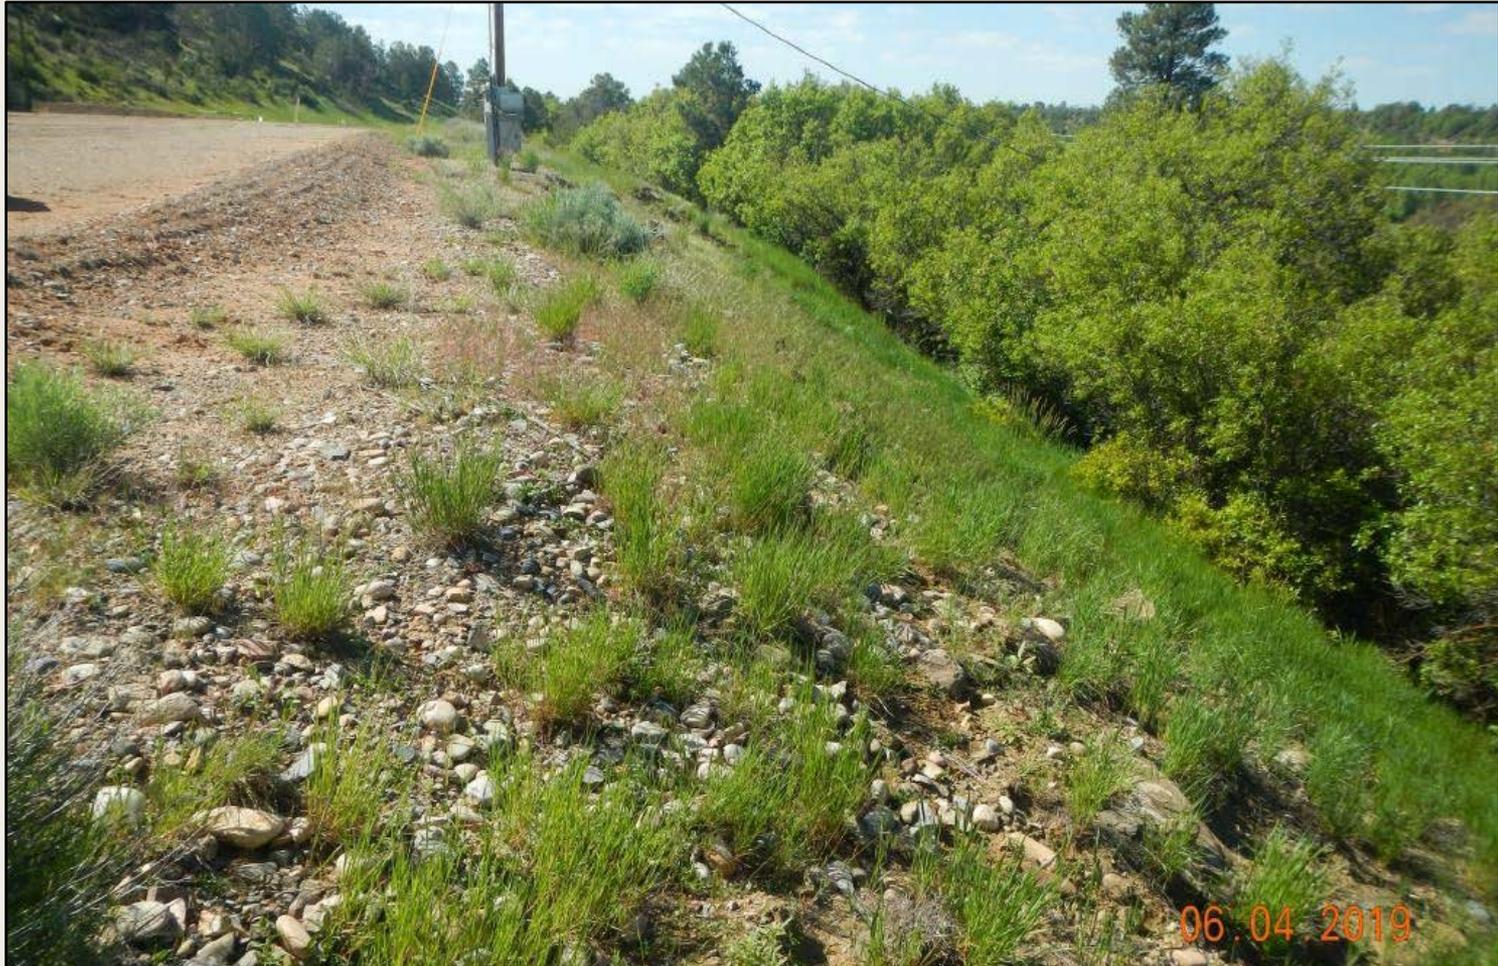
Photo 1. View of the western project area from the northwestern edge facing southward.

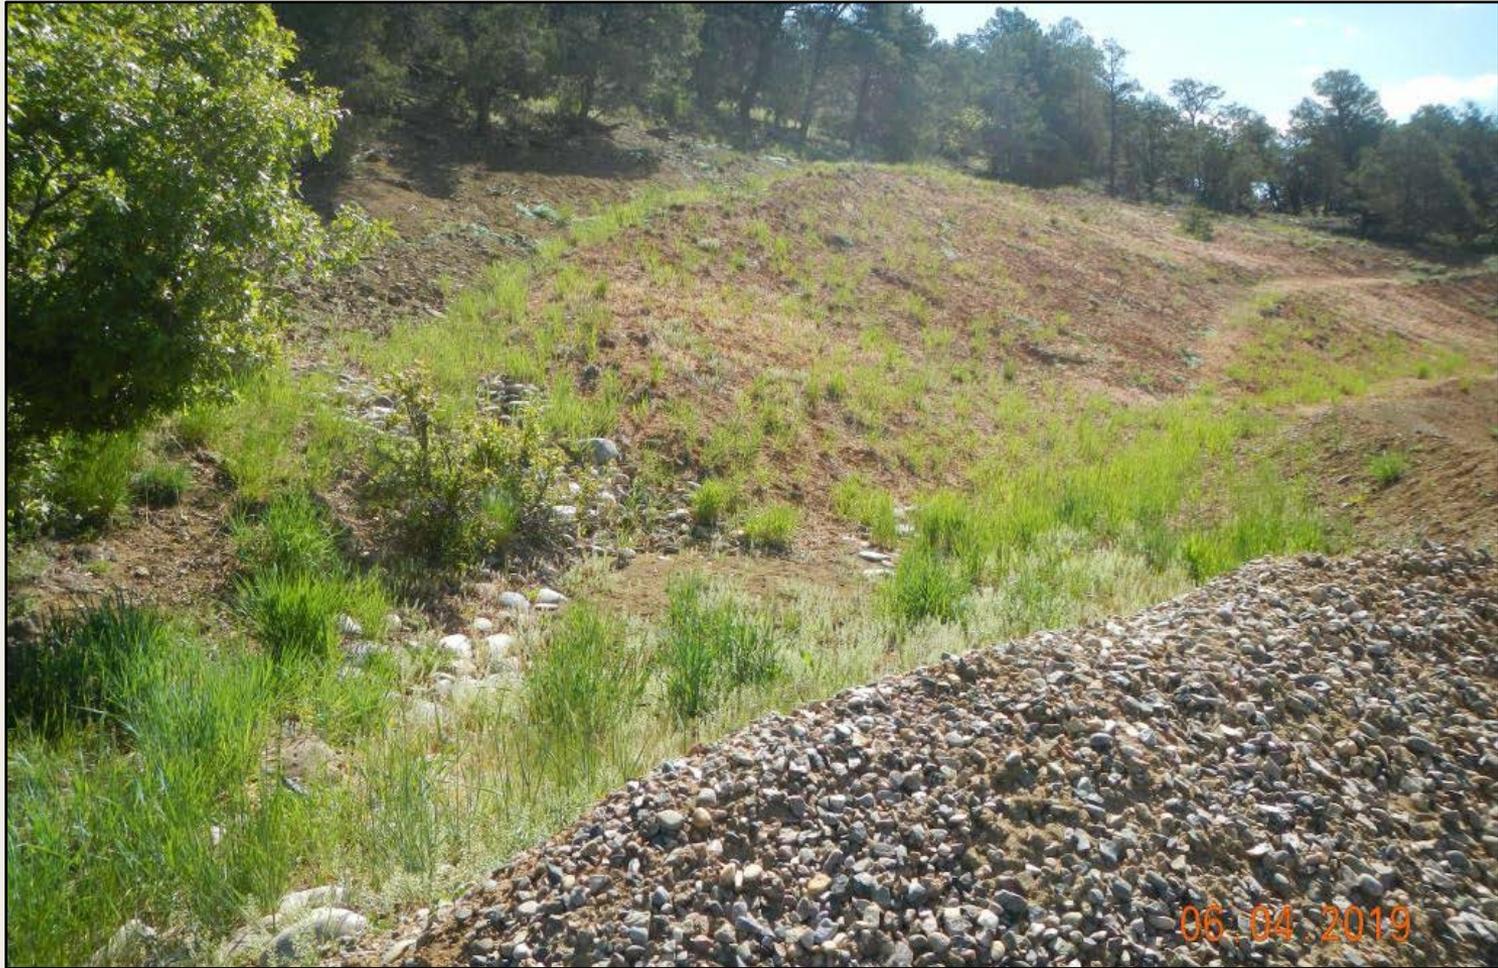
Photo 2. View of the eastern project area from the northern edge facing southeastward.

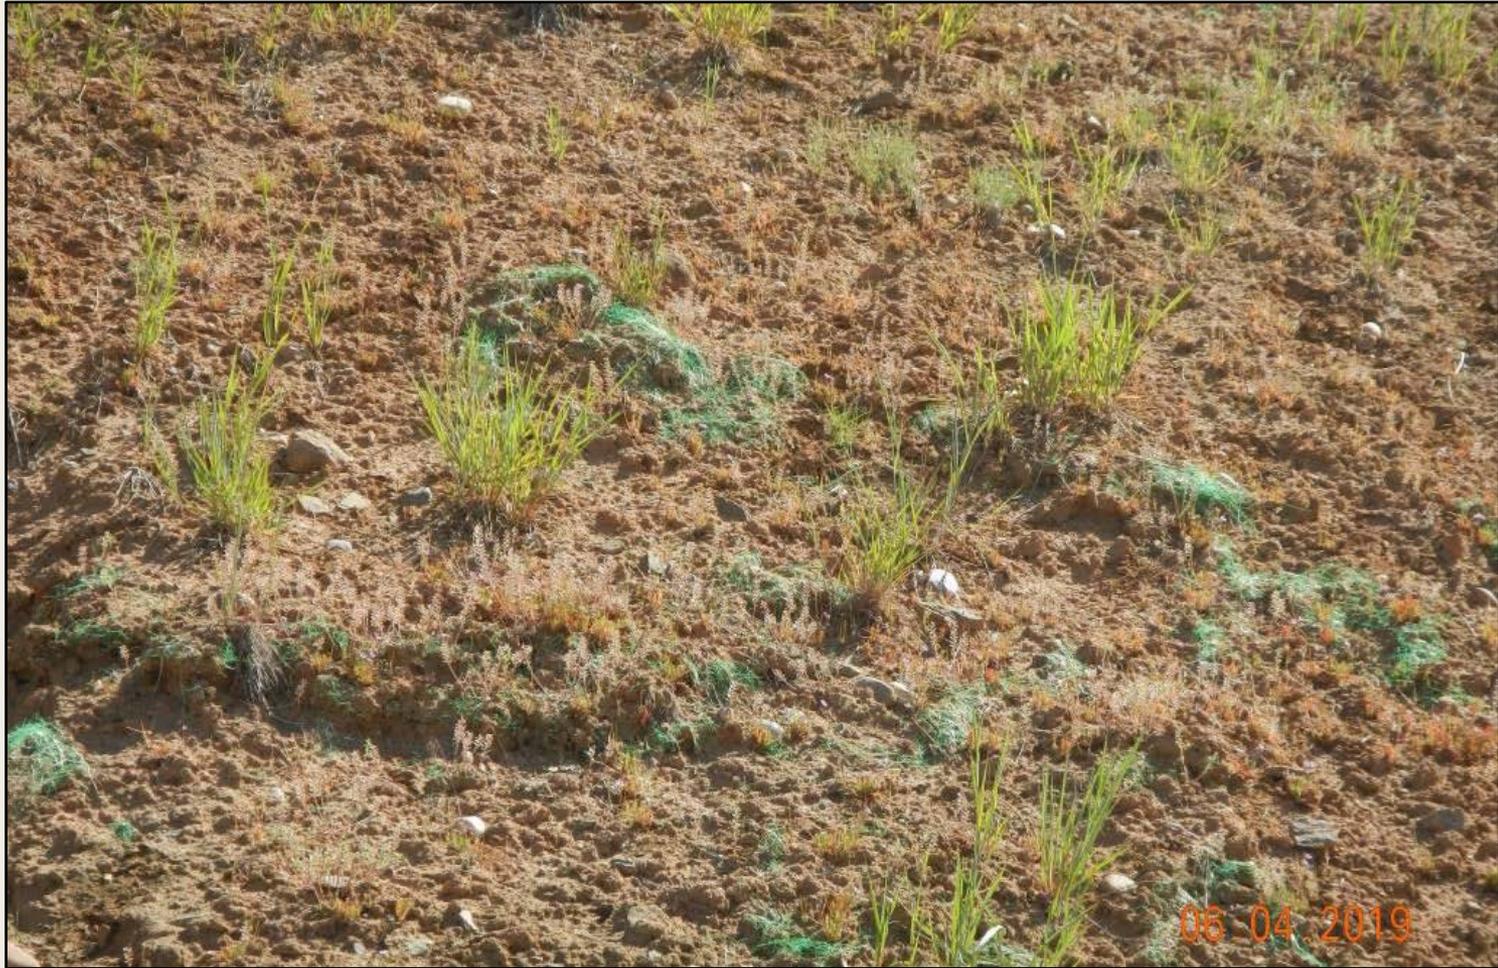
Photo 3. View of green plastic netting debris within the eastern cut-slope.

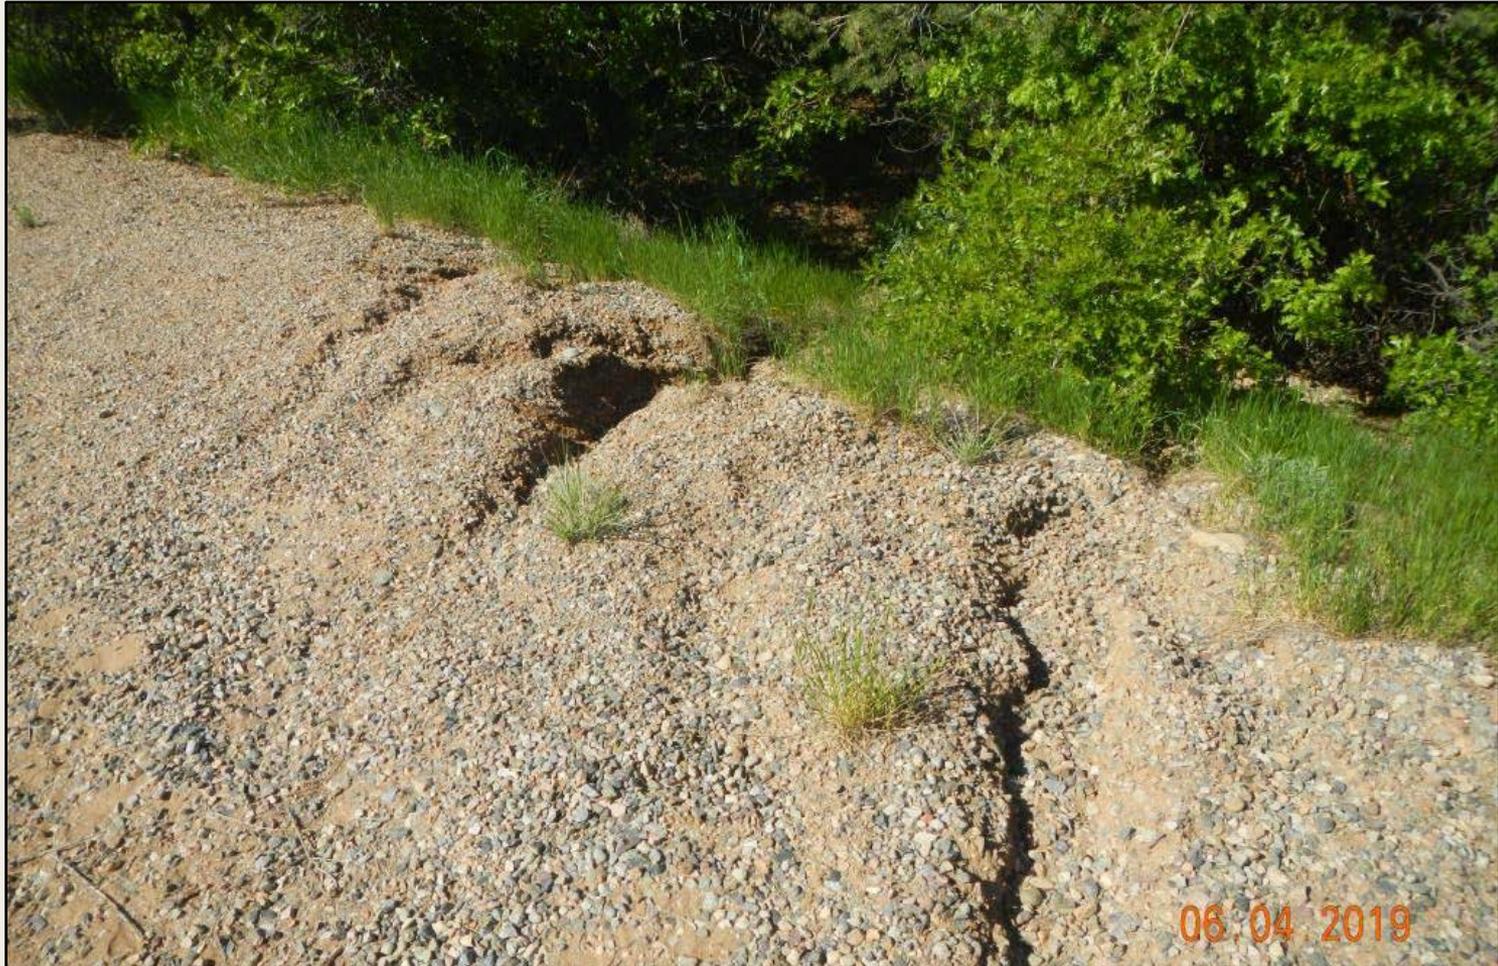
Photo 4. View of erosional rilling, up to 10 inches deep within the access road.
