## Inspection Photos

Location Name: ANTELOPE 13-32

API #: 05-071-06788

INSP. #:695100782

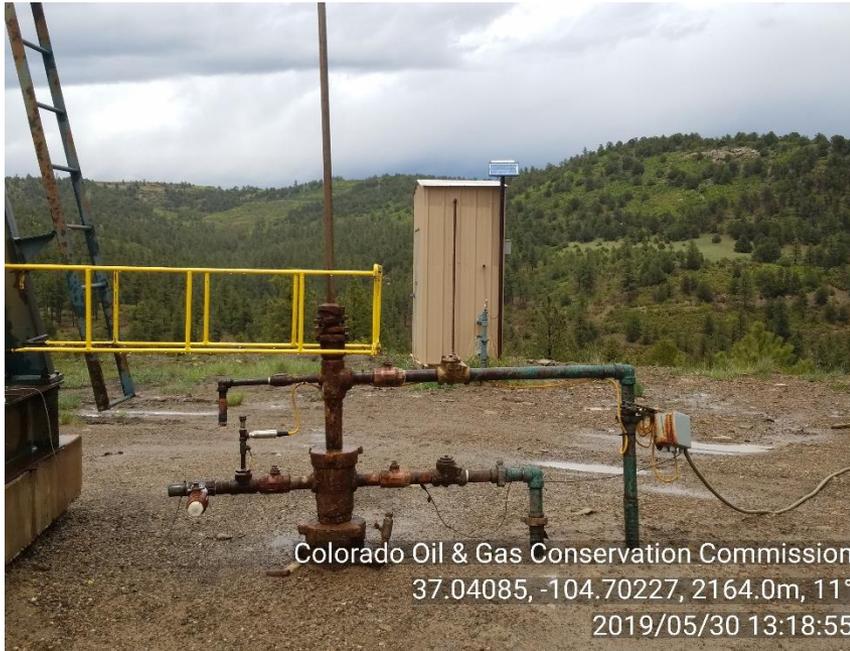
**PHOTO 1: WELLHEAD**

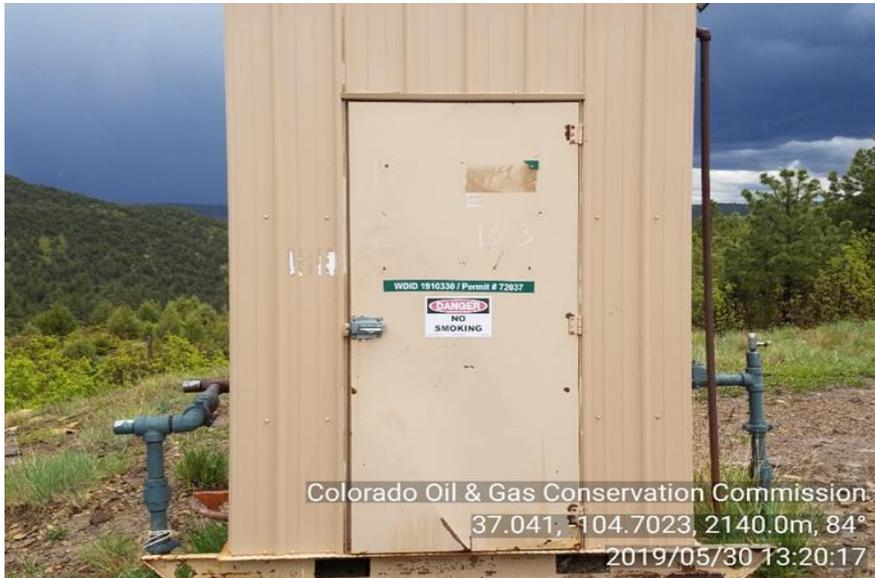
**PHOTO 2: WELL SIGN NOT POST AT LOCATION NO EMERGENCY CONTACT INFORMATION. THIS IS A FOLLOWUP TO PREVIOUS INSPECTION. INSP. DOC# 687902811 THIS CORRECTIVE ACTION HAS NOT BEEN ADDRESSED. **POST WELL SIGN TO COMPLY WITH 210 SERIES RULES.****

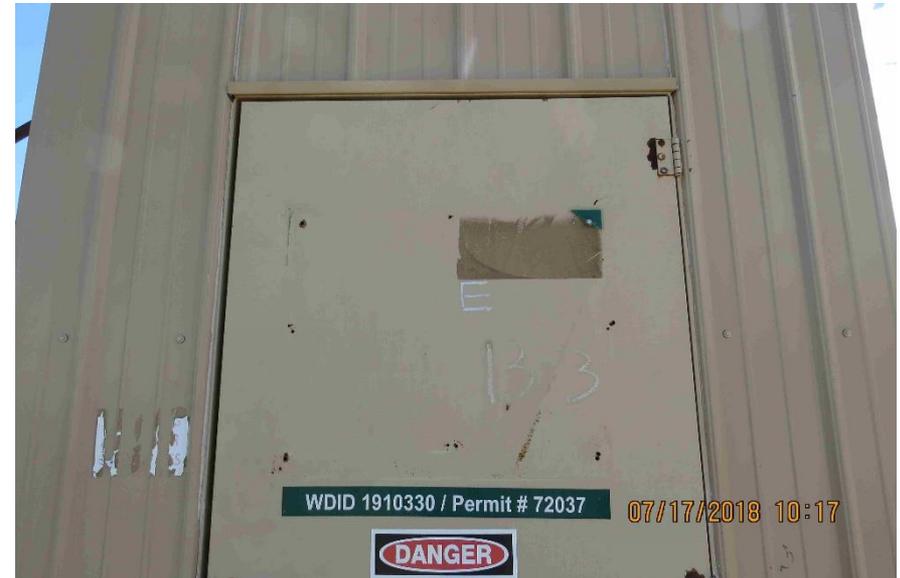
**PHOTO 3: IMAGE OF MISSING WELL SIGN FROM PREVIOUS INSPECTION DOC# 687902811.**

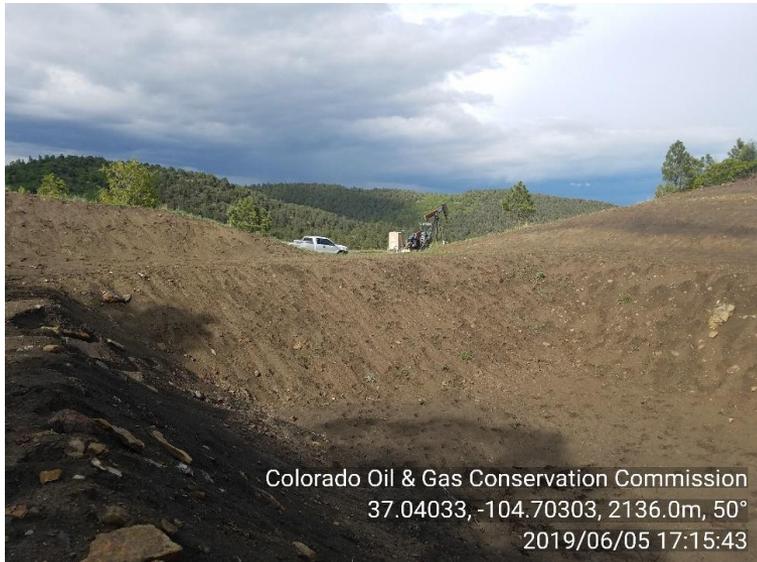
**PHOTO 4: NO FREEBOARD MARKER. PIT DOES NOT APPEAR TO BE IN USE. NO GATHERING LINES PLUMBED TO PIT. PIT IS DRY. **INSTALL FREEBOARD MARKER IN ACCORDANCE WITH 902 SERIES RULES. CONTACT COGCC EPS STAFF REGARDING FUTURE USE OF PIT. CA DATE 6/16/19****

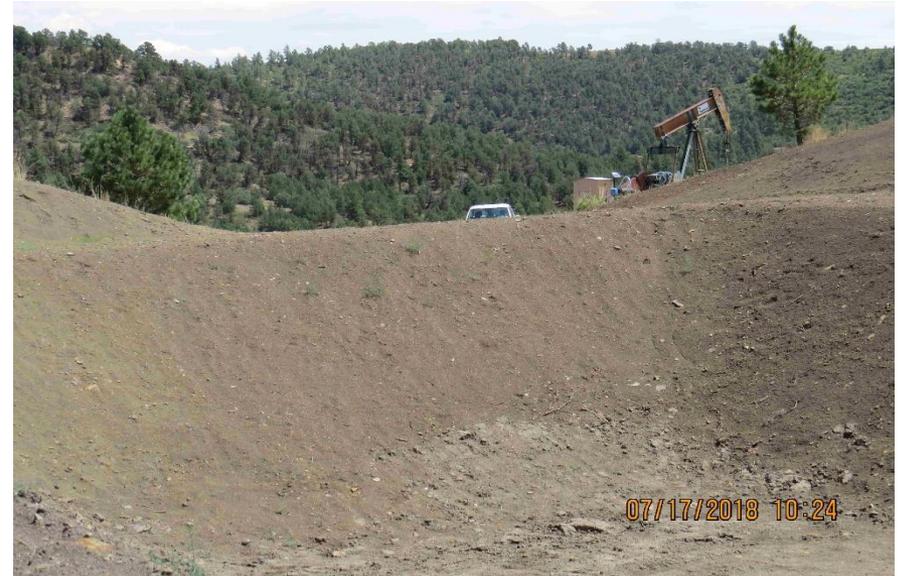
**PHOTO 5: IMAGE OF NO FREEBOARD MARKER IN PIT FROM PREVIOUS INSPECTION DOC# 687902811.**
