Inspection Photos  
Location Name: SALIDA 44-26  
API#: 05-071-07675  
INSP. #: 695100801

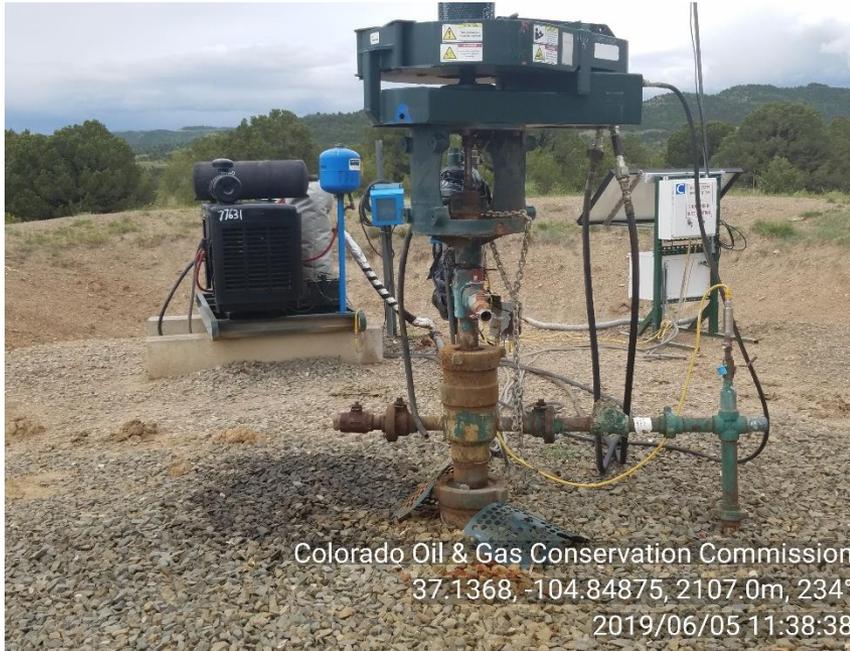
**PHOTO 1: WELLHEAD/ APPROXIMATELY 3' BY 3' AREA OF IMPACTED SOIL NEAR WELLHEAD. Remove and dispose impacted material in approved manner, service and maintain equipment and self inspect to prevent recurrence of conditions per 1002.f(2) and 907" CA DATE 7/5/19**

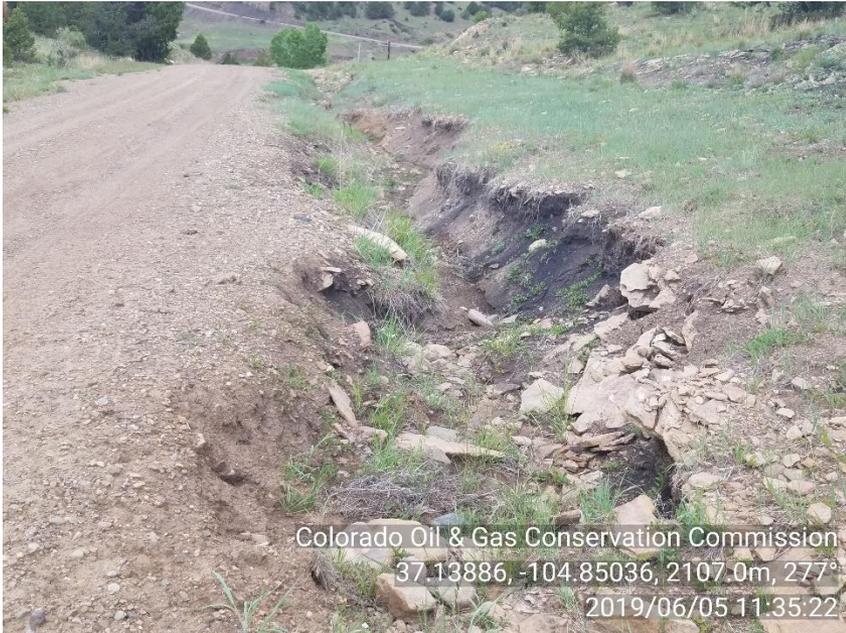
**PHOTO 3: EROSION IN DRAINAGE DITCH ON MAIN LEASE ROAD APP. 75 YARDS WEST OF LOCATION ACCESS ROAD. REPAIR DRAINAGE DITCH AND INSTALL BMP'S TO PREVENT EROSION AND SEDIMENT MIGRATION IN ACCORDANCE WITH 1002 SERIES RULES. CA DATE 7/5/19.**

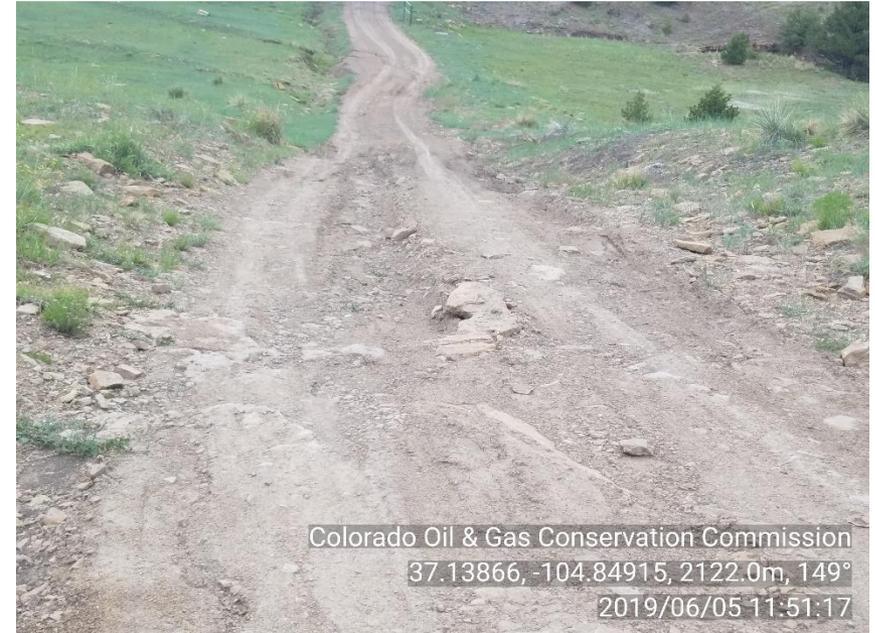
**PHOTO 4: EROSION ON ACCESS ROAD JUST SOUTH OF ENTRANCE OF ACCESS ROAD. NO DRAINAGE DITCH OR BMP'S OBSERVED AT TIME OF INSPECTION. INSTALL PROPER DRAINAGE AND BMP'S IN ACCORDANCE WITH 1002 SERIES RULES. CA DATE 7/5/19**

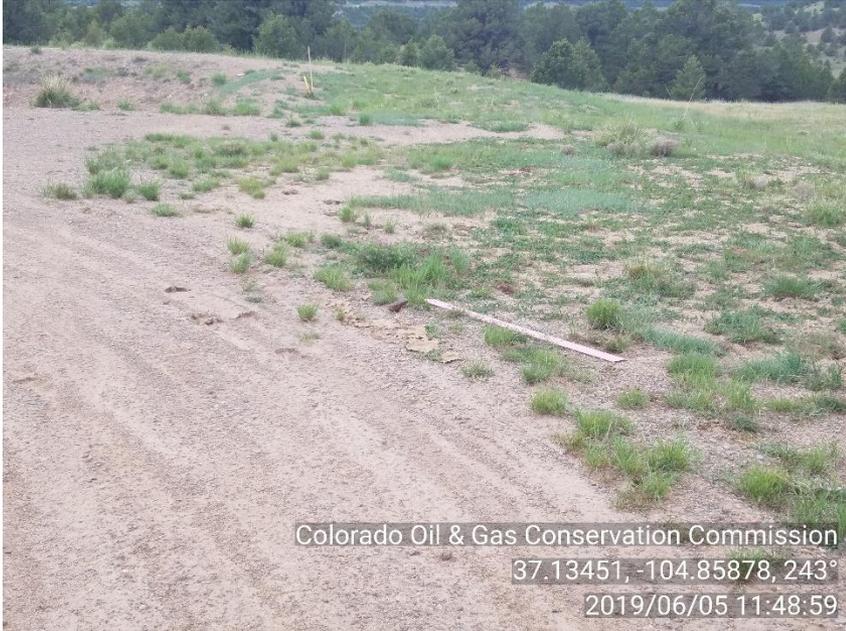
**PHOTO 5: GUY LINE ANCHORS NOT MARKED. INSTALL GUY LINE MARKERS IN ACCORDANCE WITH 1003. SERIES RULES. CA DATE 7/5/19**

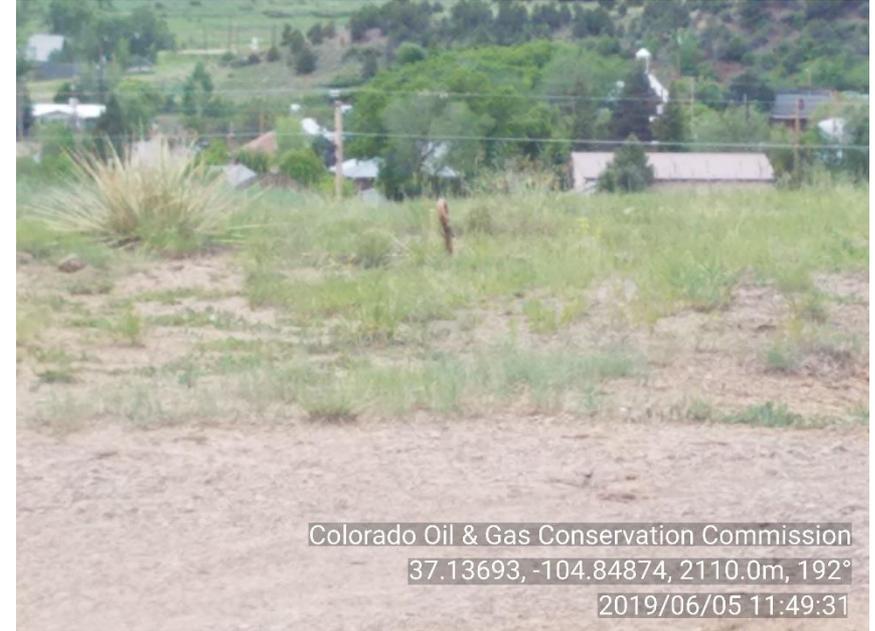
**PHOTO 6: GUY LINE ANCHORS NOT MARKED. INSTALL GUY LINE MARKERS IN ACCORDANCE WITH 1003. SERIES RULES. CA DATE 7/5/19**
