Caerus Piceance LLC  
API # 05-077-09239  
Inspection # 696600095

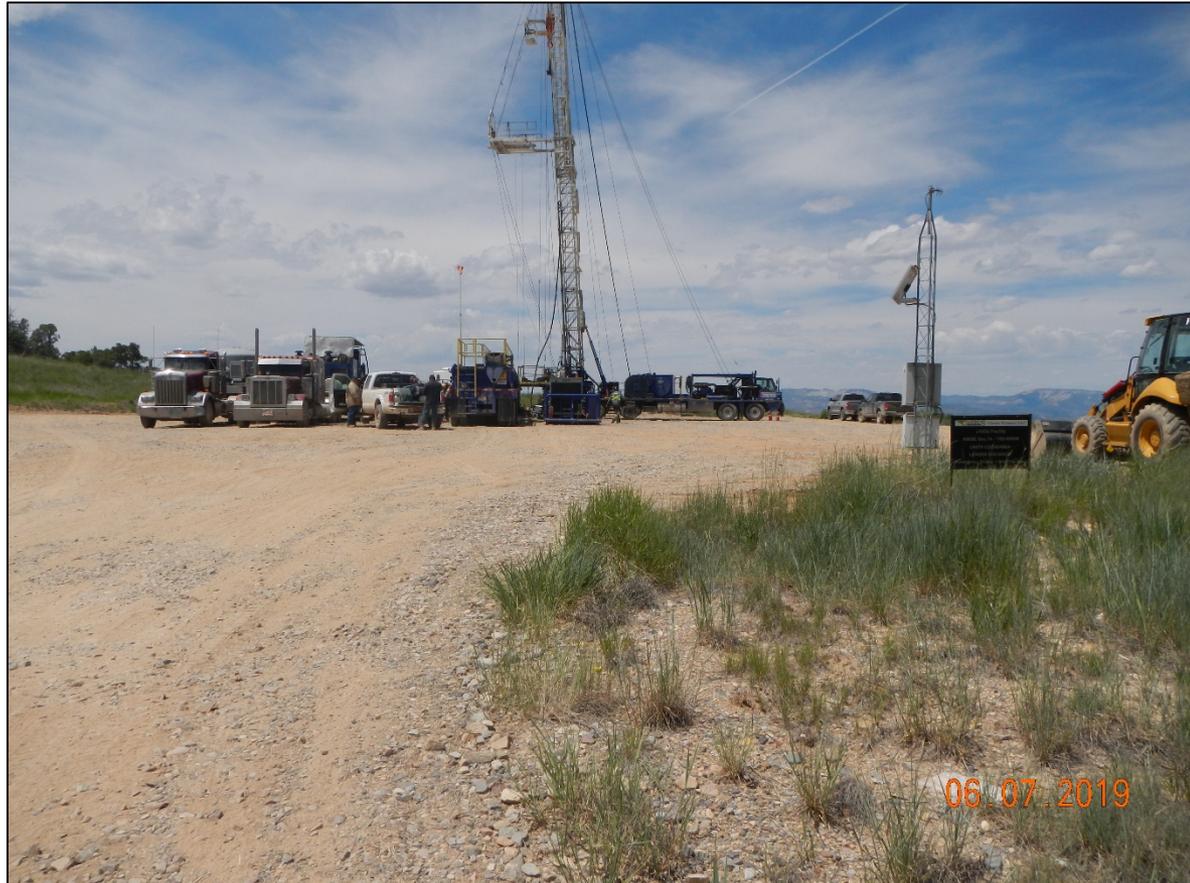
**Photo #1 Photo from entrance location**

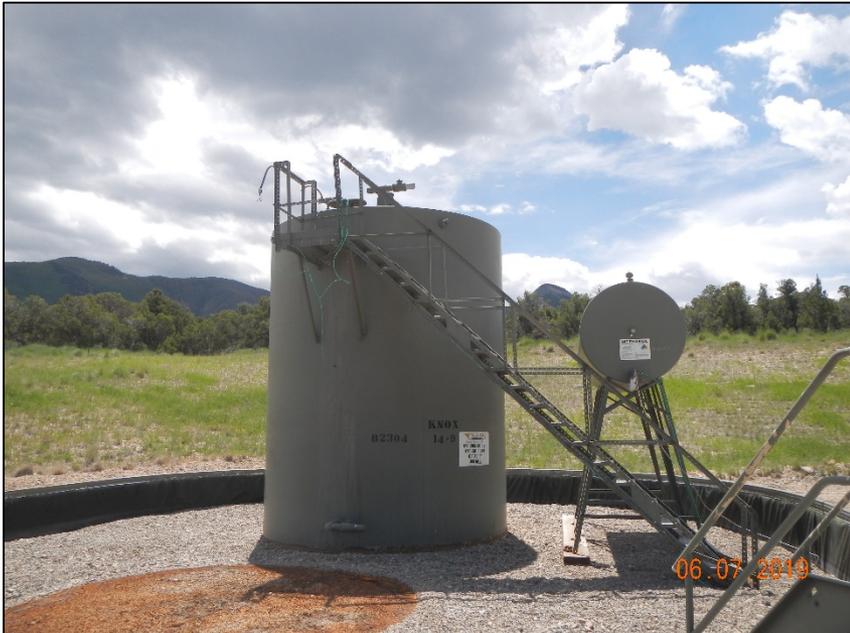
Photo #2 tank battery , one tank removed leaving rust stain inside containment.

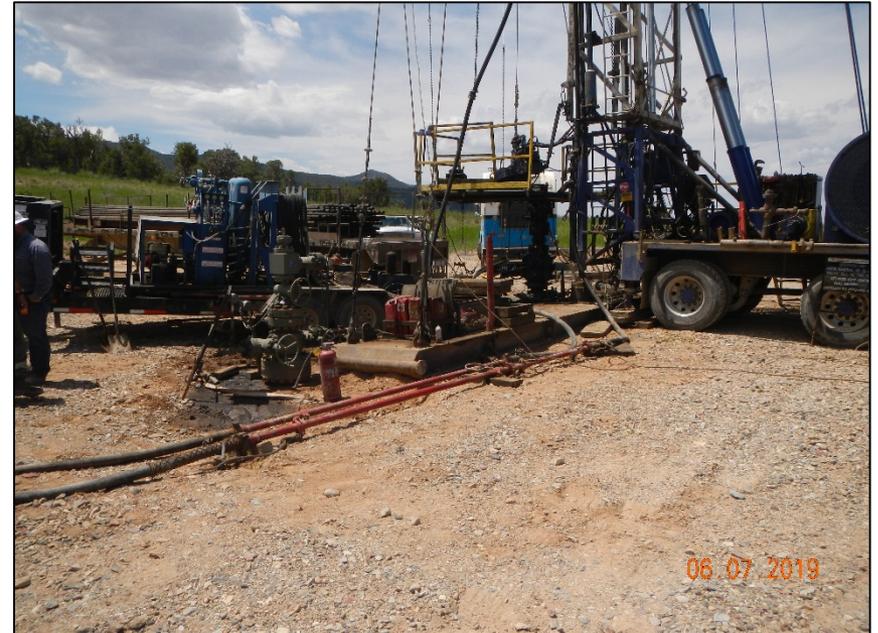
Photo#3 @ wellheads on location one hooked up to rig for PA other is TA

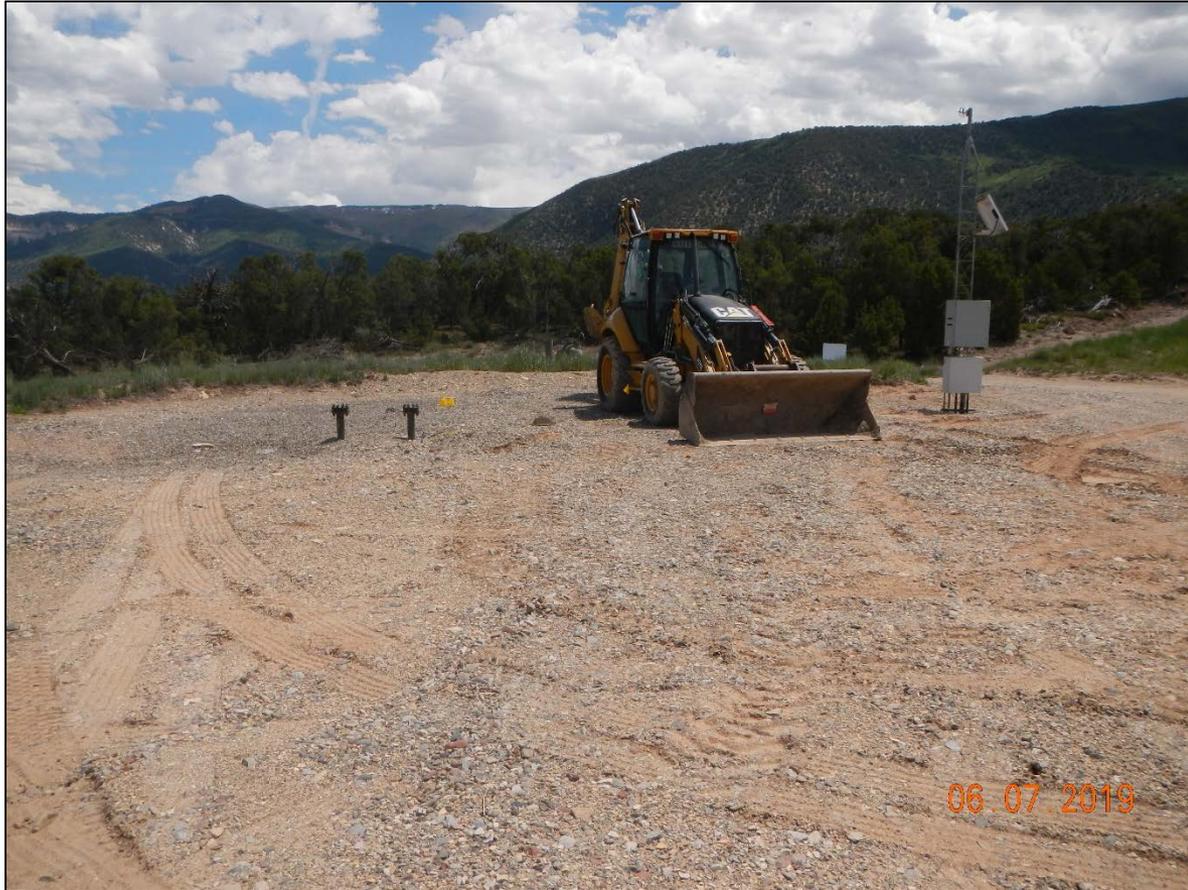
**Photo #4 Photo of site location where production equipment has been removed. Risers are not locked out tagged out**
