Encana
API # 05-077-10208
Inspection # 696600097

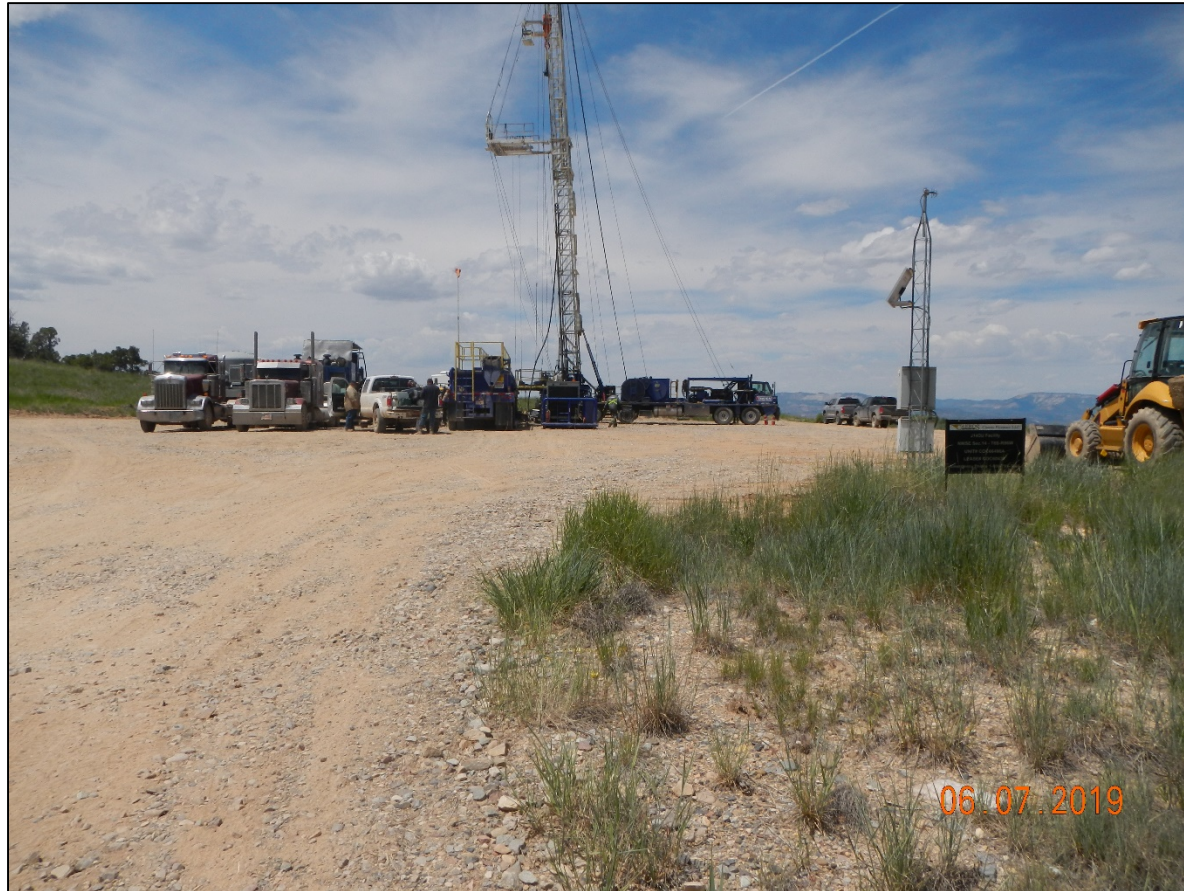
Photo #1 Photo from entrance of location. Caerus plugging operation taking place
