Caerus Piceance LLC
API # 05-077-09168
Inspection # 696600099

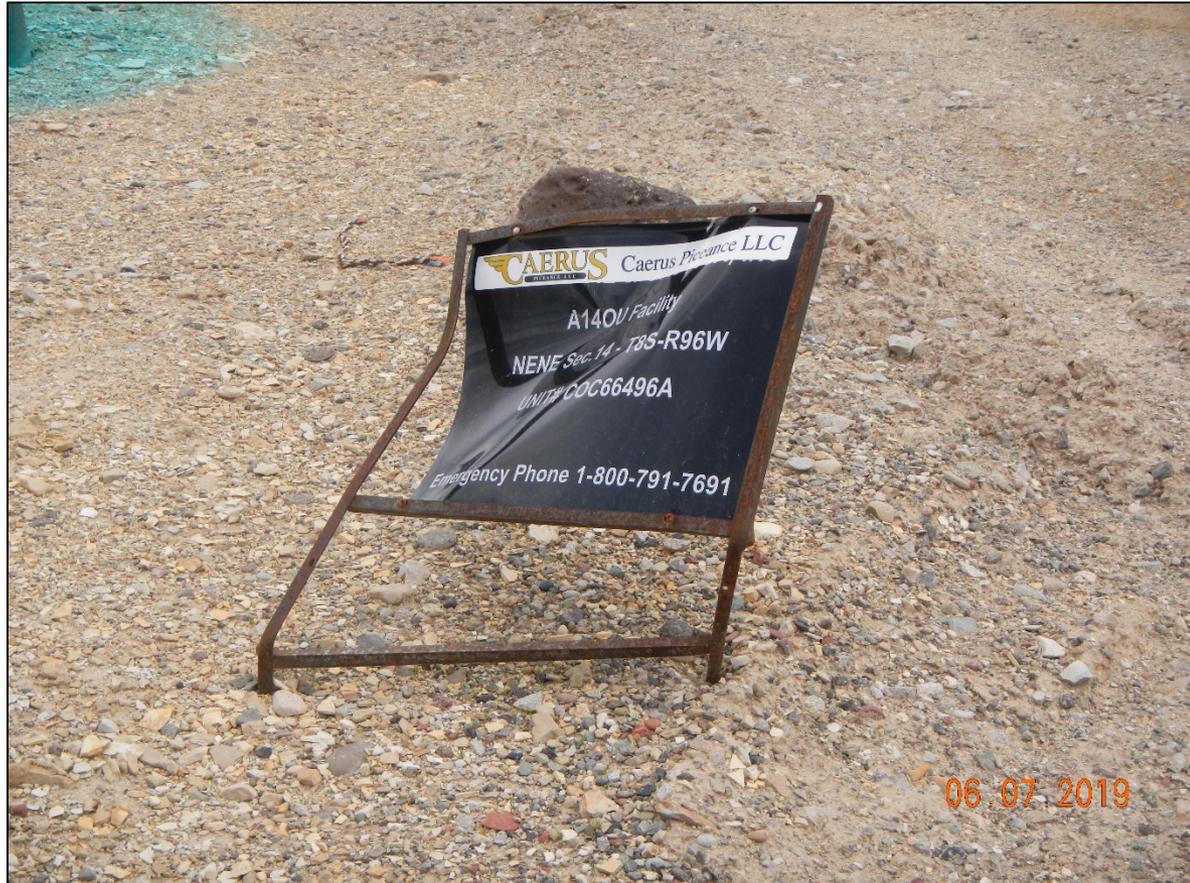
Photo #1 Photo from entrance of location. (Battery sign missing information. Laying over and damaged.)

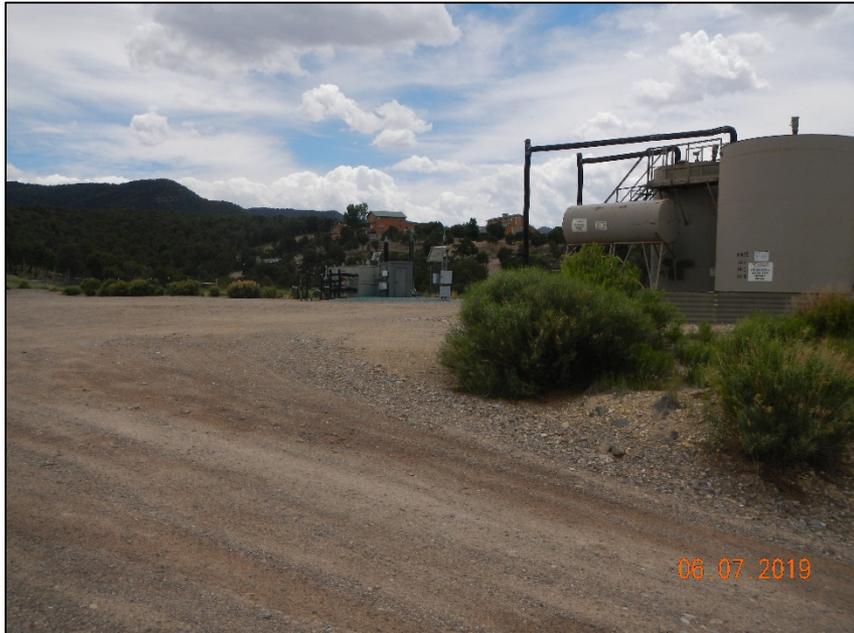
Photo #2 Photo taken from entrance of location.

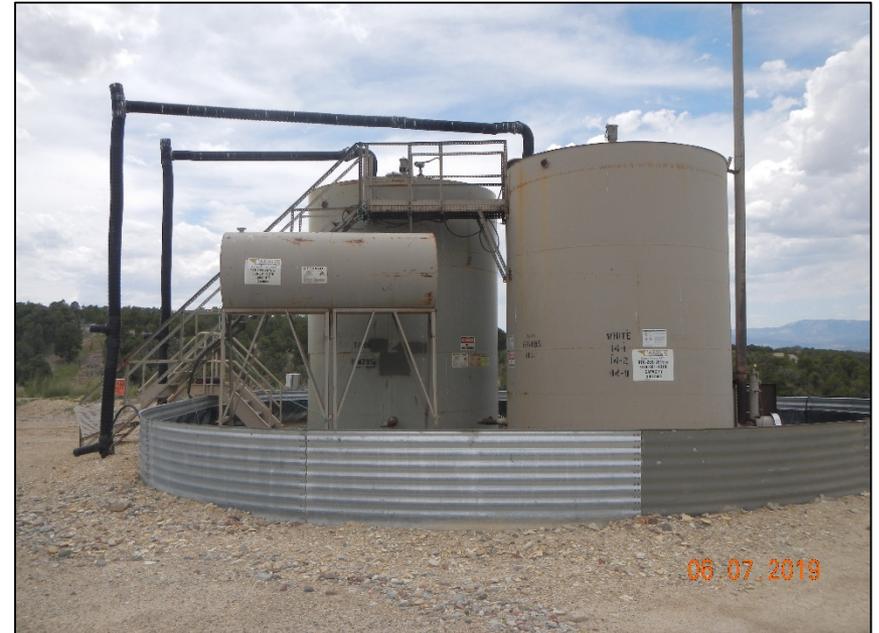
Photo #3 Photo taken of tank battery

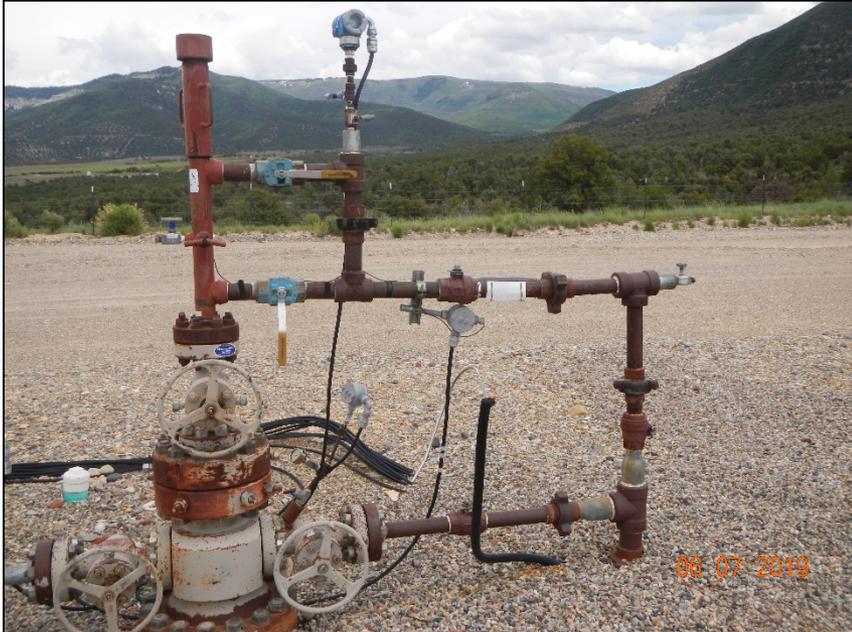
Photo 4 Photo of wellhead with sign

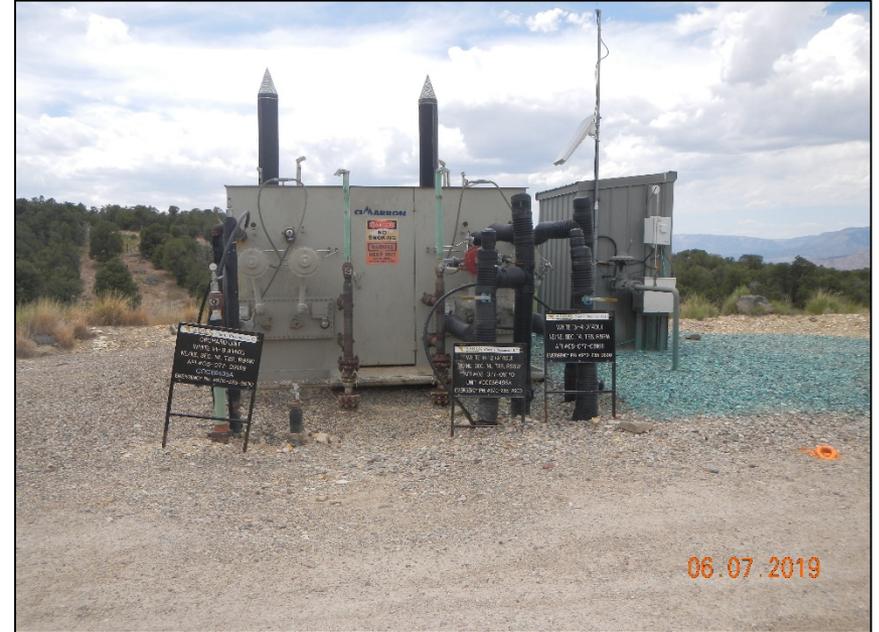
Photo 5, Photo of separators with signs
