Inspection Photos

Loc#334828

Operator: Caerus

Inspection Date: 5/31/2019

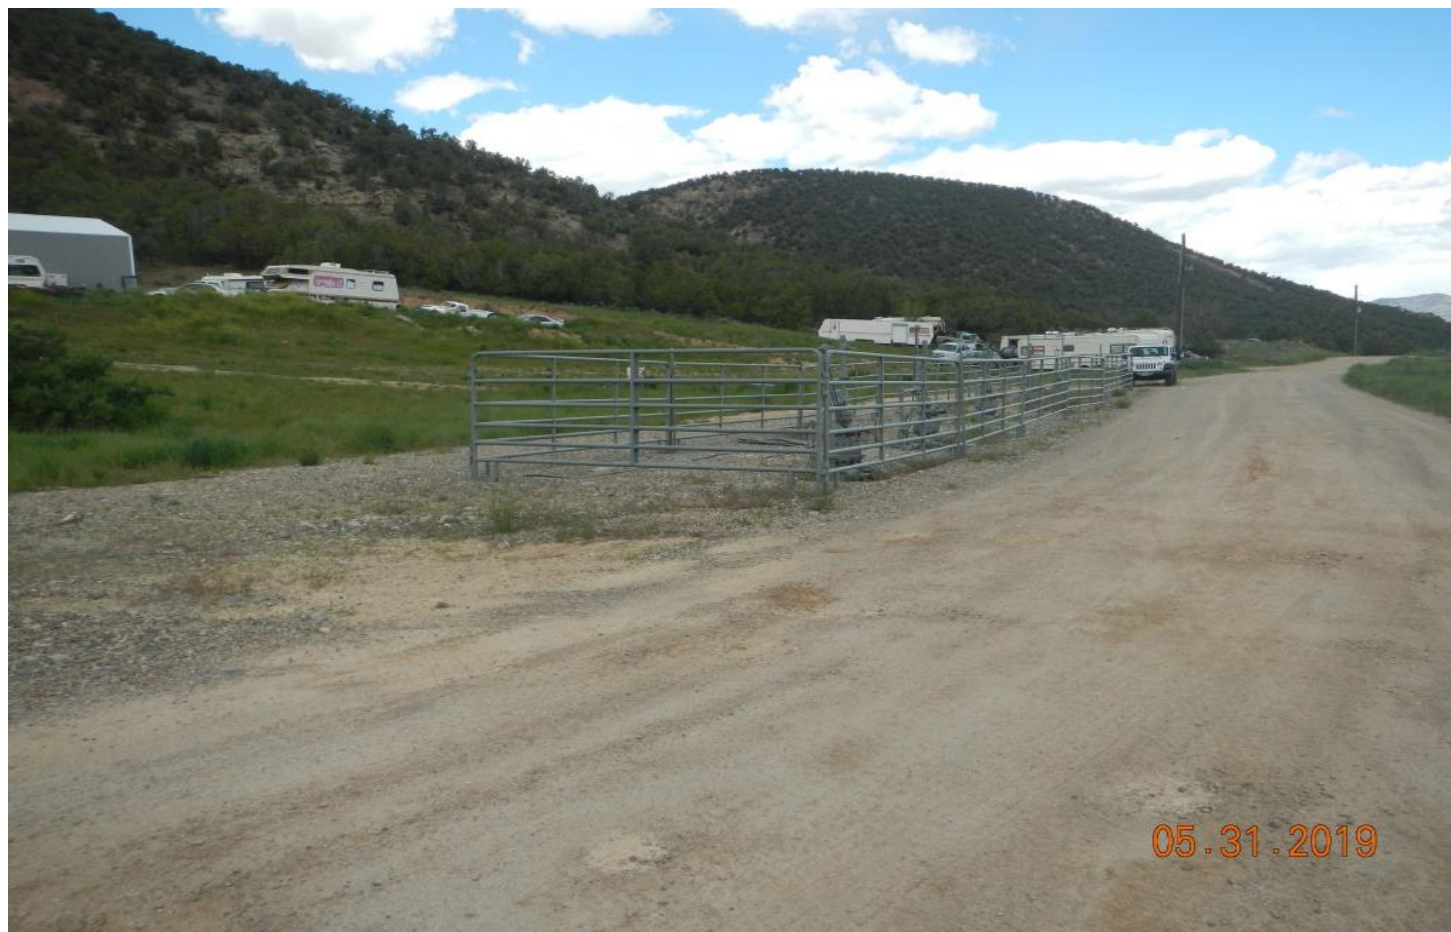
Photo#1:
Overview of Location to North.

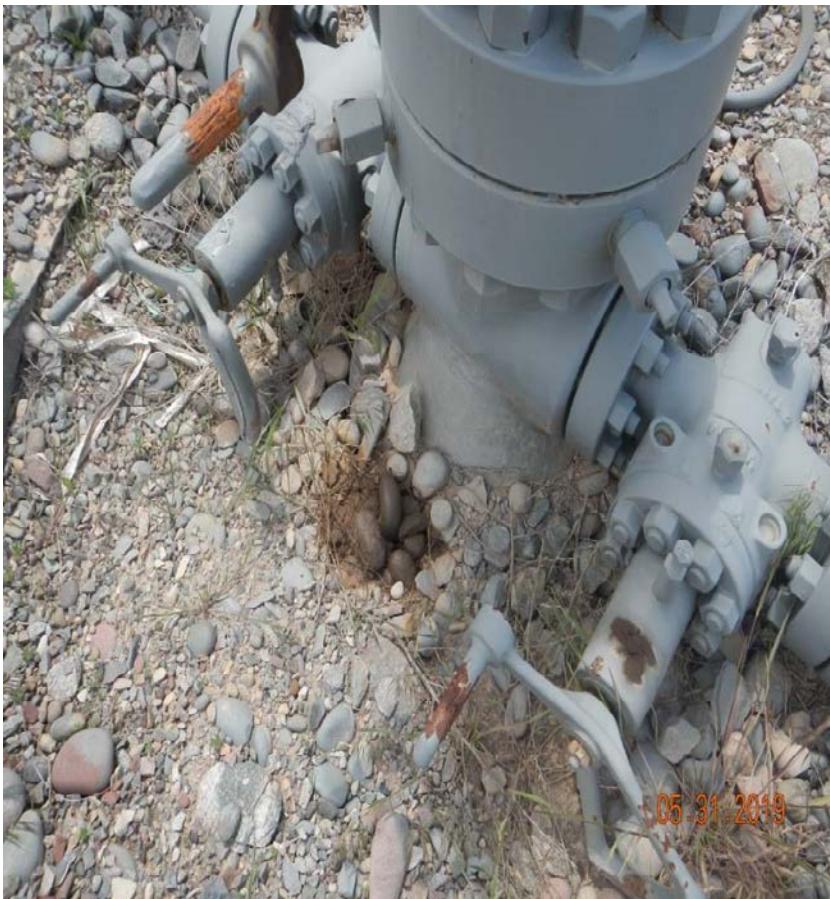
Photo#2:
Staining at Wellhead.

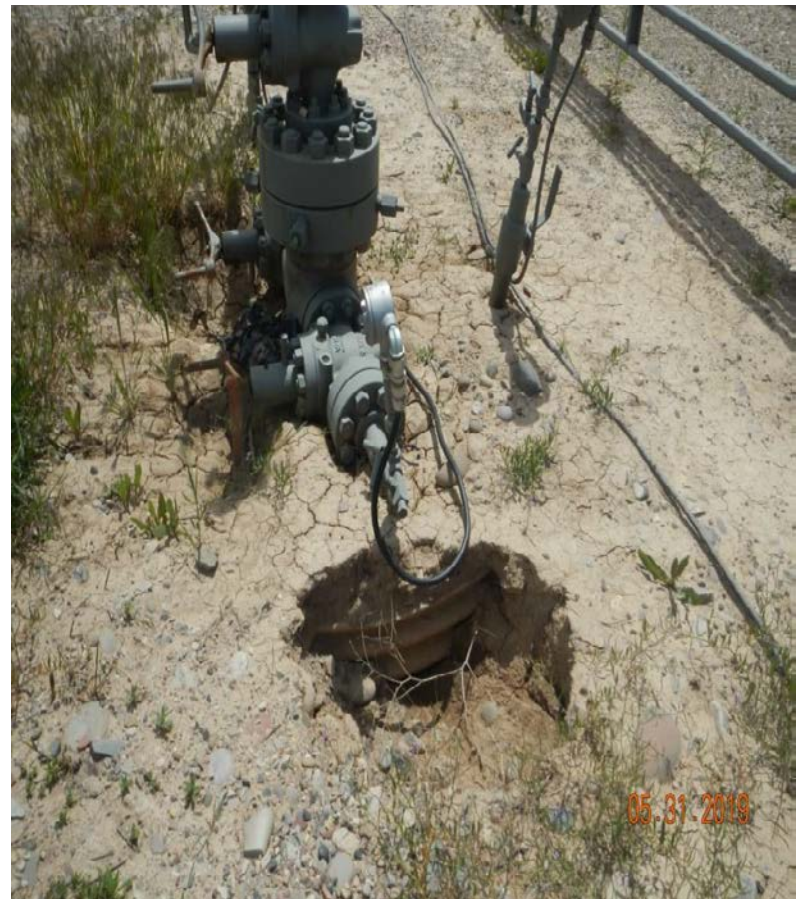
Photo#3:
Subsidence at Wellhead.

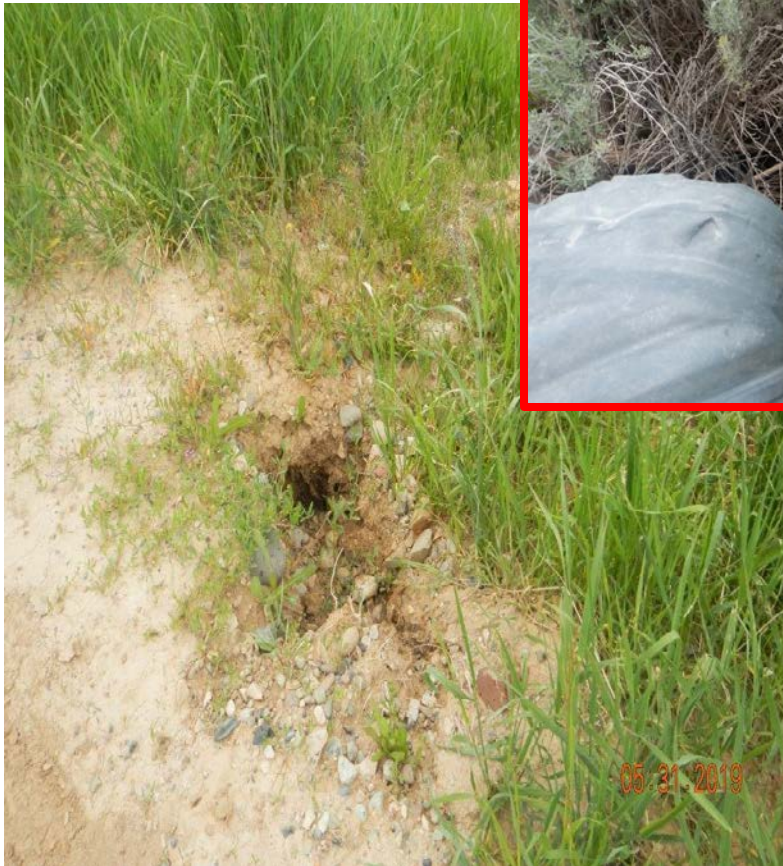
Photo#4:
Subsidence at Culvert area.

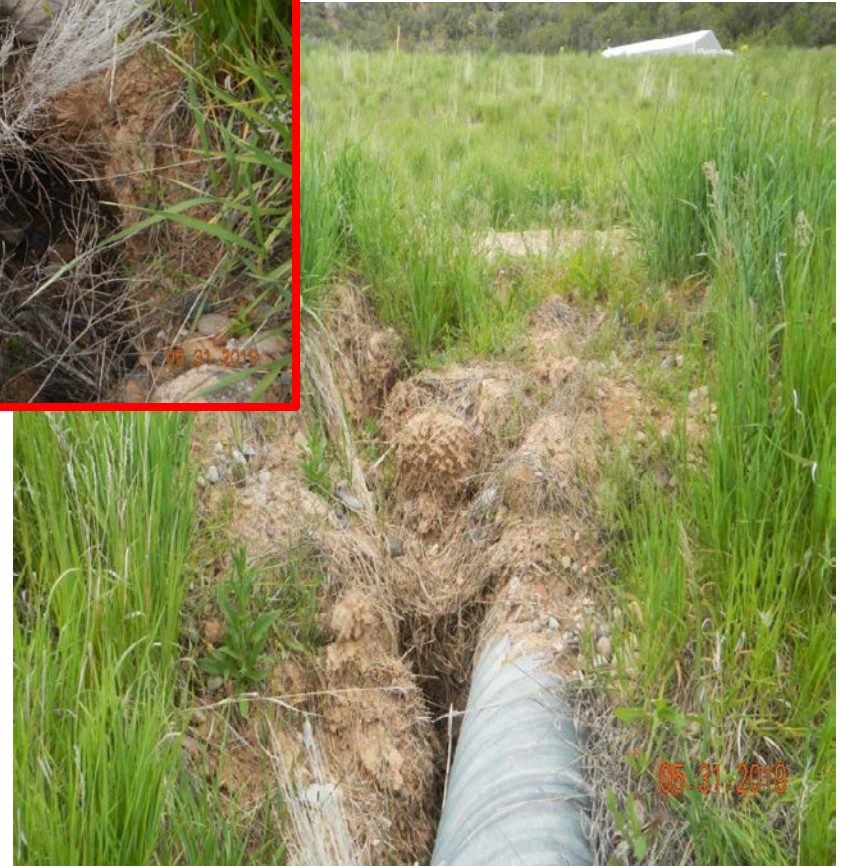
Photo#5:
Subsidence at Culvert area.

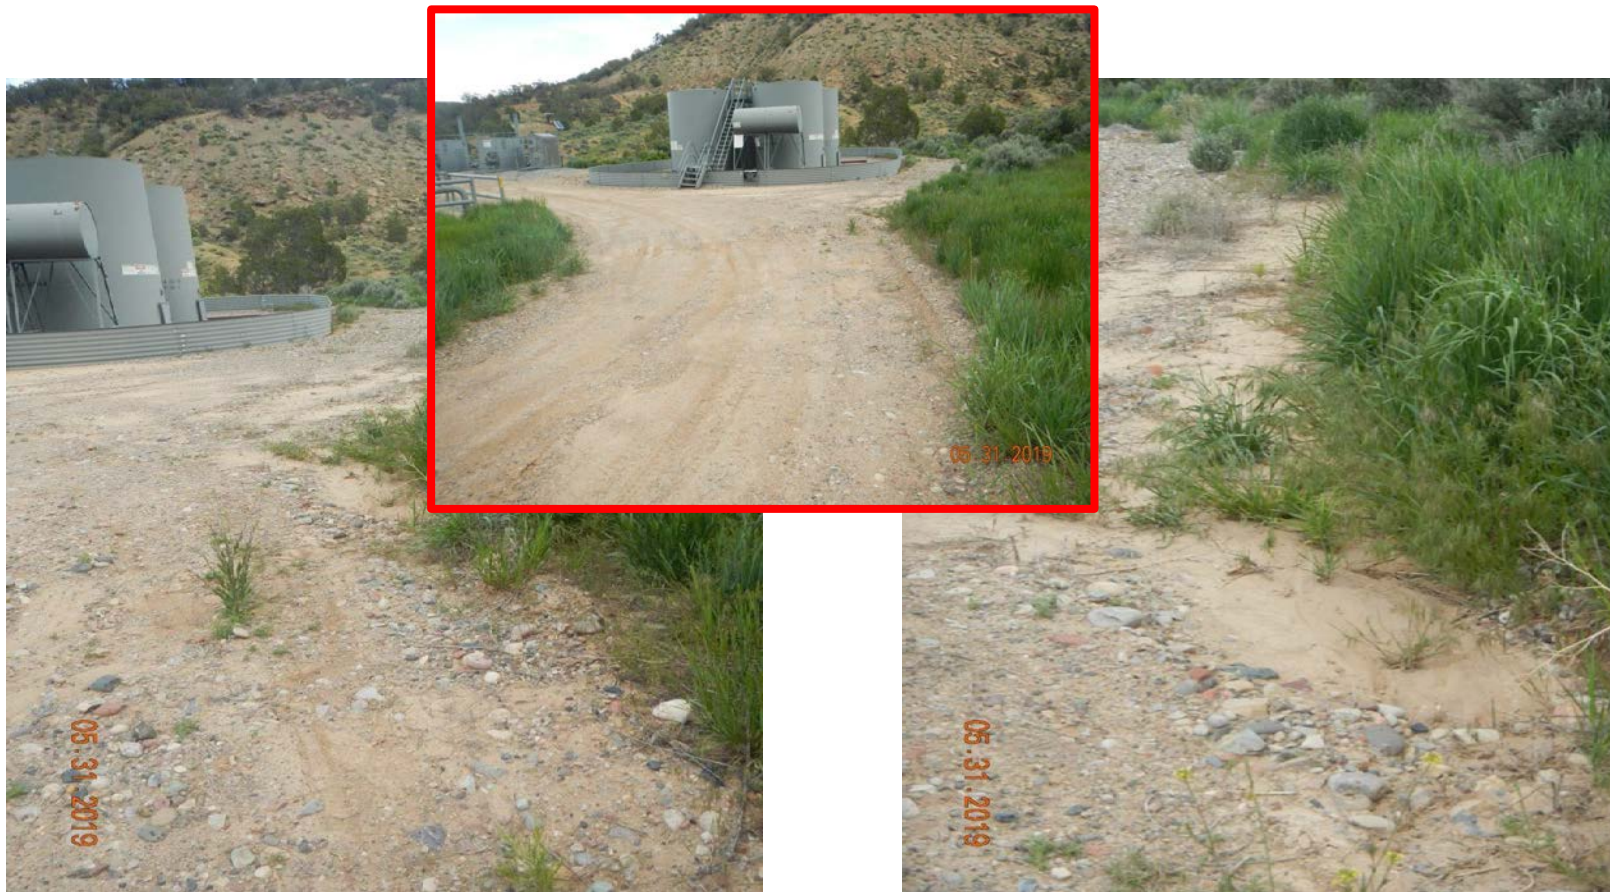
Photo#6:
Sediment migration from access Road.

Photo#7:
Sediment migration from access Road.

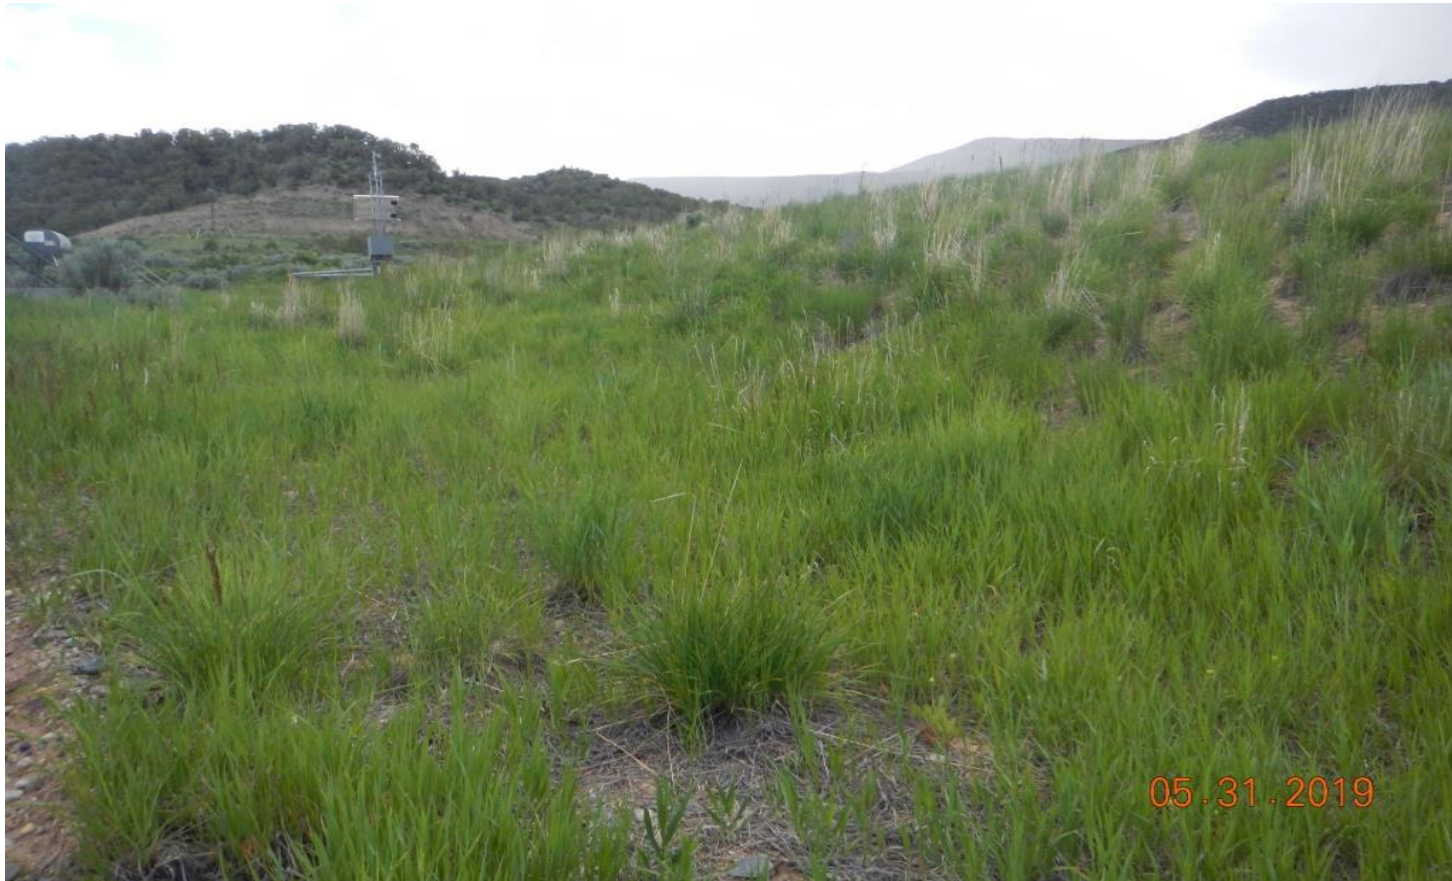
Photo#8:
Vegetation is well established.
