Inspection Photos

API: 05-055-06012

Operator: OXY USA INC

Inspection Date: 6/11/2019

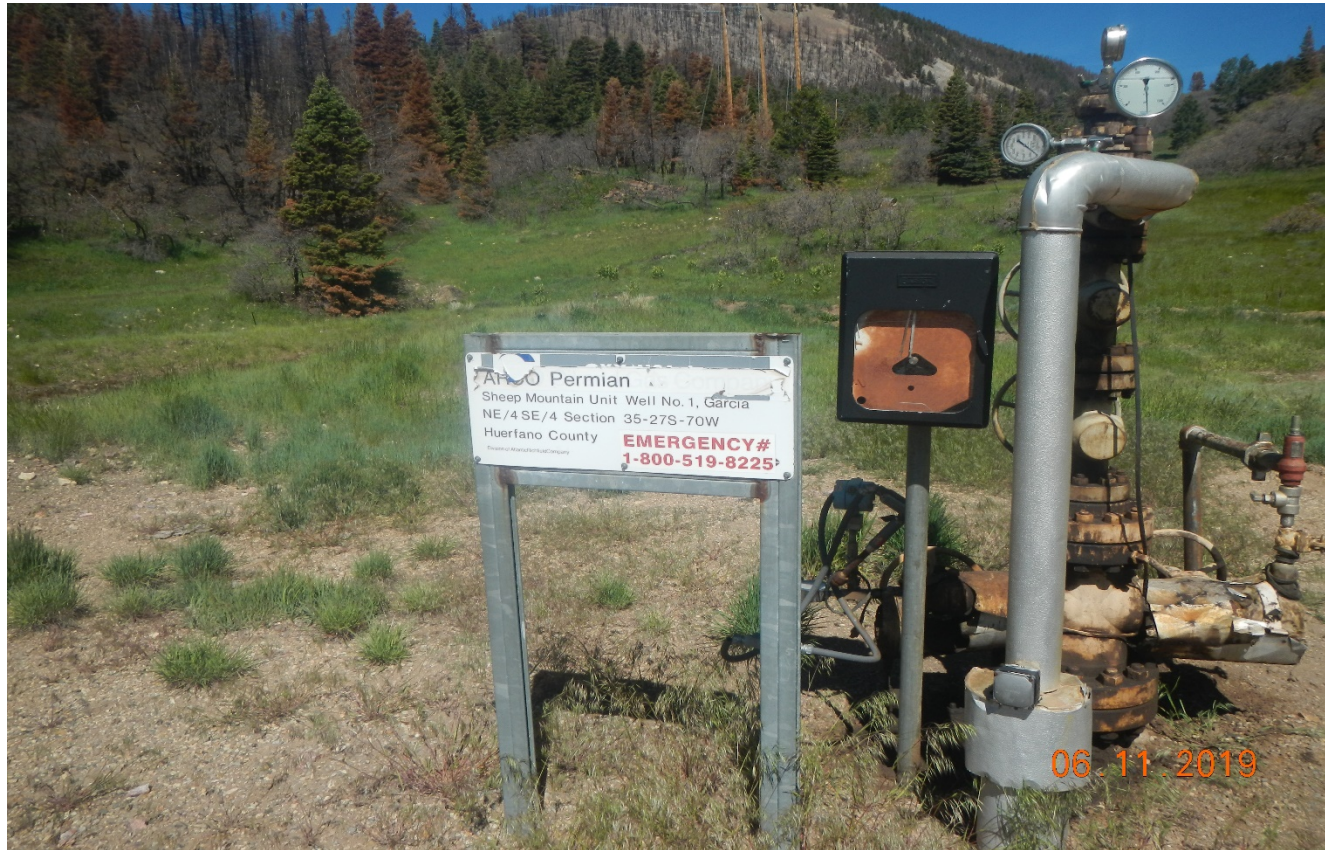
Photo 1. The operator name on well sign is not legible.

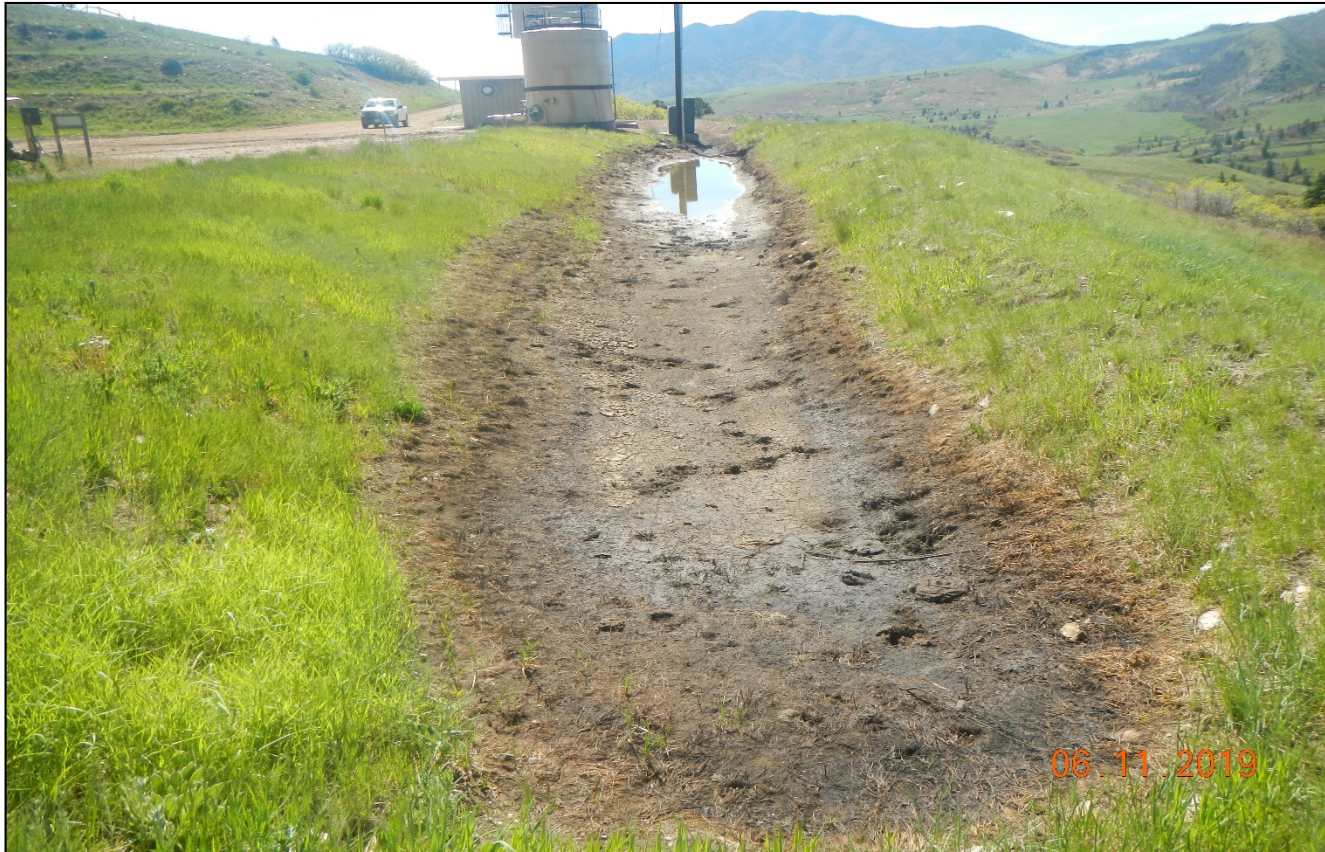
Photo 2. Facing east toward the pit at the location. There is staining that remains which was observed in the previous inspection and has not been cleaned up.

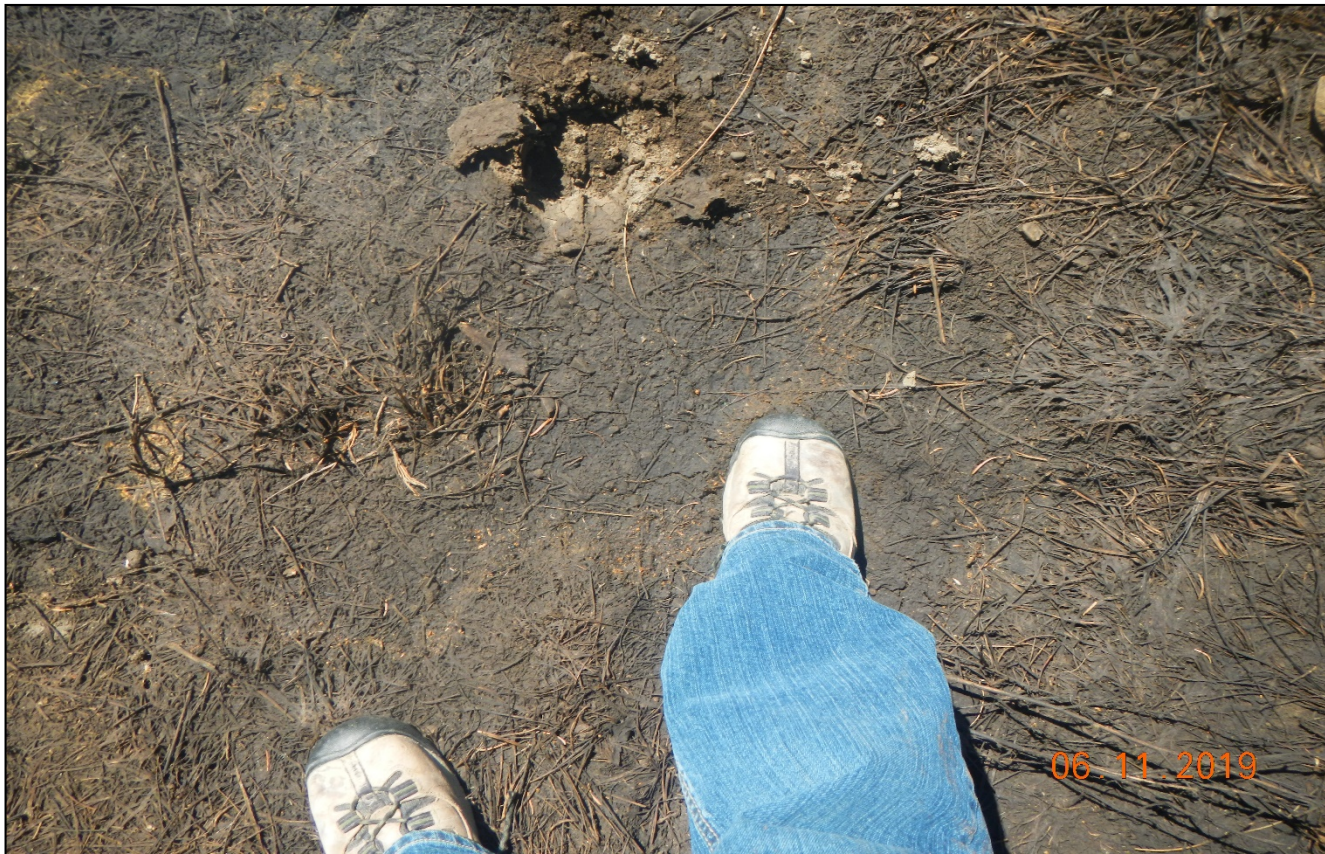
Photo 3. View of stained soil with strong hydrocarbon odor.

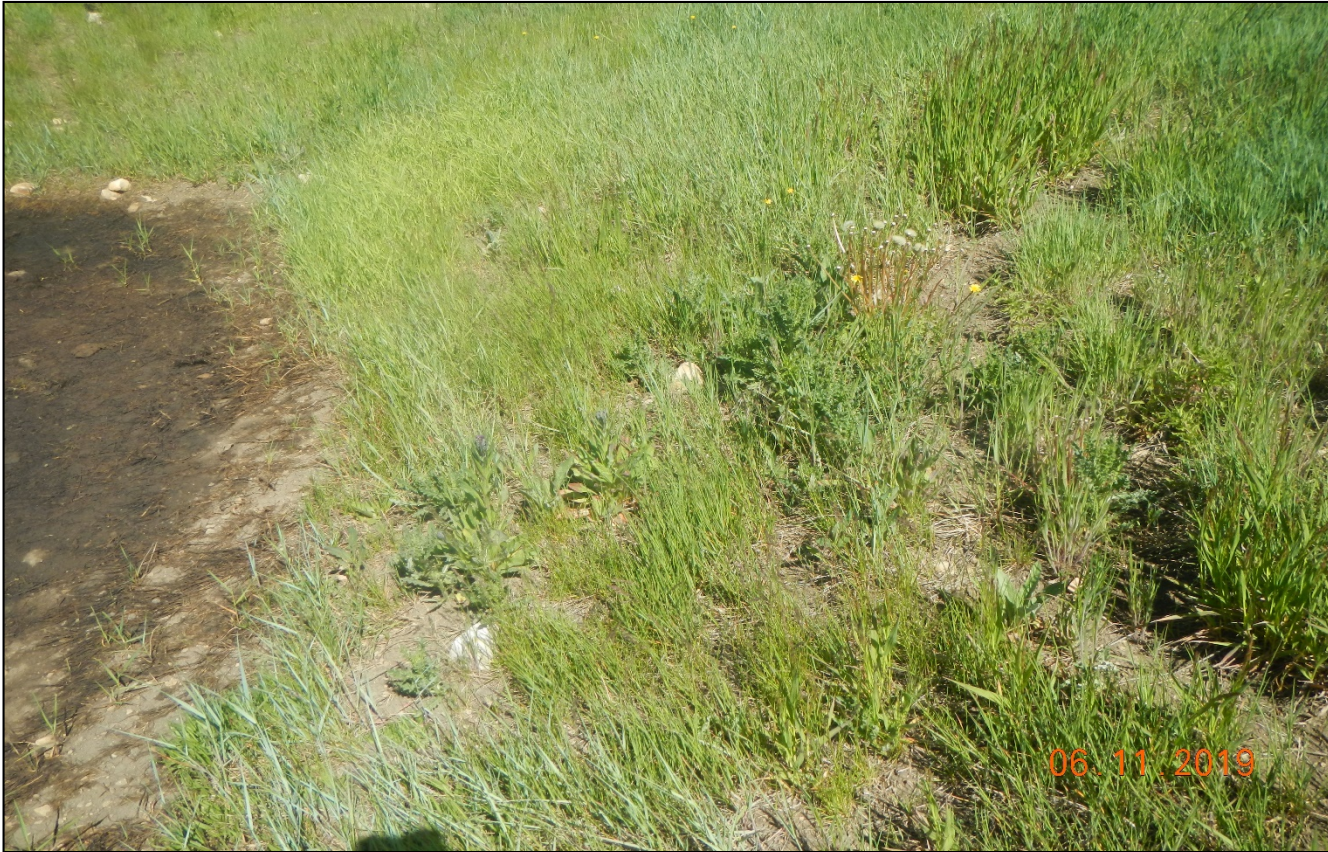
Photo 4. There are List B noxious weeds along the western side of the pit. Canada thistle and Houndstongue.

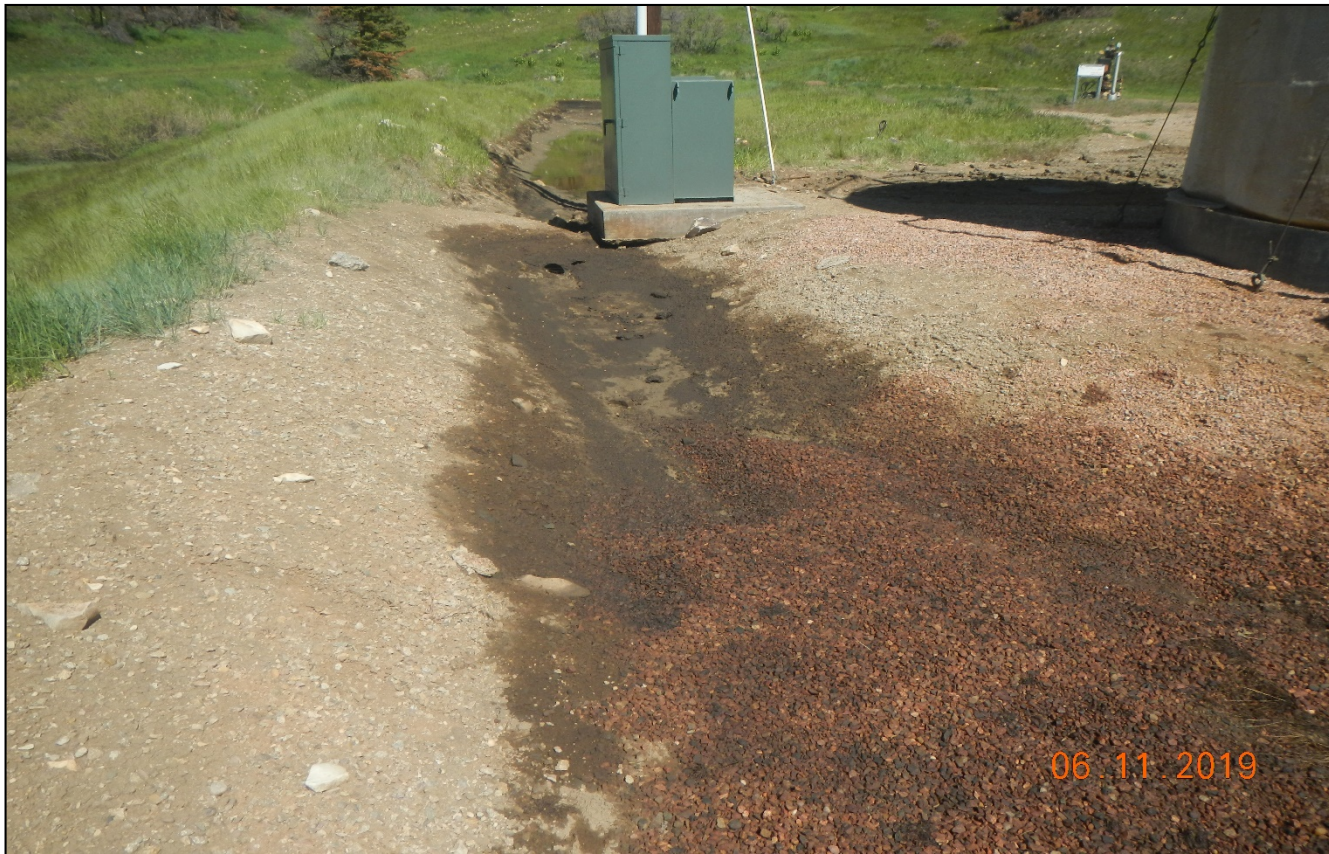
Photo 5. View of stained soils at the back side of the tanks.

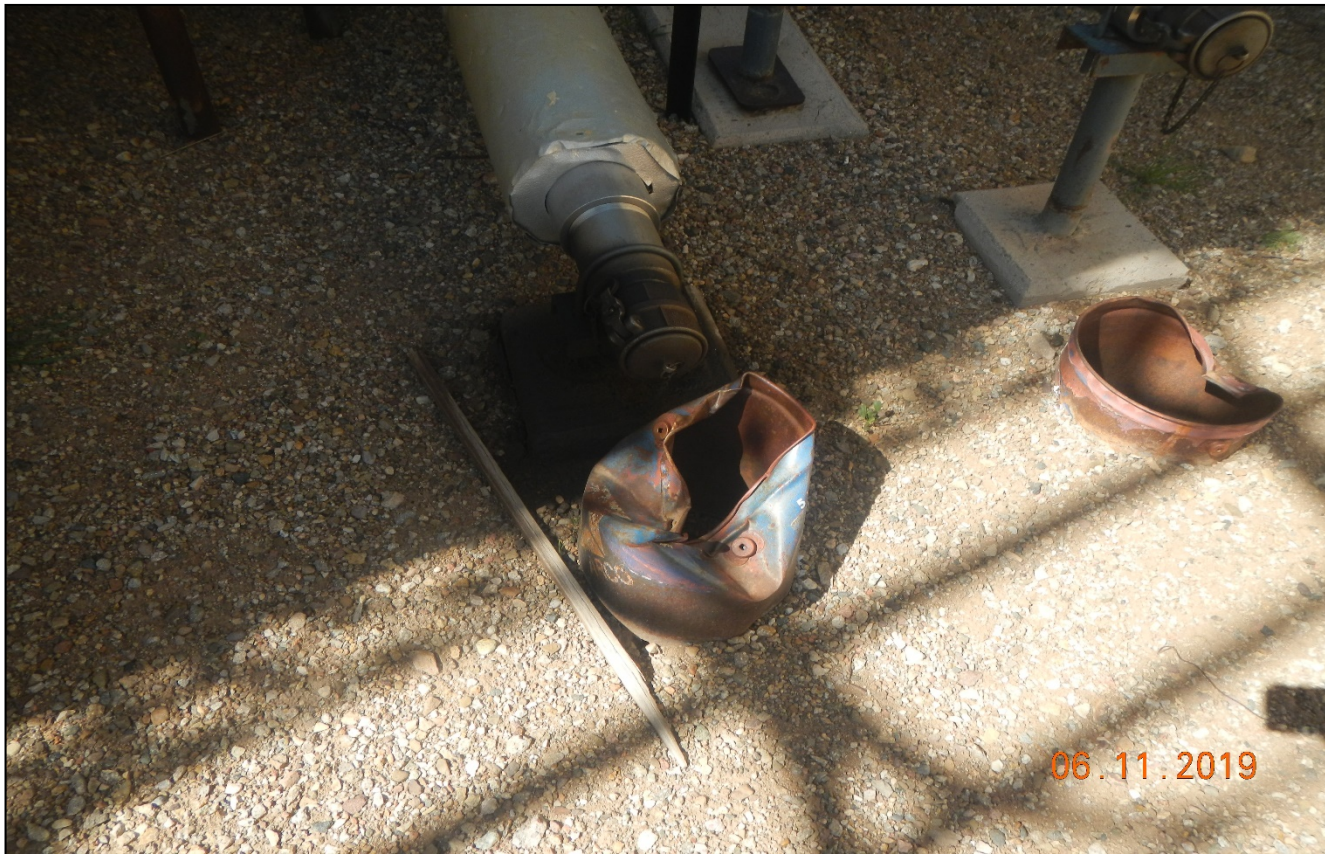
Photo 6. There is a bent bucket for secondary containment at the discharge point of the tank.
