# Inspection Photos

API: 05-055-06017

Operator: OXY USA INC

Inspection Date: 6/11/2019

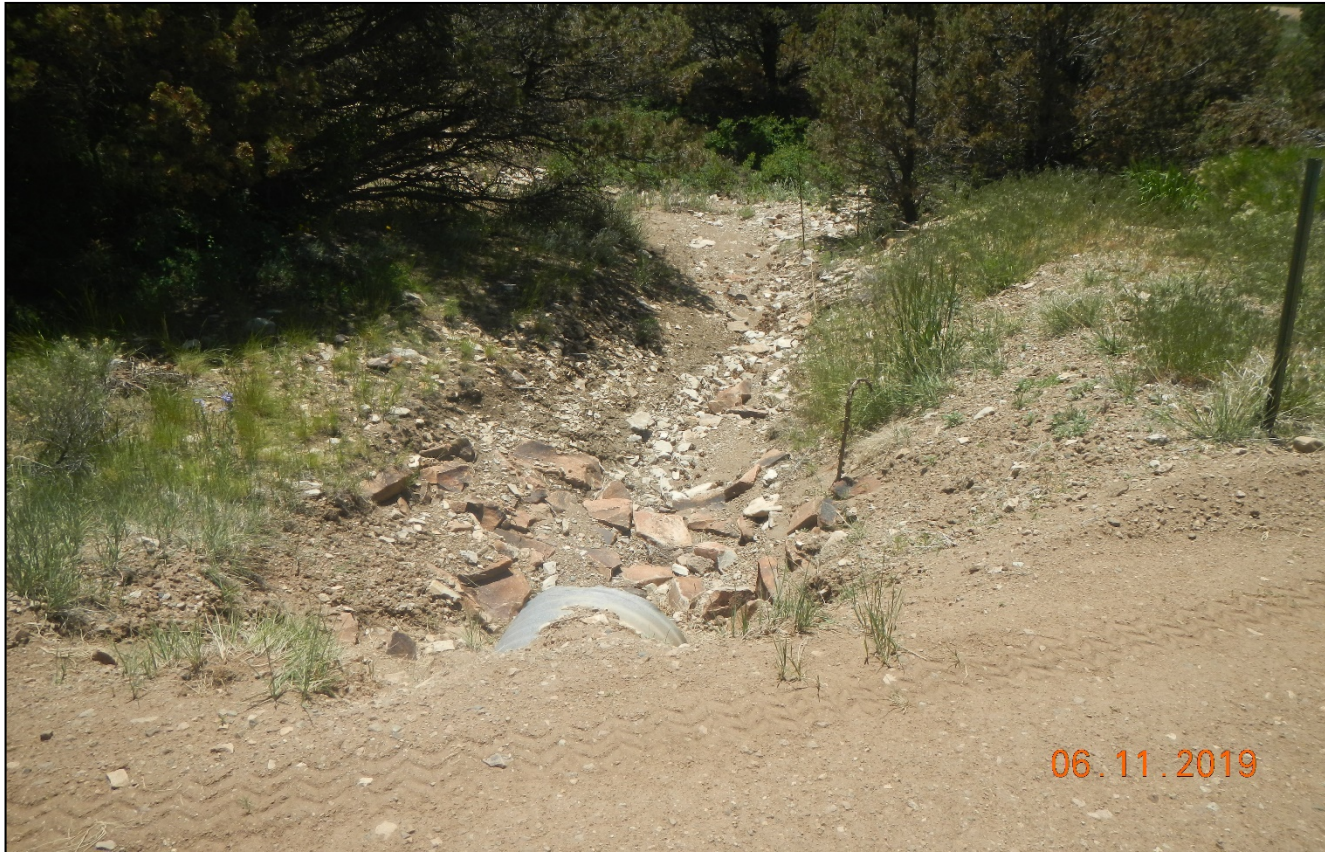
**Photo 1.** There is erosion occurring at the culvert with no outlet protection.  
Lat/Long:37.69957,-105.22668

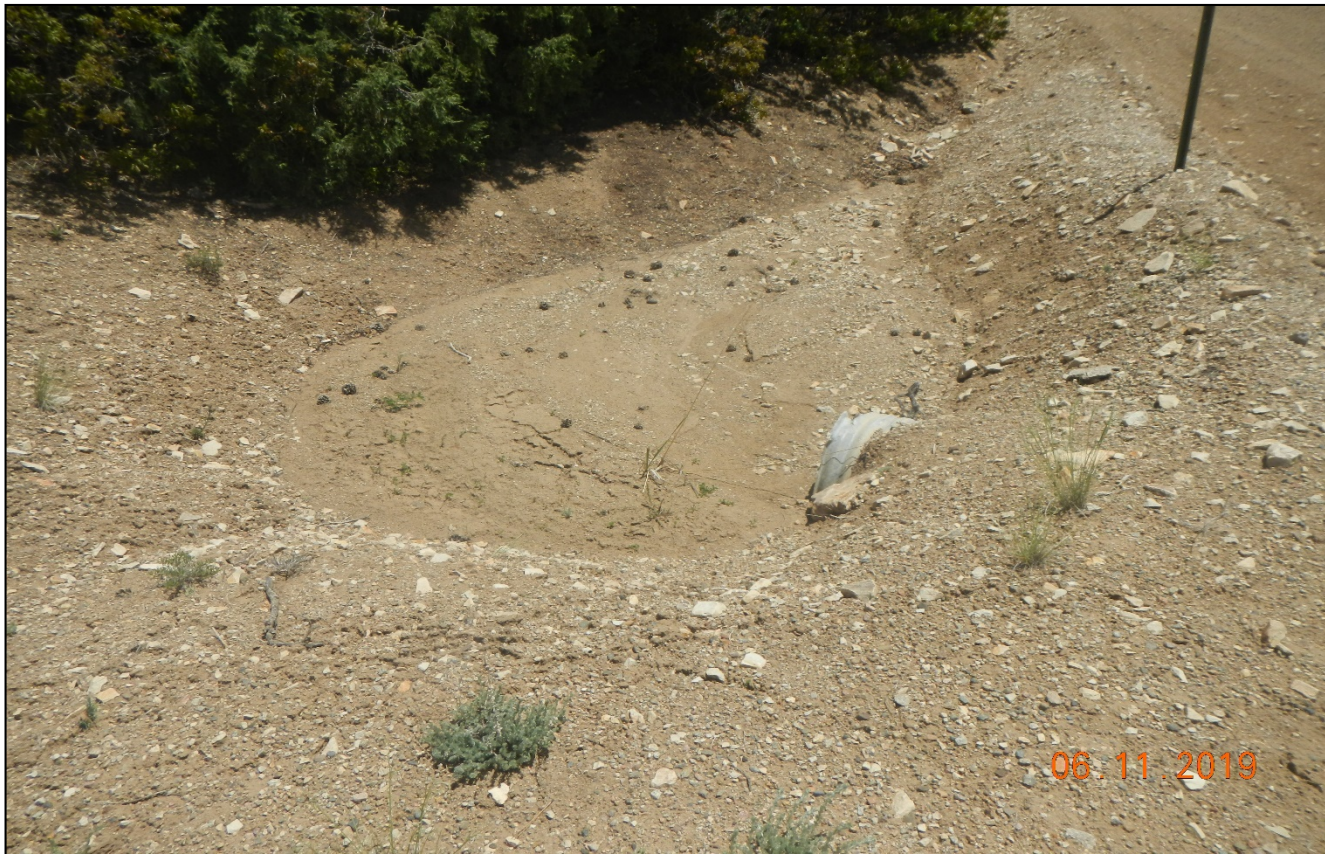
Lat/Long:37.69845,-105.22215

**Photo 2.** There is sediment accumulating at the culvert inlet.

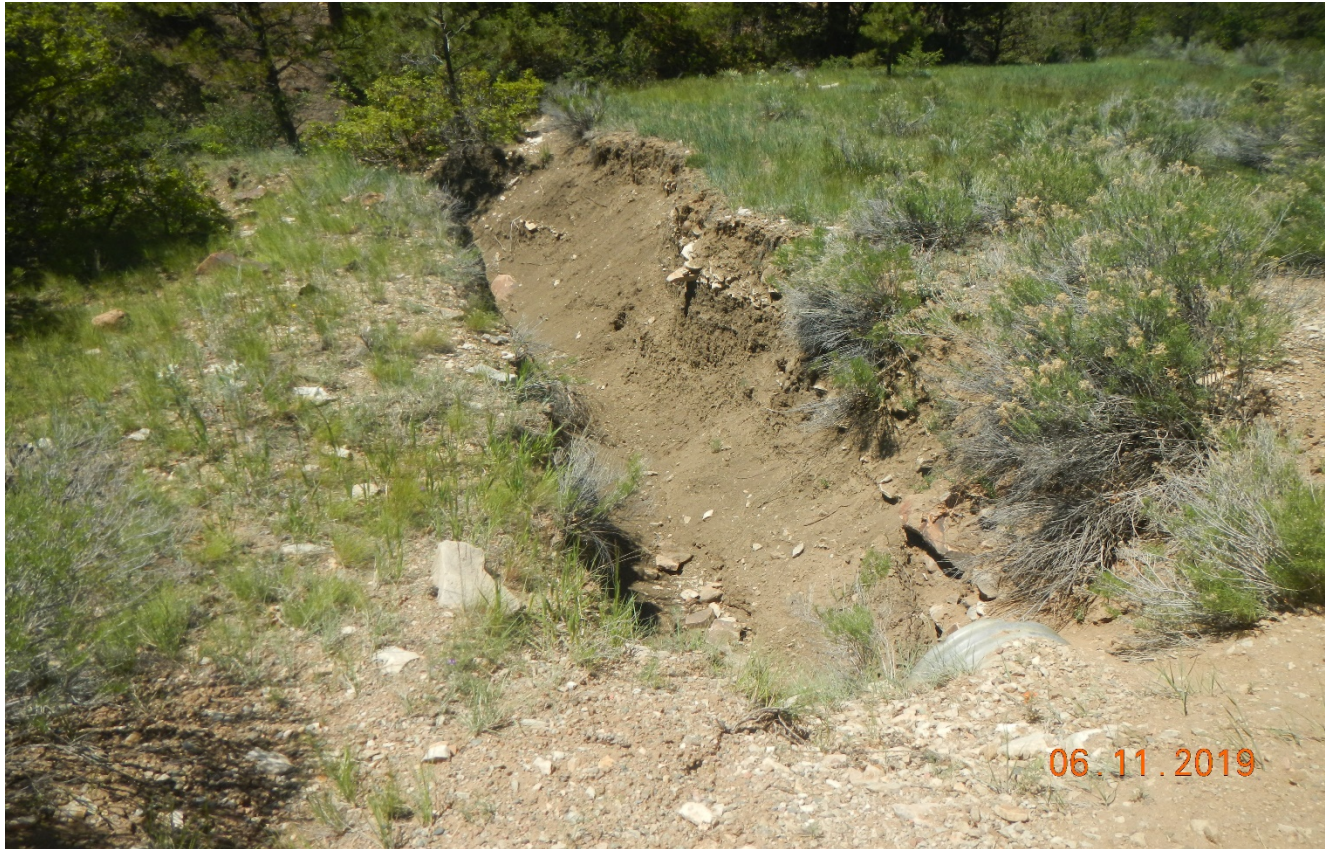
**Photo 3.** There is severe erosion (6ft. Deep) occurring at the culvert with no outlet protection. Lat/Long:37.69829,-105.21889

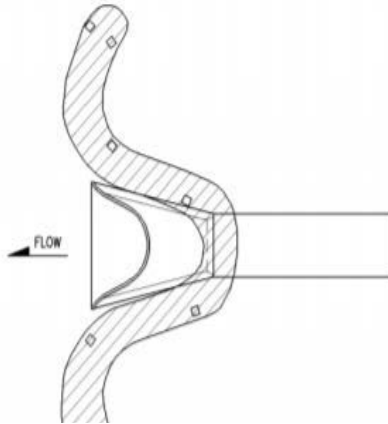
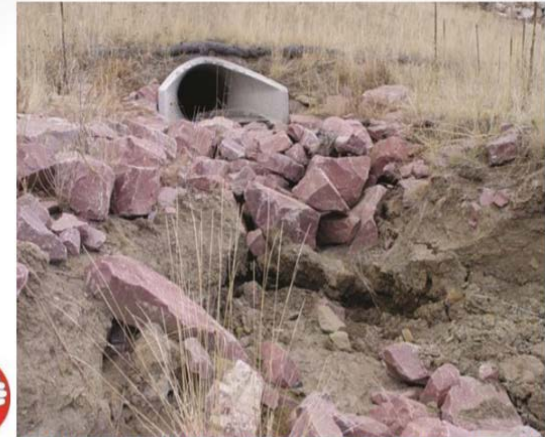
*Poor installation of outlet protection. Geotextile was not placed under the riprap and not enough rock was used. As a result, stormwater is undercutting the existing rock.*

**Photo 4.** These diagrams from CDOT manual describe the requirement for outlet protection.

Outlet protection prevents scour and erosion at the outlet of a channel or conduit by reducing the speed of stormwater. Outlet protection is comprised of geotextile fabric and riprap placed at the outlet.

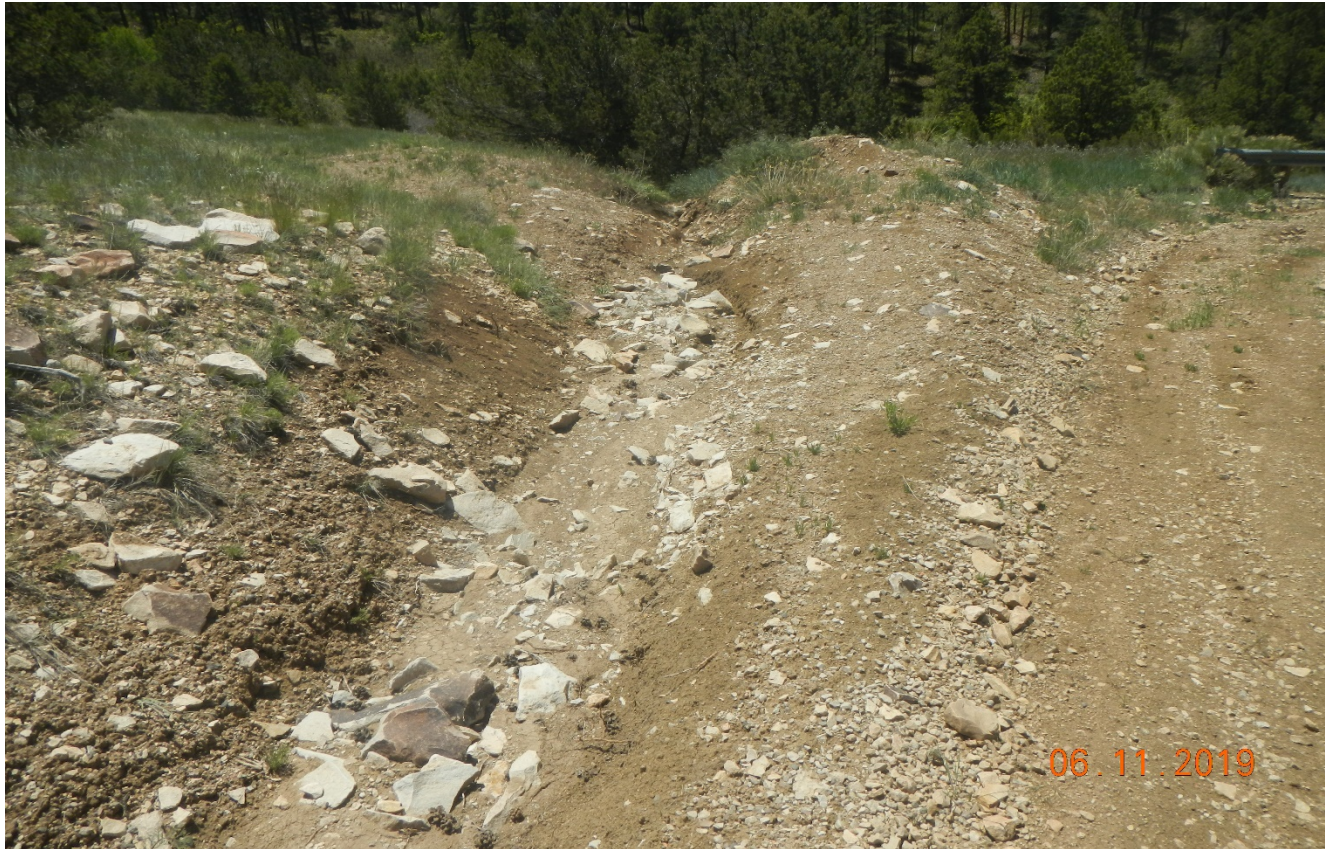
**Photo 5.** There is no erosion control BMPs at the diversion along the main road.  
Lat/Long:37.69860,-105.21673

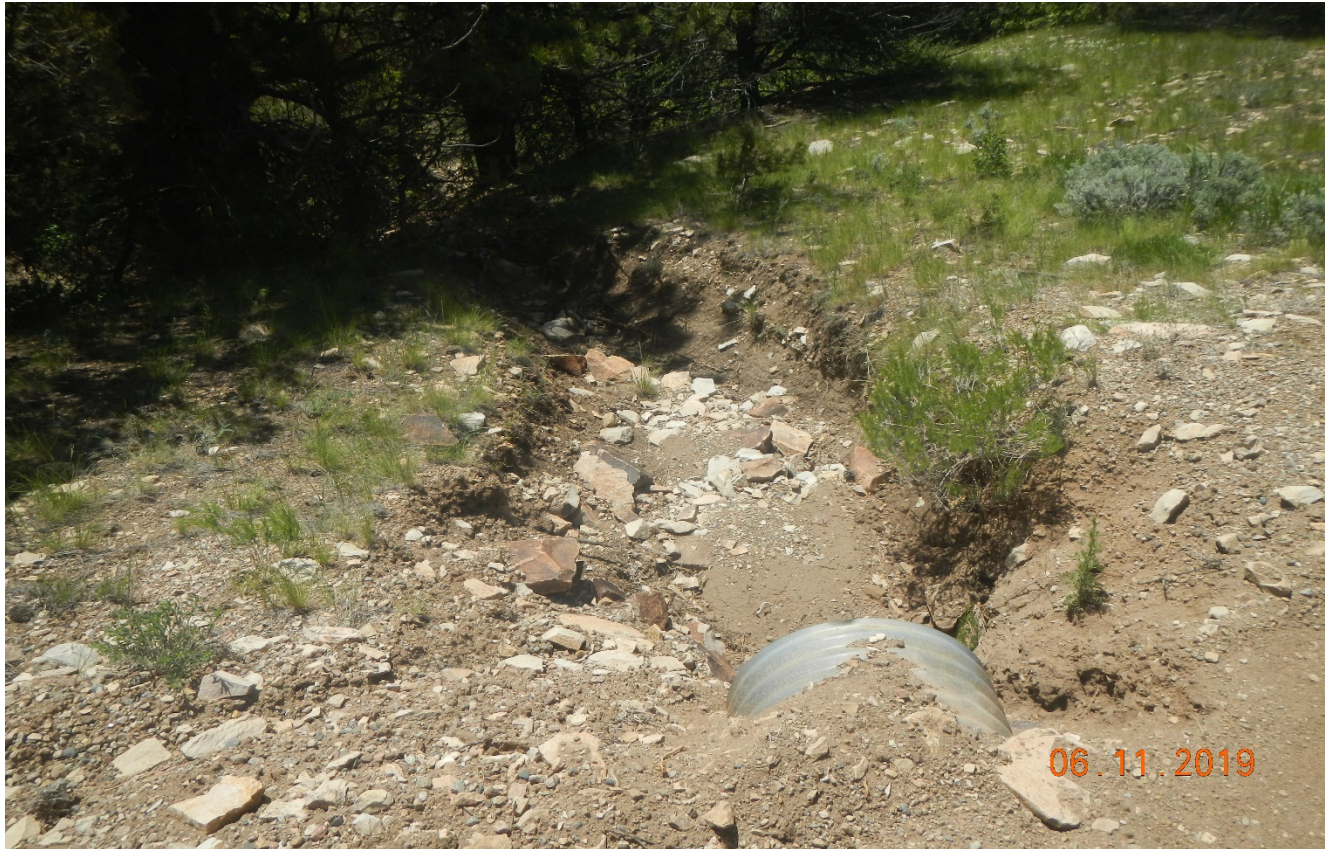
**Photo 6.** There is erosion occurring at the culvert with no outlet protection.  
Lat/Long:37.70004,-105.21143

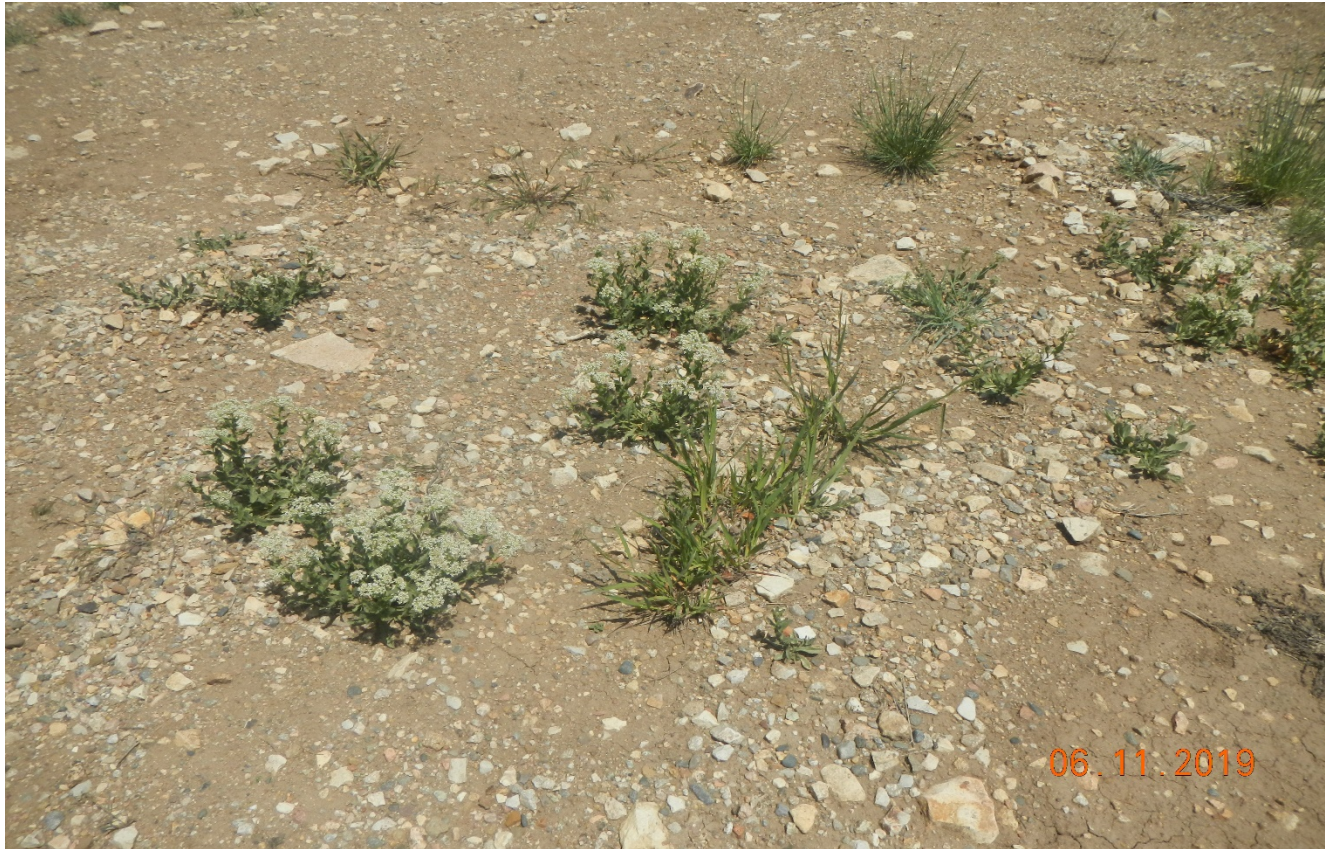
**Photo 7.** There is a patch of noxious weeds (Hoary crest) at the beginning of the access road. Lat/Long:37.69951,-105.20471

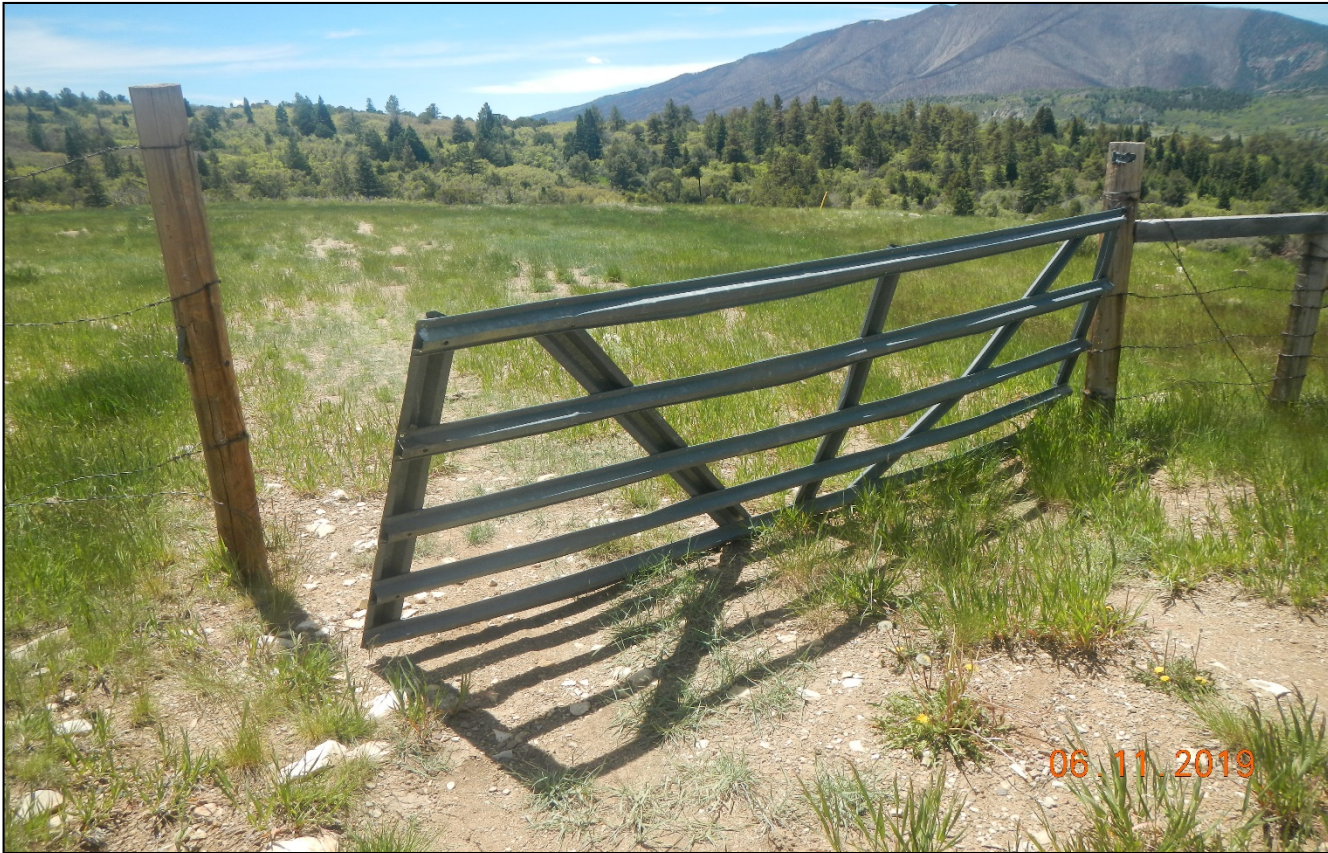
**Photo 8.** The gate at the location is off the hinges.

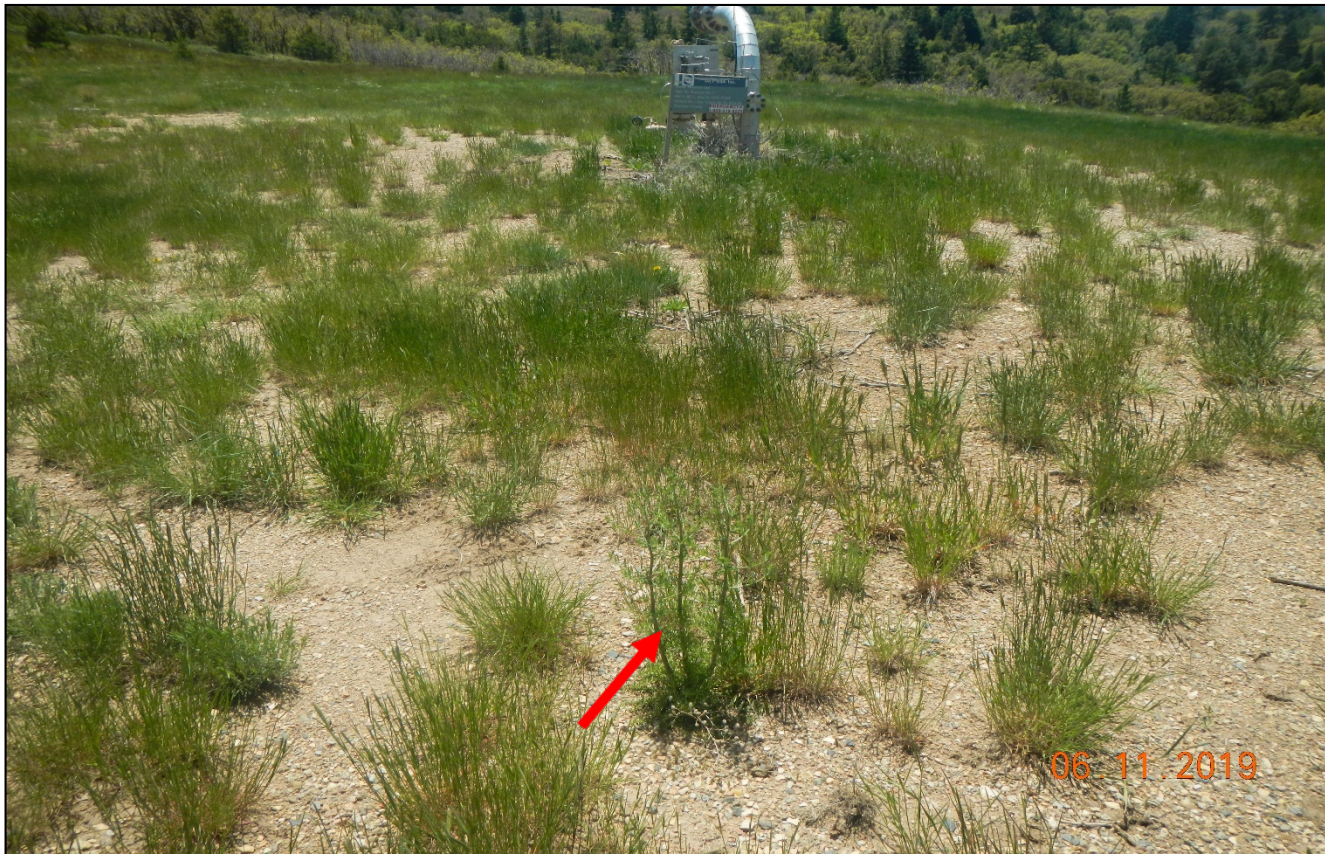
**Photo 9.** Facing south toward the location. There are numerous noxious weeds (Diffuse knapweed) in this area.
