**Inspection Photos**  
**Location Name:** DRYER-67N60W /14NWNW  
**Location #:** 306577

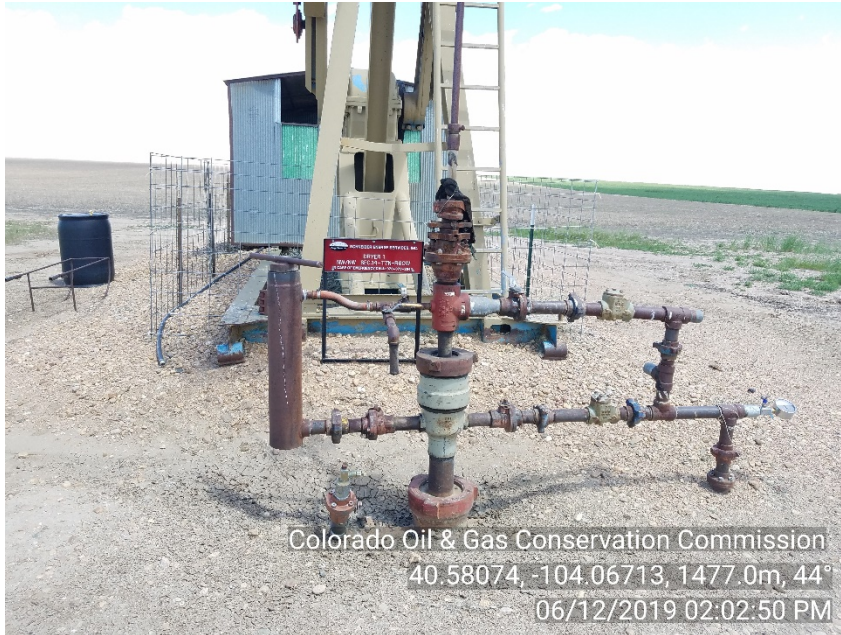
**Photo #1**  
**Dryer #1 (05-123-24938) Wellsite**  
**Shut-In | SI**

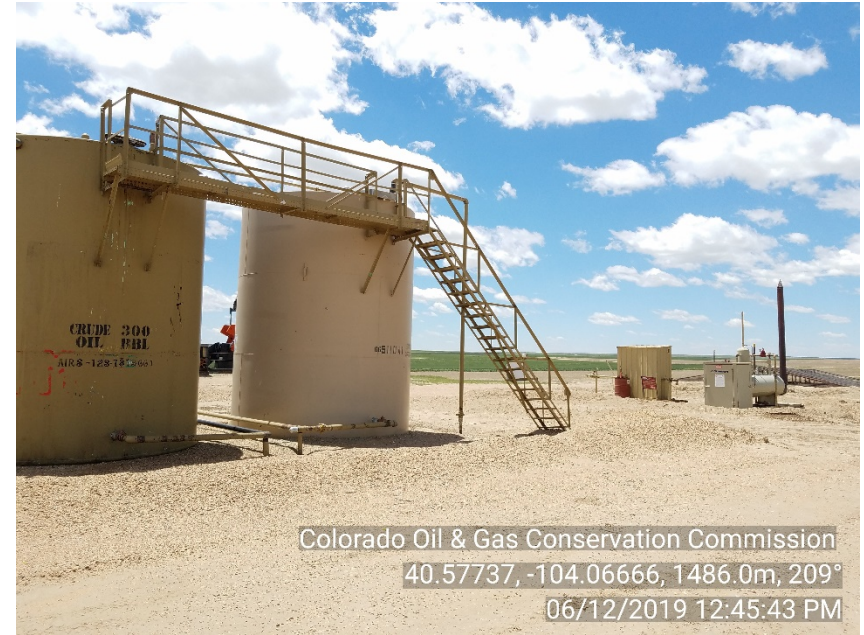
**Photo #2**  
**April 12-14, Dryer #1 Battery**  
**Shut-down**

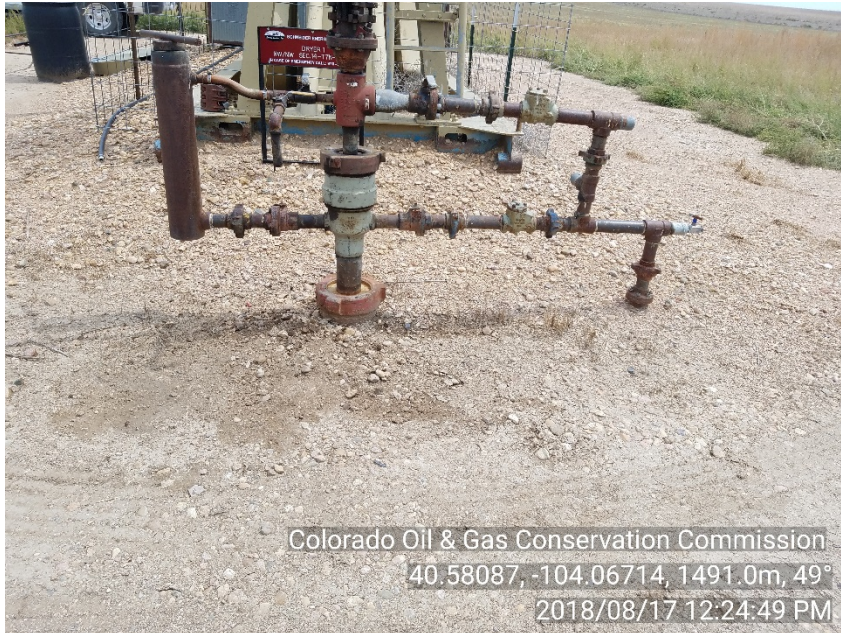
**Photo #3**  
**Dryer #1 Wellsite**

*Bradenhead does NOT appear plumbed to surface  
from prior insp.*

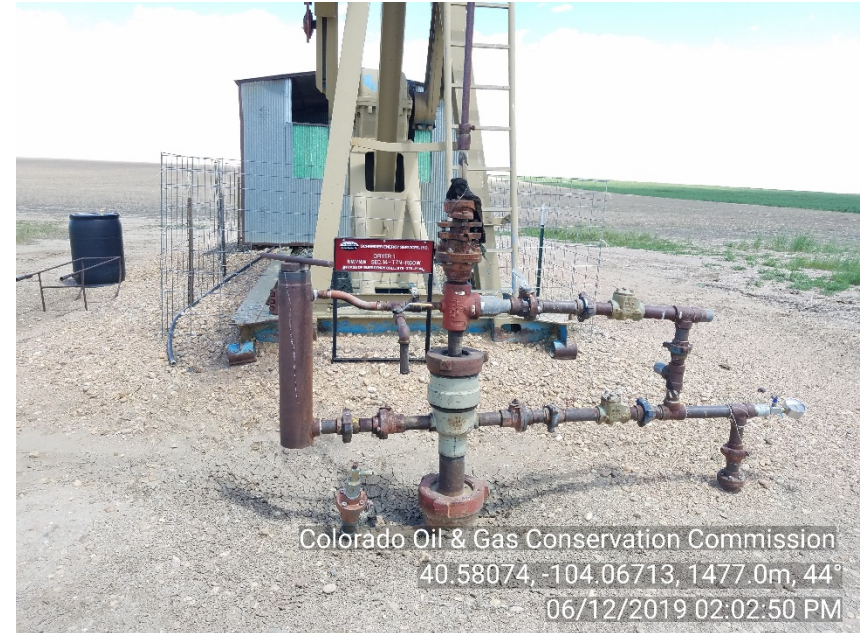
**Photo #4**  
**Dryer #1 Wellsite**

*Bradenhead NOW appears plumbed to surface*

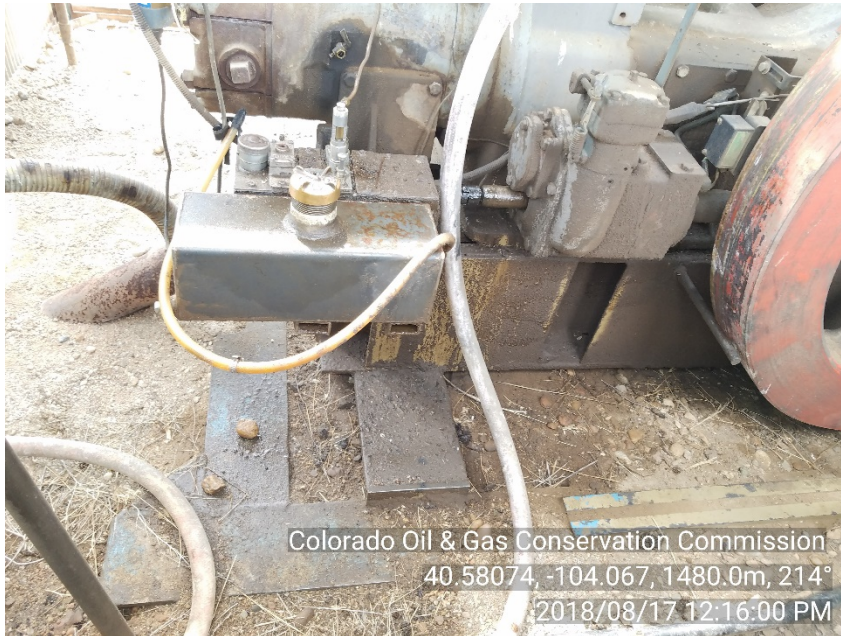
**Photo #5**  
**Dryer #1** Engine house  
*Stained soil near engine base  
from prior insp.*

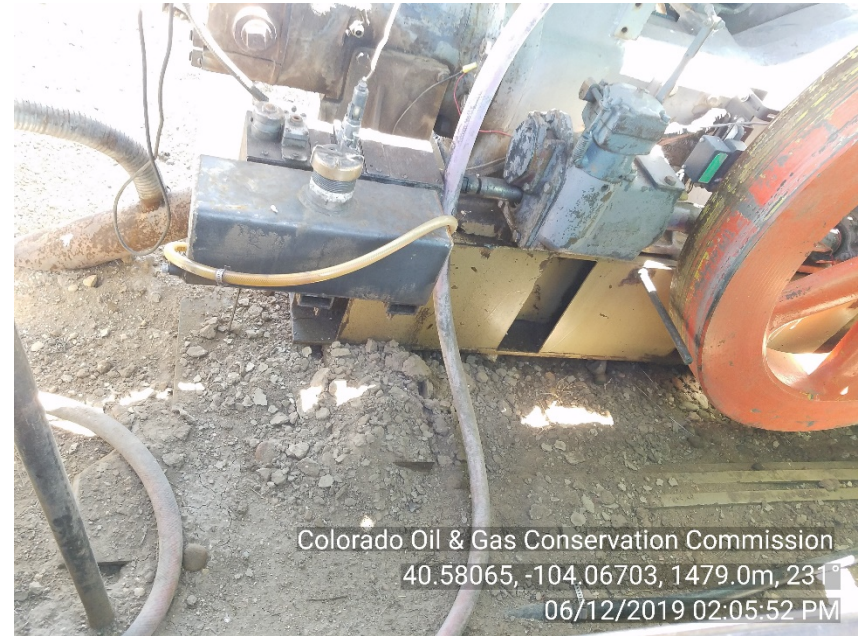
**Photo #6**  
**Dryer #1** Engine house  
*Stained soil near engine base – Appears mitigated*

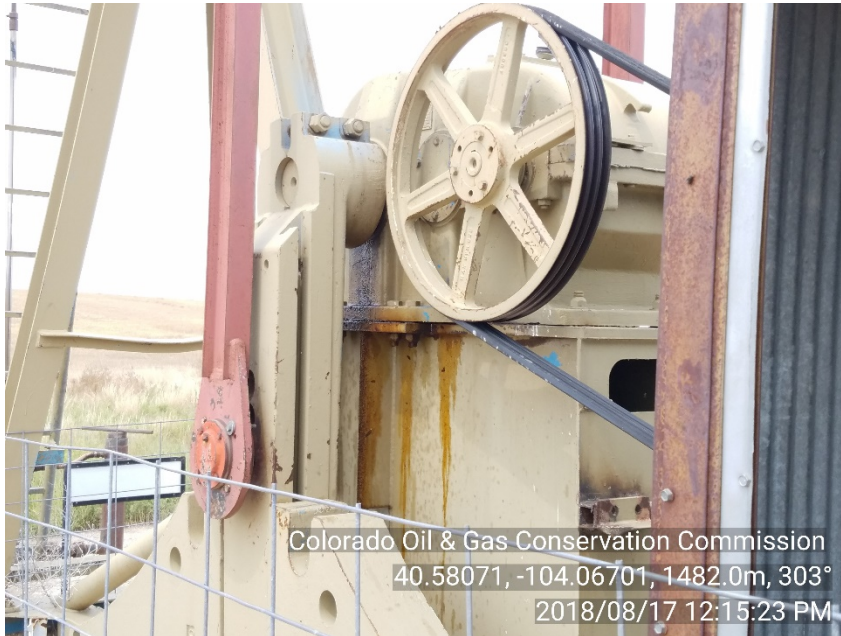
**Photo #7**  
**Dryer #1 Pumpjack**  
*Gearbox stain & apparent seepage  
from prior insp.*

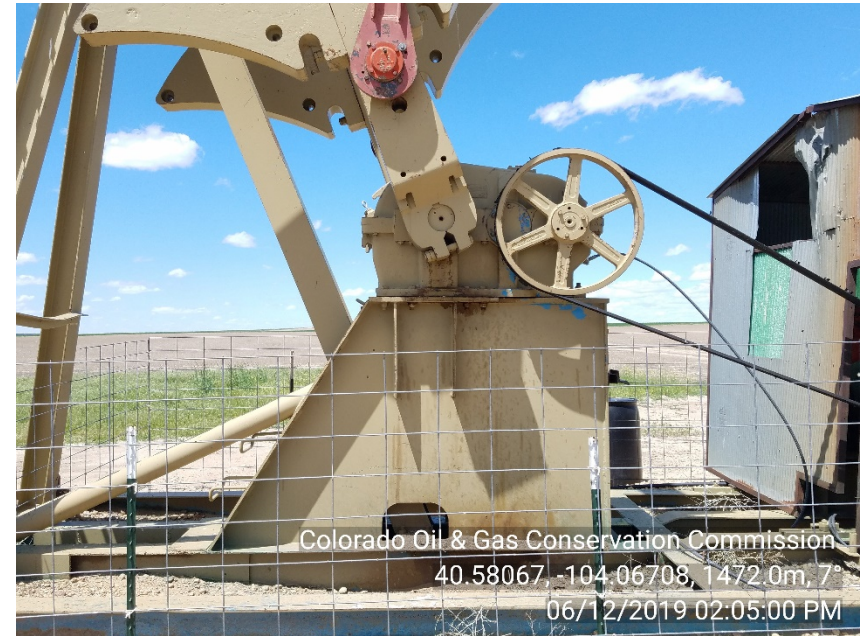
**Photo #8**  
**Dryer #1 Pumpjack**  
*Gearbox stain & apparent seepage  
Appears mitigated*

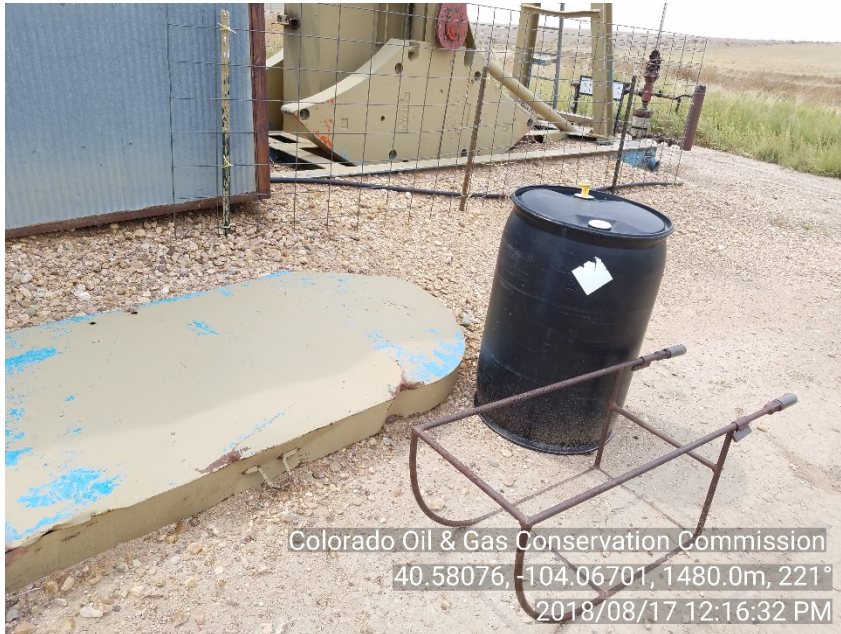
**Photo #9**  
**Dryer #1** Wellsite  
*Unused equipment (belt guard)*  
*55-gal. Drum, labeling / placard appears illegible*  
*from prior insp.*

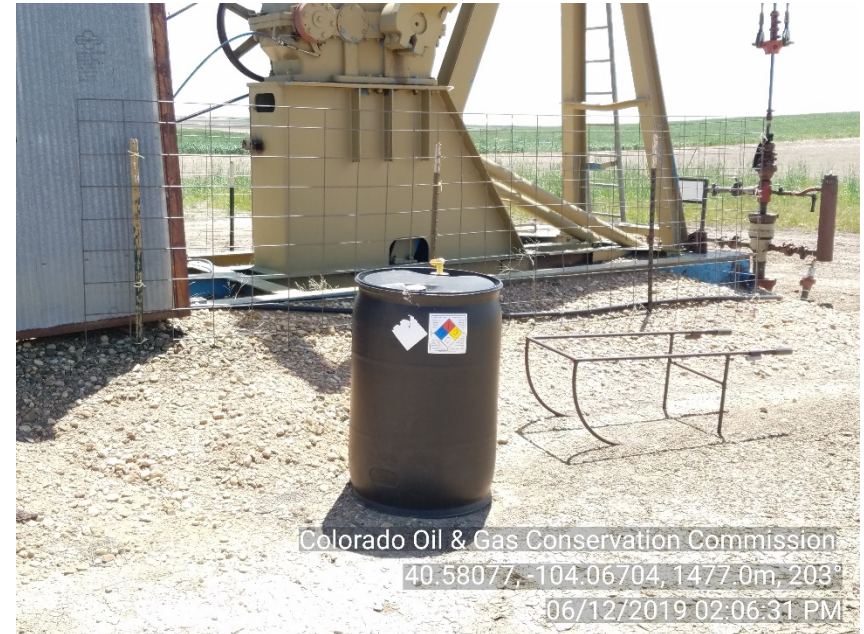
**Photo #10**  
**Dryer #1** Wellsite  
*Unused equipment (belt guard) - Removed*  
*55-gal. Drum, labeling / placard appears Legible*
