Interim Reclamation and Stormwater Inspection

June 4, 2019

Operator: EXTRACTION OIL & GAS LLC- #10459

Inspection Photos
Location Name: Livingston Pad
Location ID: 455317

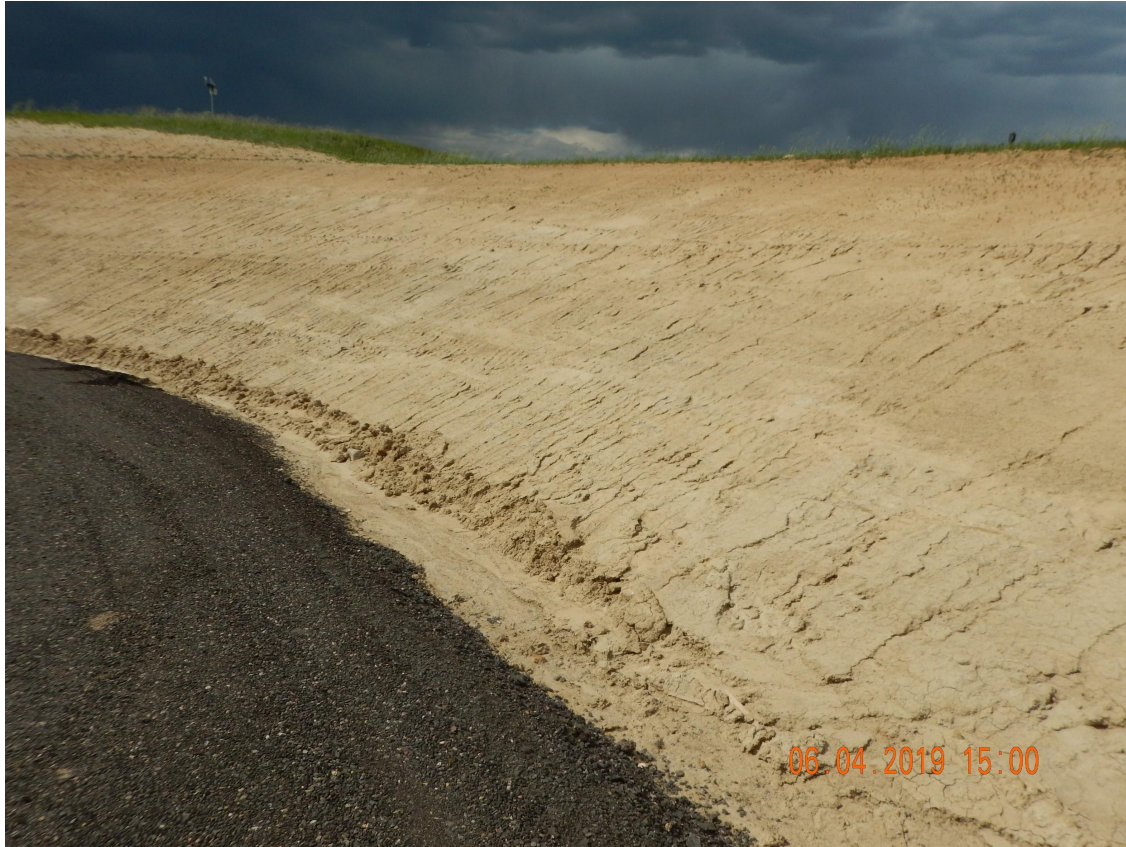
Photo 1. Photo taken from the access entrance of location, facing North. Cut slope has not been properly stabilized on either side of the access road. Photo illustrates rill erosion occurring on the north cut slope.

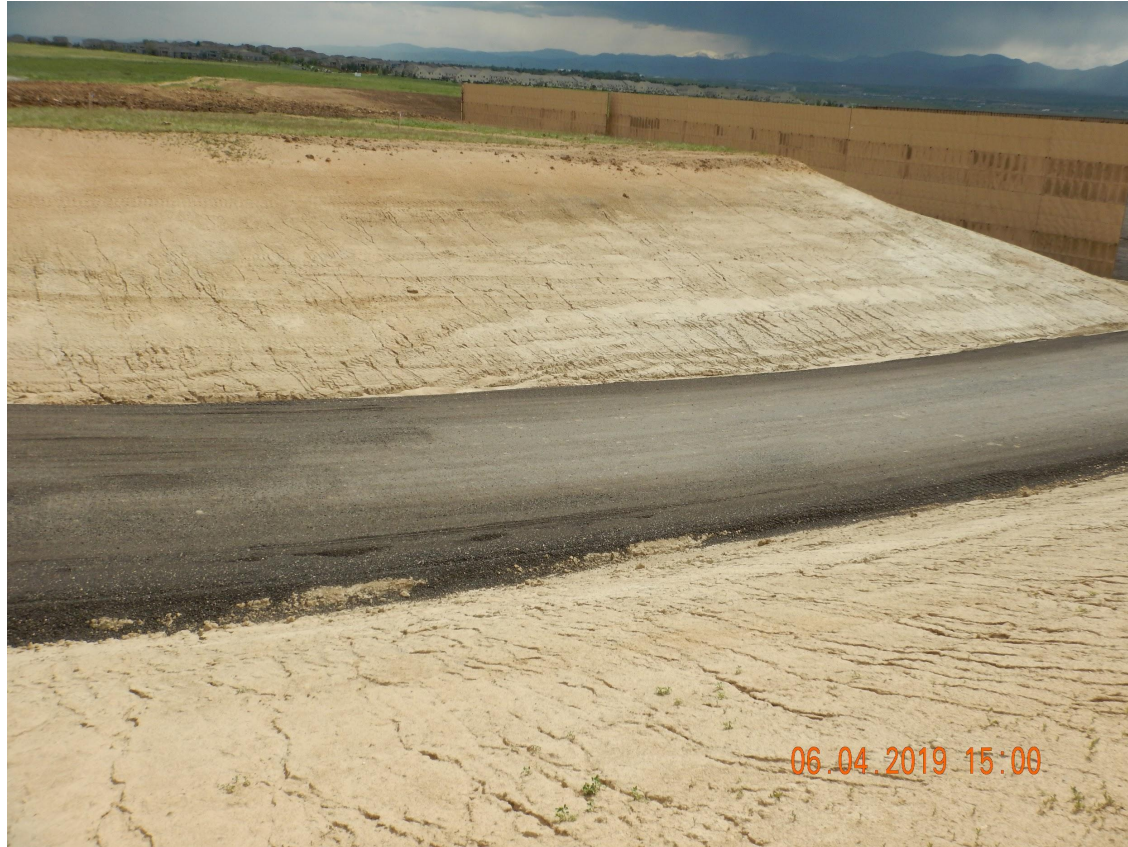
Photo 2. Photo taken from the north cut slope along the access entrance to location, facing South. Cut slope has not been properly stabilized on either side of the access road. Photo illustrates rill erosion occurring on the south cut slope.

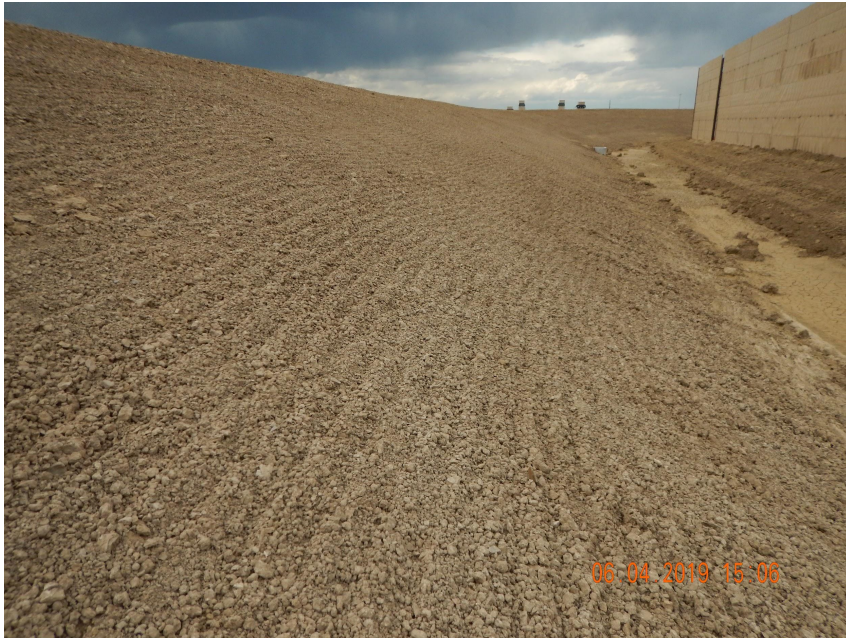
Photo 3. Photo taken from the eastern cut slope from the location, facing South. Operator has temporarily stabilized the cut slope with equipment tracking.

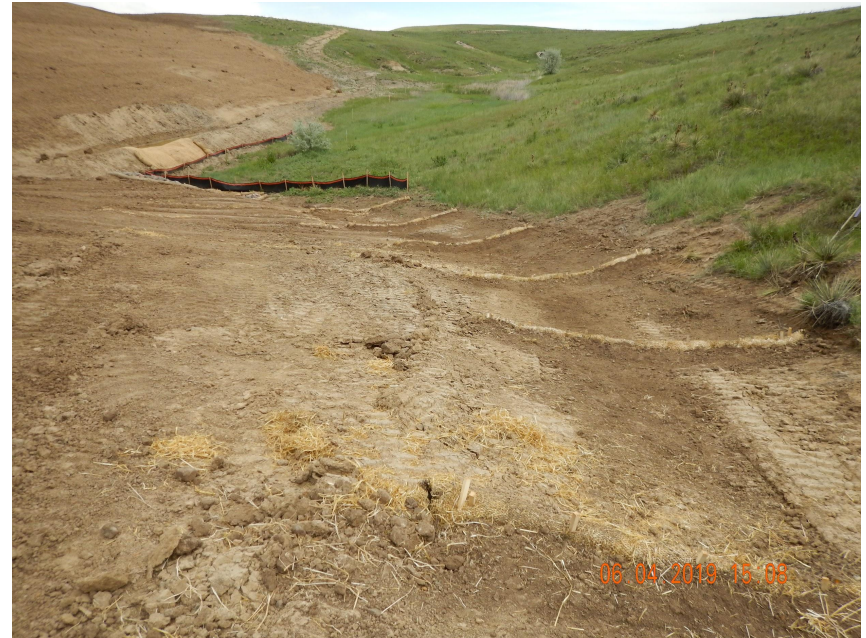
Photo 4. Photo taken from the southwestern perimeter of location, facing Southeast. Operator has installed straw wattles, silt fence and a sediment trap with a temporarily stabilized outlet. All the south-facing fill slopes were temporarily stabilized with equipment tracking.

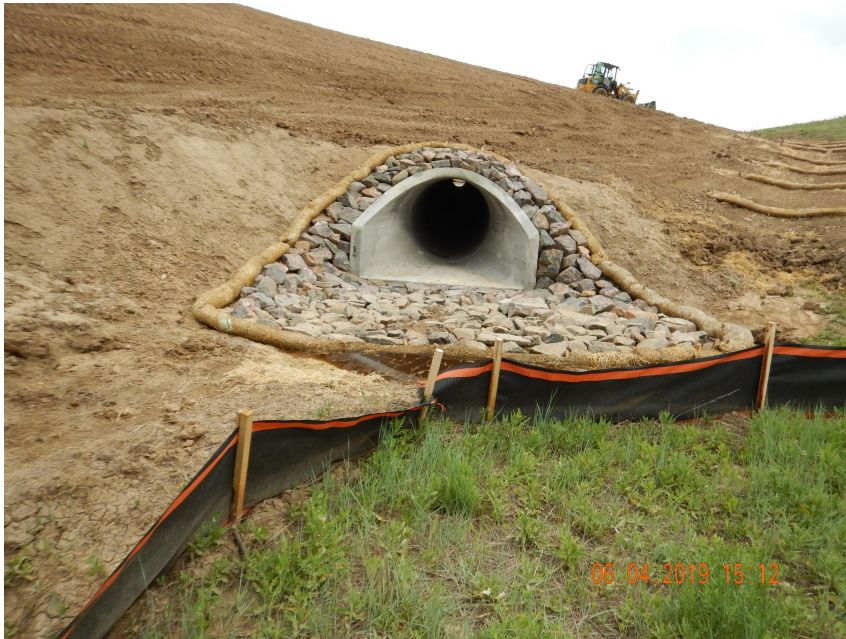
Photo 5. Photo taken from another southwestern portion along the perimeter of location, facing Southeast. Operator has installed a culvert, in conjunction with rip-rap, wattles and silt fence. Operator was repairing silt fence at the time of this inspection.

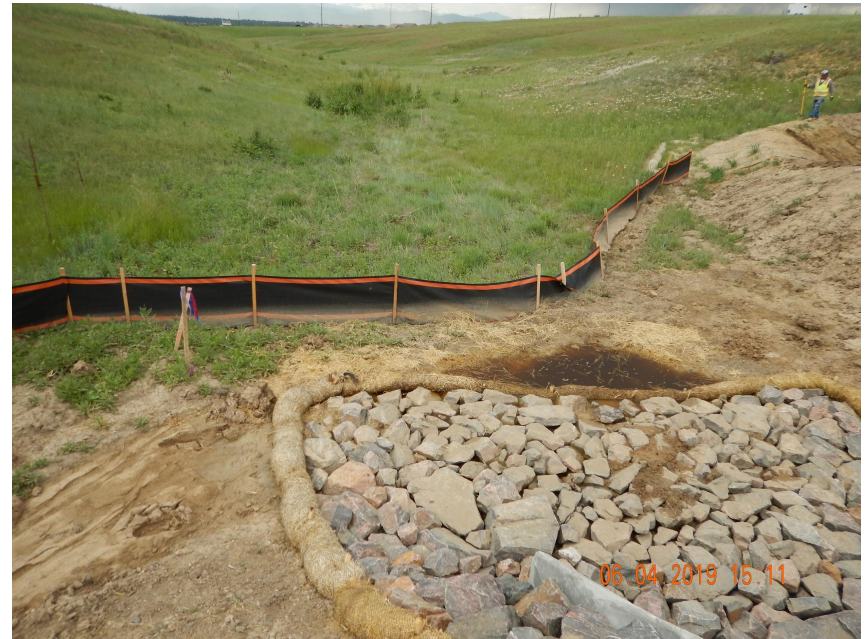
Photo 6. Photo taken from the approximate same location from the previous photo, facing Northwest. See comments under Photo 5.

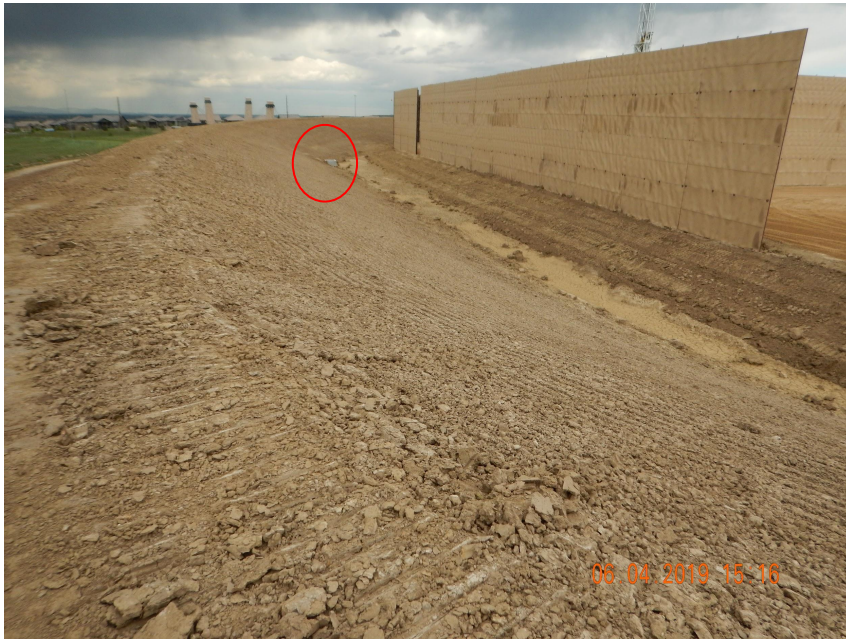
Photo 7. Photo taken from southwestern ridge of location, facing North. Fill slope areas have been temporarily stabilized with equipment tracking. Photo also illustrates what appears to be a retention area with an outlet (red circle).

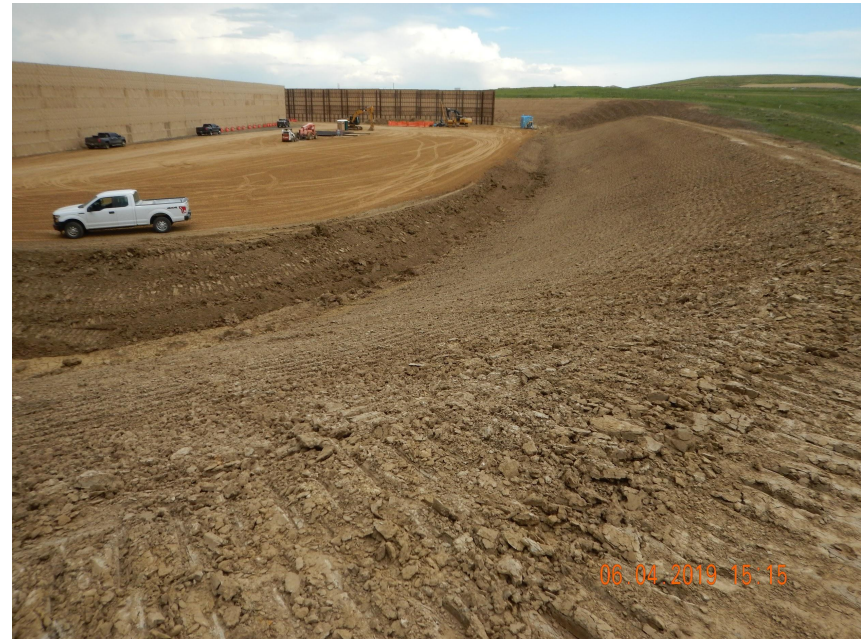
Photo 8. Photo taken from southwestern ridge of location, facing East. See comments under Photo 7.

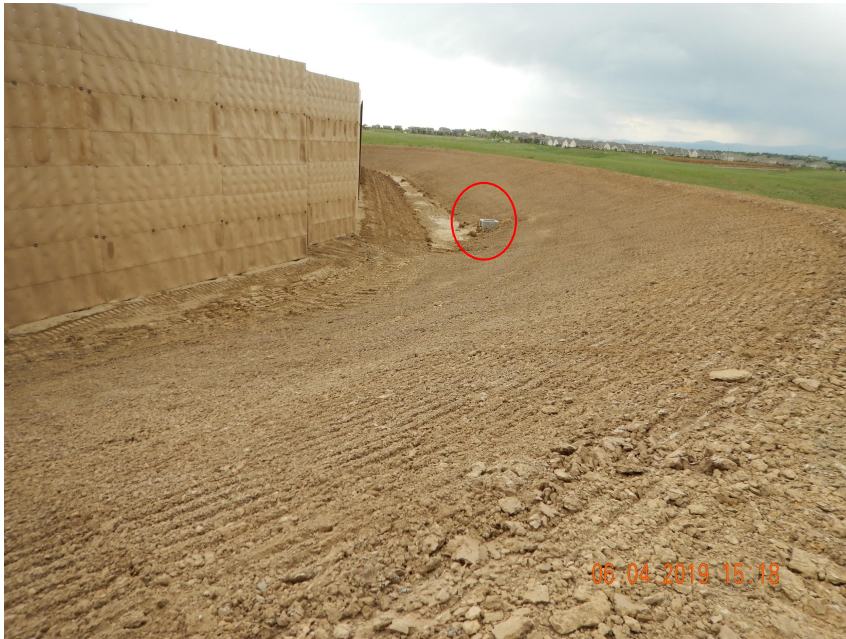
Photo 9. Photo taken from northwestern ridge of location, facing Southwest. See comments under Photo 7.

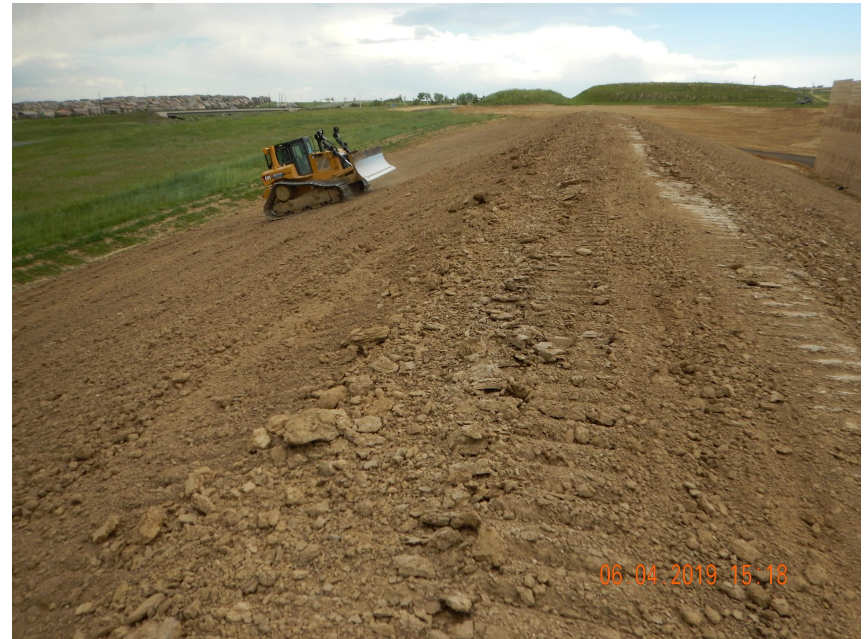
Photo 10. Photo taken from northern ridge of location, facing East. Photo illustrates the Operator temporarily stabilizing the fill slope with equipment tracking.

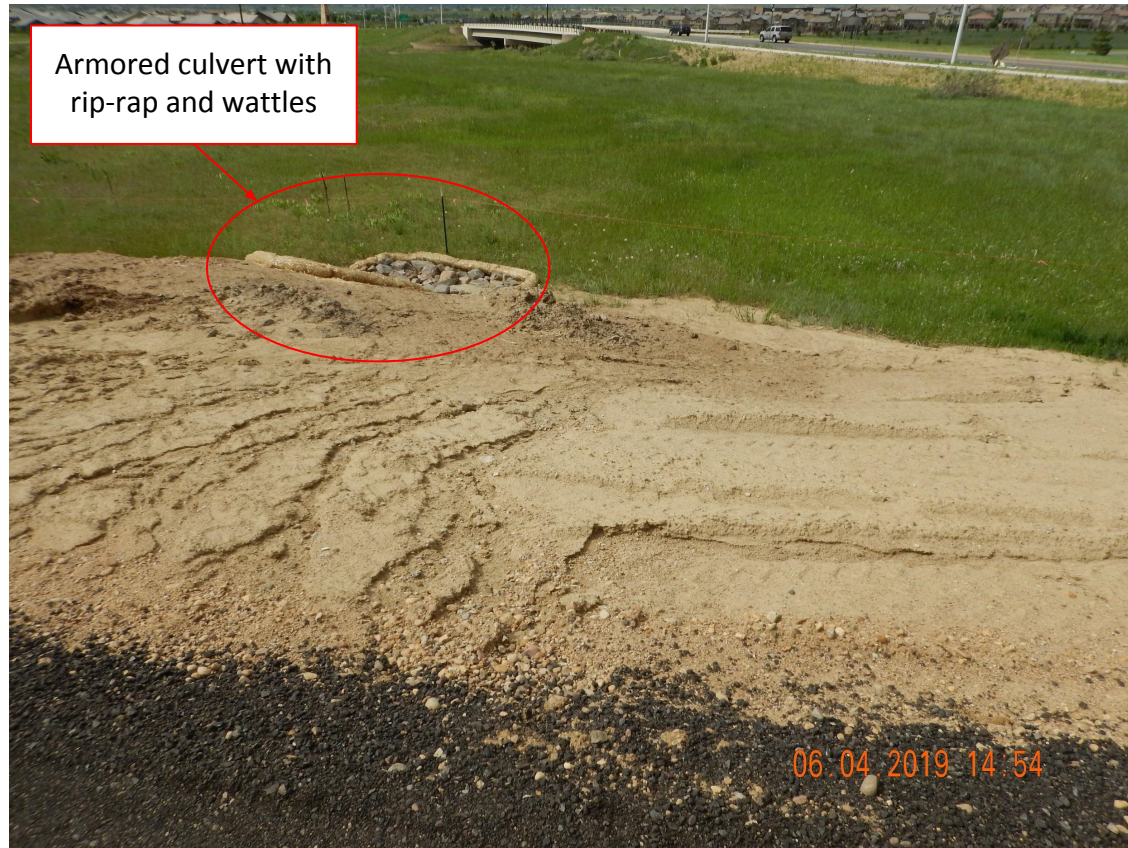
Photo 11. Photo taken from the exit of location, facing North. Fill slopes along the access road have not been properly stabilized and there are no perimeter BMPs in place to mitigate potential sediment laden stormwater from leaving the access road. Photo illustrates rill erosion occurring along the northern fill slope.

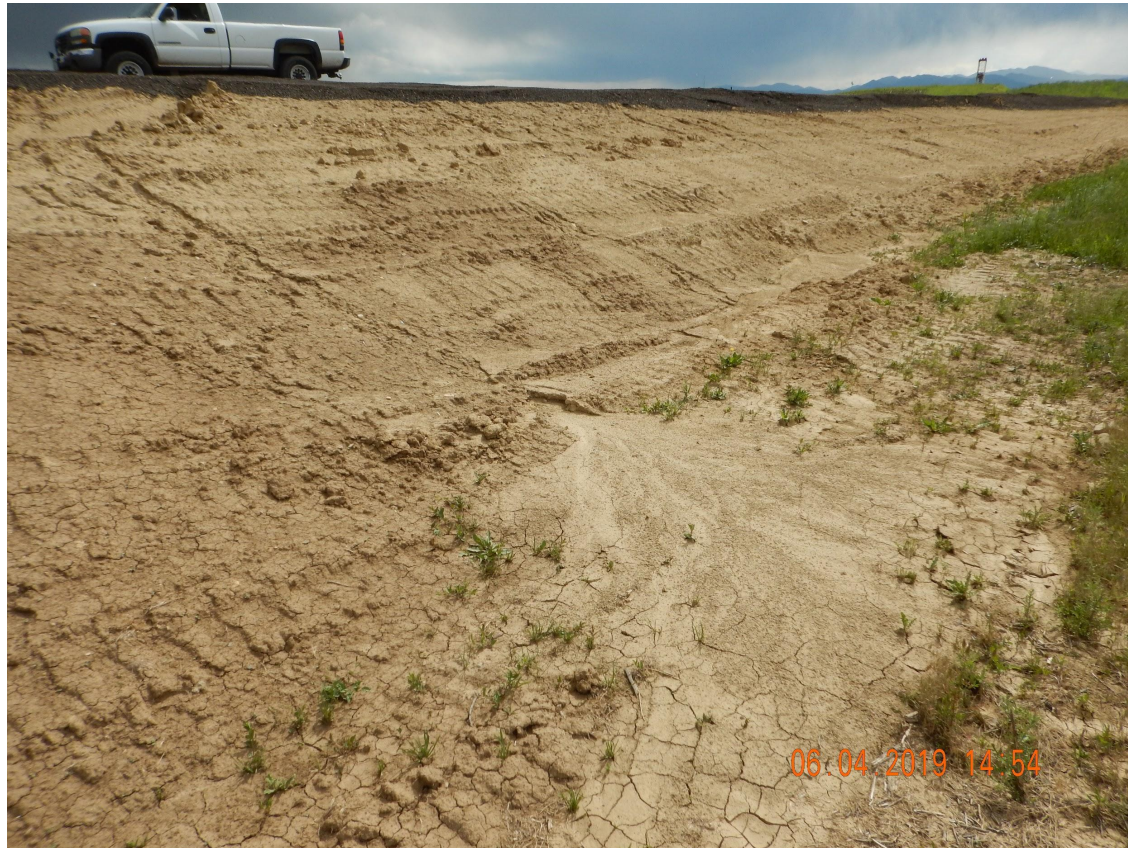
Photo 12. Photo taken from the exit of location, facing South. Fill slopes along the access road have not been properly stabilized and there are no perimeter BMPs in place to mitigate potential sediment laden stormwater from leaving the access road. Photo illustrates sediment leaving the fill slope of the access road with no stormwater BMPs implemented.

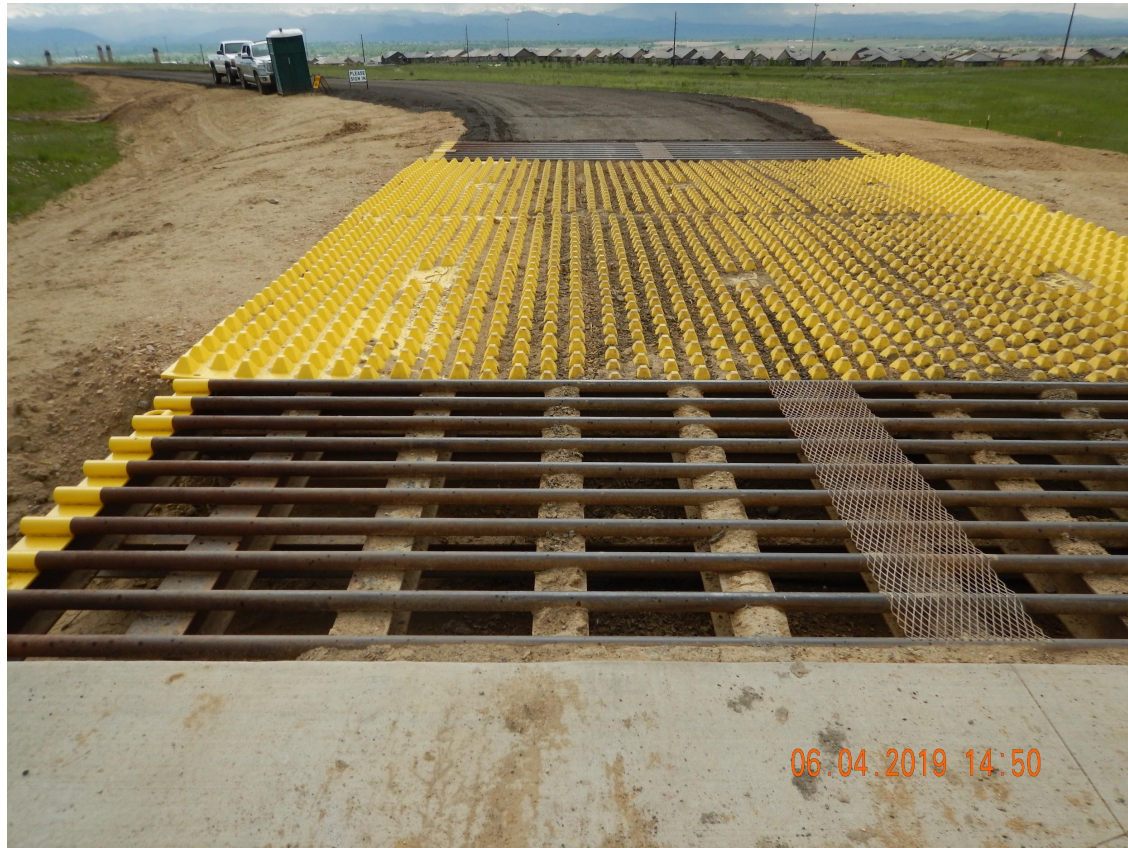
Photo 13. Photo taken from the exit of location, facing West. Tracking device BMPs appear to be in proper functioning condition.
