Inspection Photos
Location Name: Champlin 86 Amoco F#2
Location ID: 319003

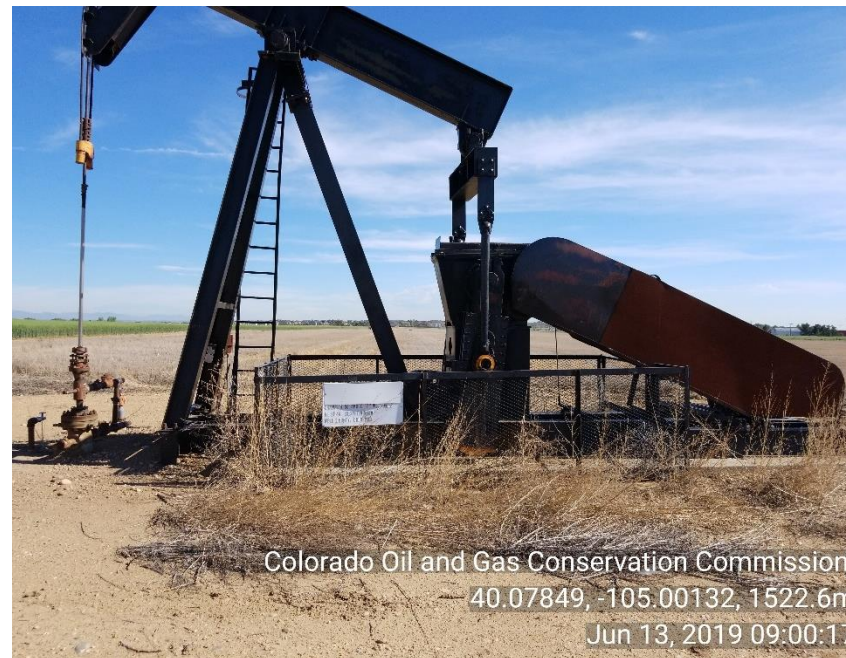
Photo 2 WH sign unreadable and Debris around PU

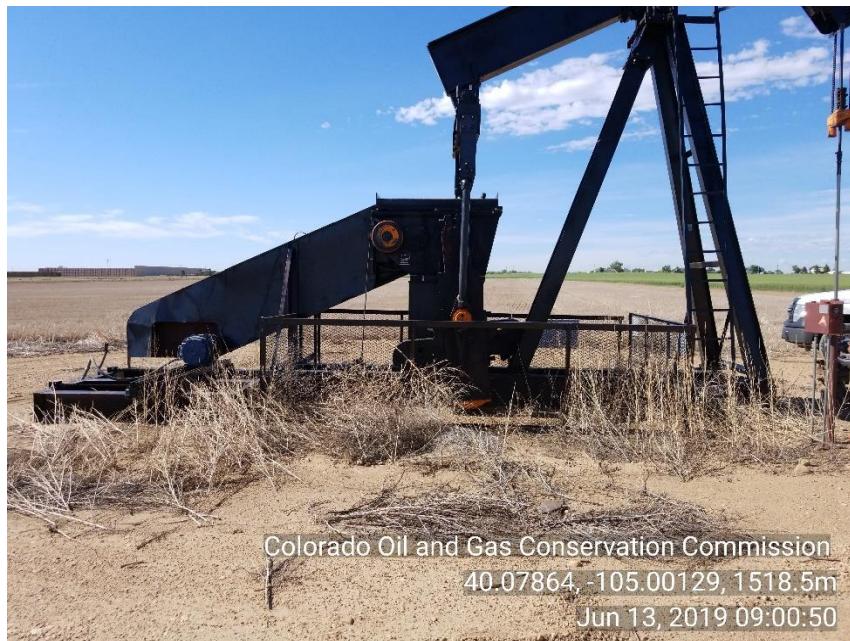
Photo 3 Debris around PU
