Interim Reclamation Inspection

June 12, 2019

Operator: EXTRACTION OIL & GAS LLC- #10459

Location ID: 426721

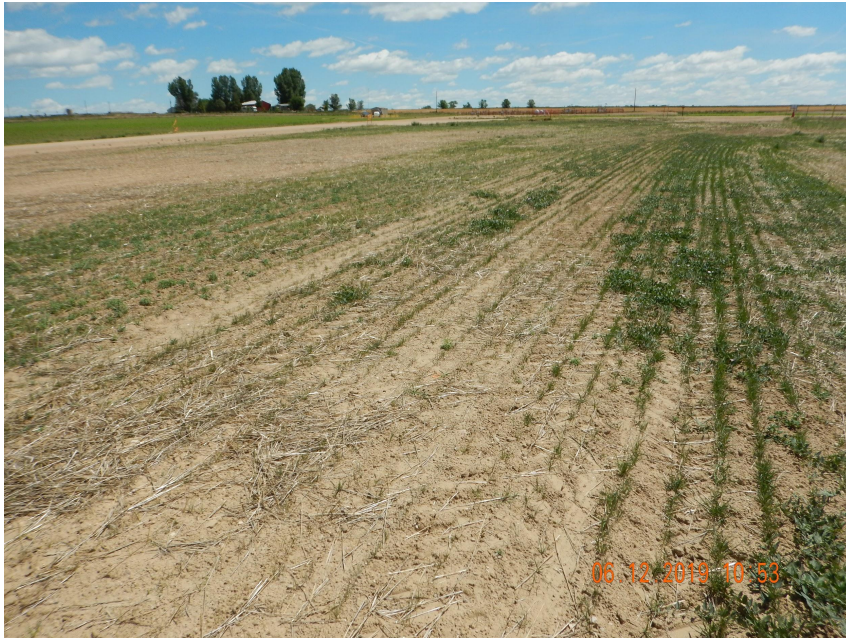
Photo 1. Photo taken from the northern interim area, facing East. Appears the Operator has performed the previous corrective action. Operator shall continue to monitor and manage this site until the location meets Rule 1003 standards, including weed management.

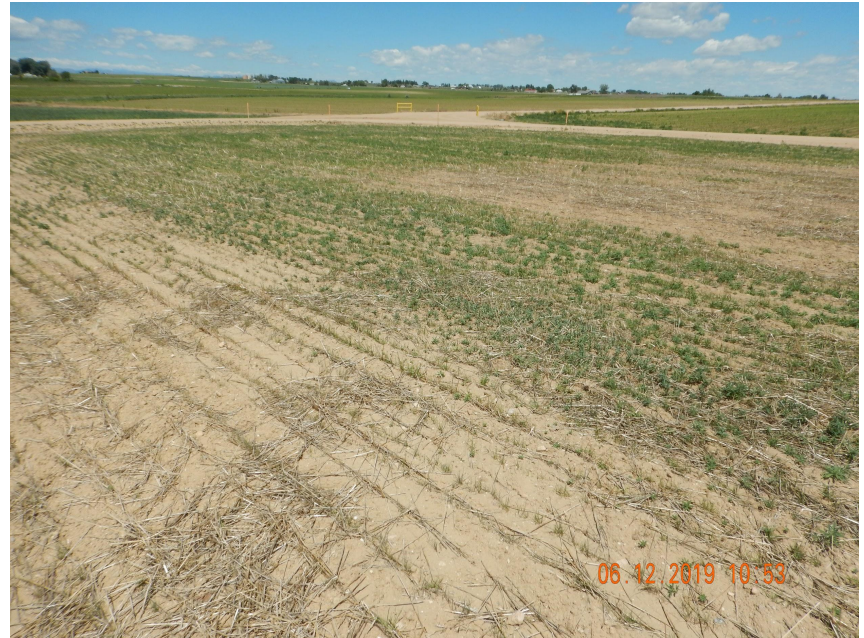
Photo 2. Photo taken from the northeastern interim area, facing West. See comments under Photo 1.

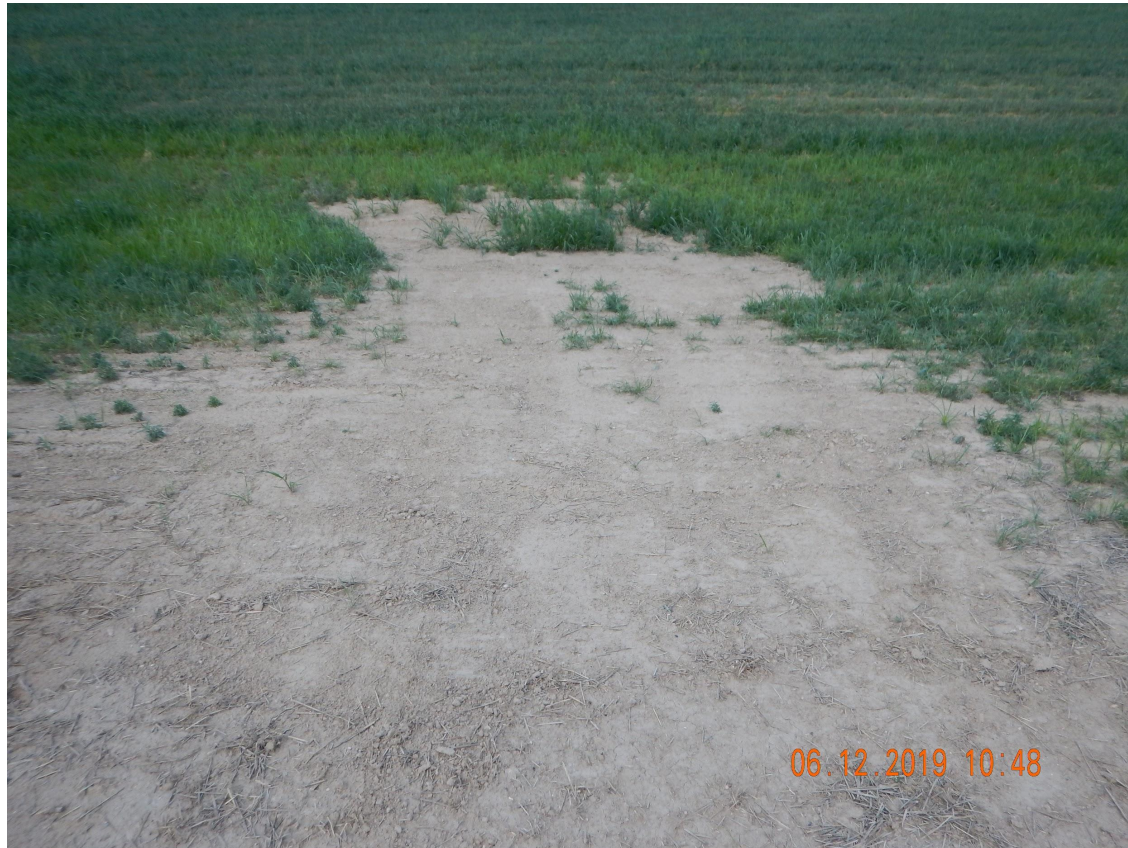
Photo 3. Photo taken from the southwestern location, facing West. Operator has made repairs to the erosion but the fill slope has not been properly stabilized. Straw mulch and germination was observed throughout portions of the western fill slope- see Photo 5- but not where erosion was repaired.

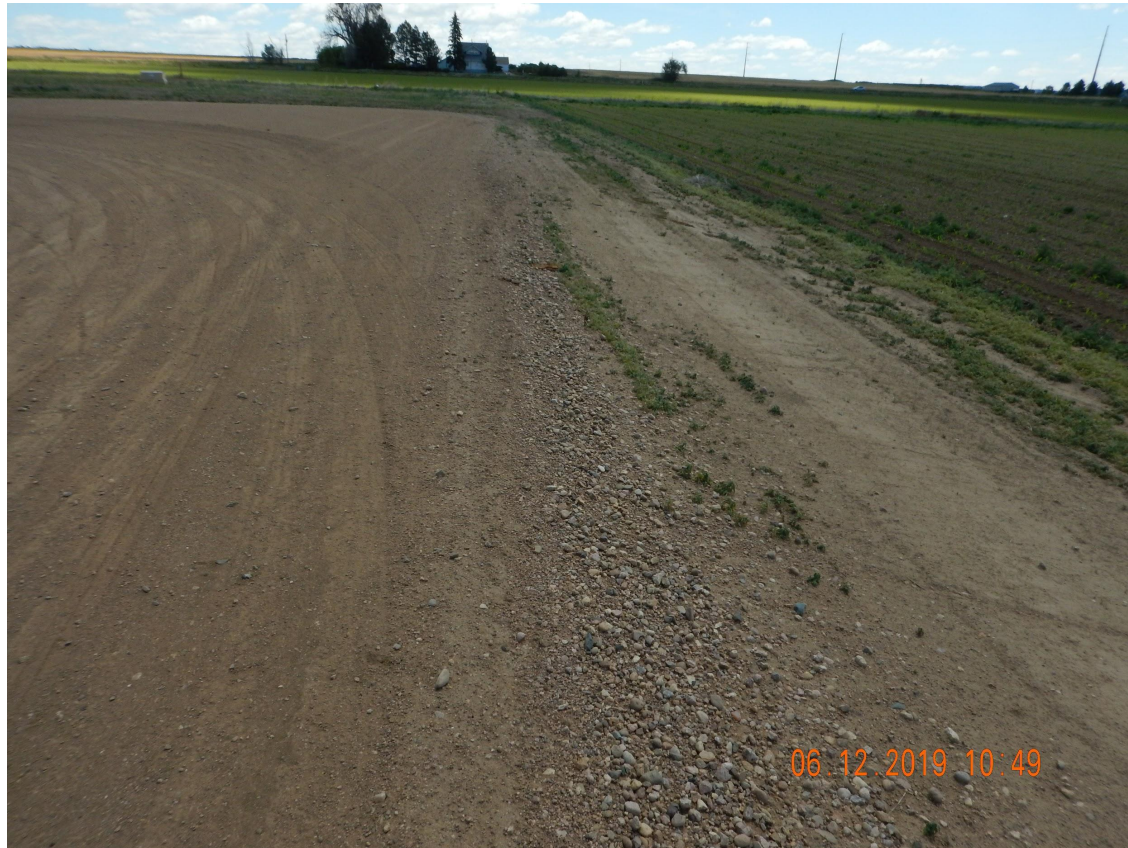
Photo 4. Photo taken from the southern location, facing East. Operator has made repairs to the erosion but the fill slope has not been properly stabilized. Appears the southern fill slope has been seeded but there was no observed mulch or other BMP to stabilize the fill slope until successful germination or establishment of vegetation.

Note: Kochia is starting to germinate along portions of the southern fill slope. Operator shall continue to monitor and manage this site until the location meets Rule 1003 standards, including weed management.

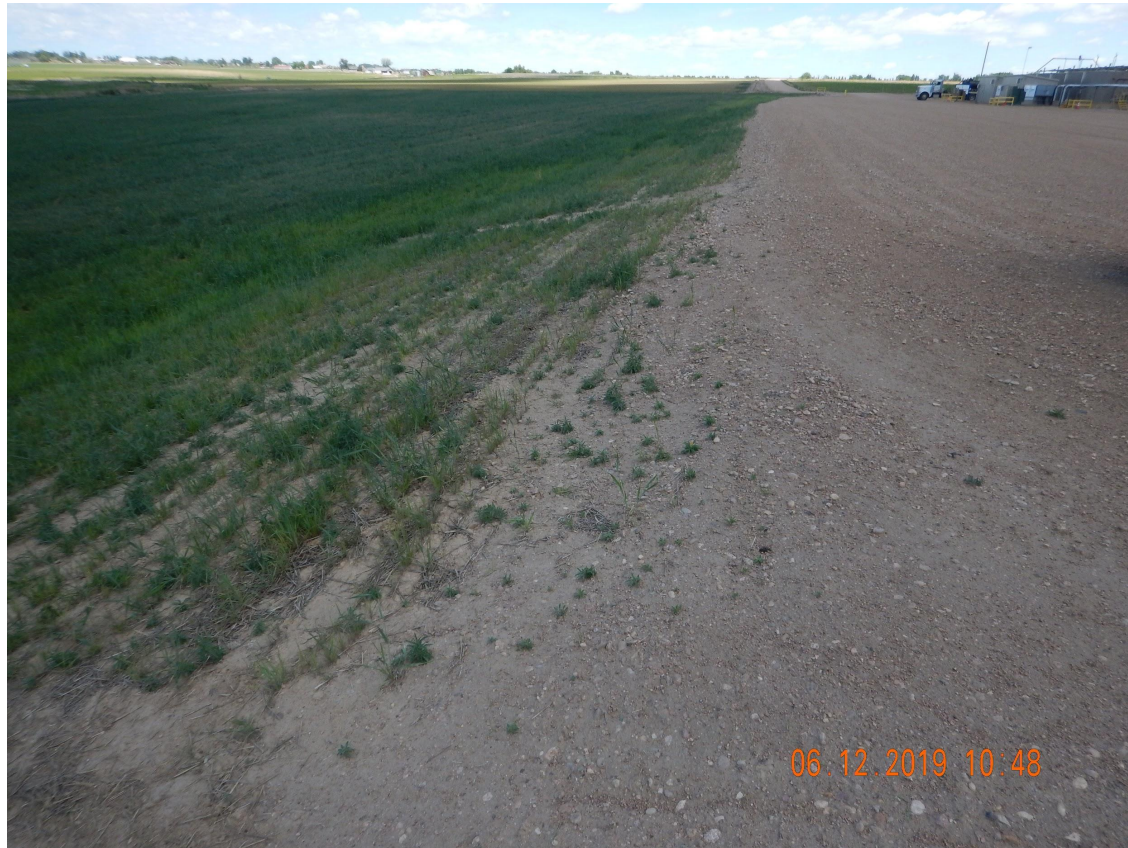
Photo 5. Photo taken from the southwestern location, facing North. Operator has only made repairs to the erosion but has not implemented additional BMPs to prevent sediment laden stormwater from leaving location. Sediment laden stormwater will continue to leave the Location because the Operator has not implemented sufficient long-term stormwater BMPs.

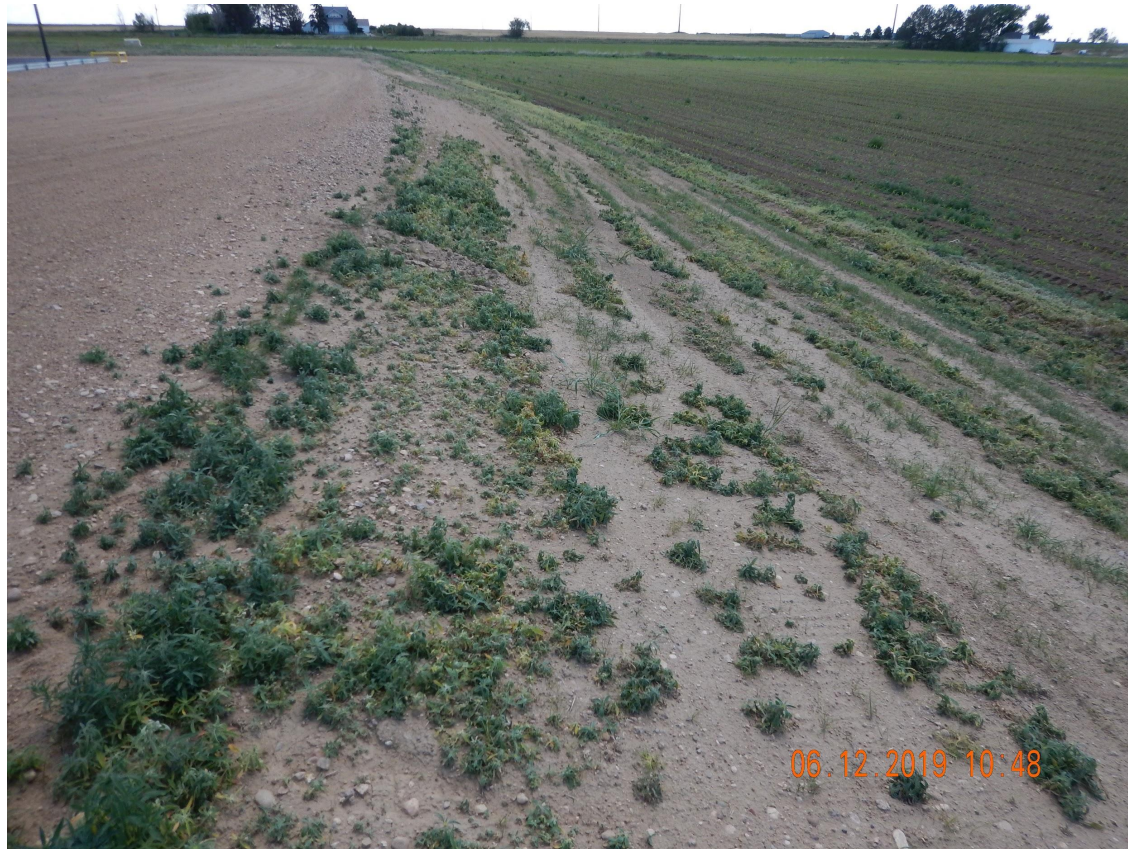
Photo 6. Photo taken from the southwestern location, facing East. See comments under Photo 5.
