Interim Reclamation and Stormwater Inspection

Operator: EXTRACTION OIL & GAS INC #10459

Location ID: 450197

Inspection Photos
Location Name: McGirr /26-L
Location ID: 450197

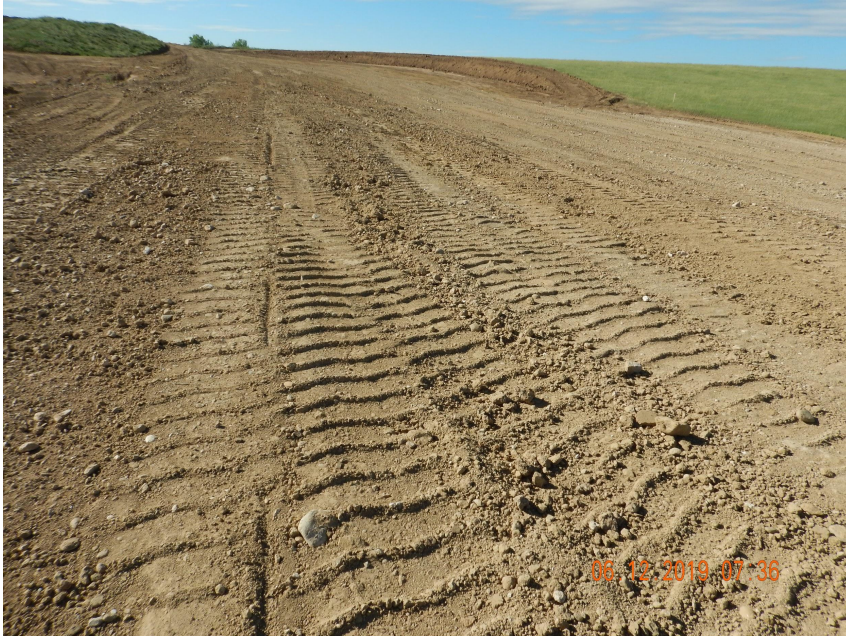
Photo 1. Photo taken from the western interim reclamation area, facing South. Operator is in-process of performing interim reclamation activities. The previous corrective action for erosion on the fill slopes has been mitigated by reducing the steepness by extending the location outward.

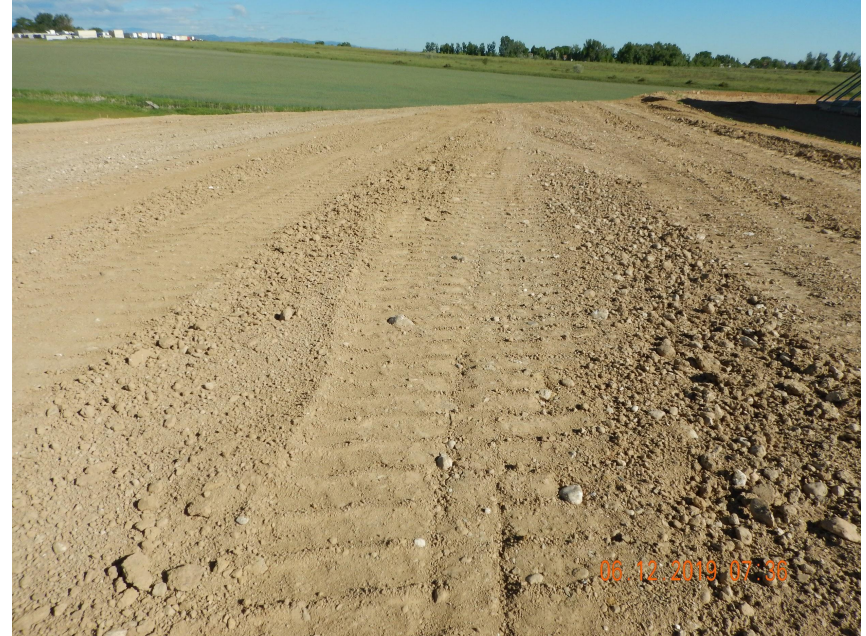
Photo 2. Photo taken from the western interim reclamation area, facing North. See comments under Photo 1.

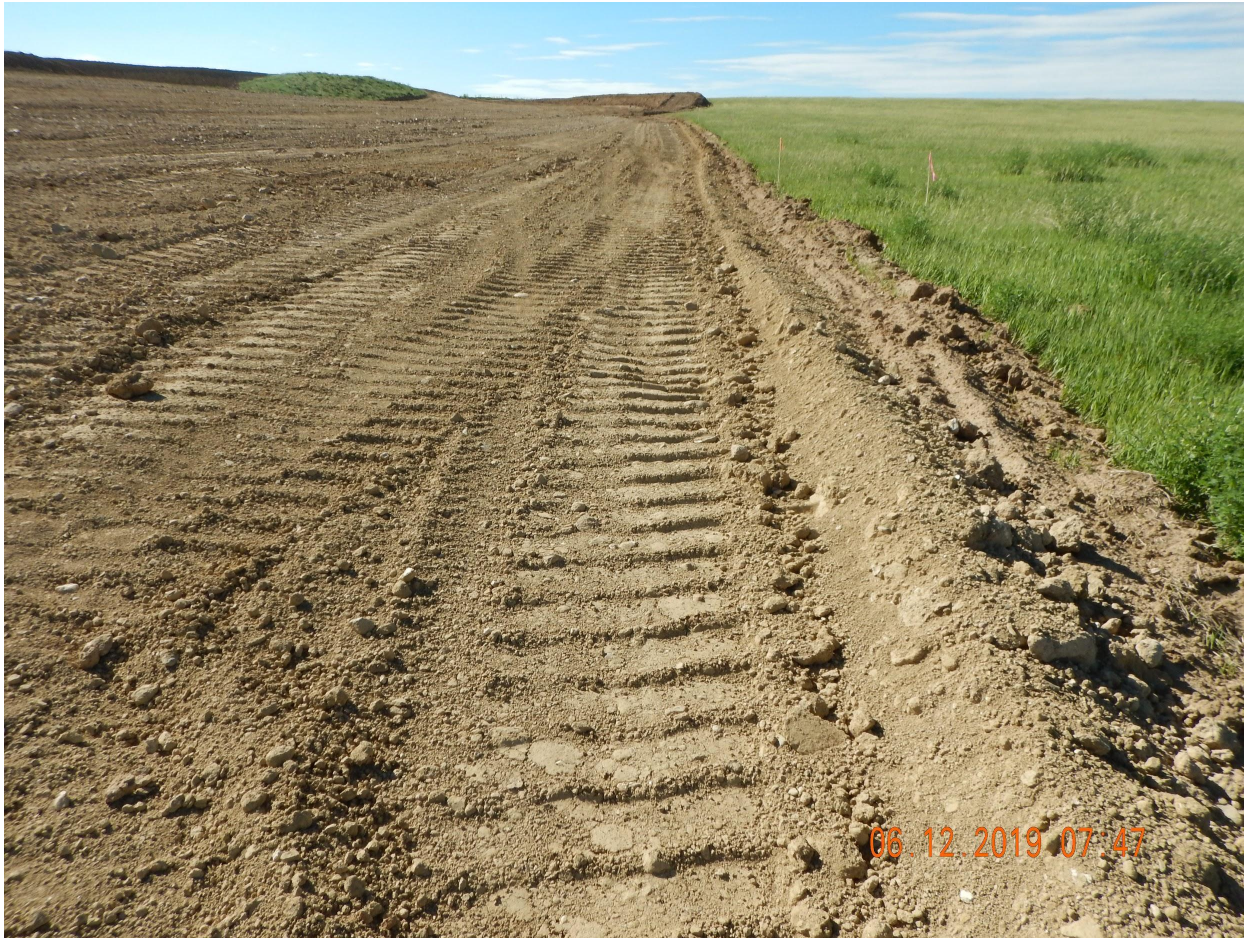
Photo 3. Photo taken from the northwestern perimeter of location, facing South. Photo illustrates the Operator is performing construction activities (i.e., interim reclamation) and has failed to install perimeter BMPs.

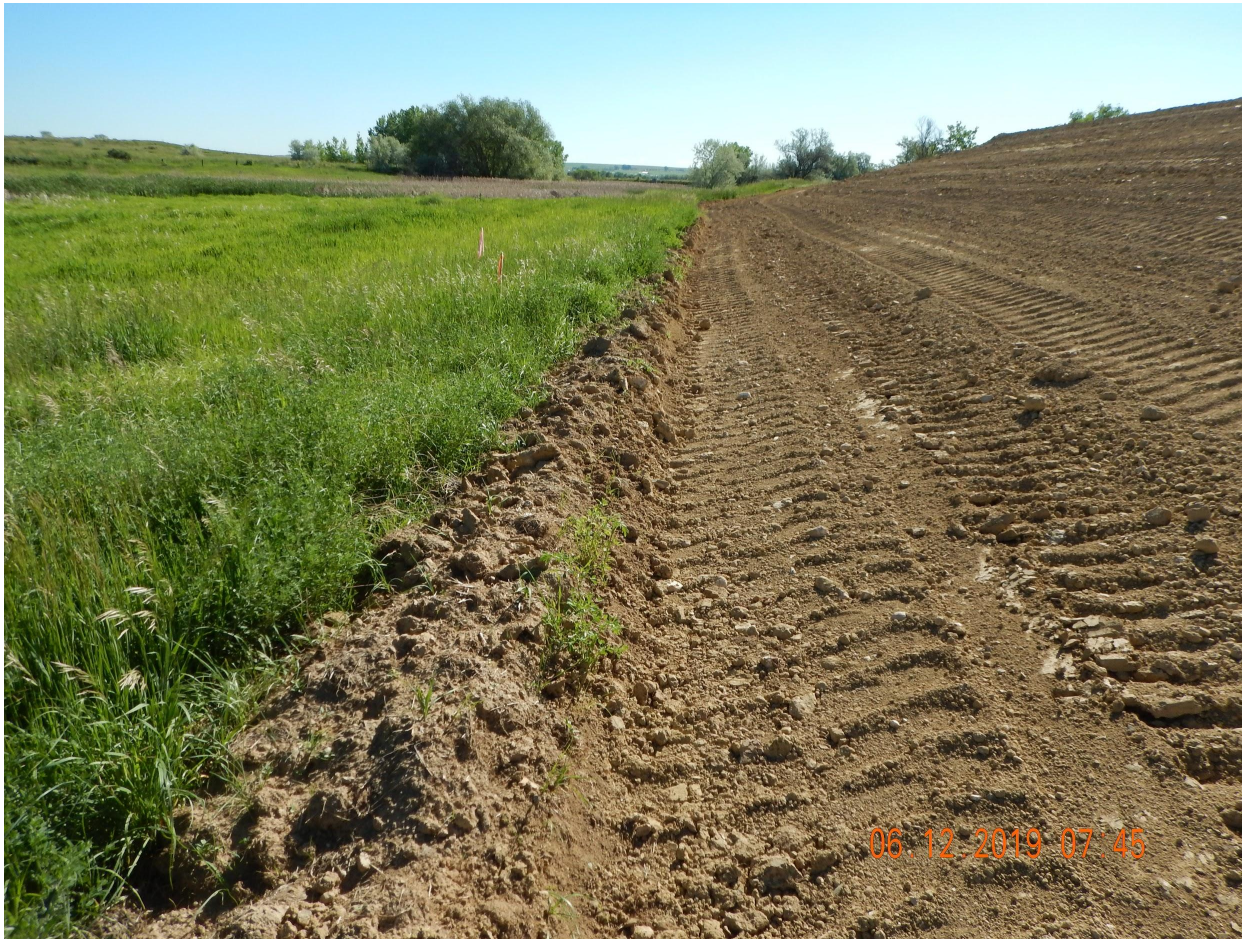
Photo 4. Photo taken from the northwestern perimeter of location, facing East. See comments under Photo 3.

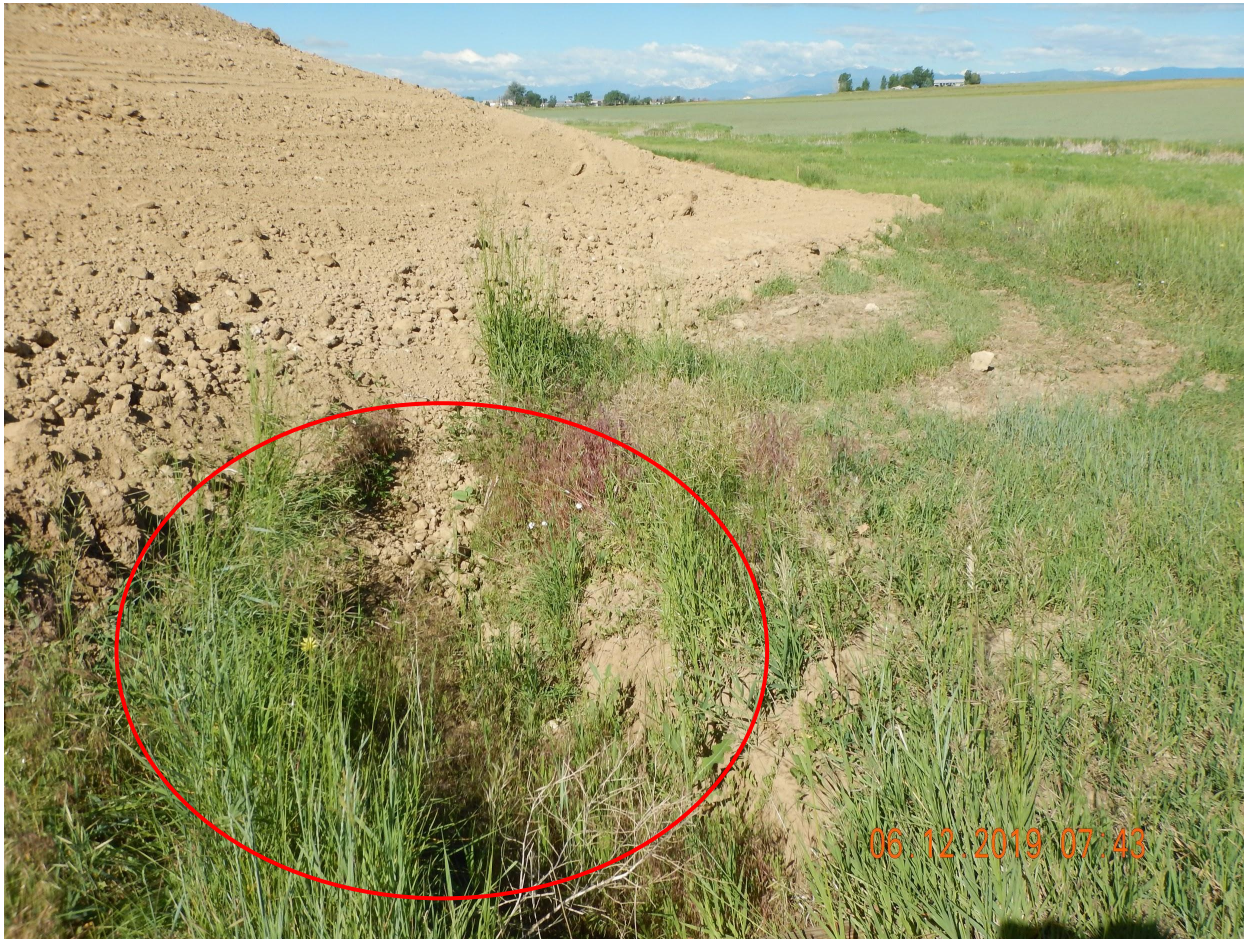
Photo 5. Photo taken from the northeastern perimeter of location, facing West. Photo illustrates the ditch and berm BMP that was previously installed during initial construction activities; however, the Operator has failed to install perimeter BMPs for other portions of the disturbance area.

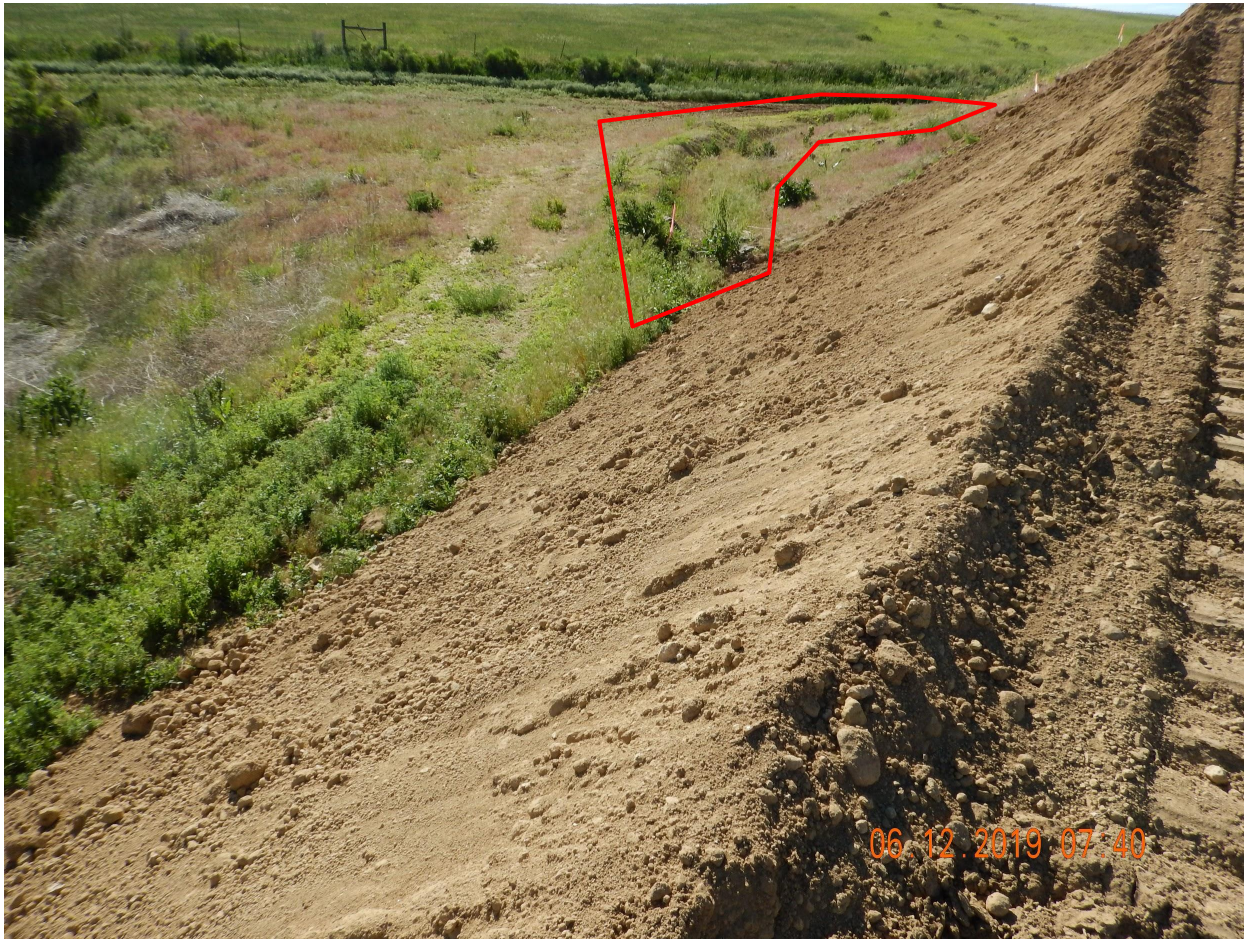
Photo 6. Photo taken from the northeastern perimeter of location, facing East. Photo illustrates soil material has covered up the previous ditch and berm (highlighted in red) and has failed to install perimeter BMPs.
