Gordon Engineering
API # 05-077-08516
Inspection # 696600130

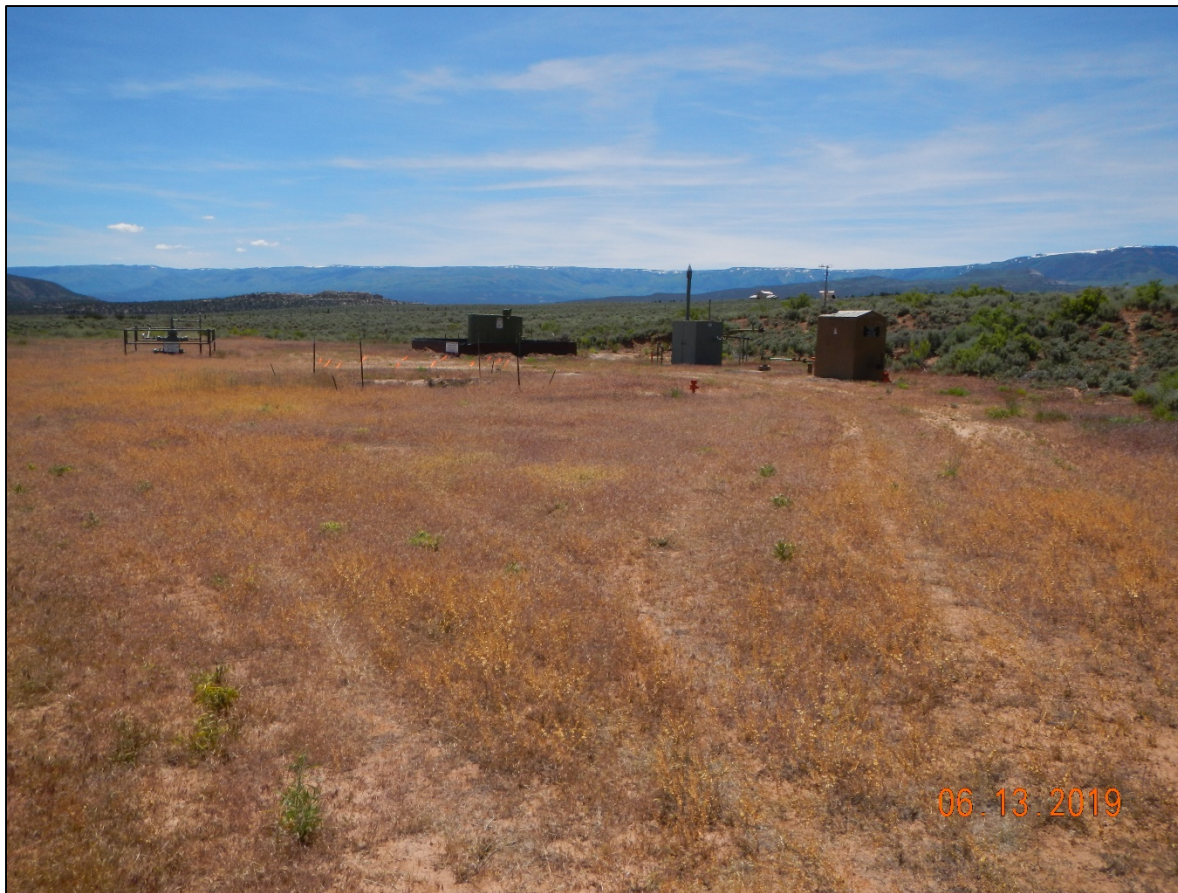
Photo #1 Photo from entrance of location.

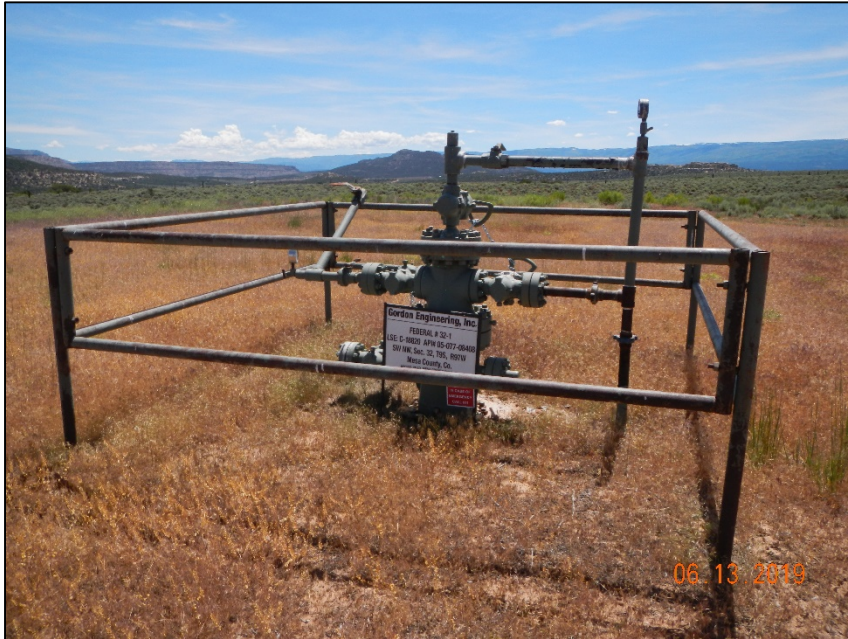
Photo #2 Well heads and signs on location.

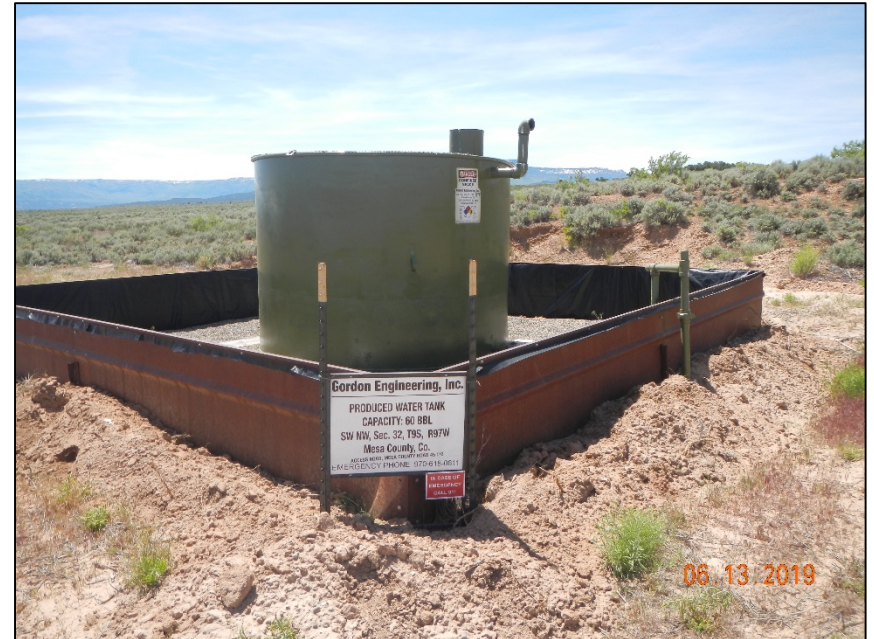
Photo #3 Photo taken of tank battery and sign

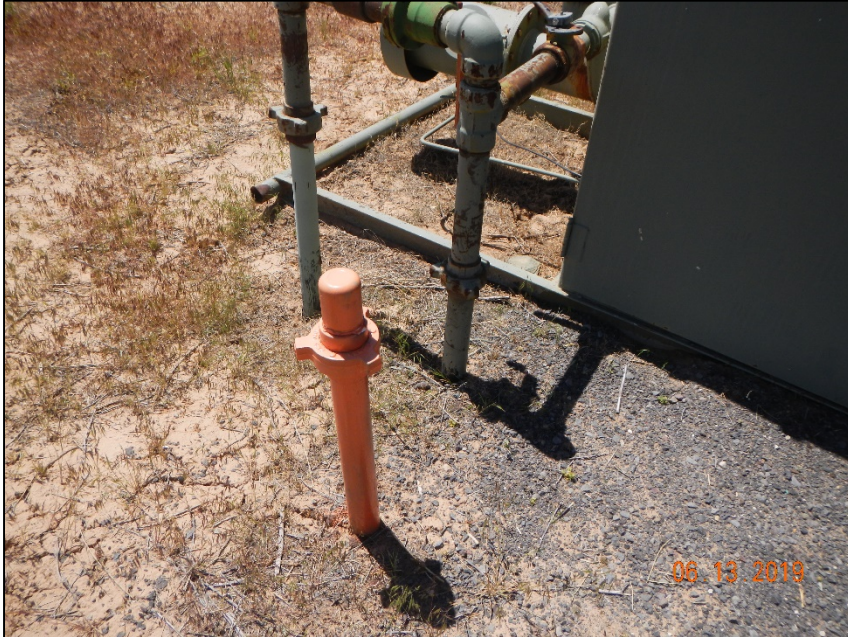
Photo #4 Riser not Locked Out / Tagged Out

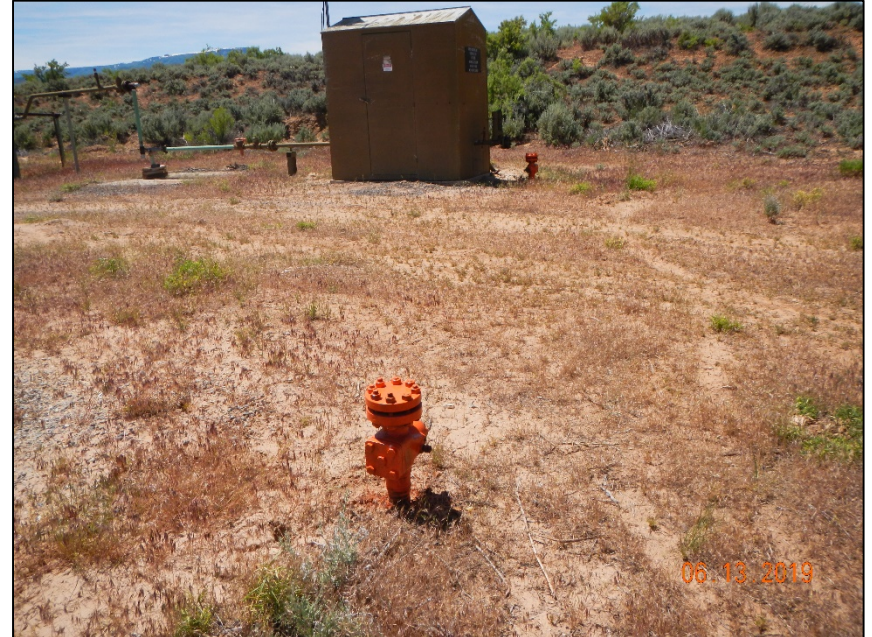
Photo #5 Riser not Locked Out / Tagged Out

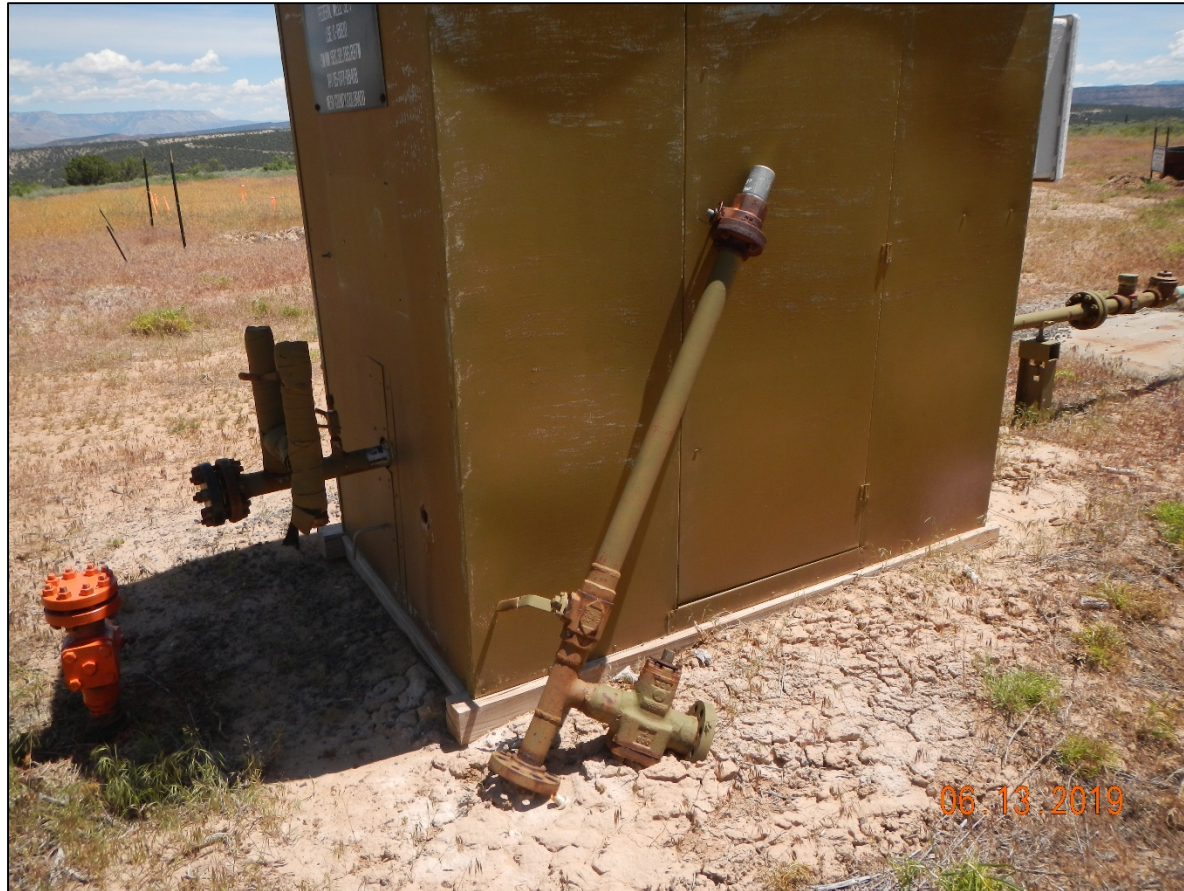
Photo # 6 unused riser left stored on location. Orange Riser not LOTO

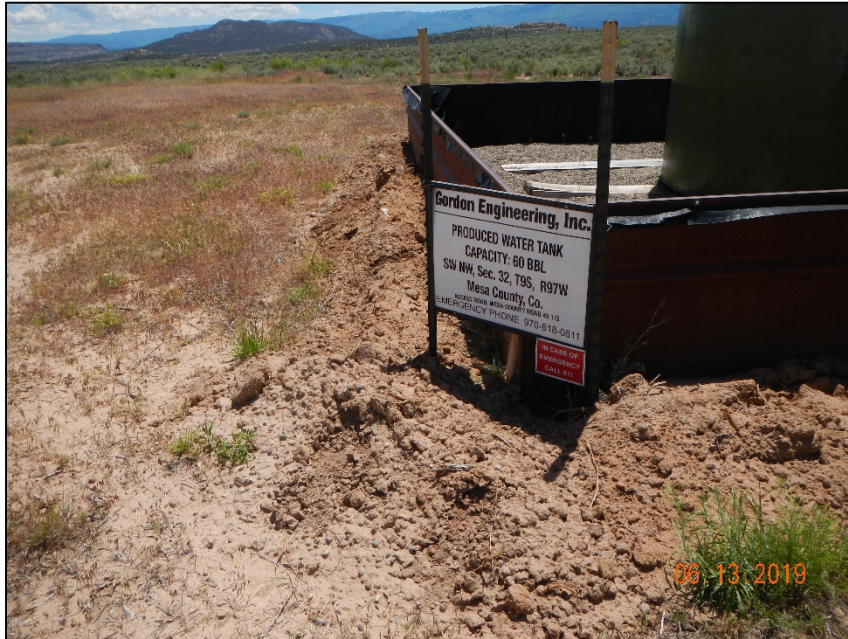
Photo #7 Berm around outside of metal berm needs maintenance if going to use as secondary containment.

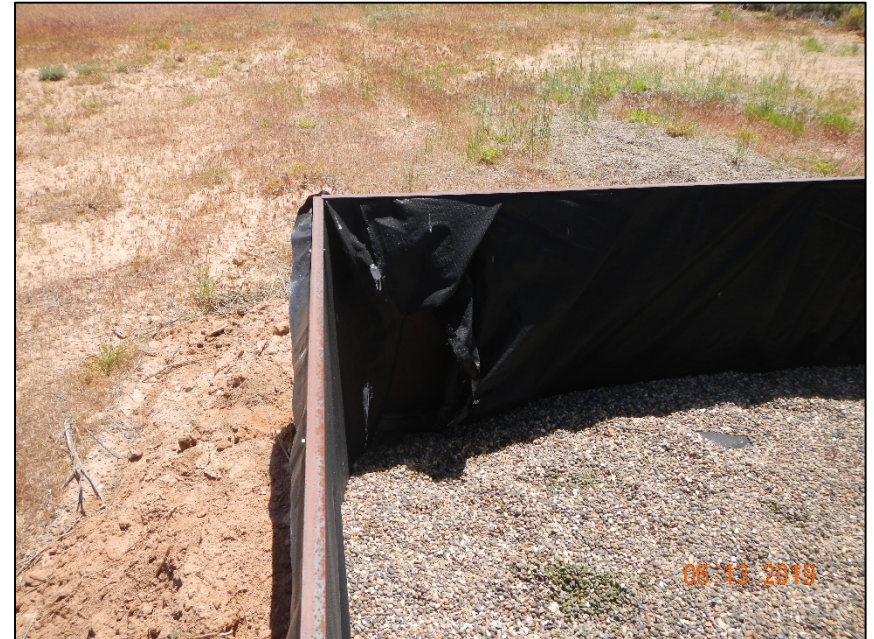
Photo #8 Hole in tank liner.
