Inspection Photos  
Location: Fish Creek 2  
Inspection Date: 6/13/2019  
Photos taken by Kris Neidel

**COLORADO**  
Oil & Gas Conservation  
Commission  
Department of Natural Resources

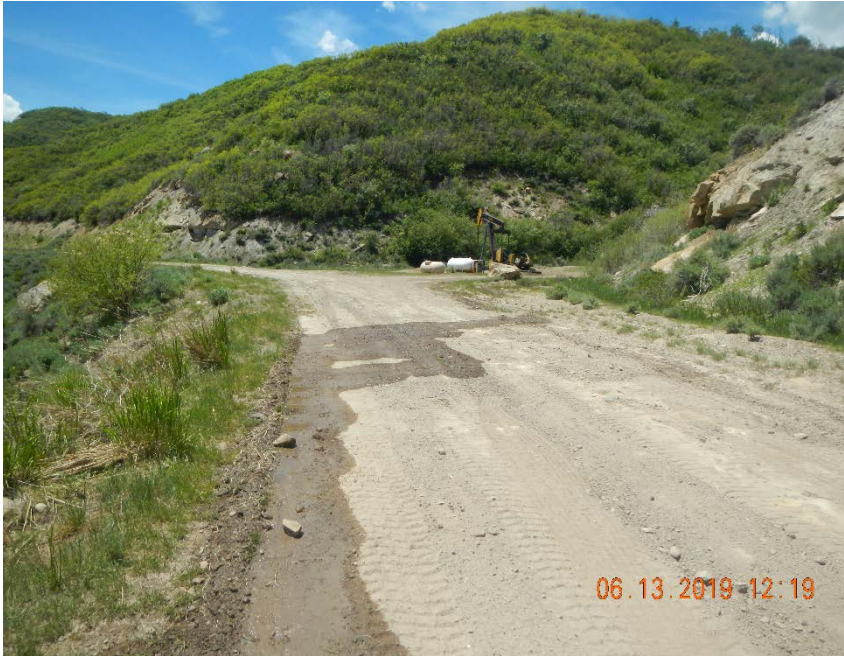
Pumpjack is in back of photo. Water seen in road is coming from hillside to the north of the well. It is known that there are springs and water coming out of the hill

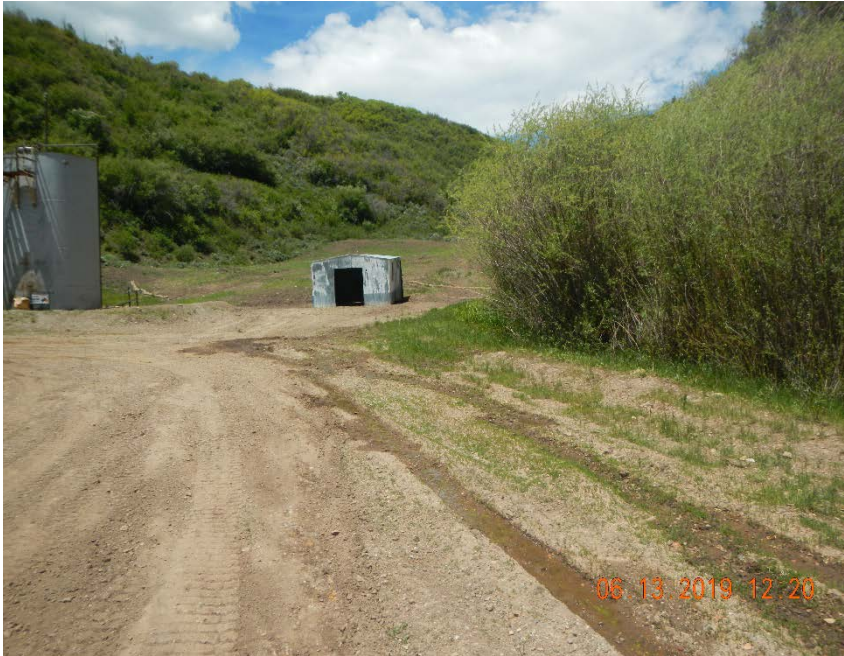
Tank battery on left

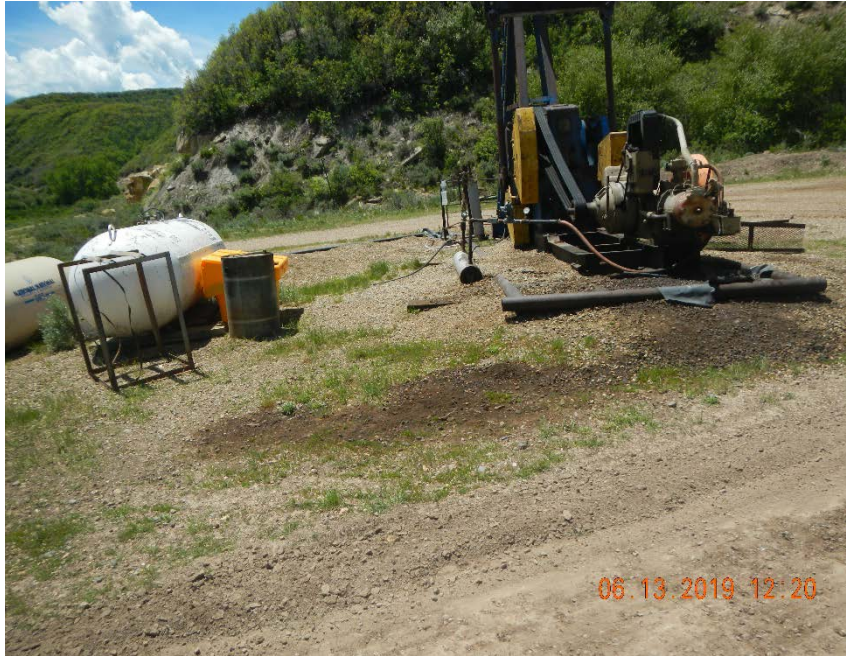
Well, some staining from exhaust on pumpjack

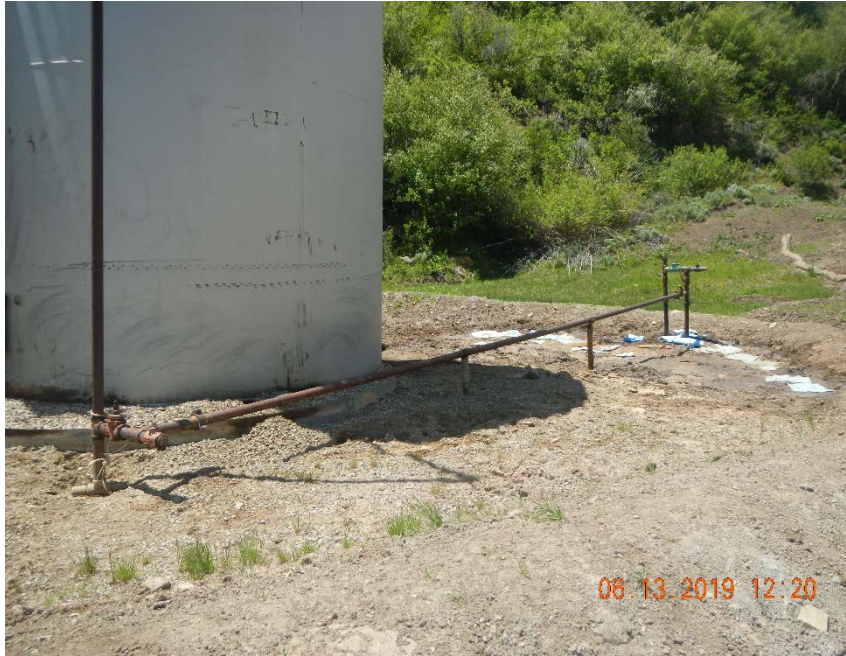
Pipe riser that had failed

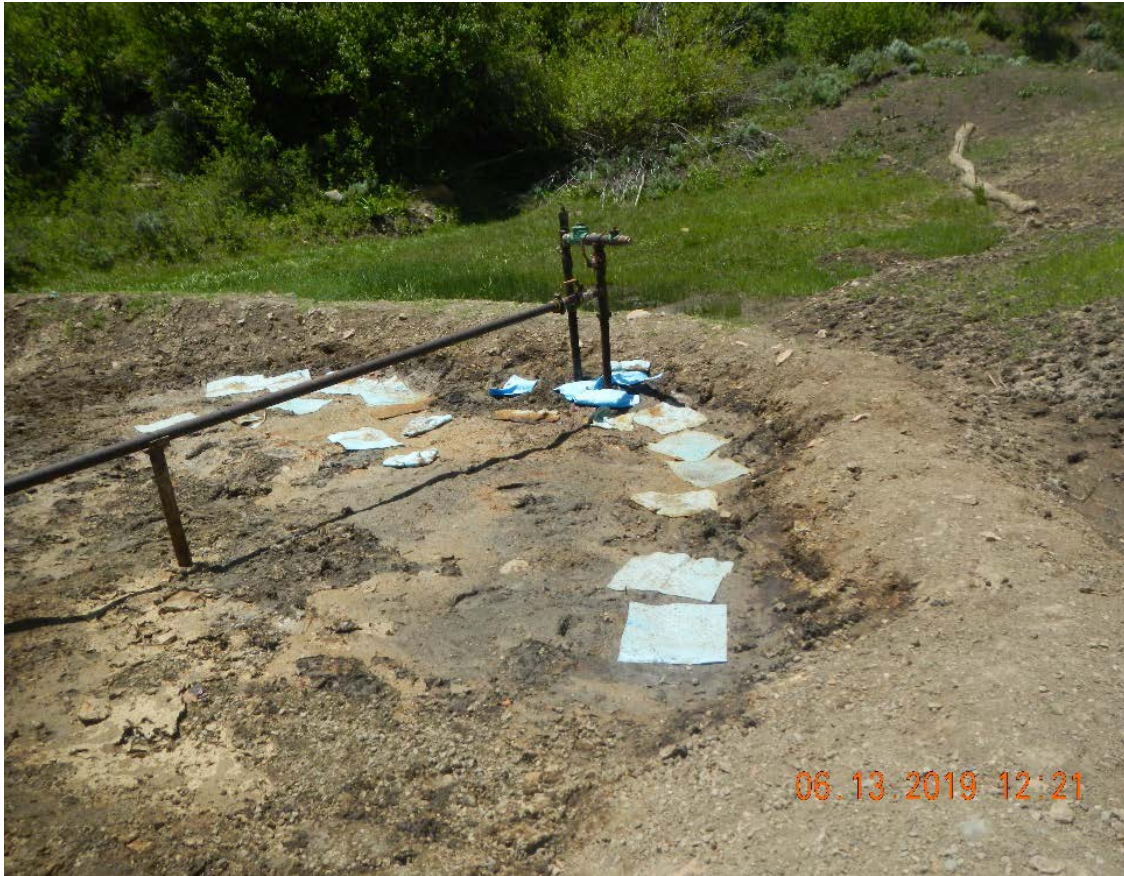
Area inside tank battery

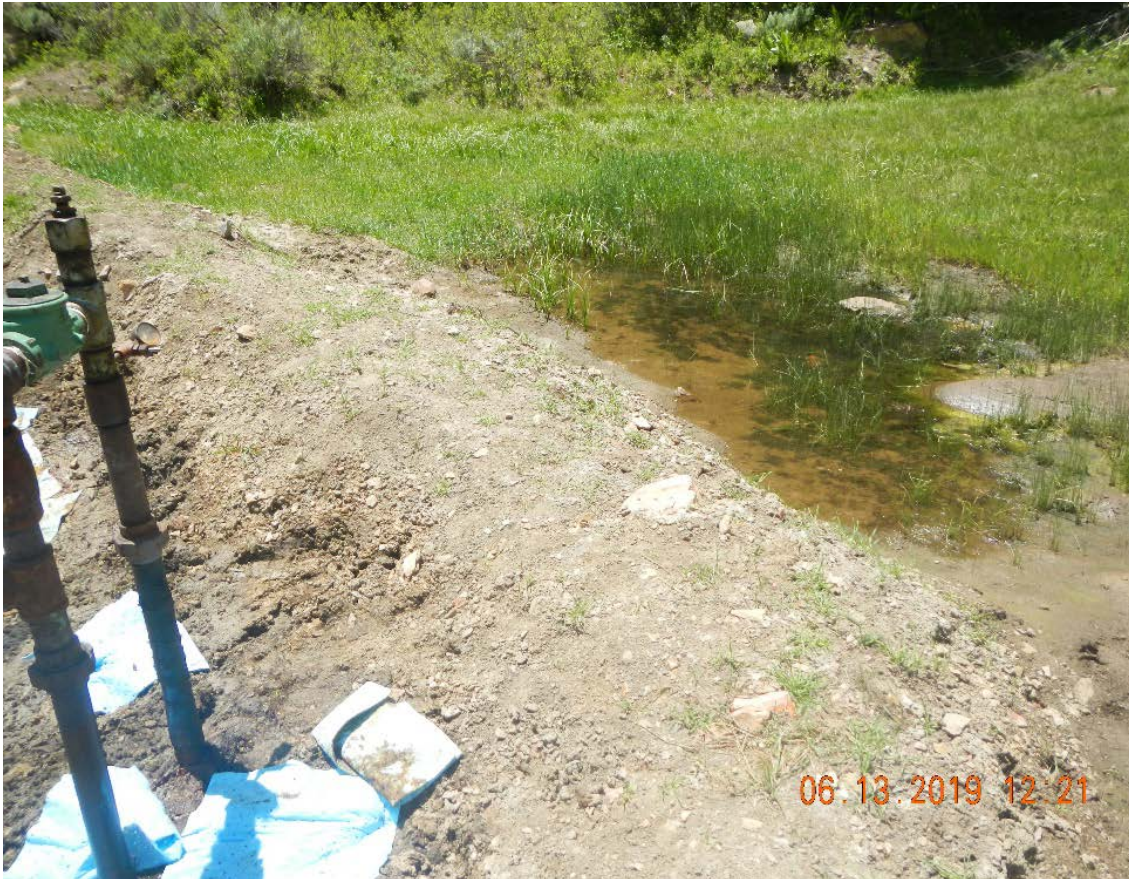
Pooled water just outside of tank battery. Appears to be from hillside

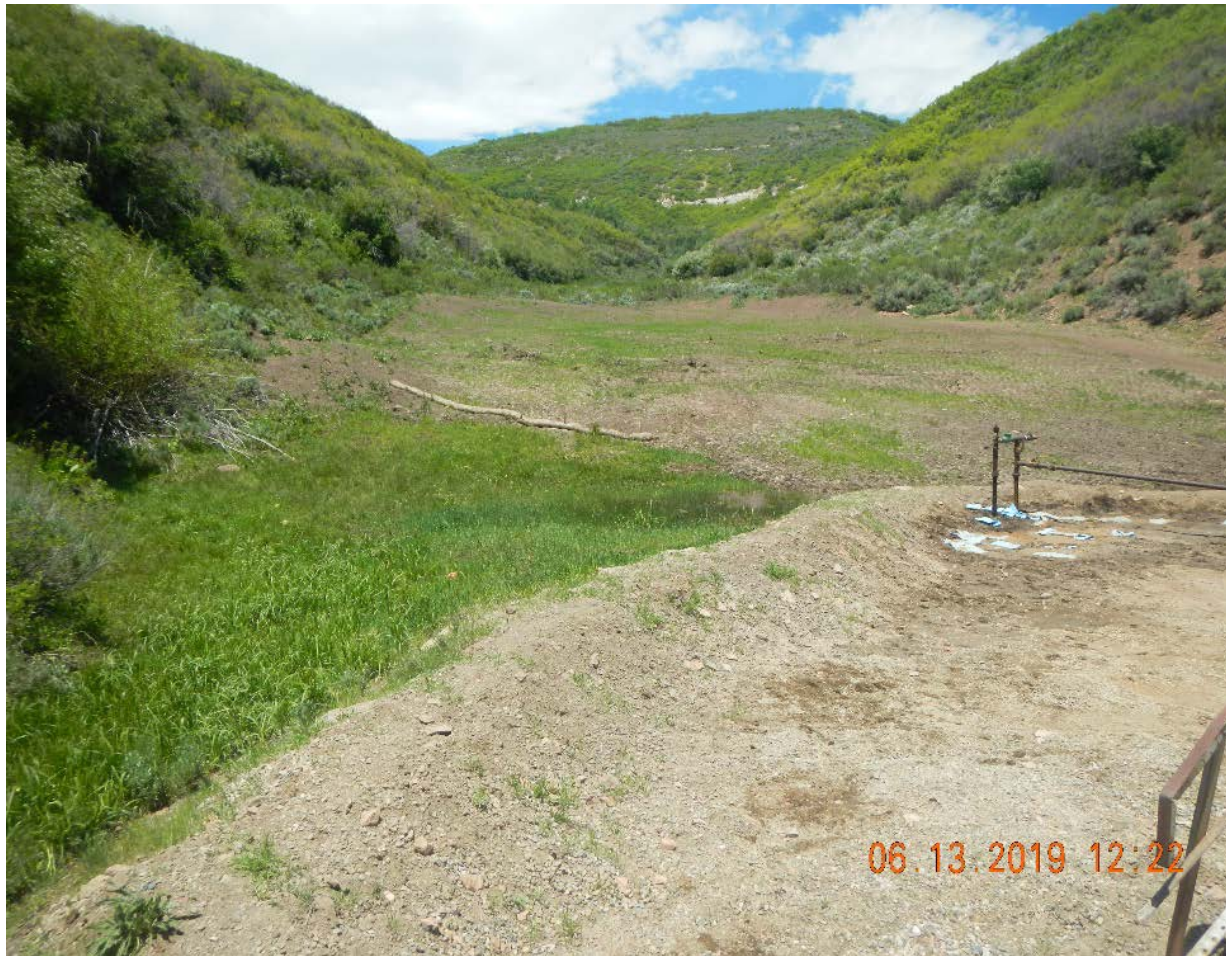
Looking up hill, mostly north

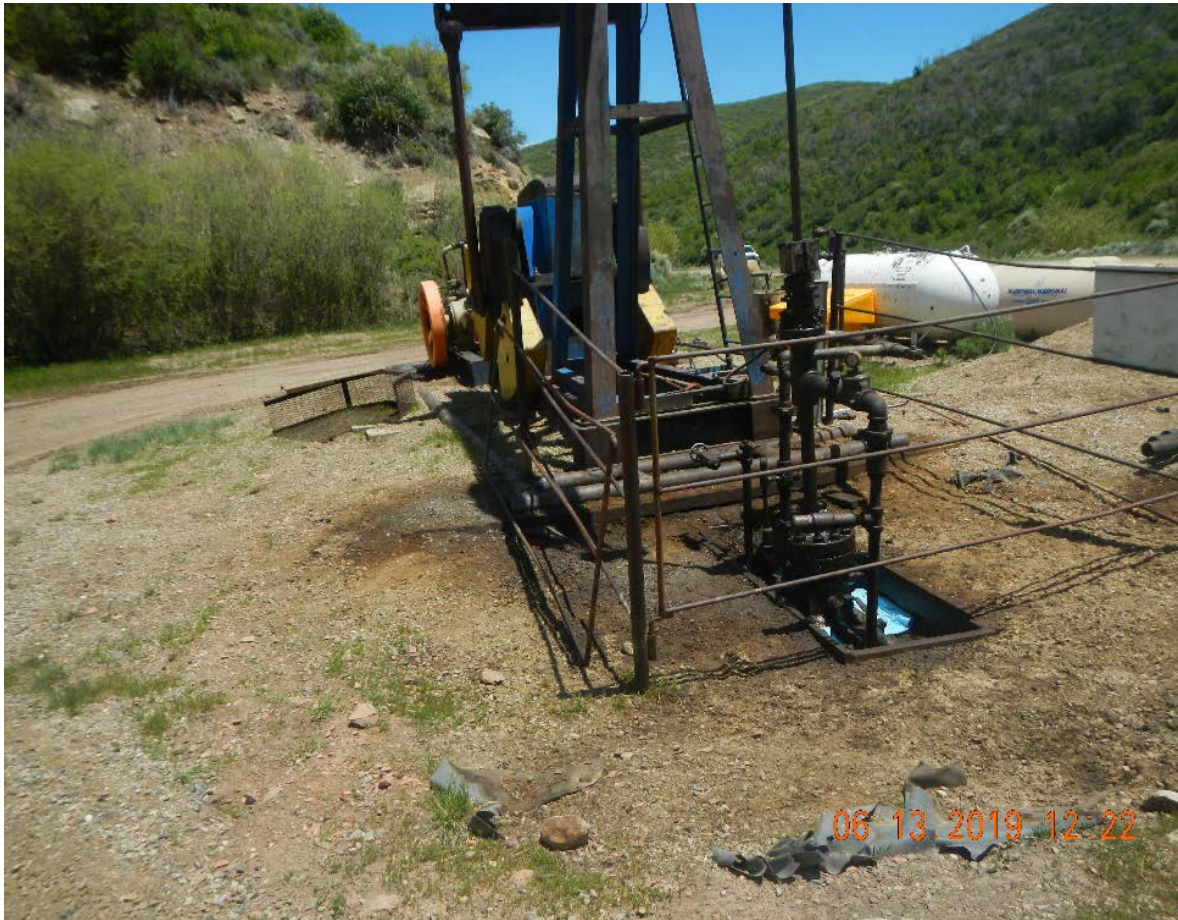
Wellhead, historic staining.
