STATE OF COLORADO

Doc# 02573004
Email Correspondence
Facility ID 374696
20190614

Jolley 22-16 Inspection

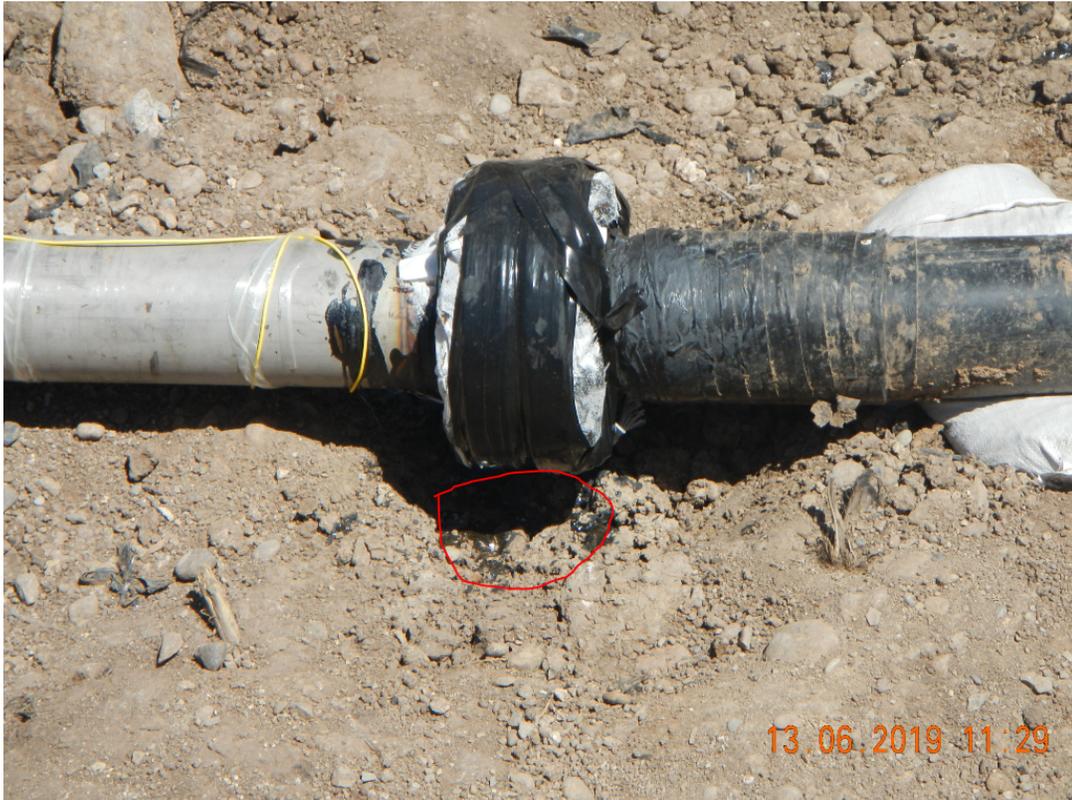
Upon inspection of the Jolley 22-16 pit and well pad, Steven and I observed some black fluids pooling below the union of an excavated flowline. FYI-if the fluids are the result of a leak then the line should be pressure tested before returning to service.

I just heard back from our construction supervisor and the "black fluid" that you see is simply a mastic (i.e., exterior coating) that is used for cathodic protection purposes. The mastic is spread over the bolts on the flange to help prevent them from rusting out. I also spoke with one of our guys who is out on that job right now and he assured me that this flange is not leaking.

The mastic is a thick, viscous, sticky material and it is a messy product to use. I will have the guys clean up any residual mastic that may be on the ground, but this is simply a protective exterior coating that is used on flanges, fittings, etc. that may be susceptible to corrosion.

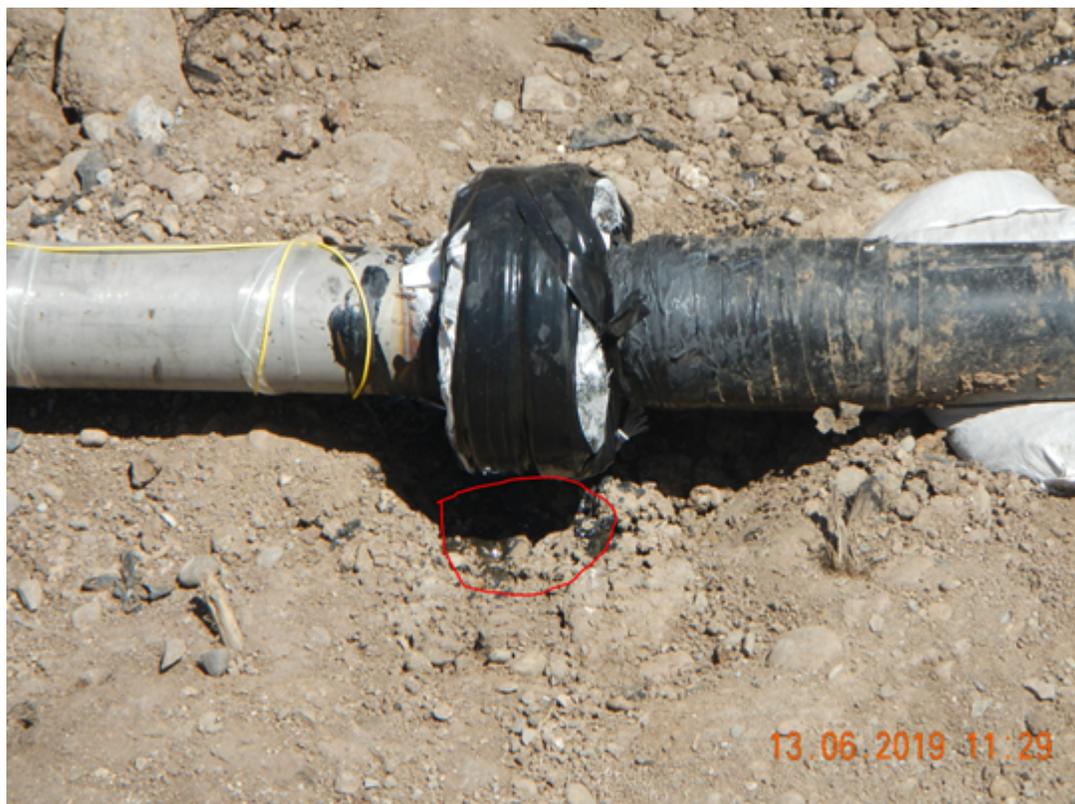
Upon inspection of the Jolley 22-16 pit and well pad, Steven and I observed some black fluids pooling below the union of an excavated flowline. FYI-if the fluids are the result of a leak then the line should be pressure tested before returning to service.
