Inspection Photos

Location Name: Railay West 2833-1NH Location ID 438066, Spill ID #465340

Inspection Date: 6/14/2019

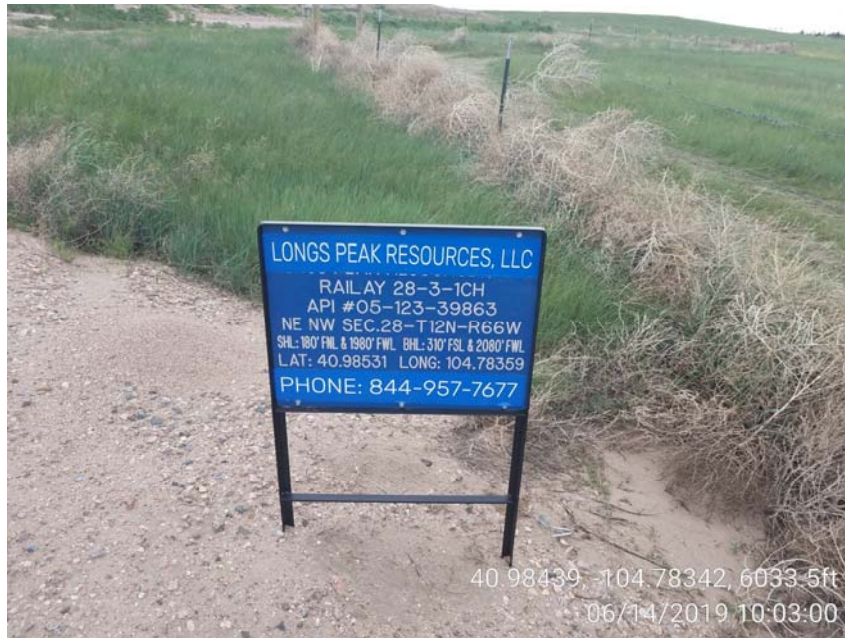
Photo 1 – Location Sign at pad entrance, not at gate near access from US Hwy 85.

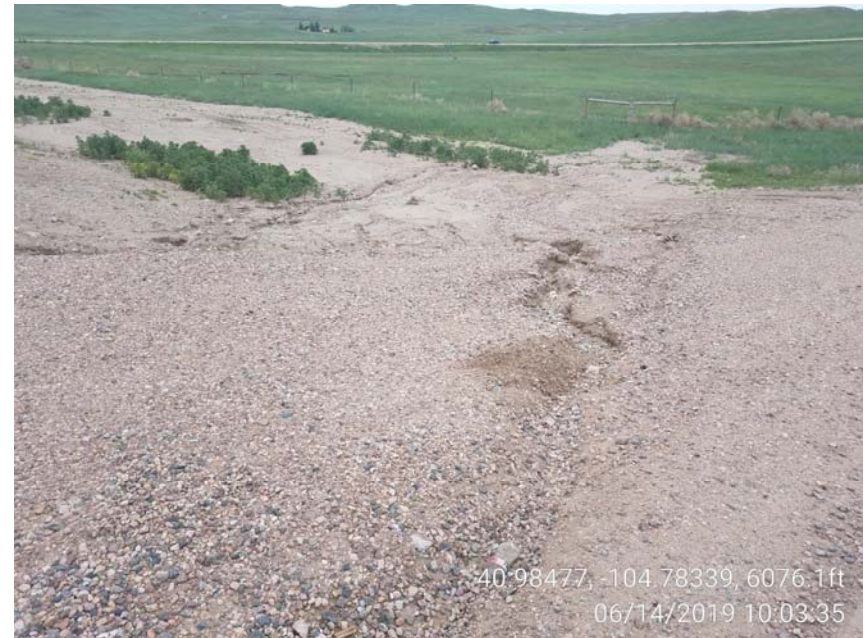
Photo 2 – Runoff and rills from south side of pad where access road enters pad.

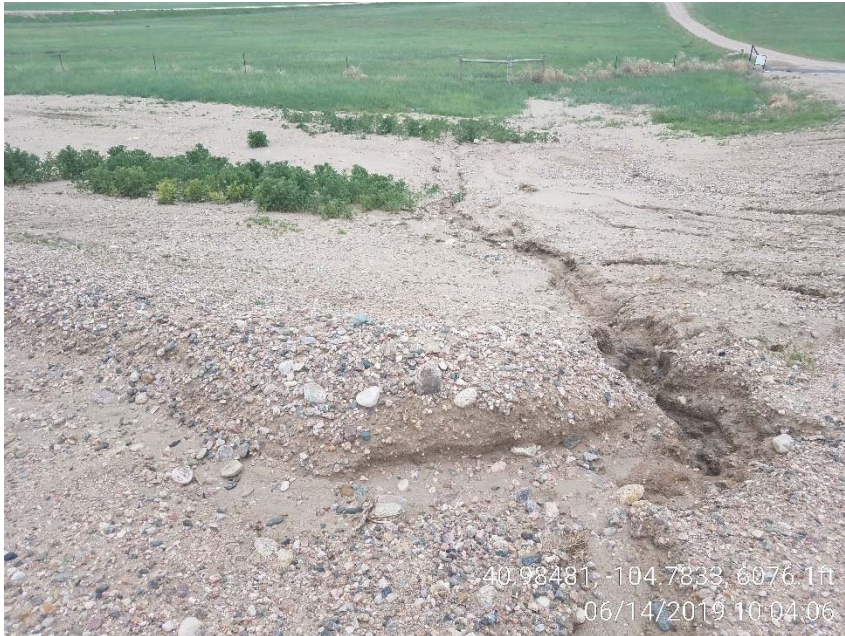
Photo 3 – Rill developing around site berm where access road enters pad on south side of pad.

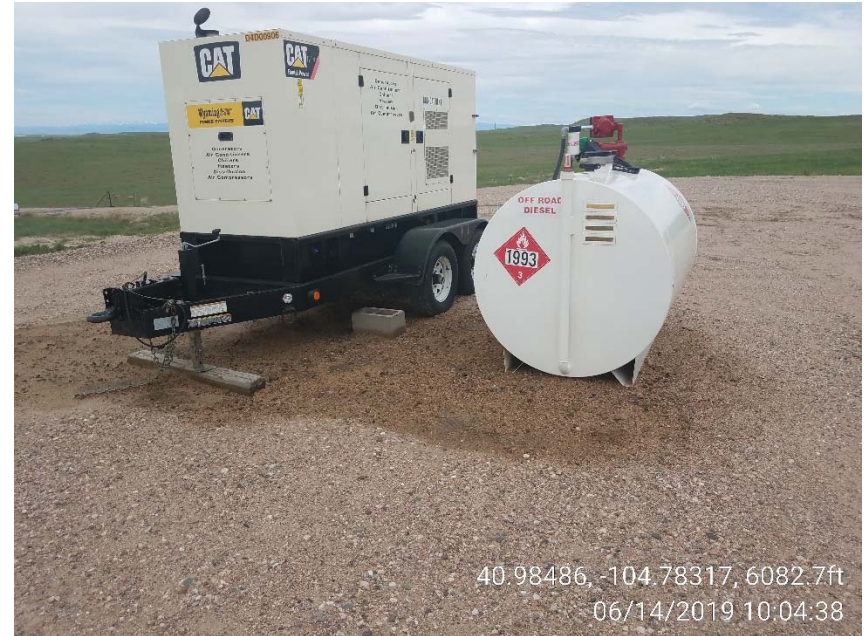
Photo 4 – Diesel AST either leaks or was overfilled. Stain on ground has diesel odor.

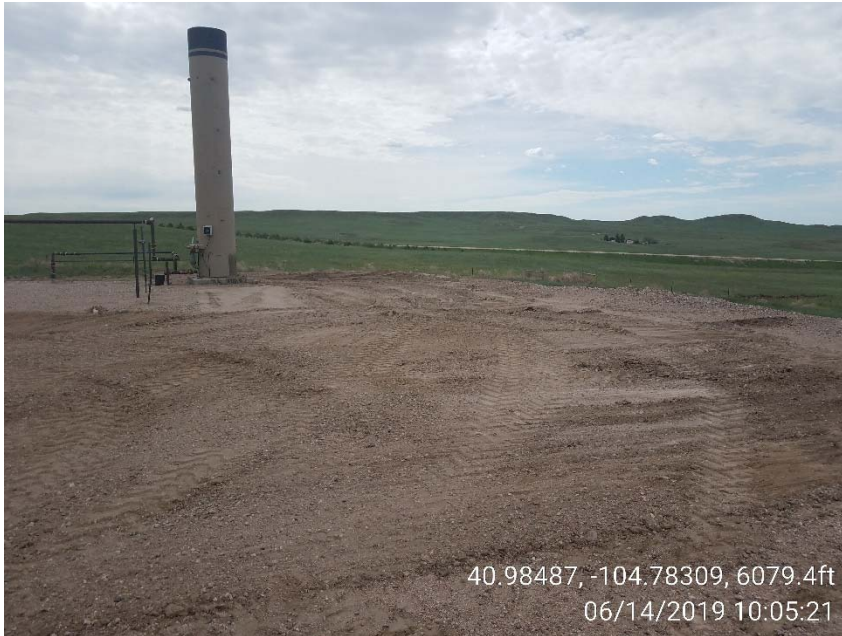
Photo 5 – Looking east at combustor, source of reported release. Pad has been scraped.

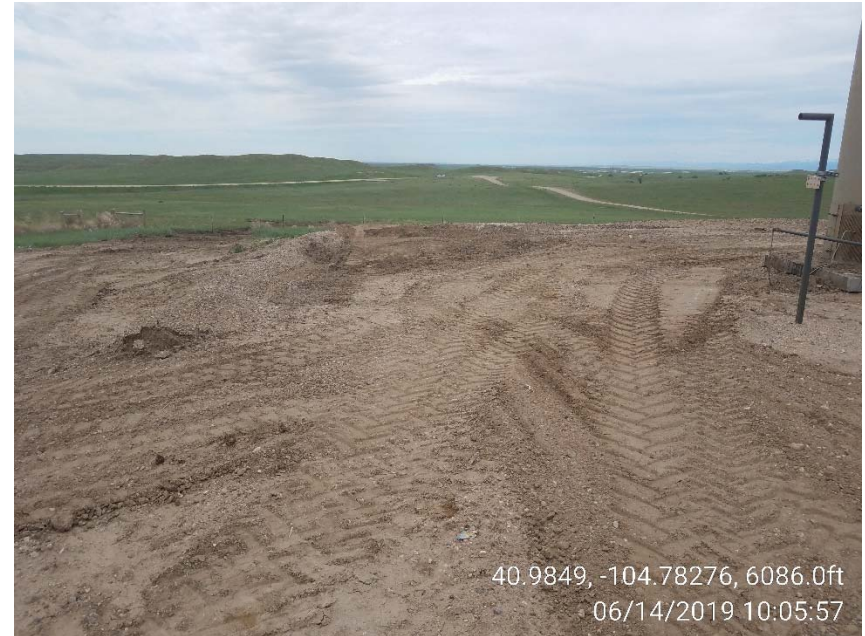
Photo 6 – East side of combustor in corner of pad, looking south.

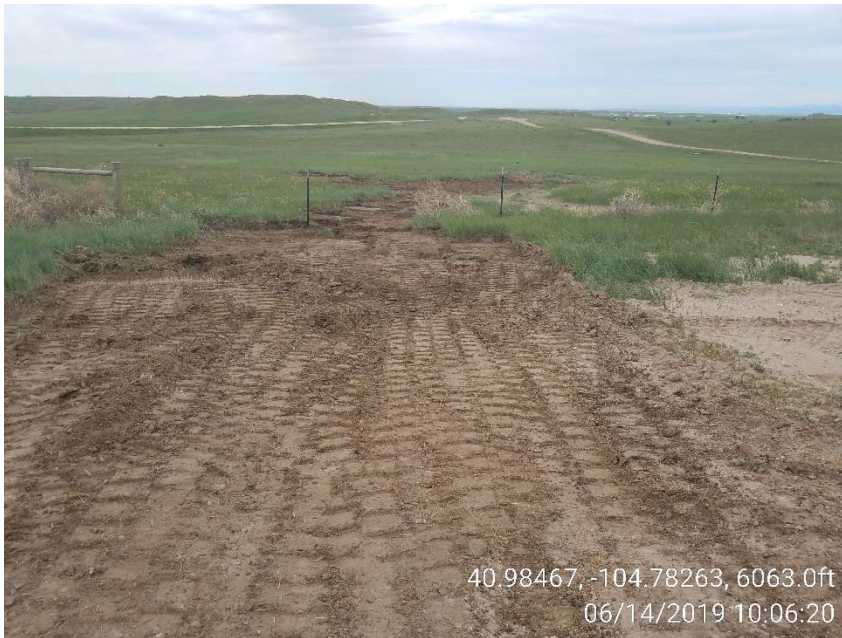
Photo 7 – On southeast corner of location looking south toward path of spill from combustor reported on 6/13/2019.

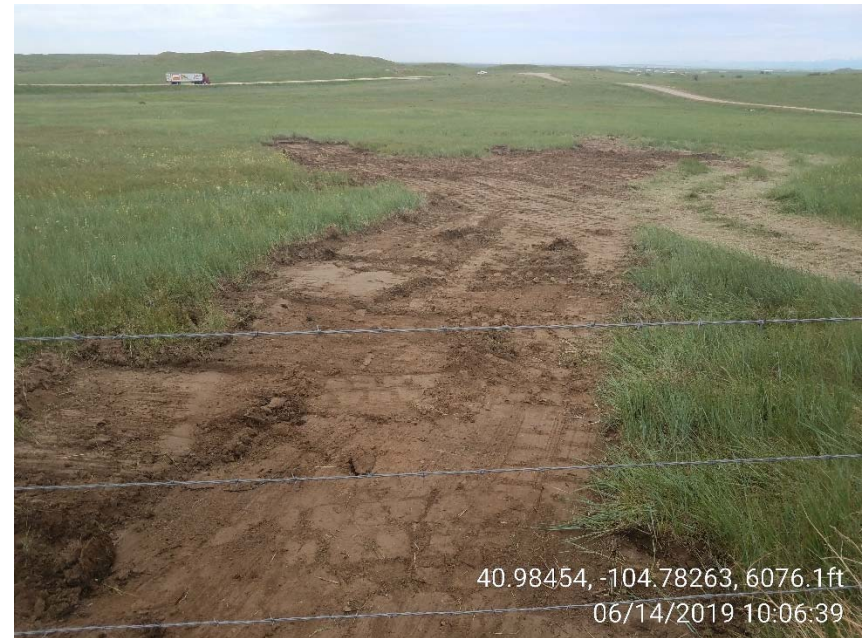
Photo 8 – Spill traveled offsite onto rangeland. Looking south from fence on south edge of pad.

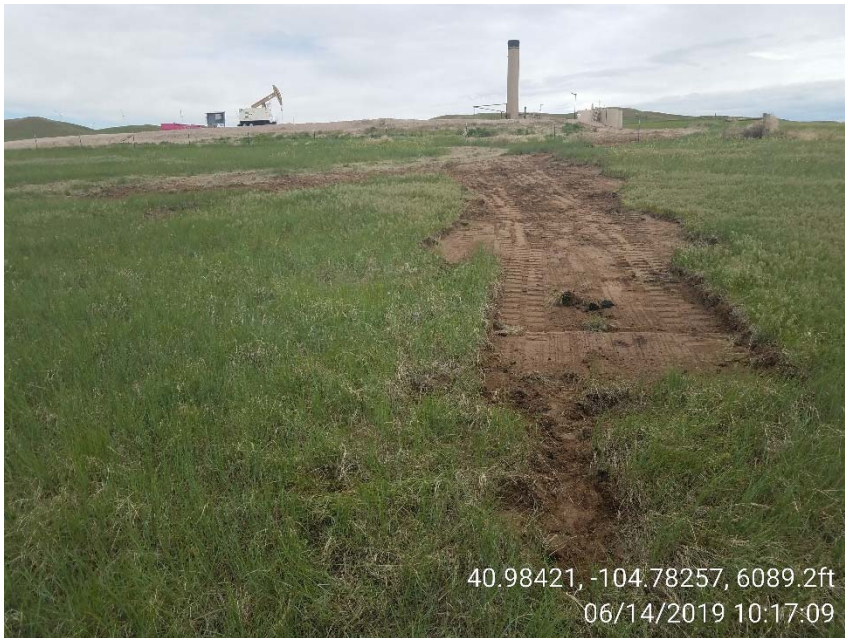
Photo 9 – From east lobe of south end of spill extent looking north.

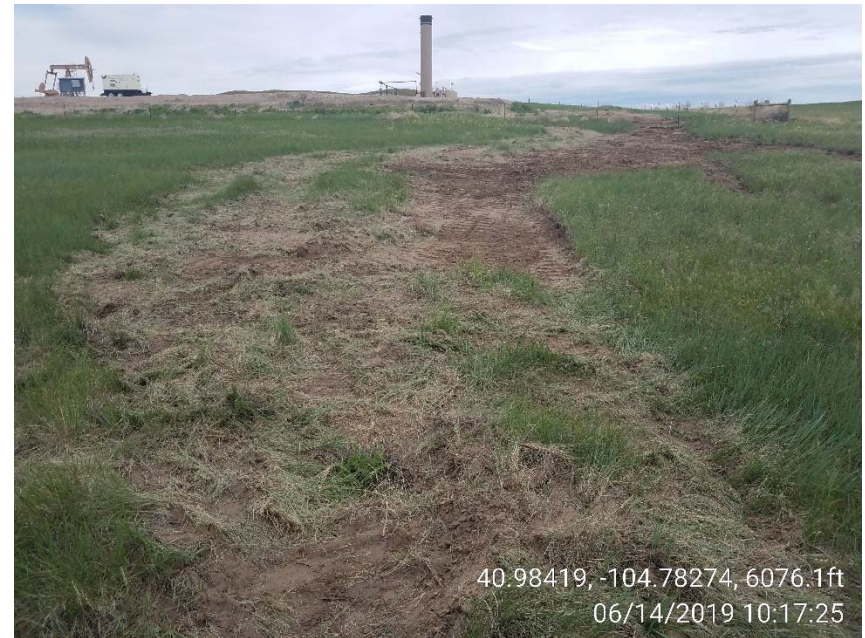
Photo 10 - From west lobe of south end of spill extent looking north.

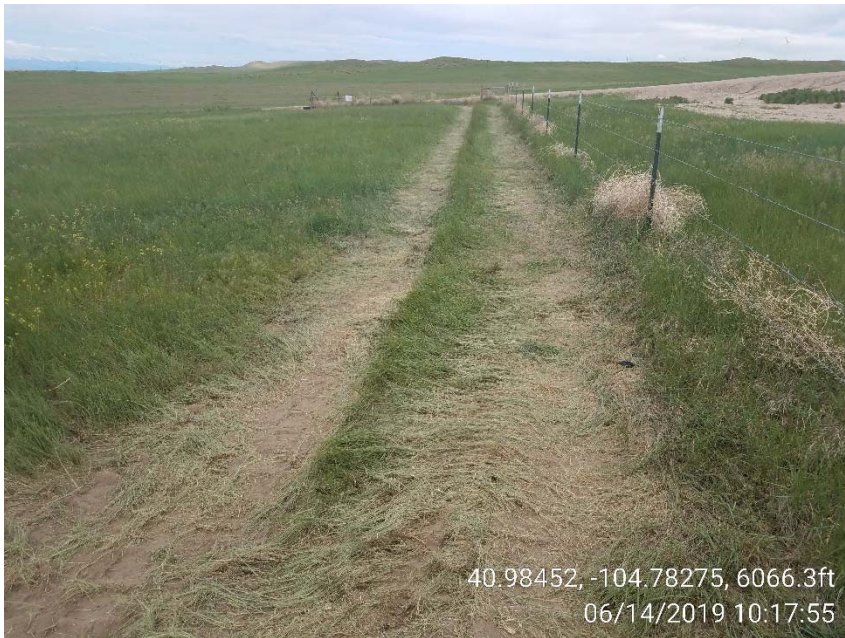
Photo 11 – Two track that developed outside location southern fence line from equipment access spill area. Looking west.

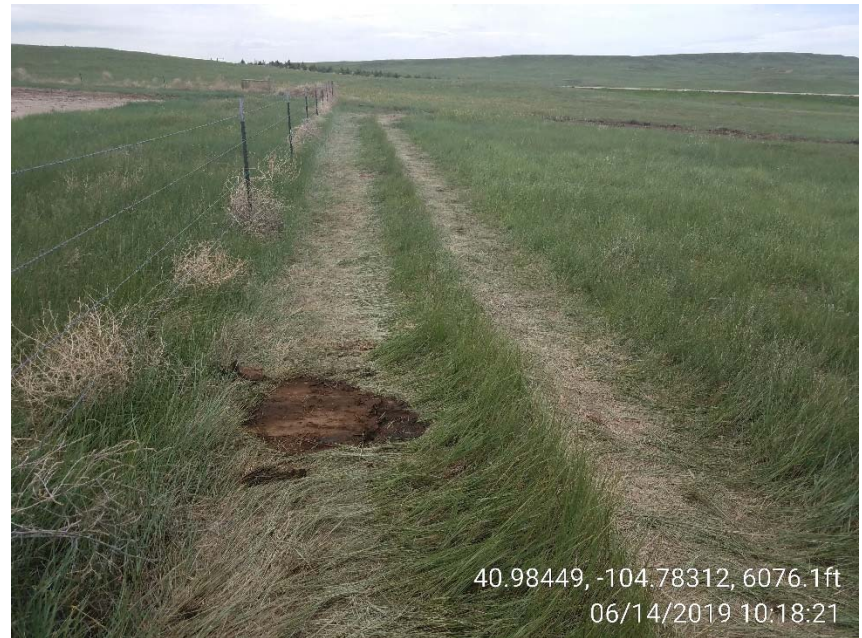
Photo 12 – Two track that developed outside location southern fence line from equipment access spill area. Looking east. Deminimus oily soil present along two track.

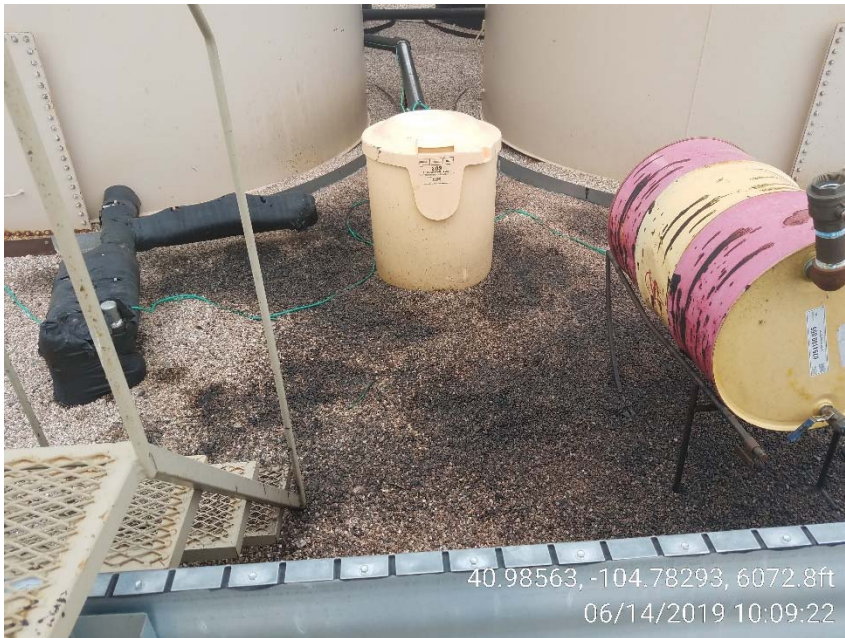
Photo 13 – Residual oil impacts in AST secondary containment.

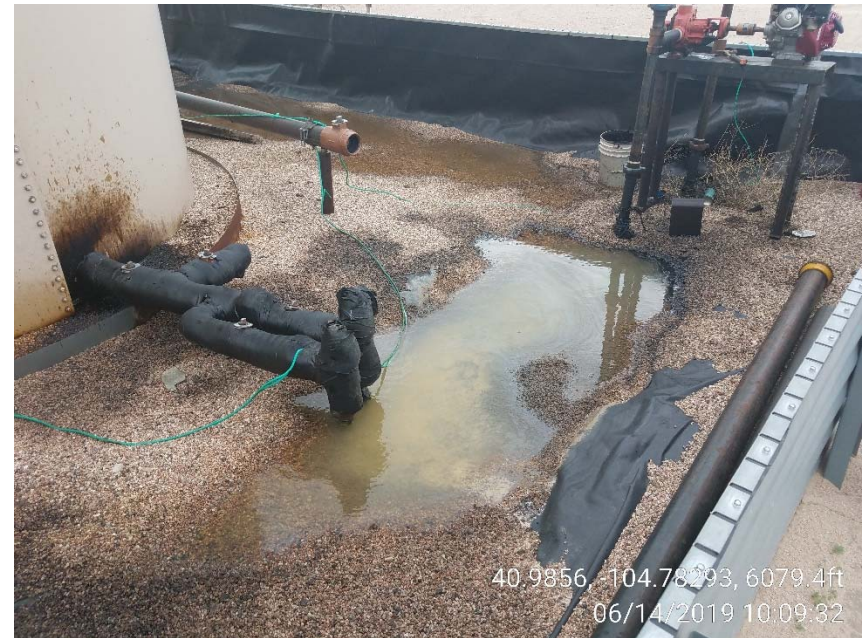
Photo 14 – Stormwater mixed with oil inside AST secondary containment.

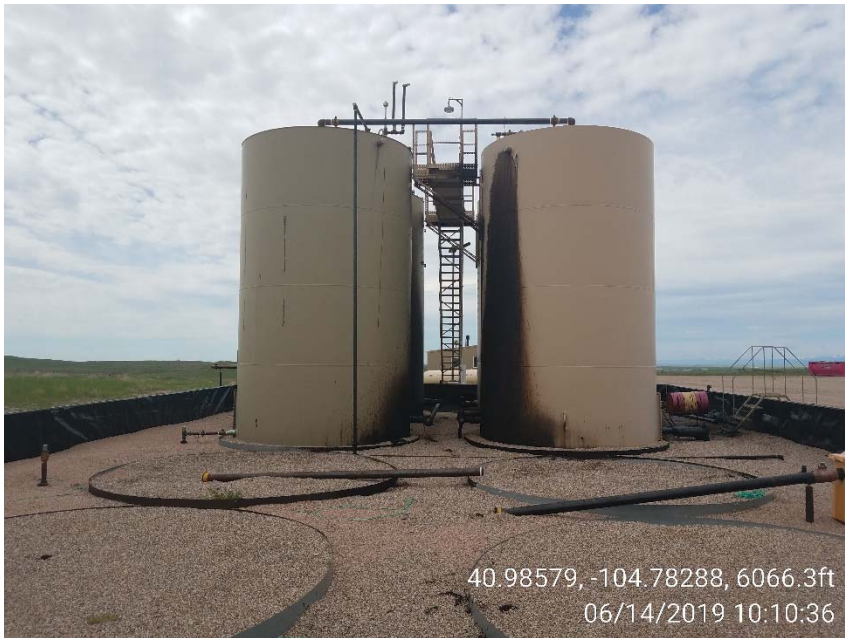
Photo 15 – Oil stains on ASTs from former oil release.

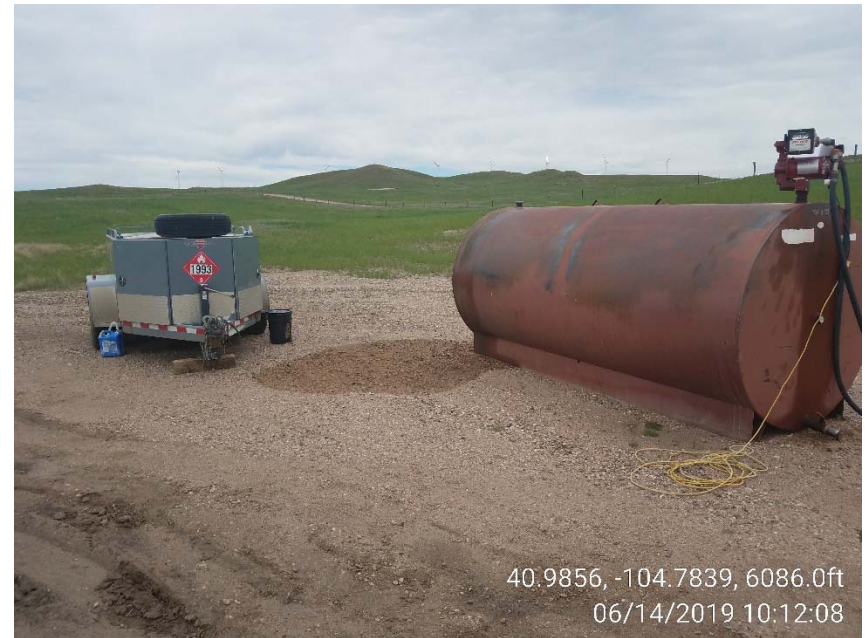
Photo 16 – Diesel fuel leaked from AST stored on northwest corner of location.
