# Inspection Photos

API: 05-009-06568

Operator: ENERGY ALLIANCE COMPANY

Inspection Date: 6/13/2019

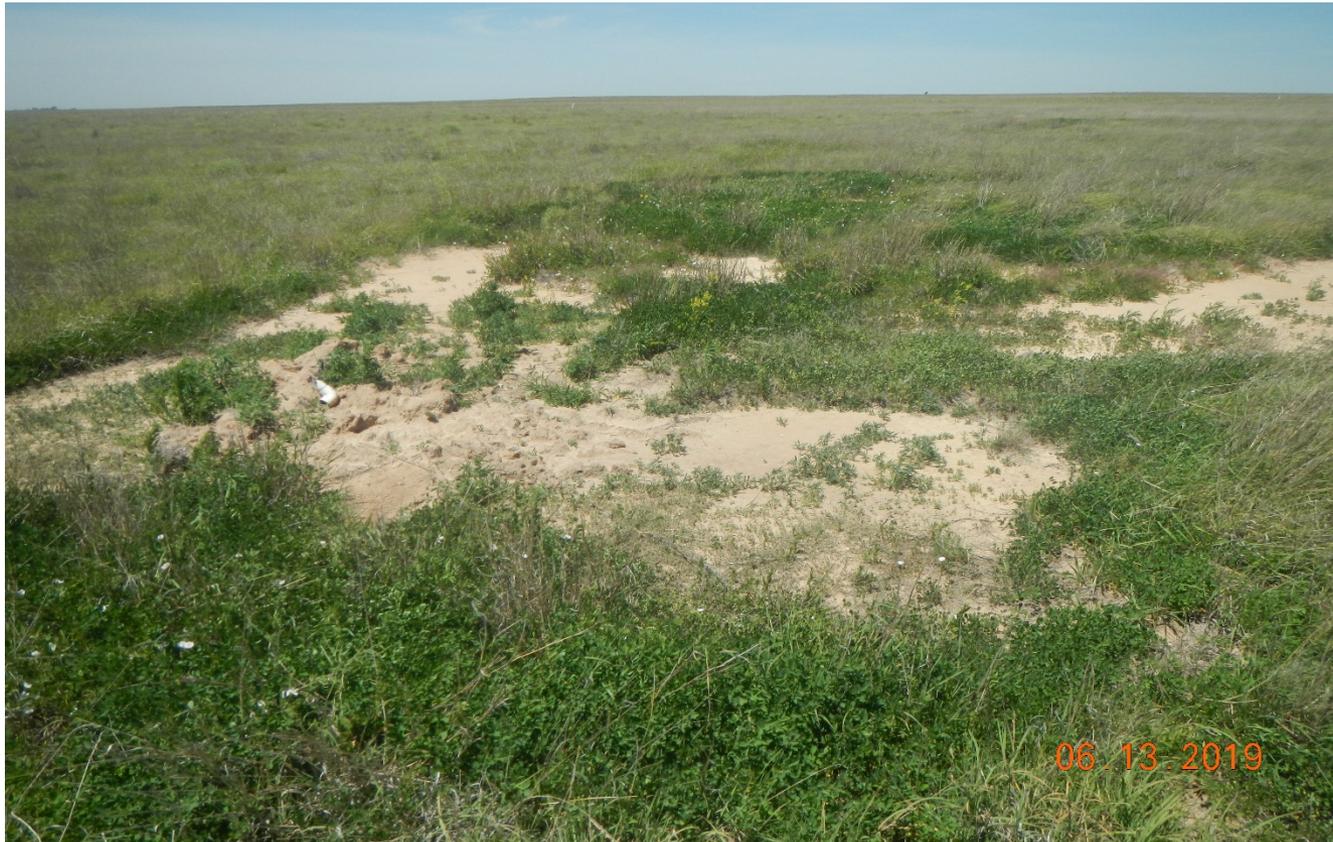
**Photo 1.** Facing west at the location. Pipe risers have been removed.

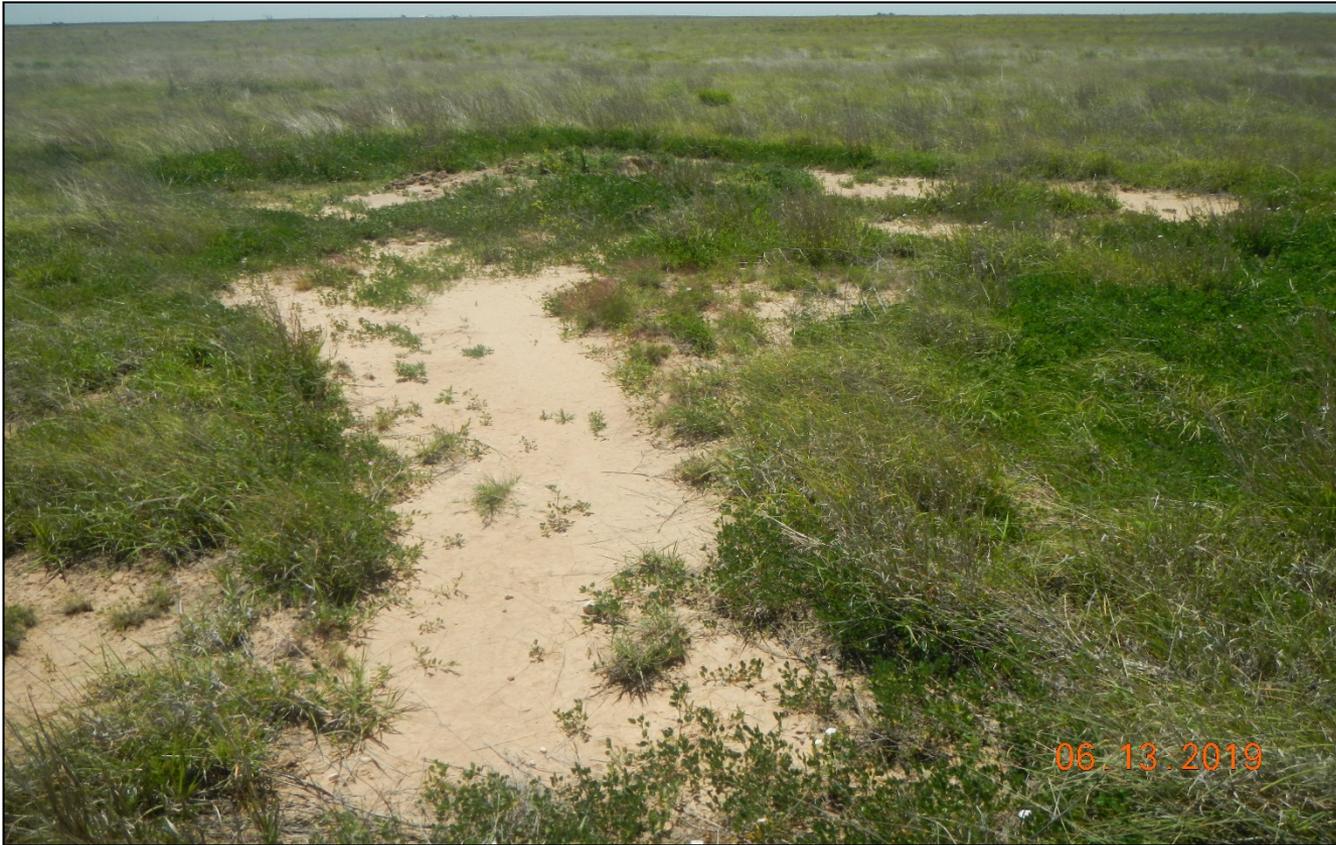
**Photo 2.** Facing east. Vegetation has not reestablished on 50 ft. x 50 ft. area.

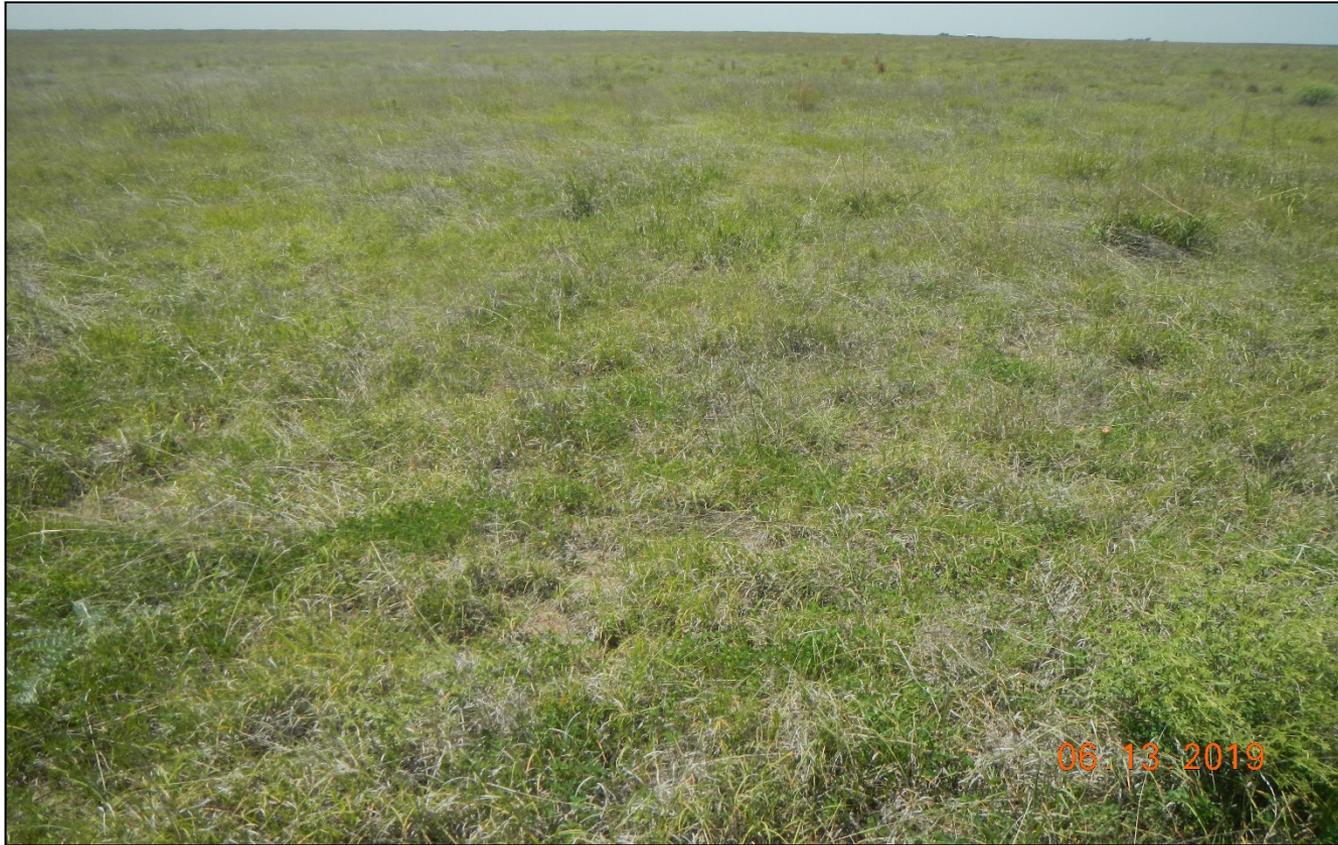
**Photo 3.** Facing north at the surrounding reference area.
