Caerus Piceance LLC
API # 05-045-15432
Inspection # 696600153

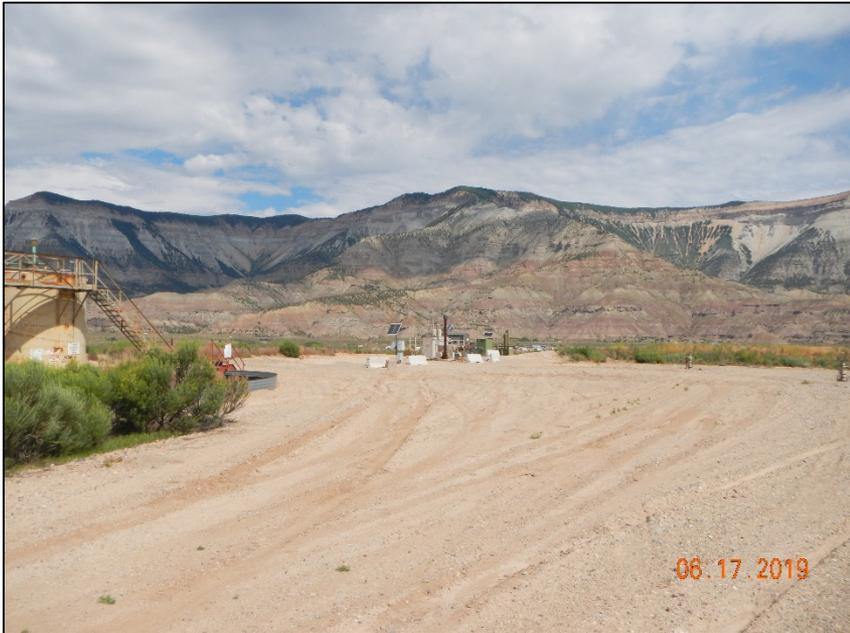
Photo #1 Photo from entrance of location.

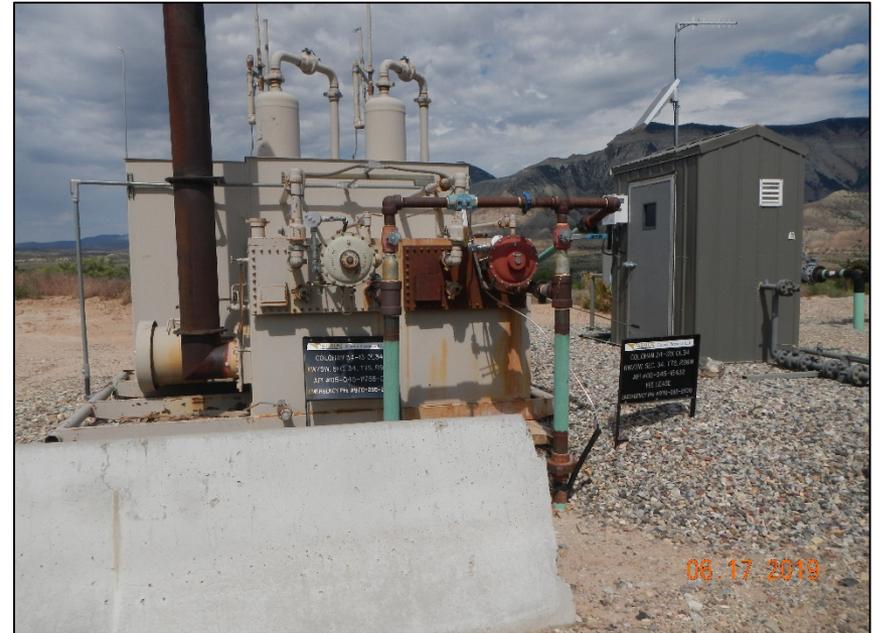
Photo #2 Separators on location.

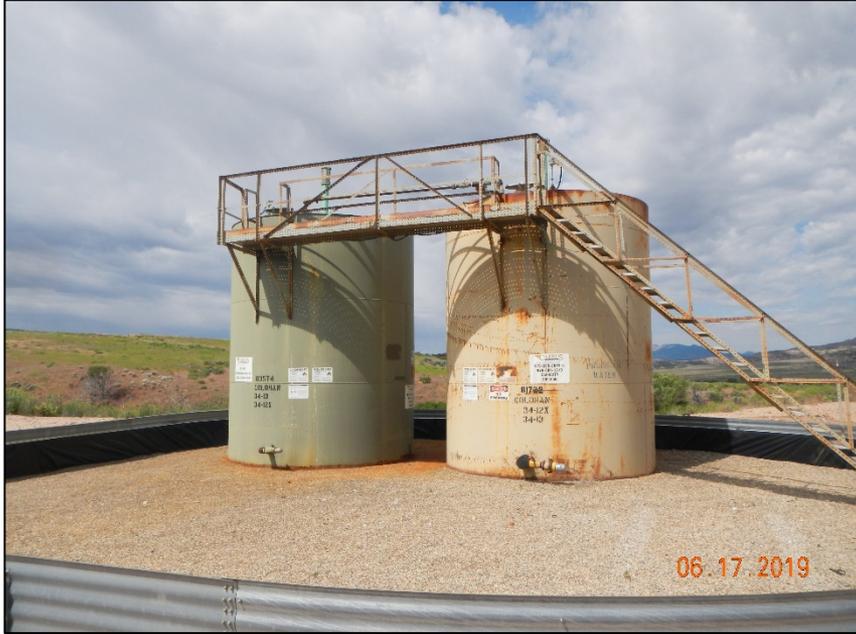
Photo #3 Photo of tank Battery

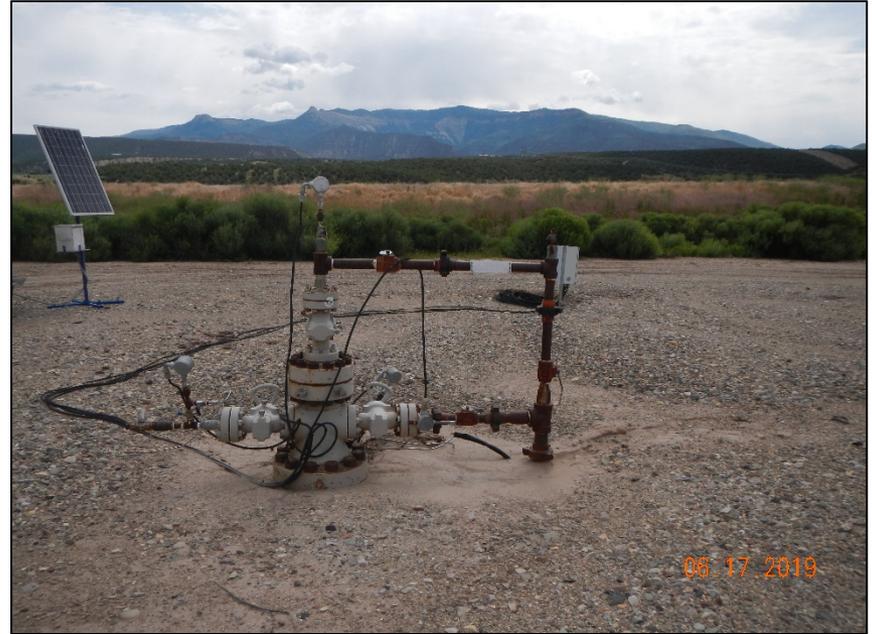
Photo #4 Photo of Wellheads

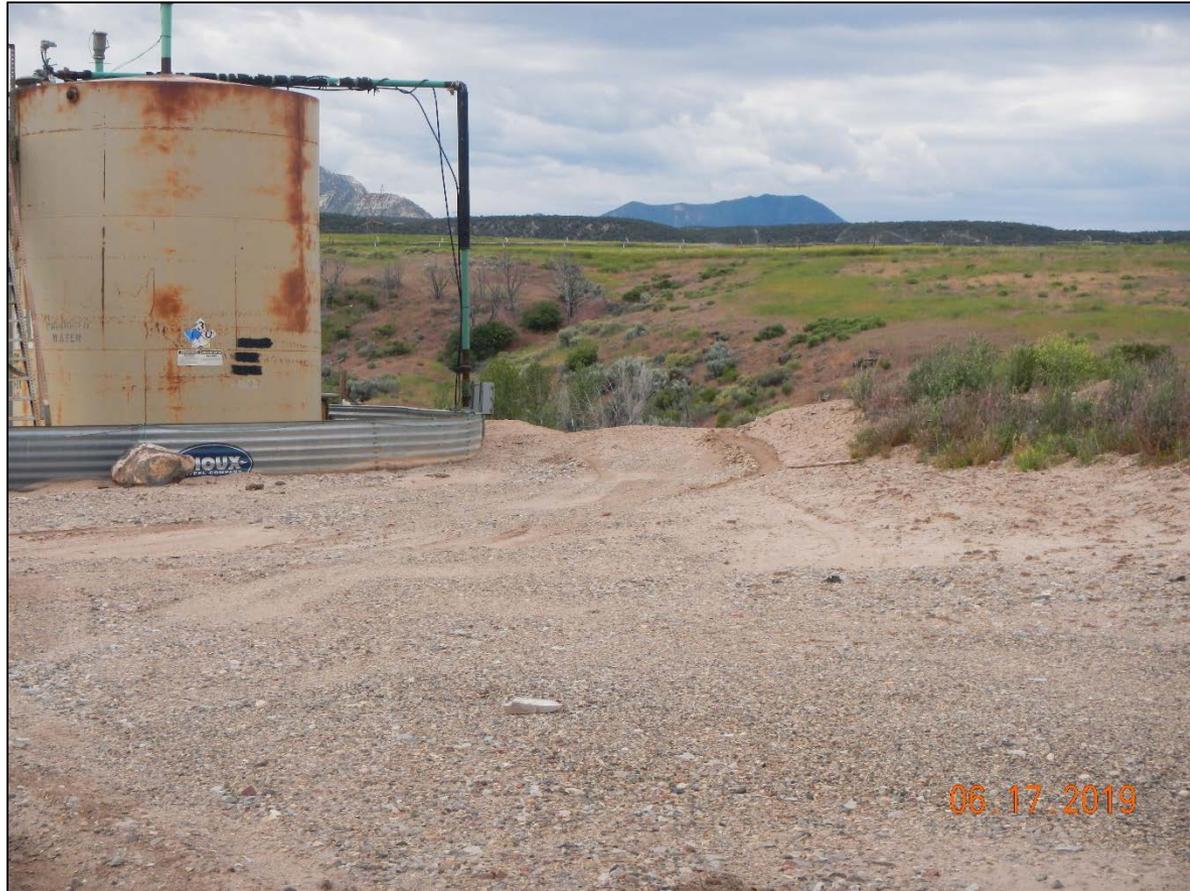
Photo # 5 Berm at SW corner of location need maintenance.

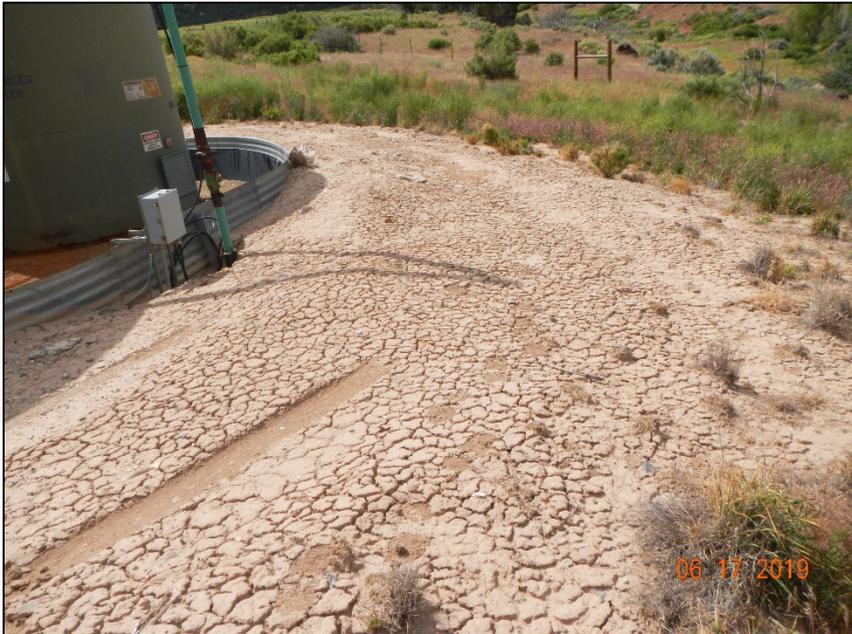
Photo # 6 Berm at SW corner of location need maintenance.

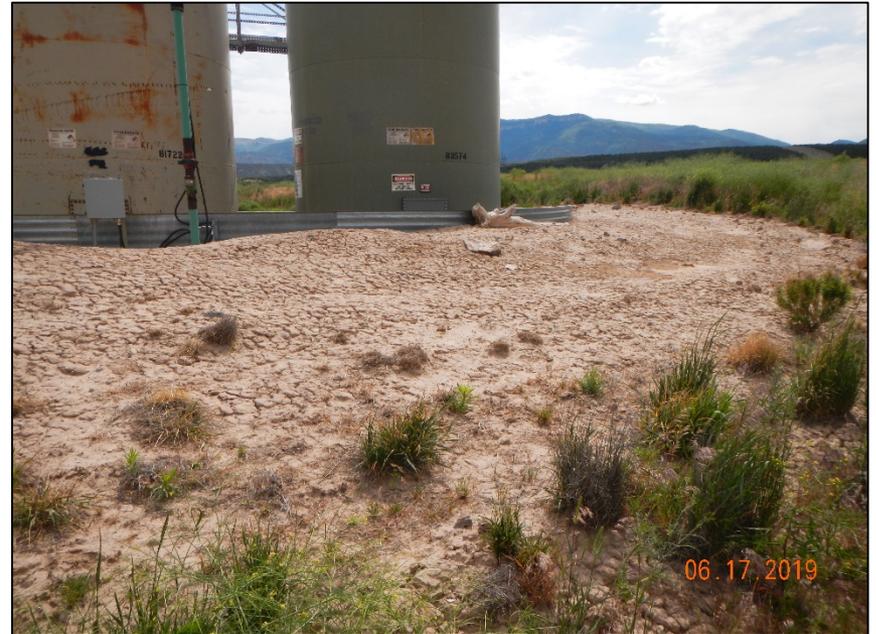
Photo # 7 Berm at SW corner of location need maintenance.
