DC-16 CO2 Well Location Photos
API #05-033-06185 / Facility ID #463479
FIR #693900266 / Form 4 #402079696

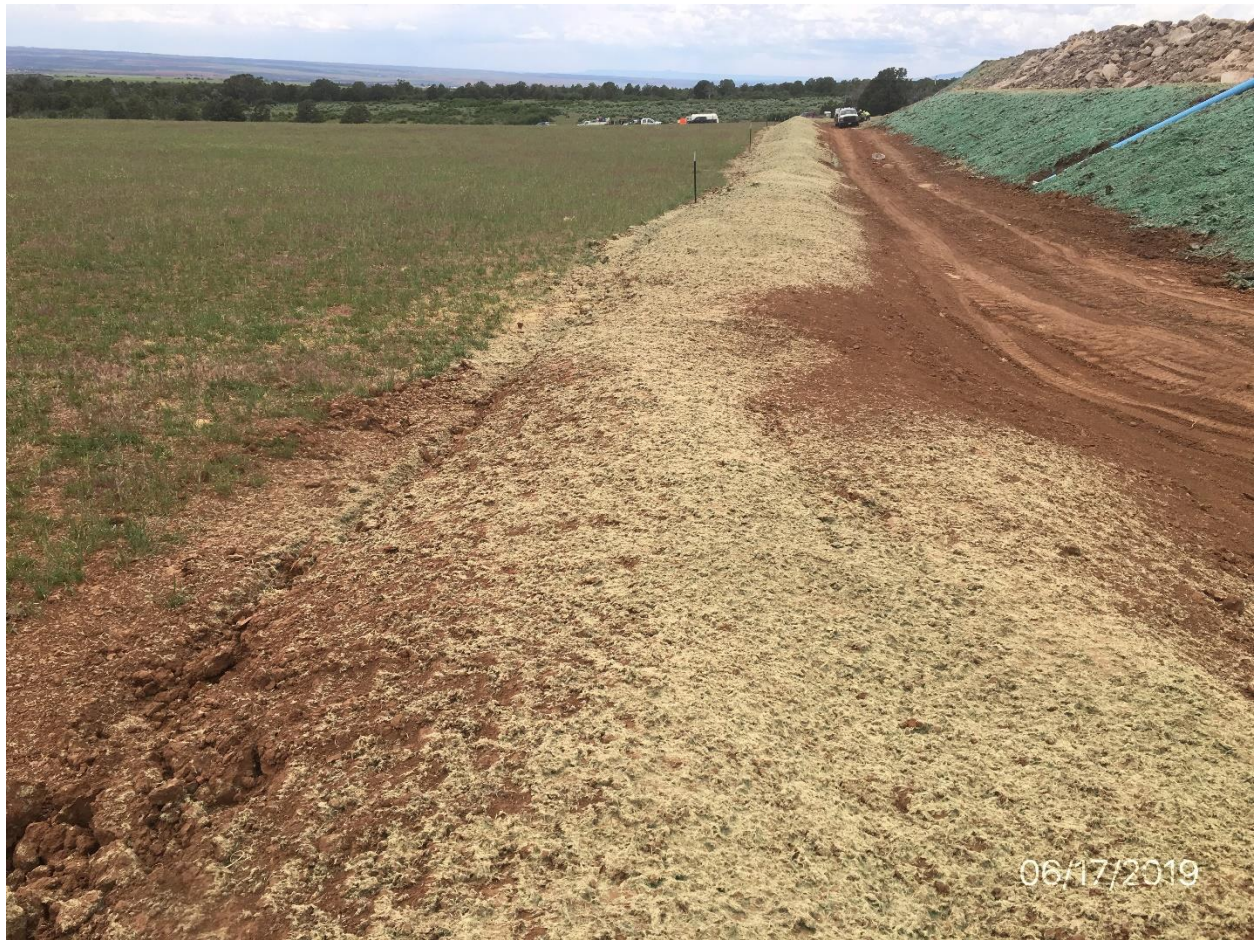
Photo 1: View of the southern project area from the southeastern corner facing westward. Storm water erosion controls installed.

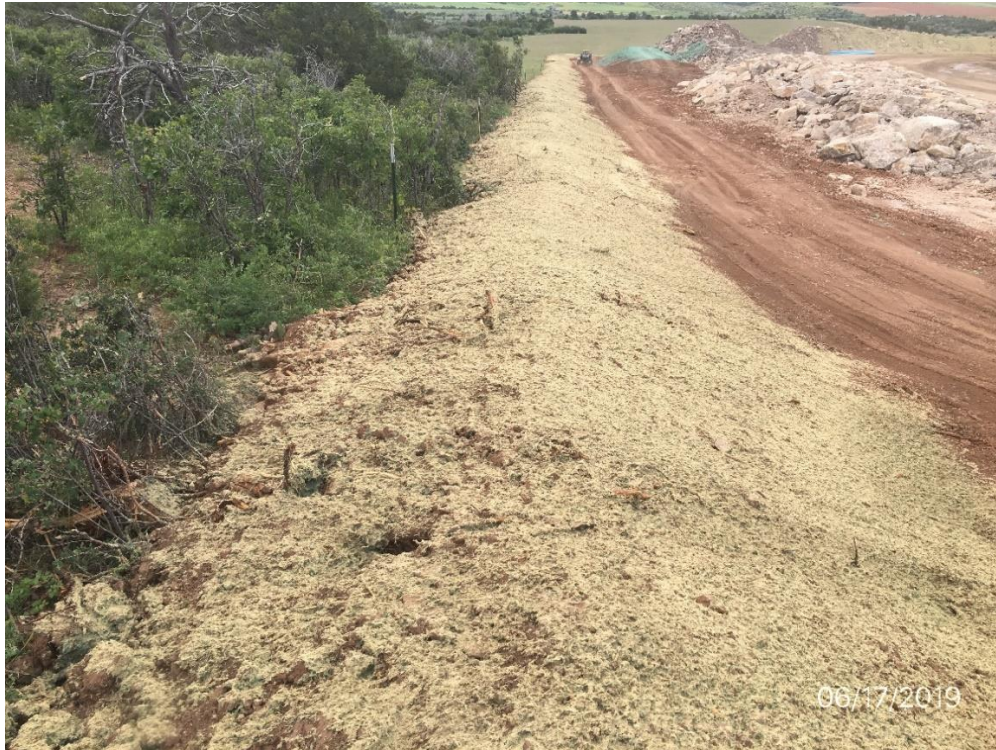
Photo 2: View of the eastern project area from the northeastern corner facing southward. Storm water controls in place.

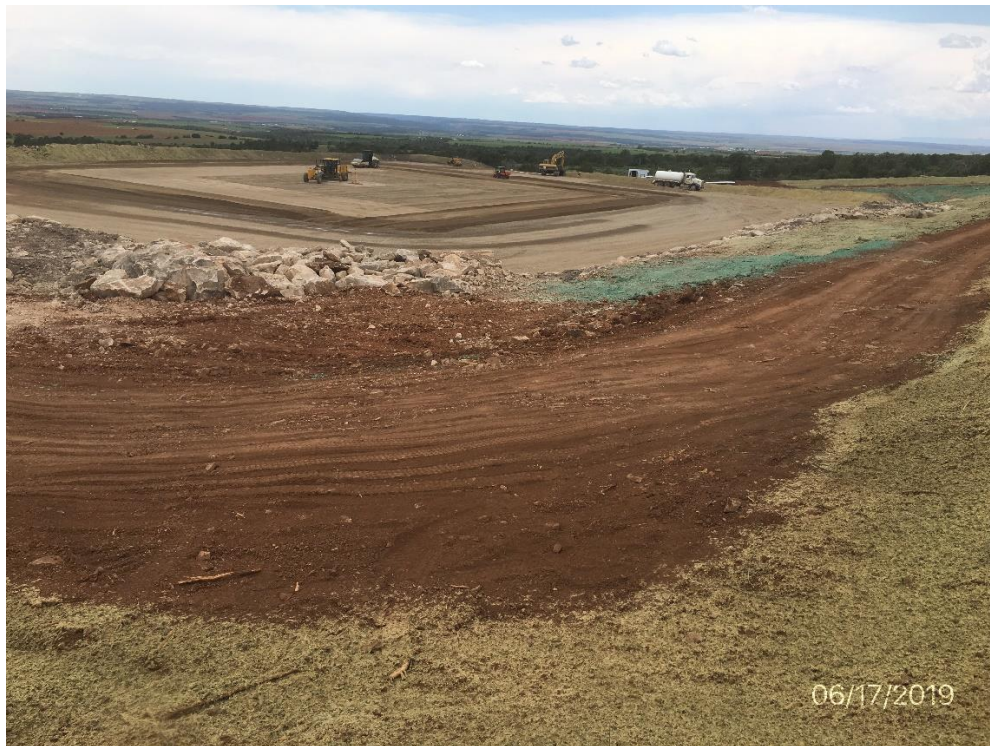
Photo 3: View of the project area from the northeastern corner facing center.

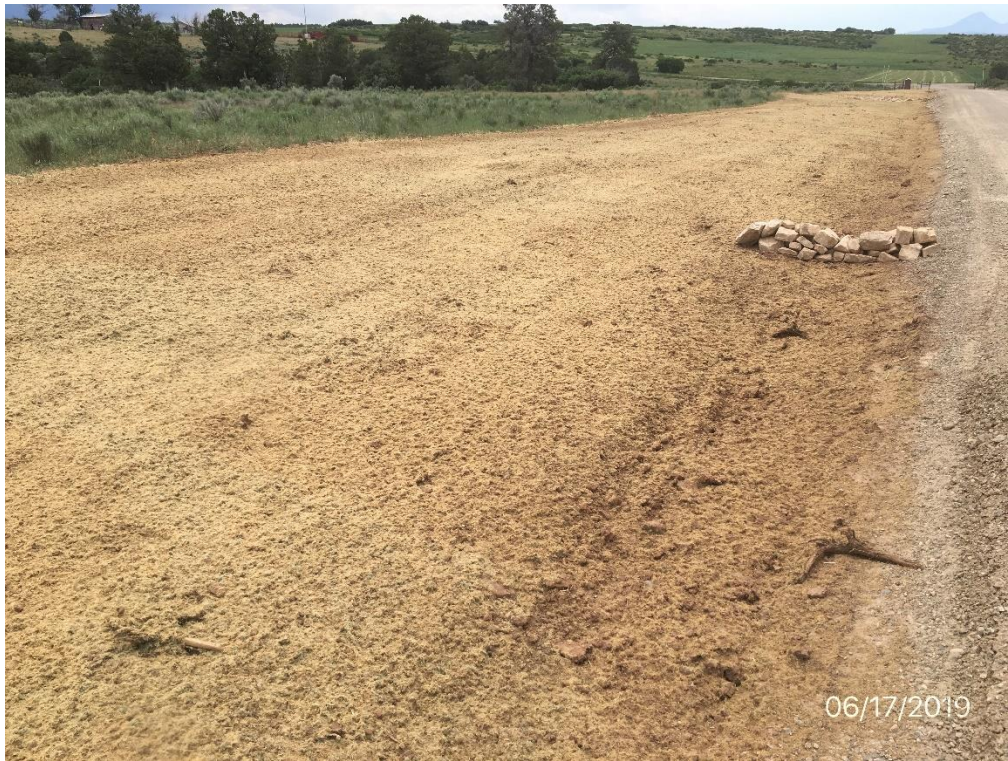
Photo 4: Perimeter controls installed along access road to prevent topsoil loss.
