# Inspection Photos

API: 05-071-09060

Operator: ARP PRODUCTION COMPANY  
WAPITI OPERATING LLC

Inspection Date: 6/19/2019

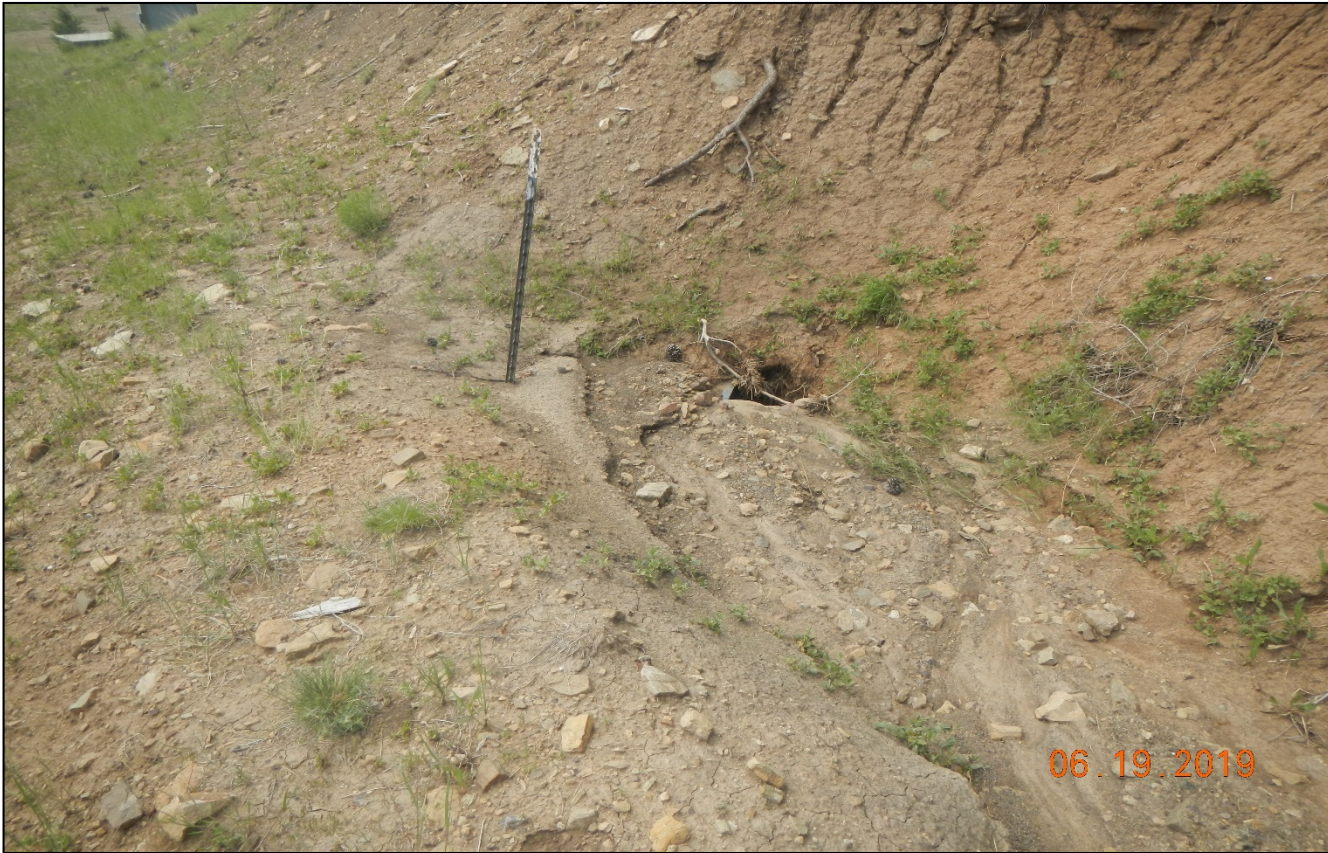
**Photo 1.** The culvert along the main access road has filled in with sediment.  
Lat/Long:37.02576,-104.83253

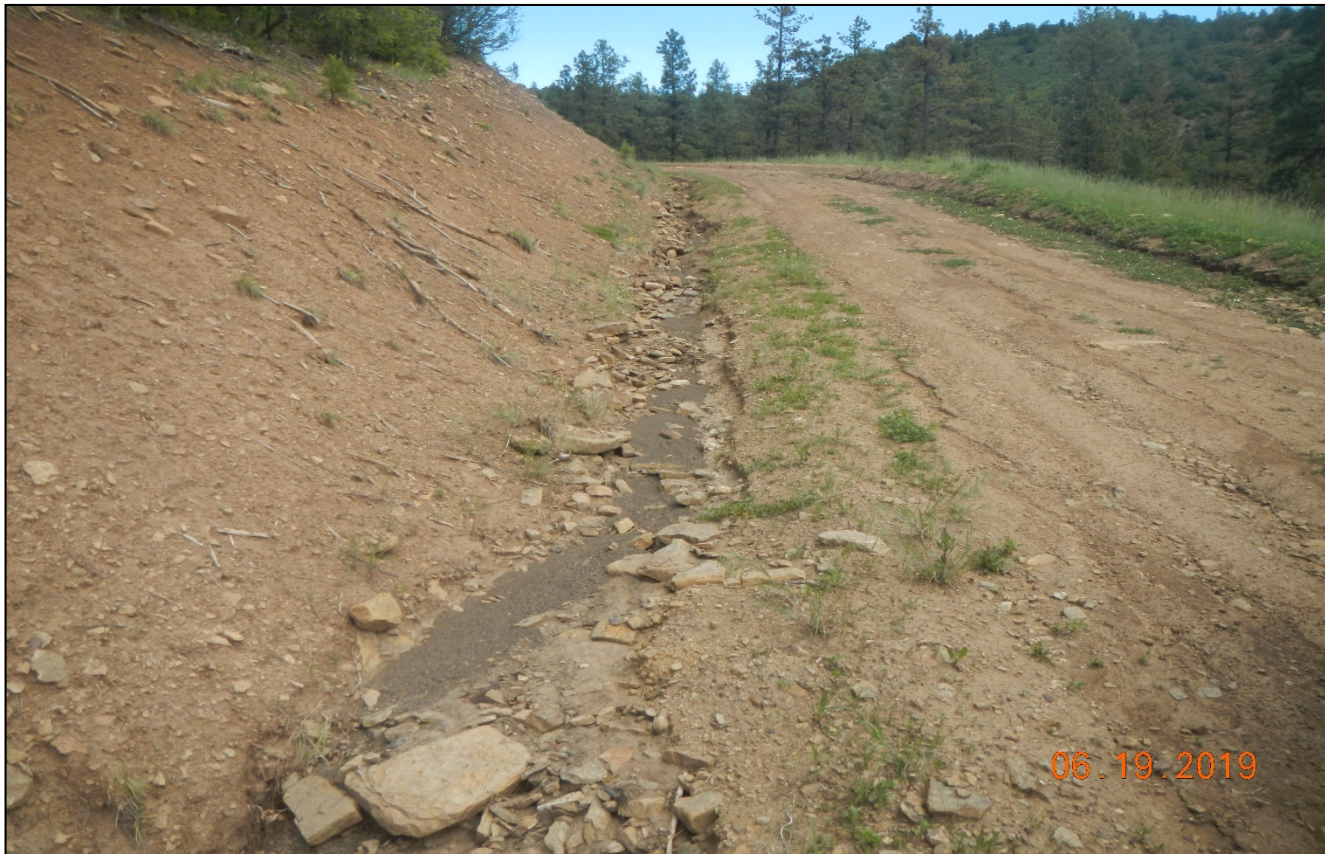
**Photo 2.** There is erosion down the side of the road. No BMPs installed to prevent erosion. Lat/Long:37.02576,-104.83253

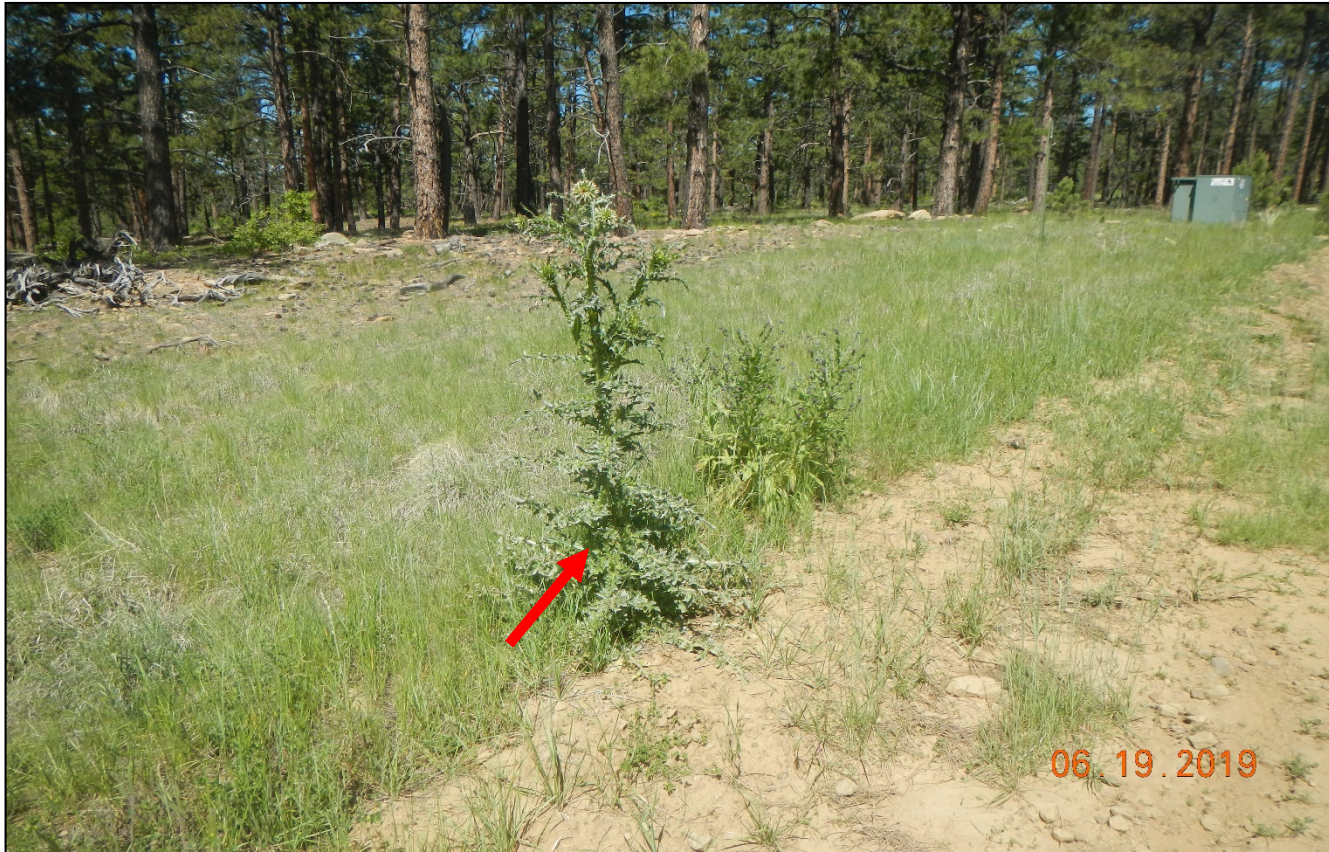
**Photo 4.** There is List B noxious weeds growing along the main & access road to the location. (Musk thistle shown in photo)

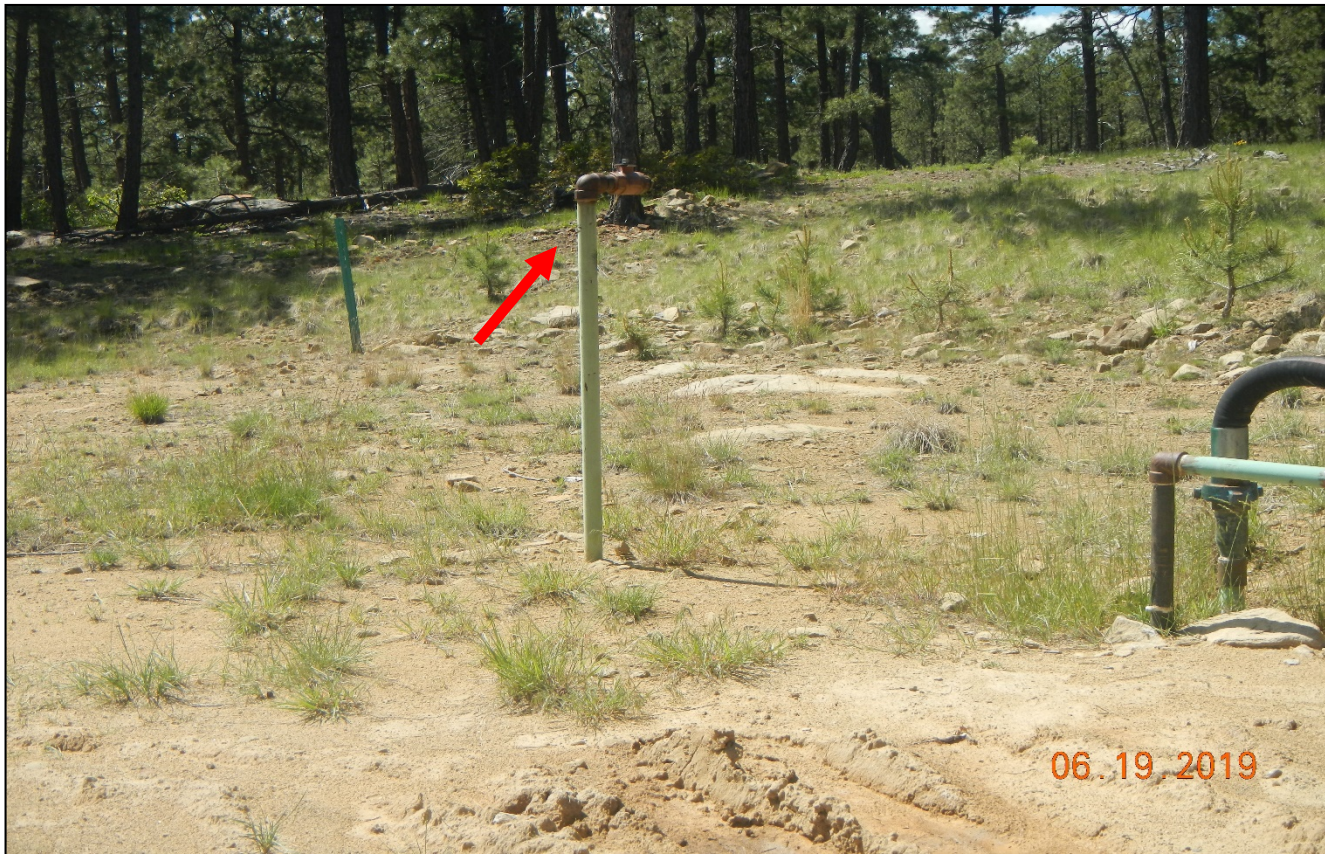
**Photo 5.** No LO/TO on pipe riser.

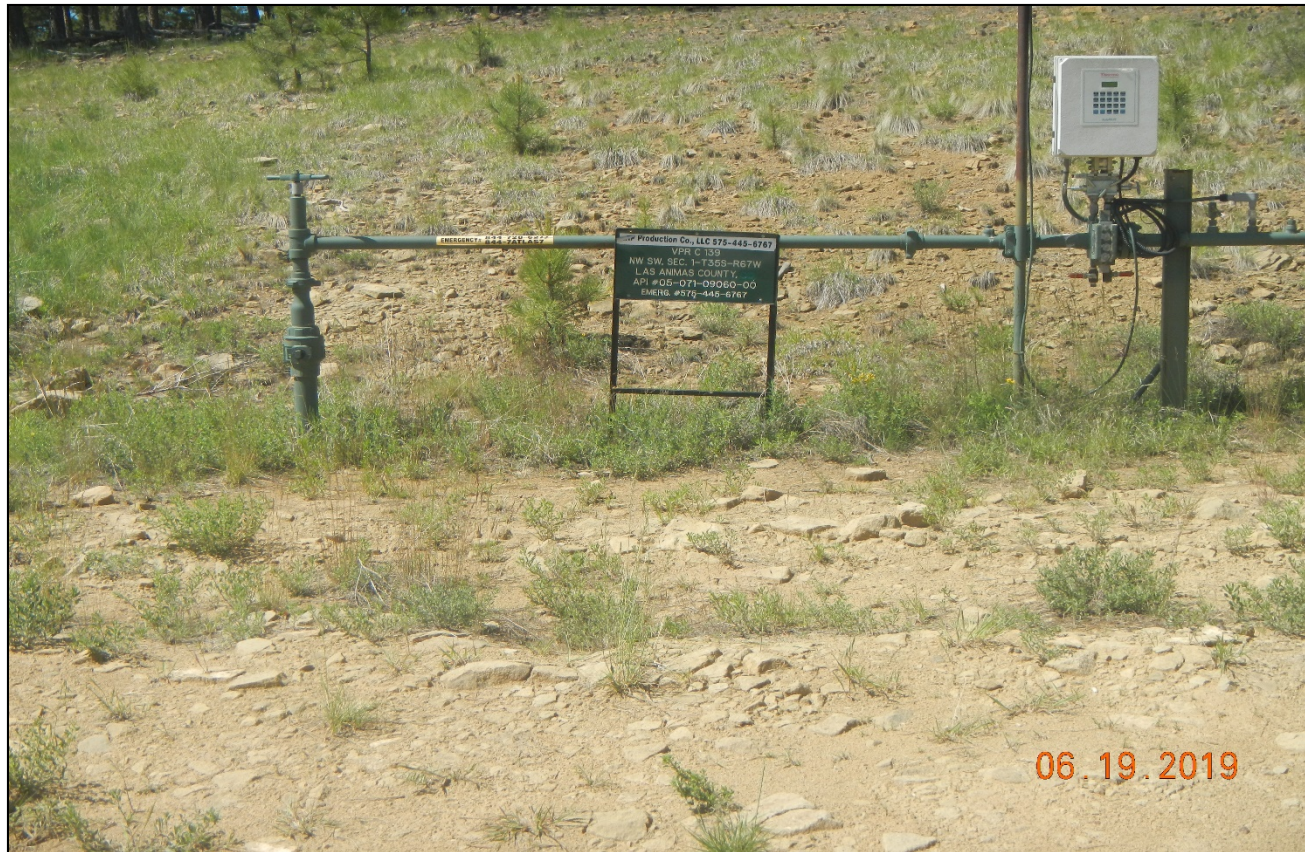
**Photo 6.** Well sign is present. Operator name on sign has not changed yet.
