Inspection Photos

API: 05-071-06867

Operator: ARP PRODUCTION COMPANY
WAPITI OPERATING LLC

Inspection Date: 6/19/2019

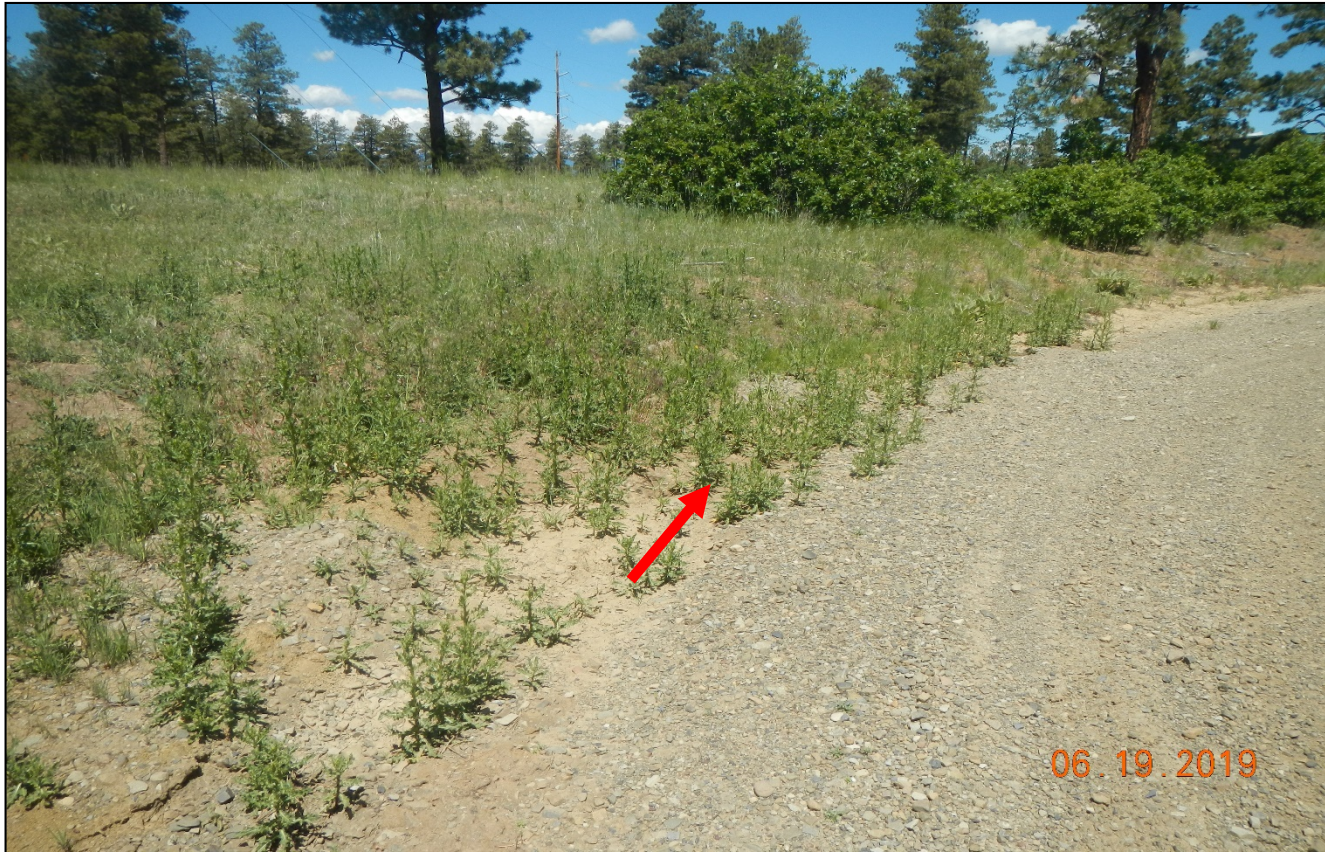
Photo 1. There is List B noxious weeds growing along the access road near the building near the location. (Canada thistle shown in photo)

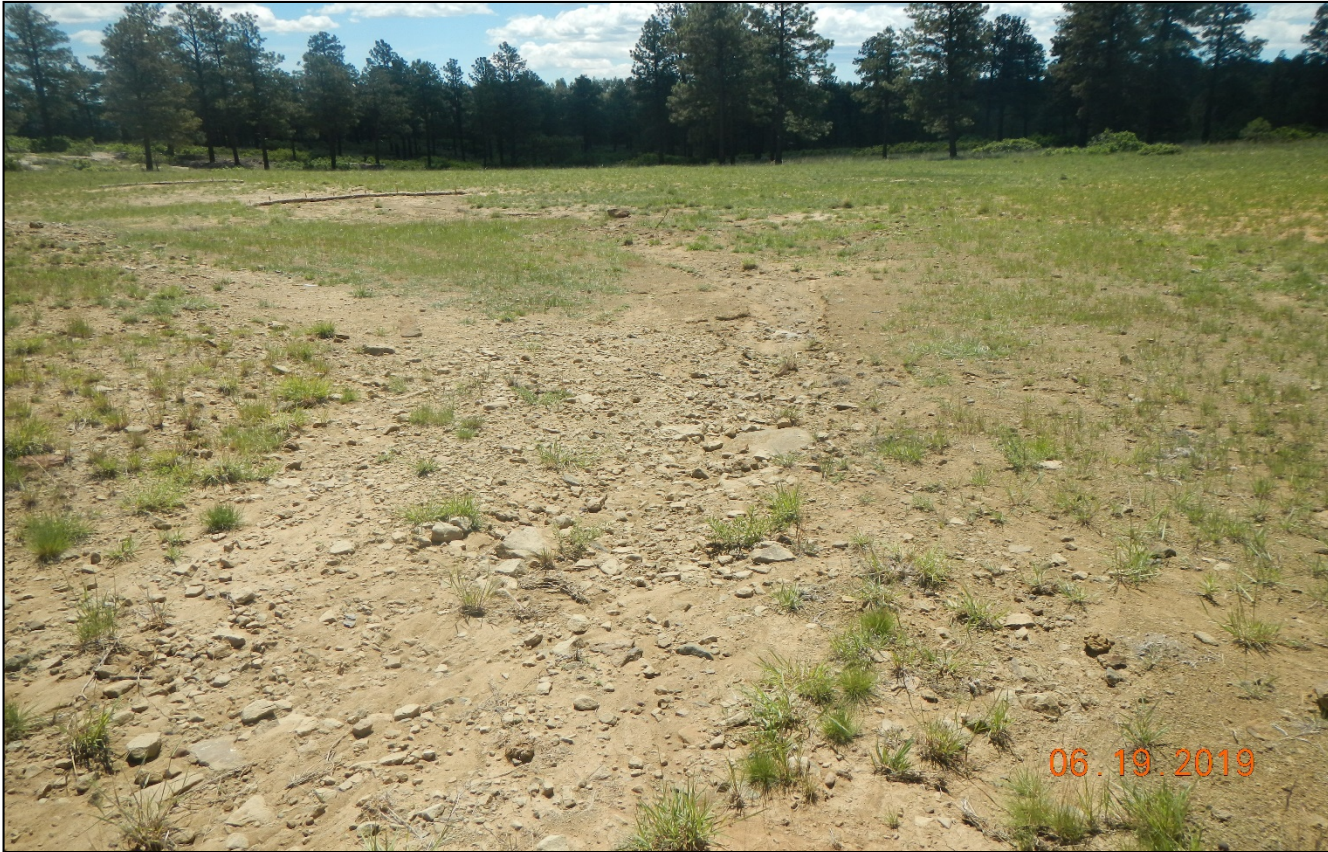
Photo 2. Facing toward the location. Vegetation has not established throughout the location.

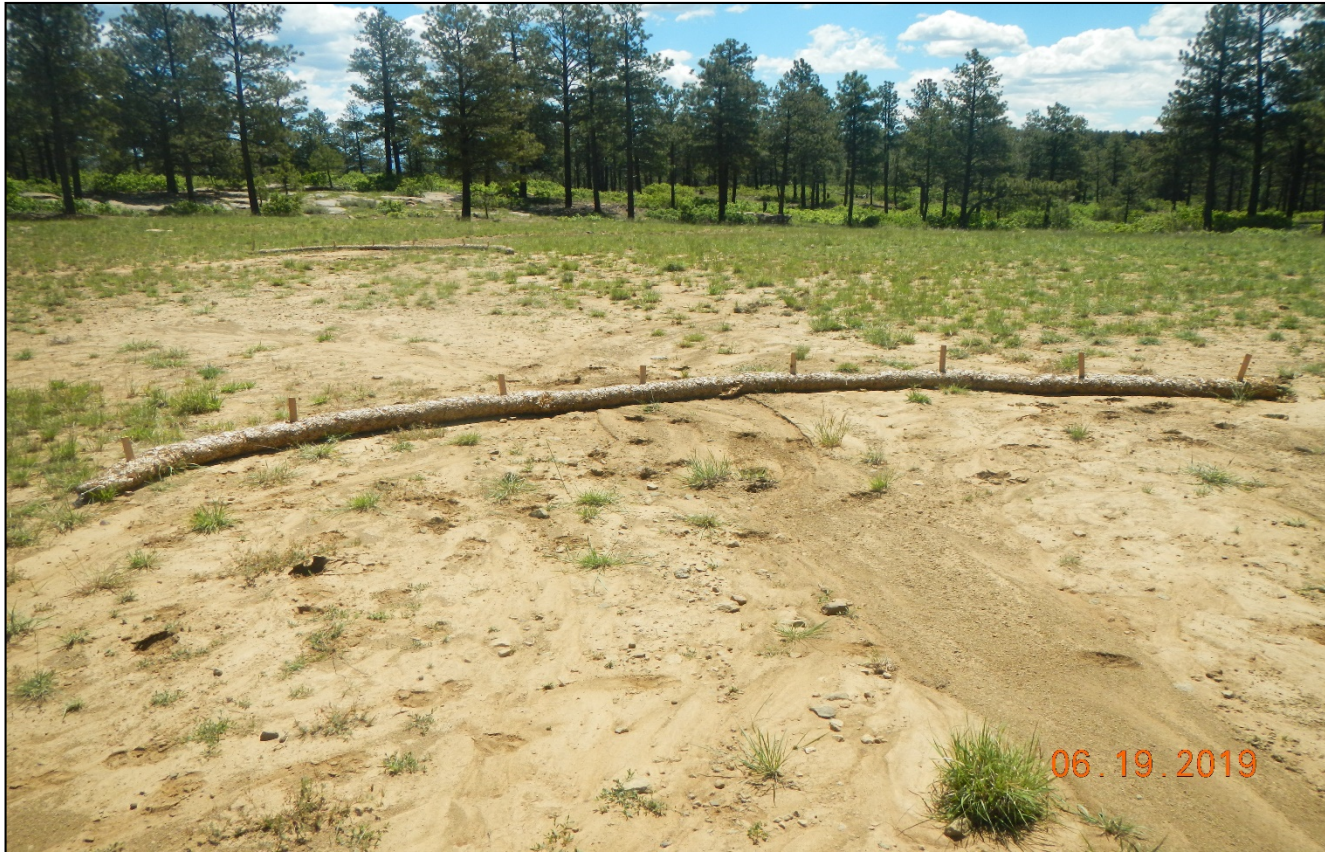
Photo 3. Wattles were installed. There was no sign of seeding or germination in area. Erosion may have washed away seed.

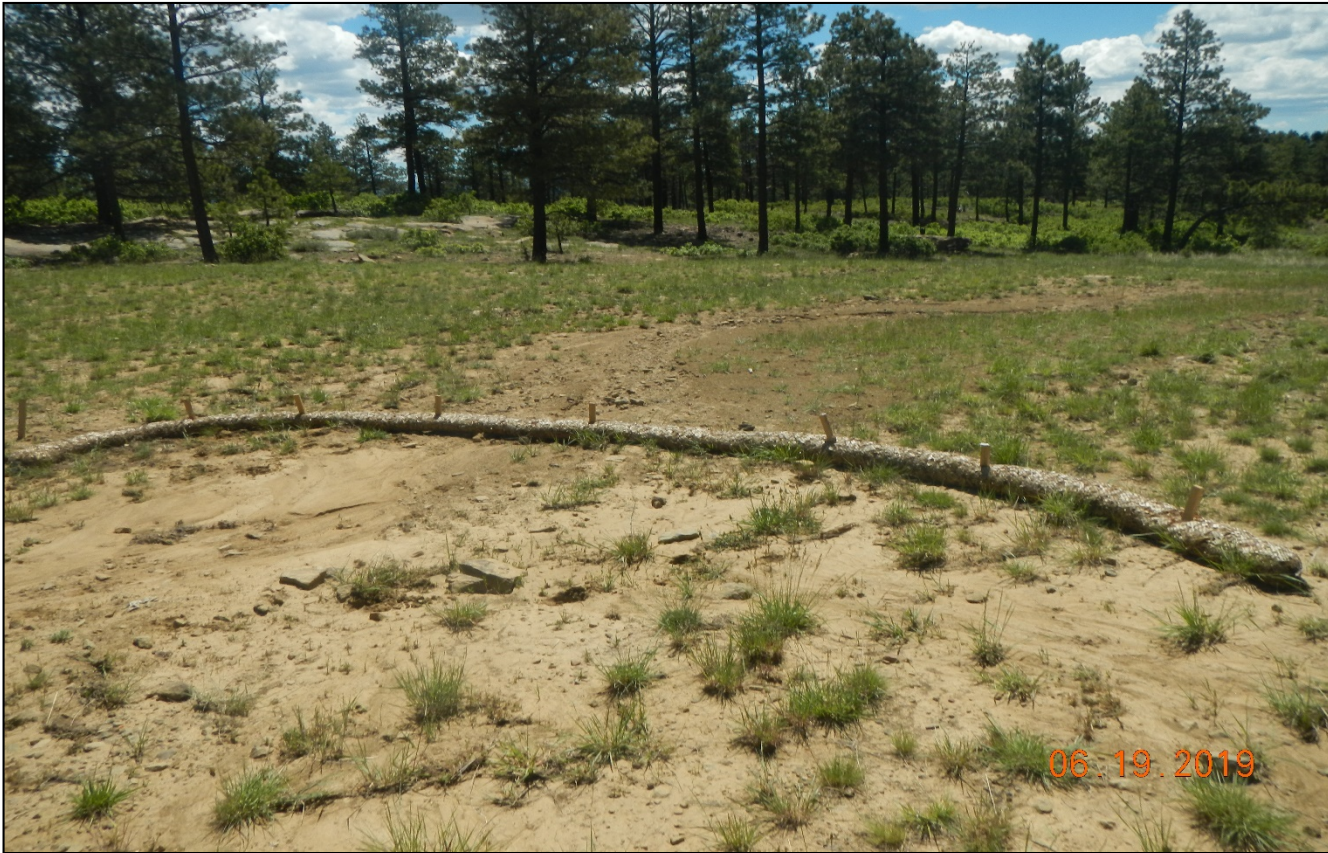
Photo 4. Wattles have been installed however stormwater is flowing underneath wattles.,

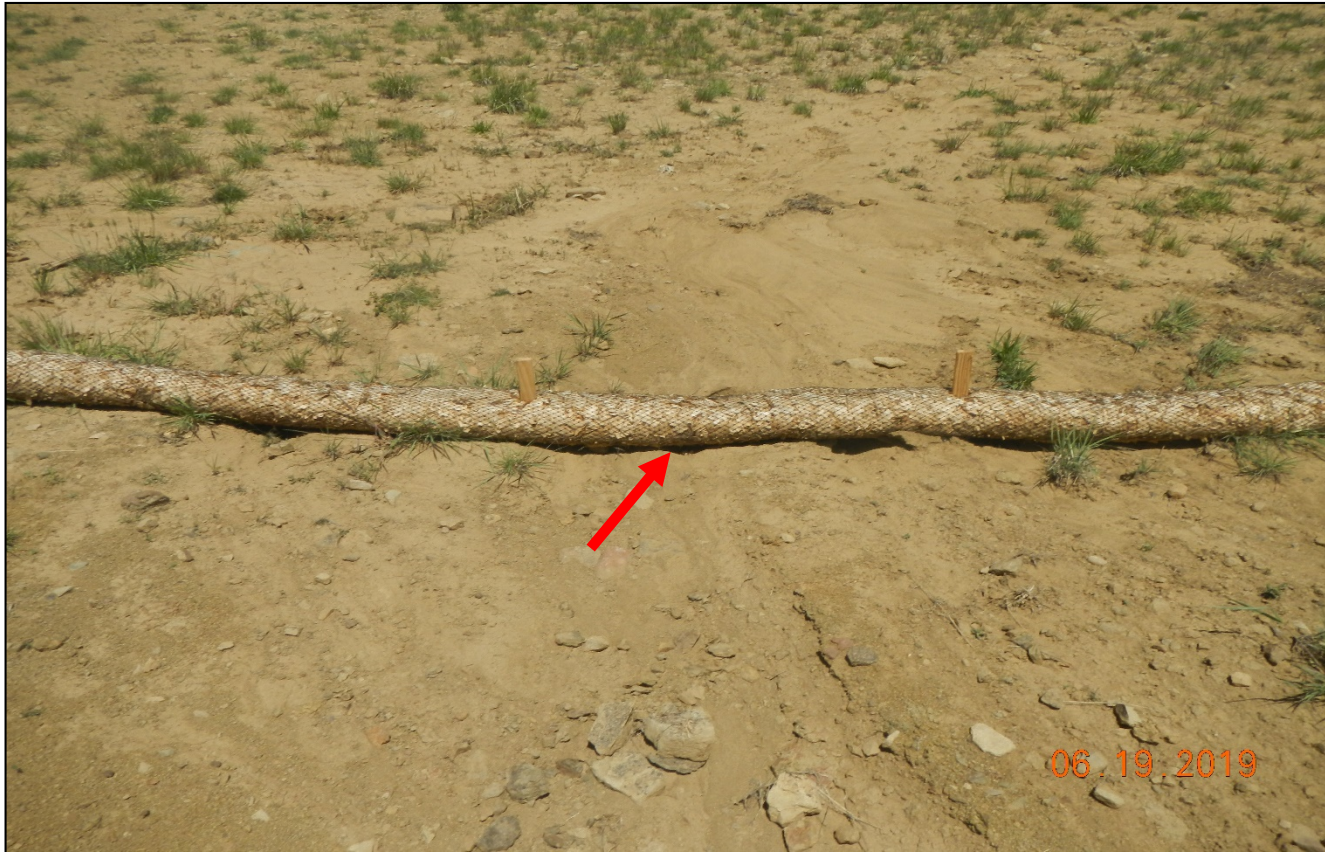
Photo 5. There are sign stormwater is flowing underneath the wattle. Wattles were not properly trenched into the ground.
