Inspection Photos
Location Name: Baierl Fee 3
API: 05-107-06048

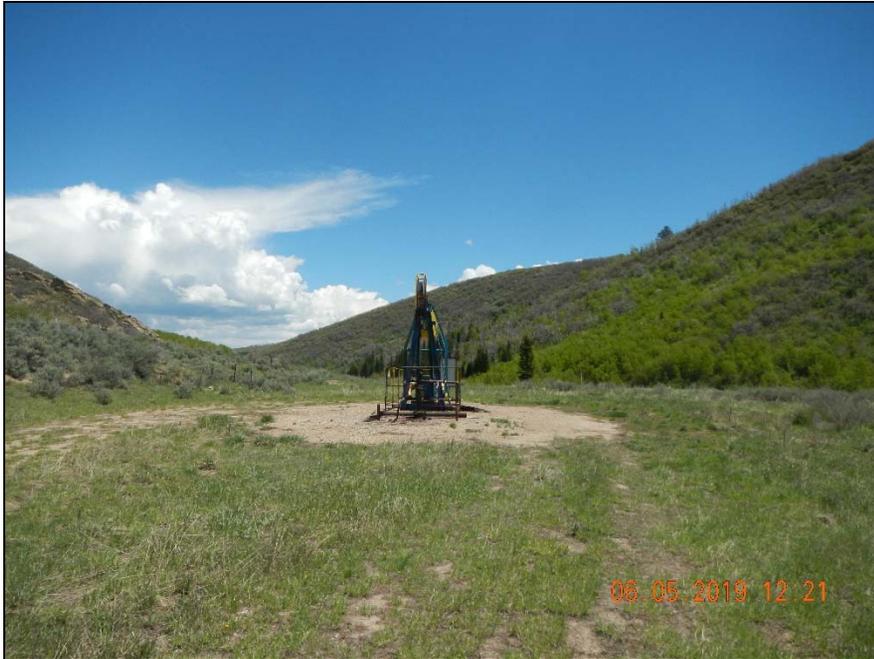
Photo 1. Overview of location taken at entrance facing northeast.

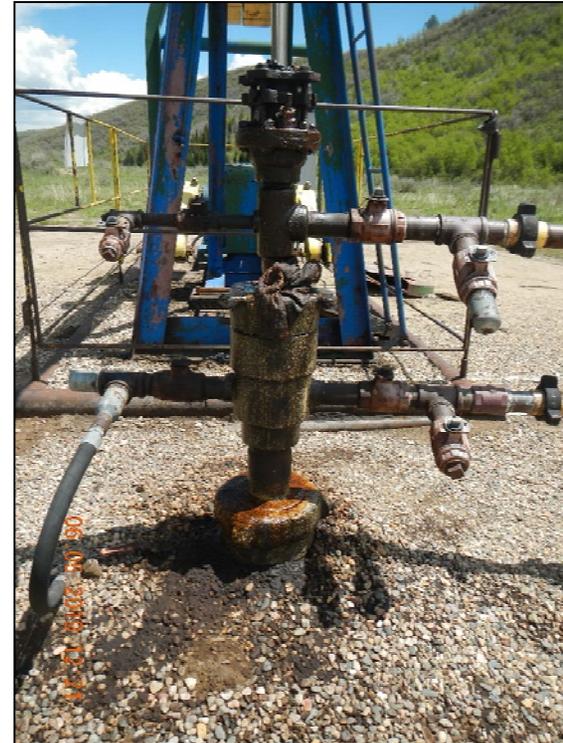
Photo 2. Stained soil at wellhead with fresh gravel on top. Rag stopping apparent slow leak.

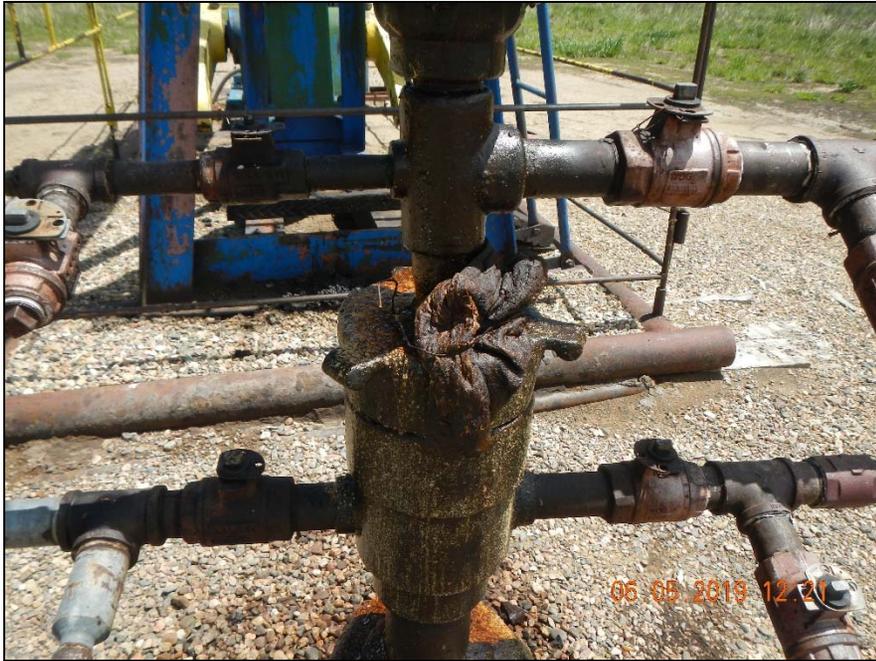
Photo 3. Close-up of rag and apparent slow leak from Photo 2.
