Inspection Photos
Location Name: Mary Hite Fee 1
API: 05-107-06013

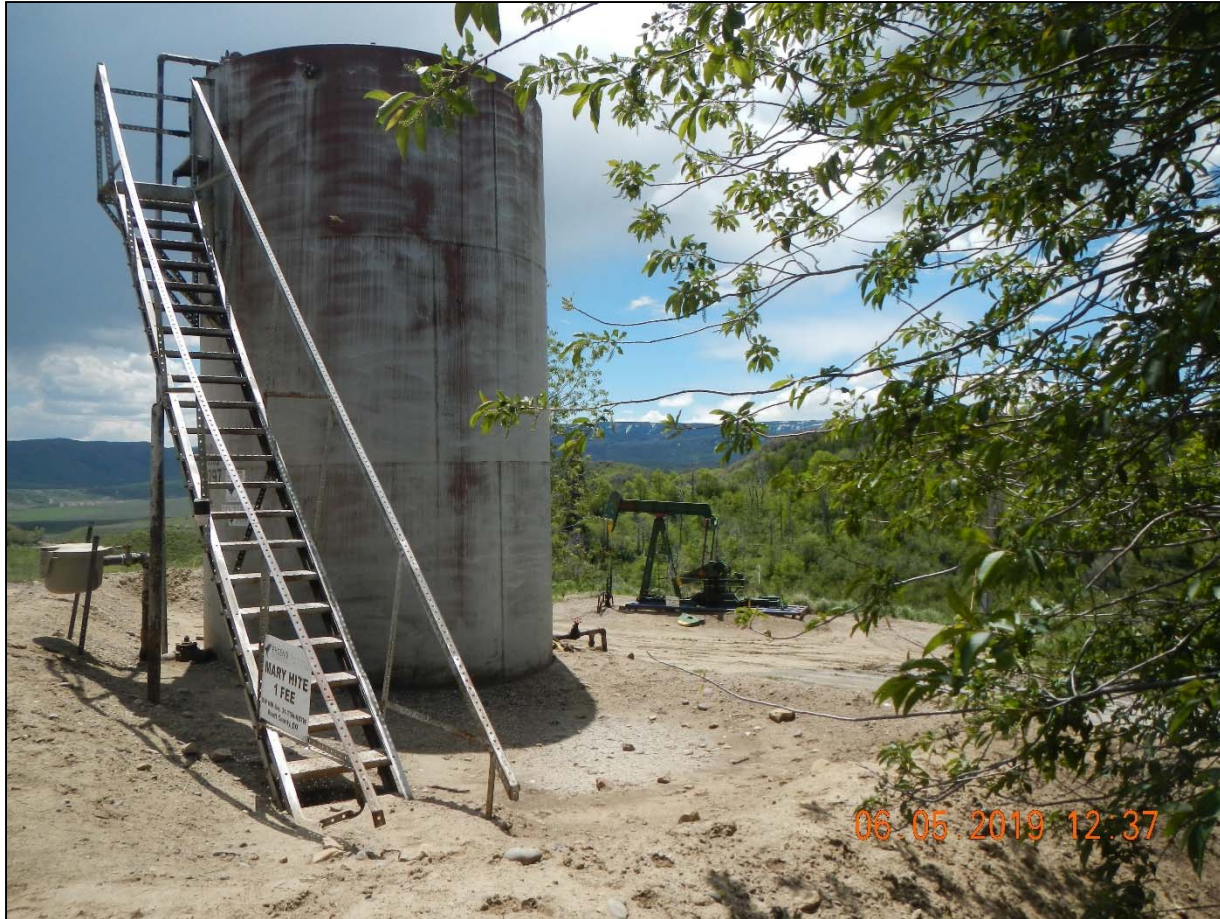
Photo 1. Overview of location taken at entrance facing southwest.

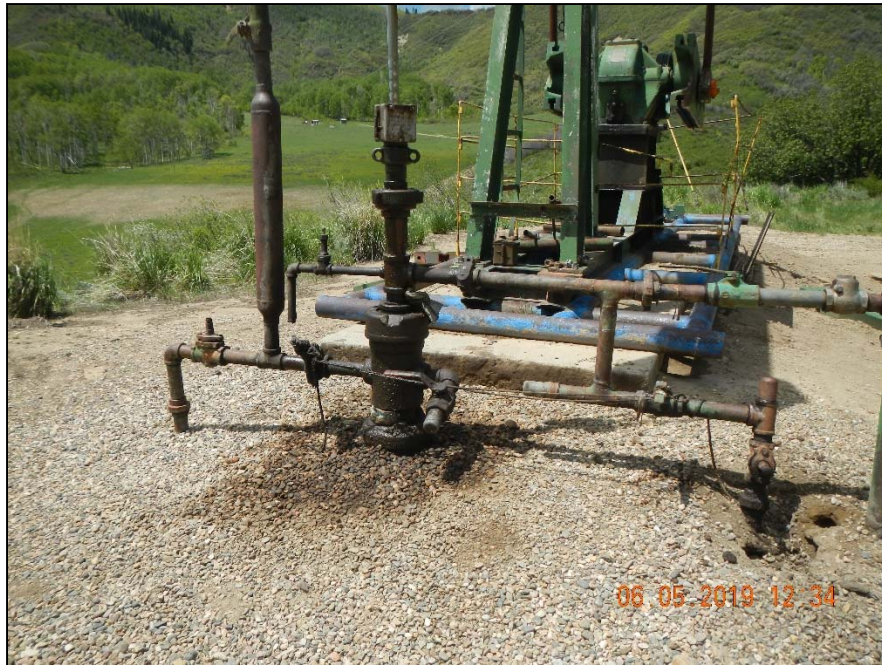
Photo 2. Stained soil at wellhead with fresh gravel on top. Rag stopping apparent slow leak.

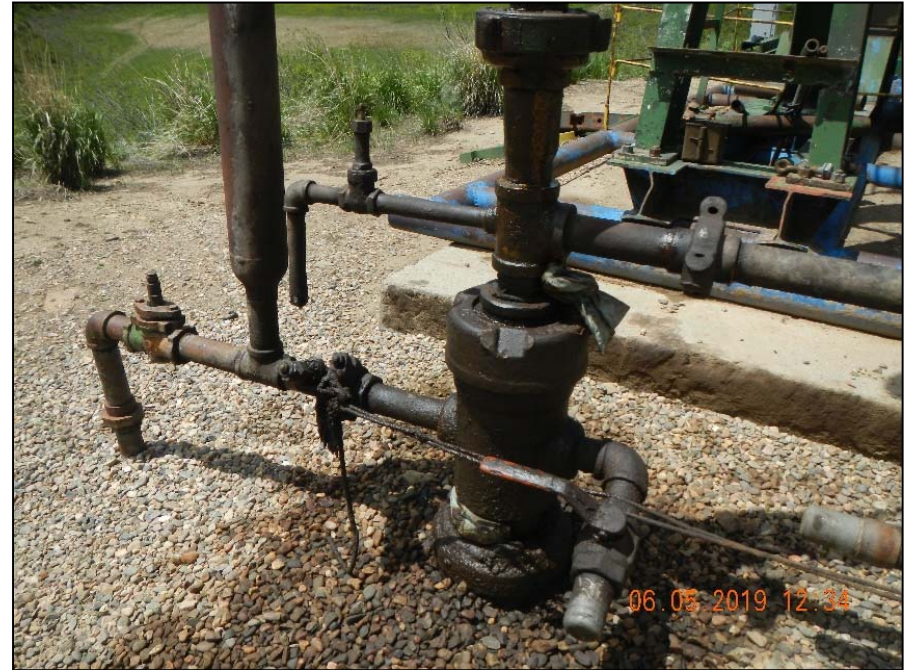
Photo 3. Close-up of photo 2.
