Pit Status Evaluation:

Pit Status Determination

Updated Pit Status: Closed

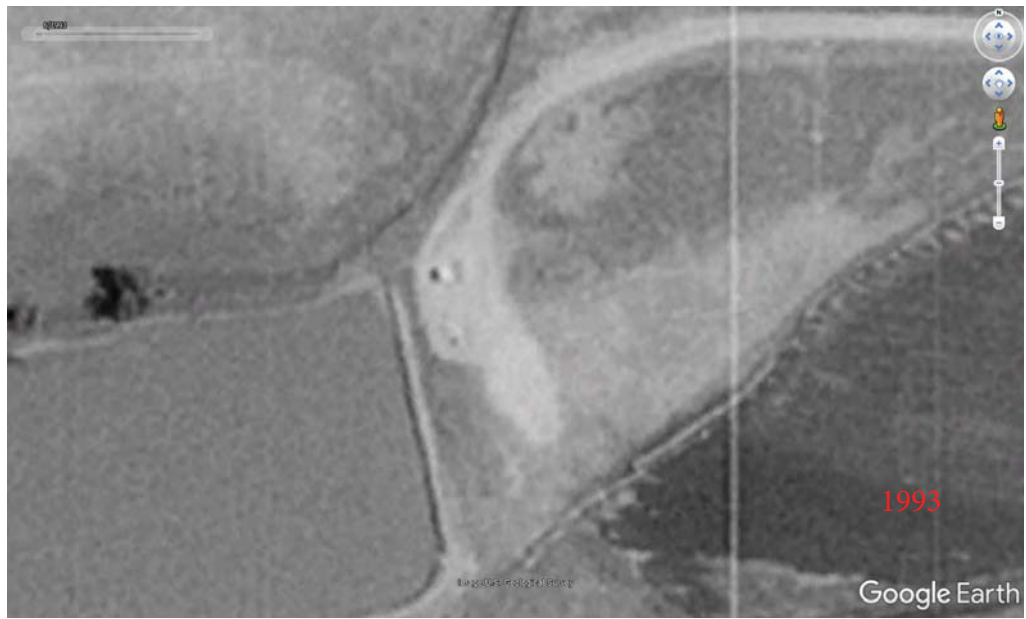
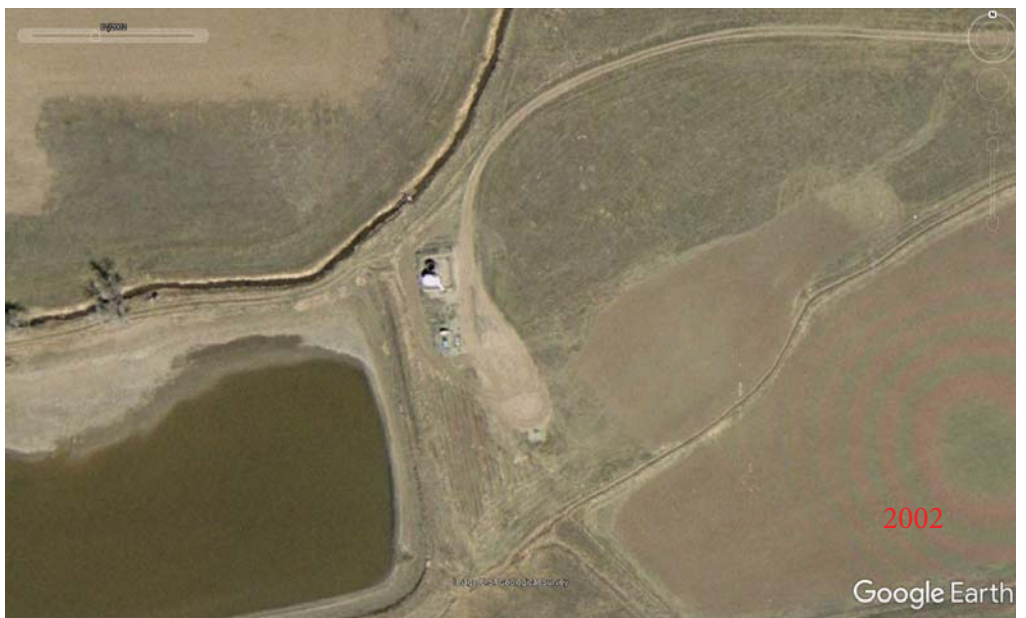
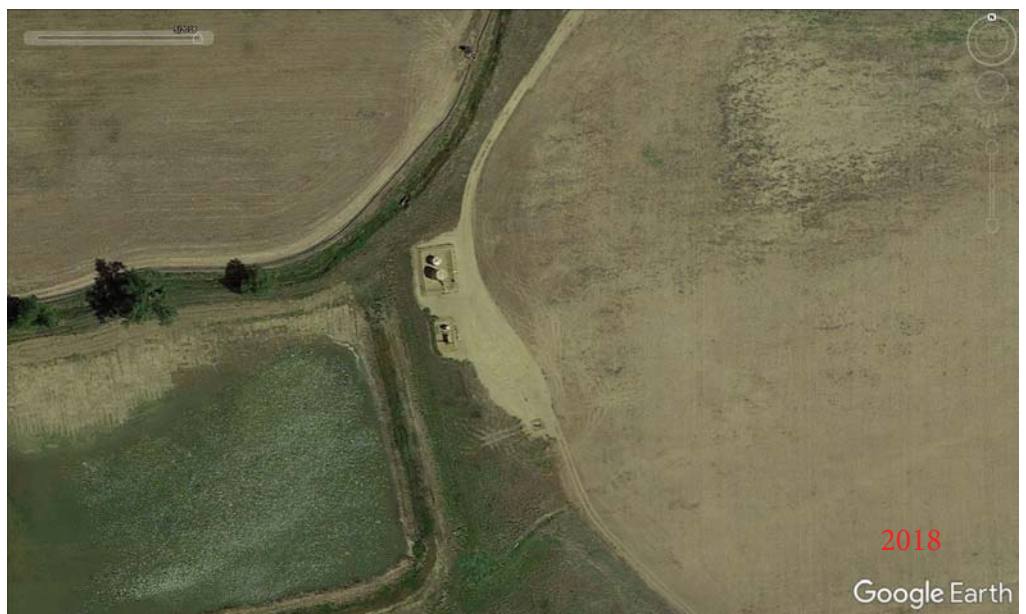
Based on records review and aerial photos, there is no evidence that there was a produced water pit on location. Inspection reports and pit inventory report document a concrete water vault then fiberglass tank on location. The tank was removed under remediation project #13542. Pit status has been changed to closed.
