Inspection Photos
Location Name: ROADSTER 11-34 TR
API#: 05-071-07611
INSP. #: 695100923

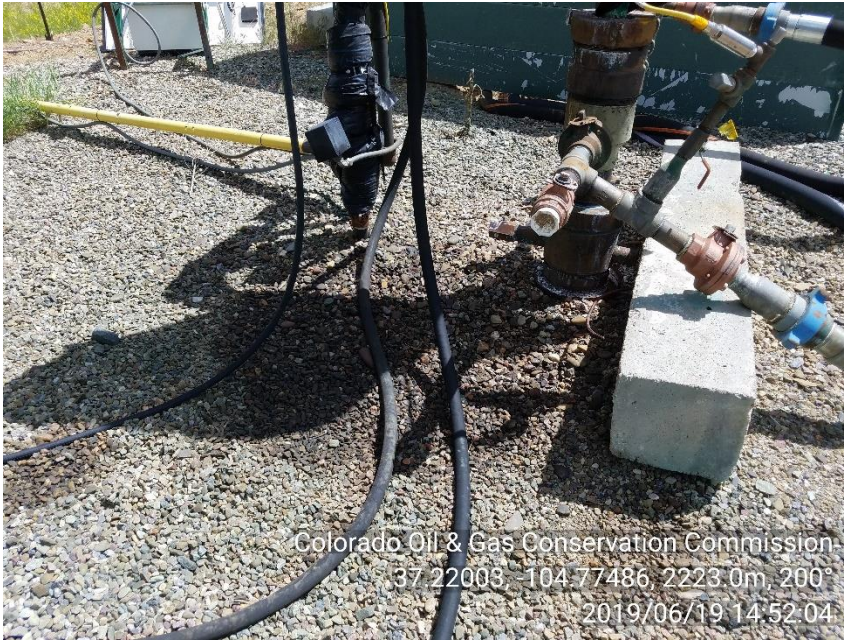
PHOTO 3: AREA OF IMPACTED GRAVEL APP. 7' ROUND NEAR WELLHEAD. Remove and dispose impacted material in approved manner, service and maintain equipment and self inspect to prevent recurrence of conditions per 1002.f(2) and 907. CA DATE 7/19/19

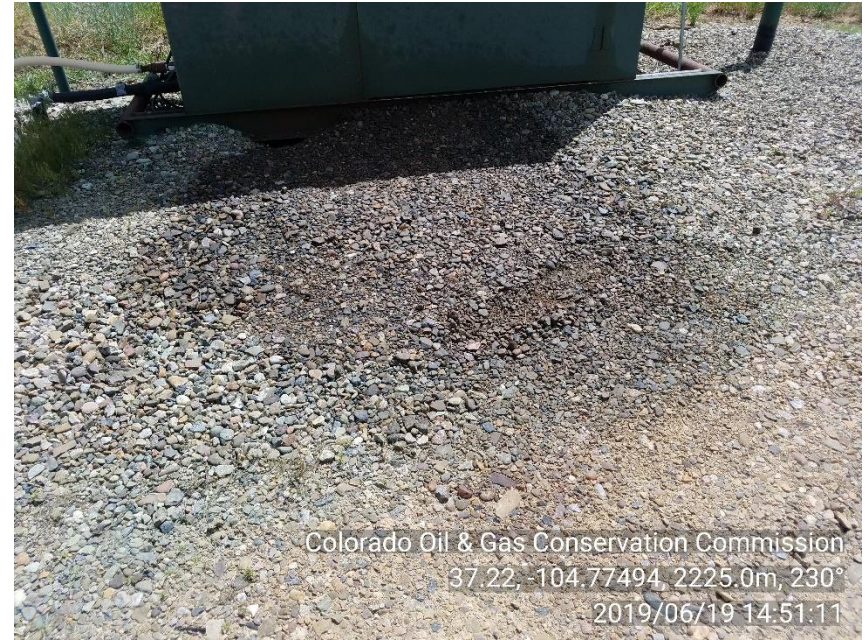
PHOTO 4: AREA OF IMPACTED GRAVEL APP. 5' ROUND NEAR METERHOUSE. Remove and dispose impacted material in approved manner, service and maintain equipment and self inspect to prevent recurrence of conditions per 1002.f(2) and 907. CA DATE 7/19/19

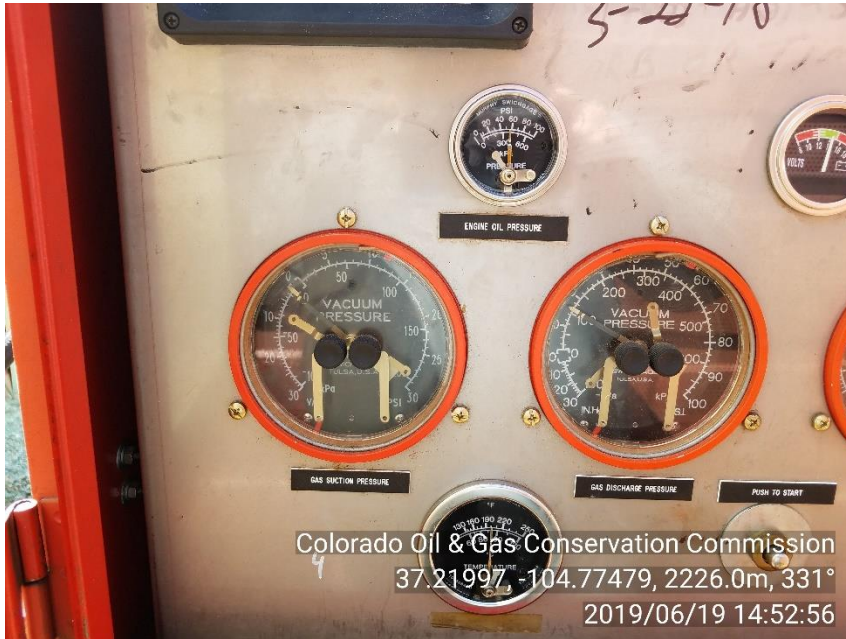
PHOTO 5: Vacuum pump observed on well without COGCC approval. Provide COGCC with documentation showing approval of use of vacuum pump. CA DATE 7/4/19.
