Inspection Photos

Location Name: BURRO CANYON 13-28 FOLLOWUP

API#: 05-071-06113

INSP. #: 695100925

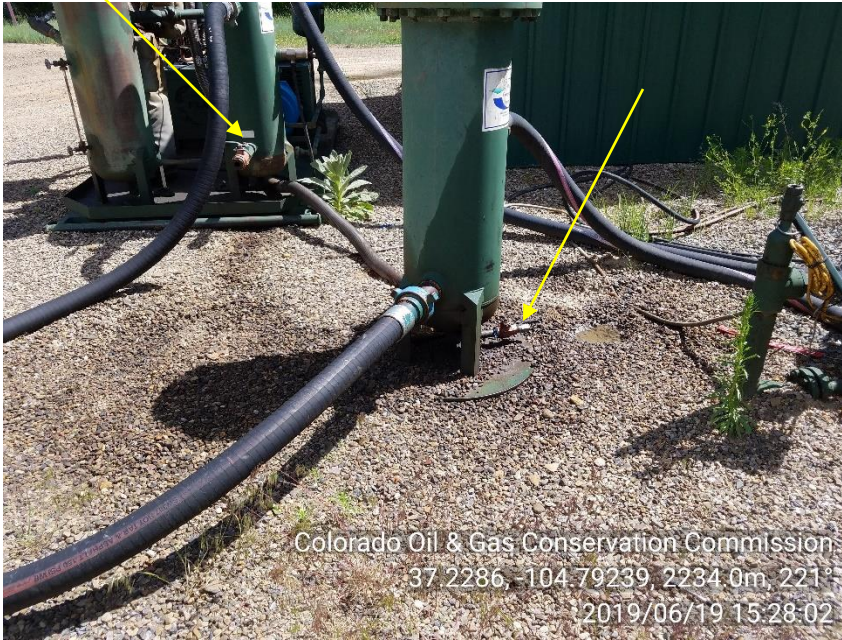
PHOTO 3: APP. 10' BY 5' AREA OF IMPACTED SOIL BETWEEN WELLHEAD AND COMPRESSOR APPEARS TO BE FROM DRAINING TWO DIFFERENT DRAINS HIGHLIGHTED BY ARROWS ON PHOTO. IMMEDIATELY STOP DUMPING DRAINS ON LOCATION AND Remove and dispose impacted material in approved manner, service and maintain equipment and self inspect to prevent recurrence of conditions per 1002.f(2) and 907. CA DATE 7/21/19.

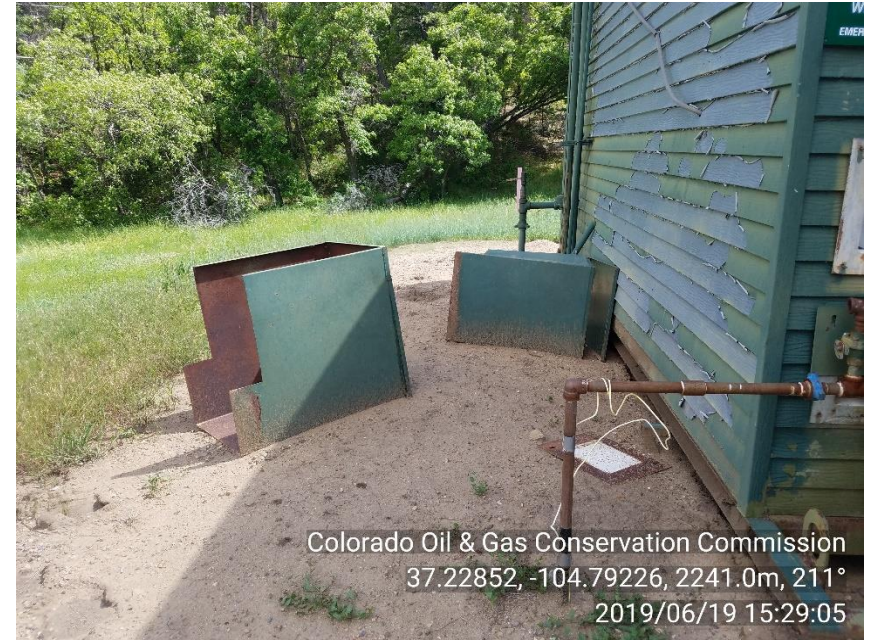
PHOTO 4: UNUSED EQUIPMENT THAT WAS NOTED IN PREVIOUS INSPECTION (DOC# 688400098) WAS NOT ADDRESSED. IMMEDIATELY REMOVE UNUSED EQUIPMENT IN ACCORDANCE WITH RULE 603.f. CA DATE IMMEDIATELY.

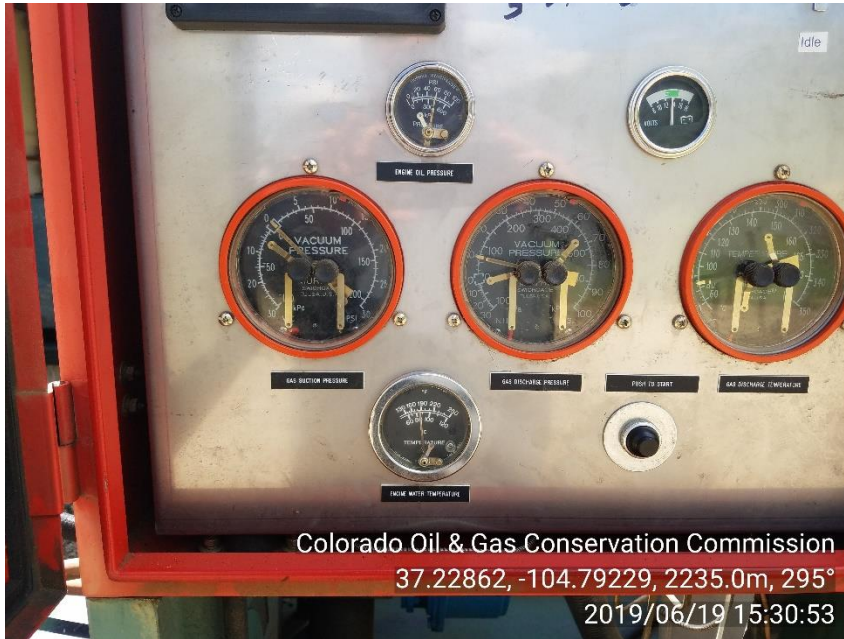
**PHOTO 5: Vacuum pump observed on well without COGCC approval.
Provide COGCC with documentation showing approval of use of
vacuum pump. CA DATE 7/6/19.**
